# Pantex Plant

## Third Five-Year Review Report Remedial Action Progress Pantex Plant

August 2023  
Final

**THIRD FIVE-YEAR REVIEW REPORT  
PANTEX PLANT SUPERFUND SITE  
CARSON COUNTY, TEXAS  
EPA ID NO: TX4890110527**

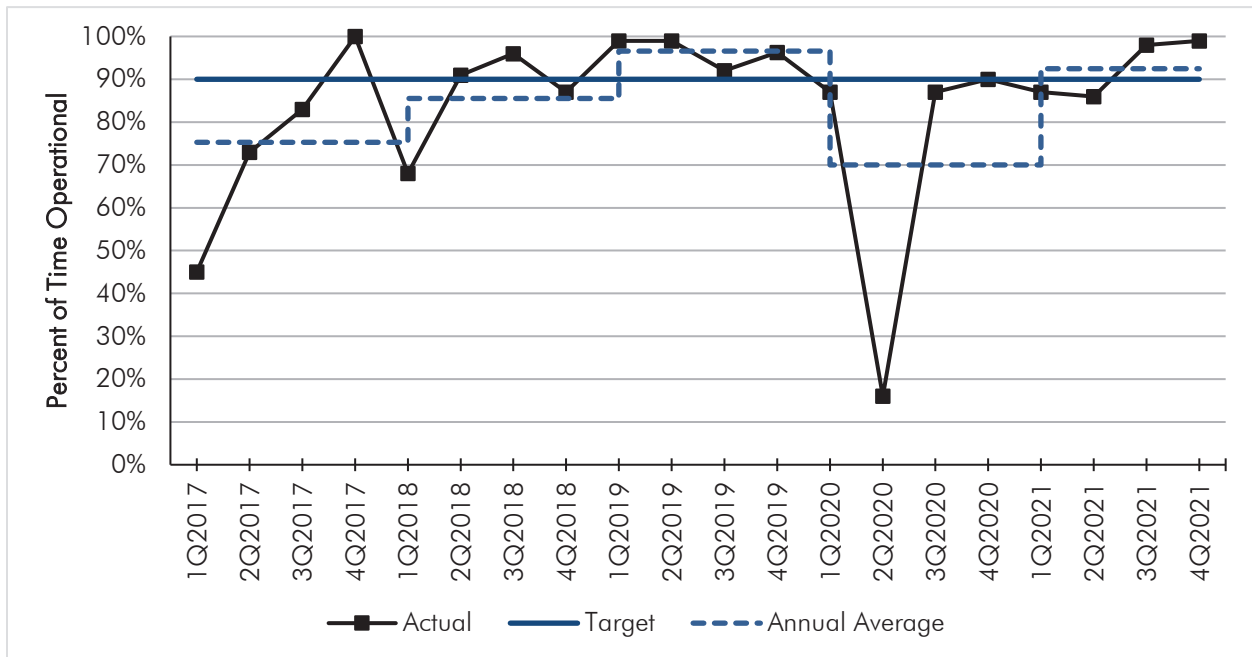
Figure 4.9. SEPTS Operational Time vs. Target

Significant downtime for the SEPTS occurred in Quarter 2 2020 as a result of the COVID-19 pandemic, and reduced operation resulted from equipment failures in the subsurface irrigation system throughout the FYR period.

As depicted on **Figure 4.10** and **Figure 4.11**, the SEPTS was below throughput goals throughout the Third FYR period. System throughput was primarily affected by permit discharge limitations to Playa 1, necessitated by breaks in the subsurface irrigation system. Initially both the P1PTS and SEPTS were operated at a limited throughput to accommodate discharge limitations, but the SEPTS was prioritized over the P1PTS in the later portion of the Third FYR period.

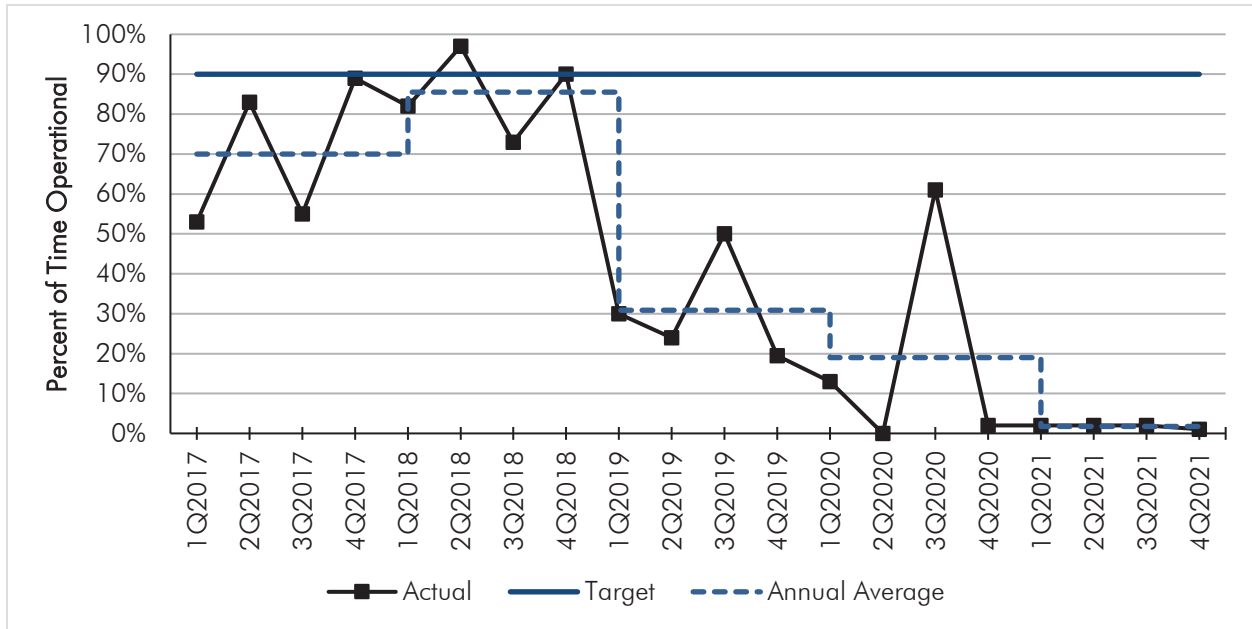
Figure 4.15. P1PTS Operational Time vs. Target

The operational time for the P1PTS over the previous five years is shown on **Figure 4.15**. Overall operational time for the P1PTS was close to the 90% goal through 2018 but decreased in 2019 to prioritize operation of the SEPTS. The primary O&M challenge for the P1PTS was operation of the irrigation system for discharge of treated groundwater. A new center-pivot irrigation system is being constructed east of FM 2373 and is expected to be operational in summer 2023. The center-pivot

irrigation system will supplement the subsurface irrigation system and allow discharges of treated water to Playa 1 to cease.

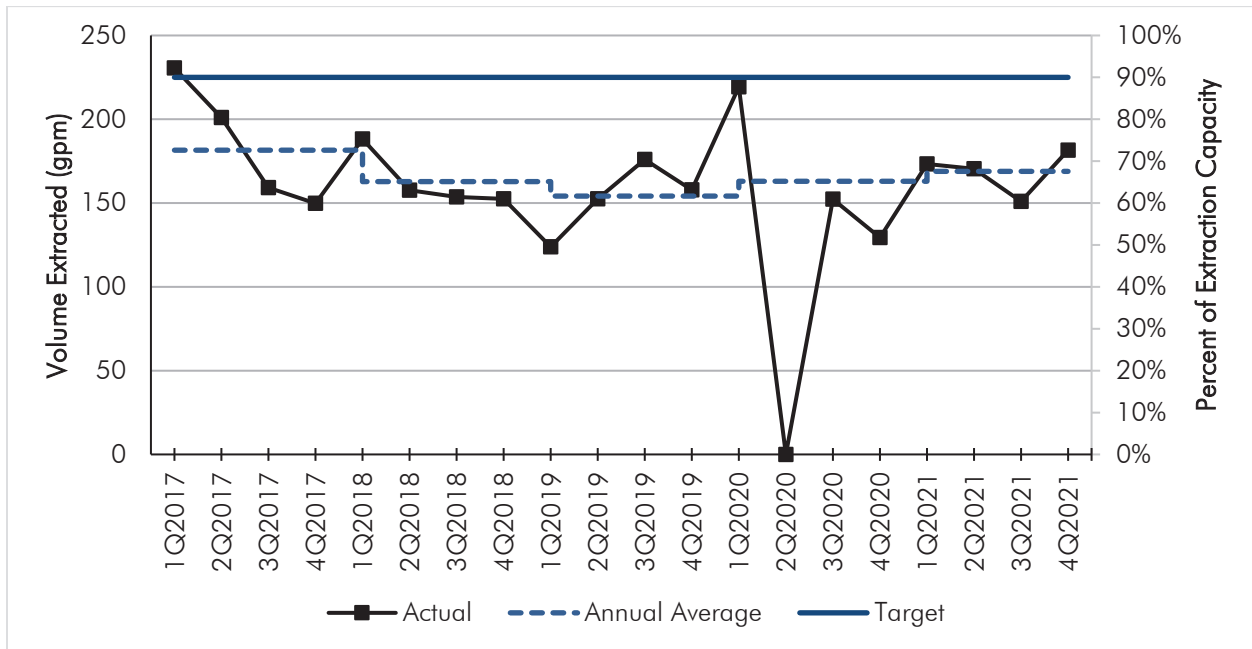
Figure 4.16. P1PTS Average GPM and % Capacity

The calculated gpm depicted on Figure 4.16 accounts for water extracted from the well field during the time the system operates and is affected by the yield from each well, well downtime, or reduced flow required by restrictions associated with the WWTF/irrigation system or permit discharge limits to Playa 1. As shown on Figure 4.16, the gpm goal was met for only one quarter during the FYR period in 2017.

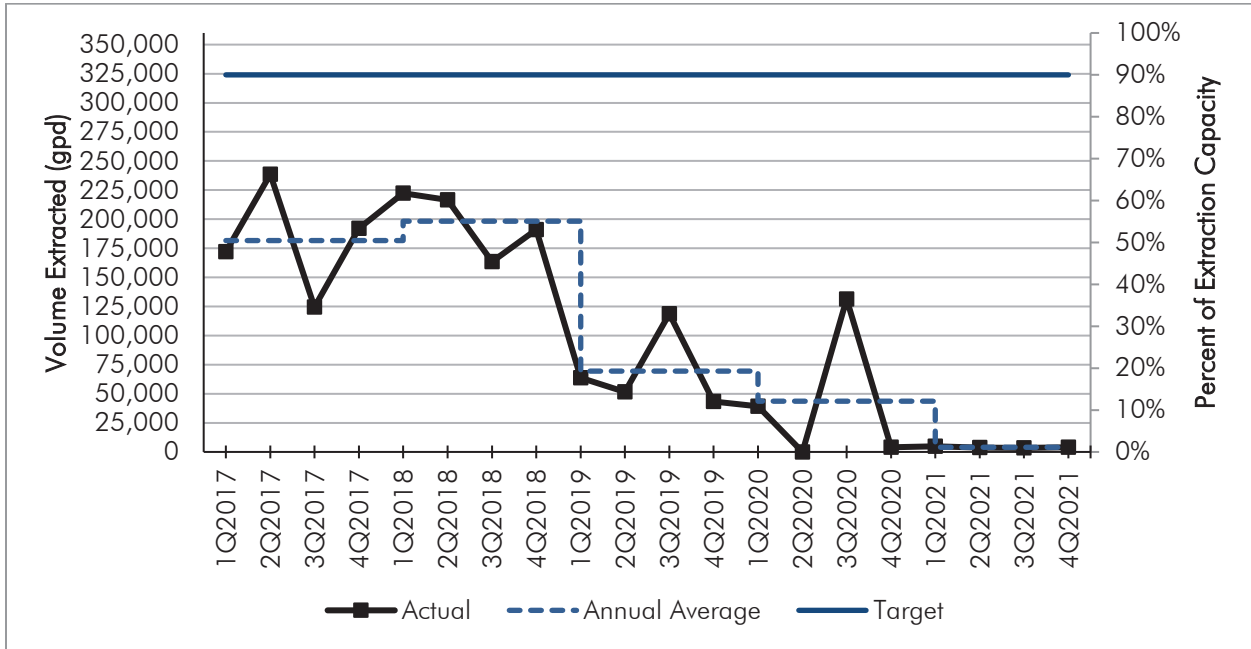
Figure 4.17. P1PTS Average GPD and % Capacity

Figure 4.17 depicts the average gpd by quarter, the percentage of total capacity achieved, and the goal for the system. The calculated gpd accounts for flow from the well field, as well as system operation time during the day, and is affected by system operational time, ability to extract water from the wells, and reduced flow to the WWTF/irrigation system and Playa 1. Therefore, the P1PTS gpd was affected by the aforementioned subsurface irrigation system equipment failures, permit discharge limitations, and prioritization of the SEPTS.
