## PANTEX QUARTERLY PROGRESS REPORT

### Remedial Action Progress

## 1st Quarter 2019

In support of Hazardous Waste Permit #50284 and Pantex Plant Interagency Agreement
June 2019

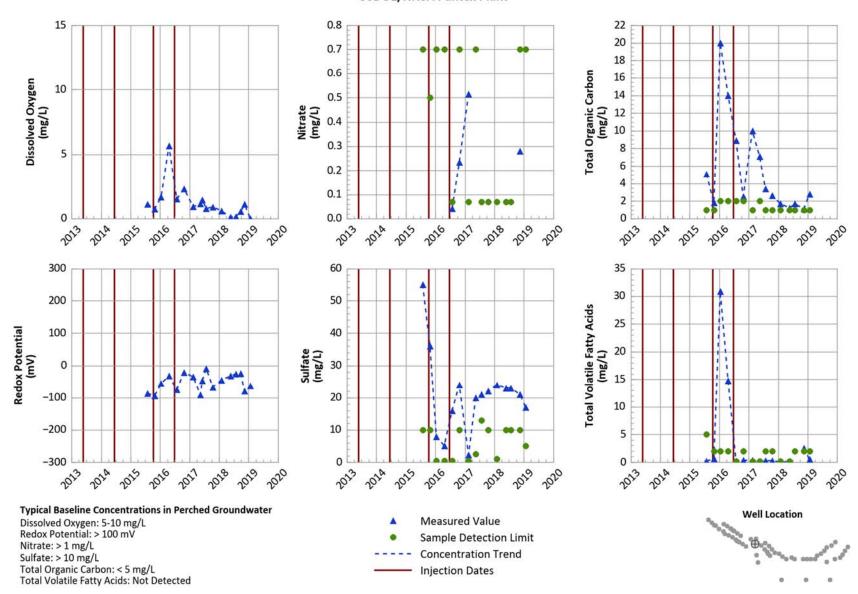
PTX06-1170 Treatment Zone Performance Indicators USDOE/NNSA Pantex Plant

Although there are areas in the treatment zone that indicate mild reducing conditions, the downgradient data indicate that treatment is effectively reducing contaminants and risk across the Zone 11 ISB. The mild conditions at PTX06-1170 and PTX06-ISB075 indicate a greater loss of reducing conditions in that area of the ISB and possible higher concentrations of TCE moving through the system. Future downgradient COC concentrations may increase after the impacted water moves through the system.

Pantex began rehabilitation of wells in March 2019 and injection began in May 2019. Due to very mild conditions that occur in the new treatment zone wells in the expansion area, Pantex will continue to evaluate data to determine the appropriate timing and need for bioaugmentation.

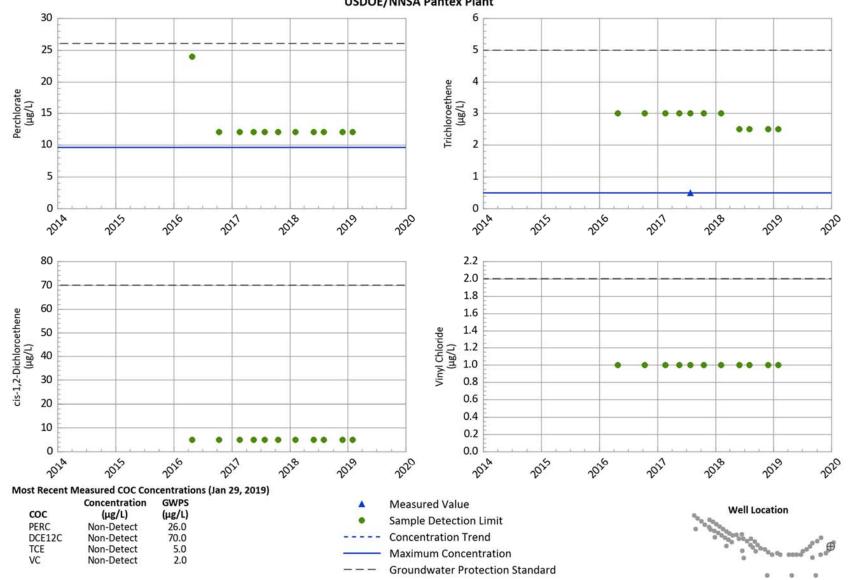
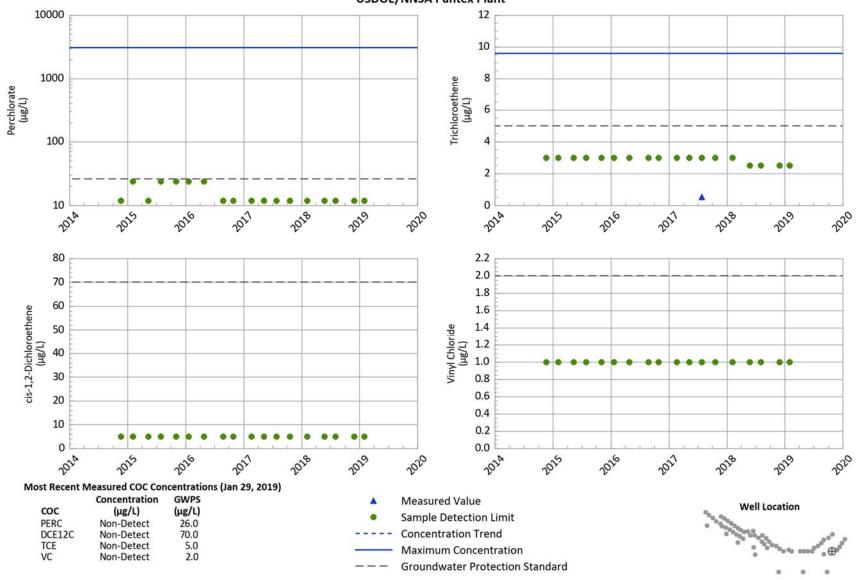
Two former ISB injection wells (PTX06-ISB079 and PTX06-ISB082) are now monitored to evaluate conditions on the perchlorate (eastern) side of the ISB, in the second row of injection wells. Pantex will no longer inject into the second row of wells, and will evaluate these wells to ensure that treatment continues on the perchlorate side of the ISB. Additionally, the results for upgradient well PTX06-1127 indicate that TCE is increasing above GWPS on the eastern side of the ISB, so treatment of the TCE will also be evaluated to determine if changes in the system operation will be required. Currently, perchlorate and the low concentrations of TCE that occur on the eastern side are treated to non-detect. No degradation products of TCE were detected.
