PANTEX QUARTERLY PROGRESS REPORT

Remedial Action Progress

3rd Quarter 2021

In support of Hazardous Waste Permit #50284 and Pantex Plant Interagency Agreement December 2021

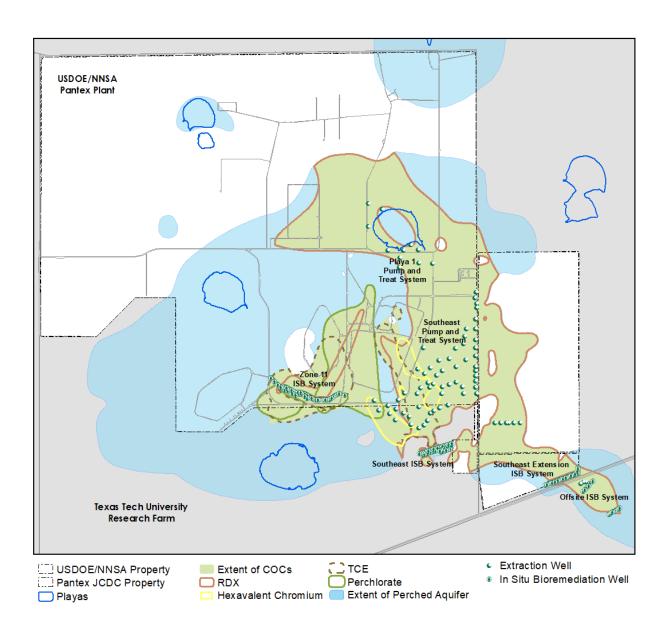
Extent of Perched Groundwater and Contaminant Plumes

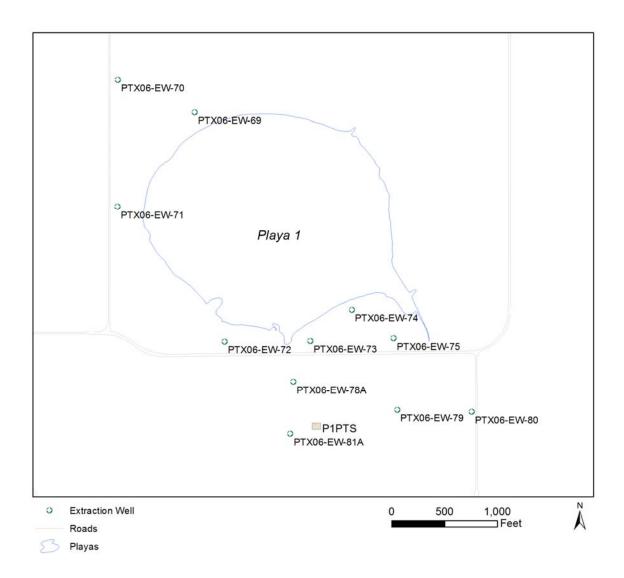
Playa 1 Pump and Treat System Wells

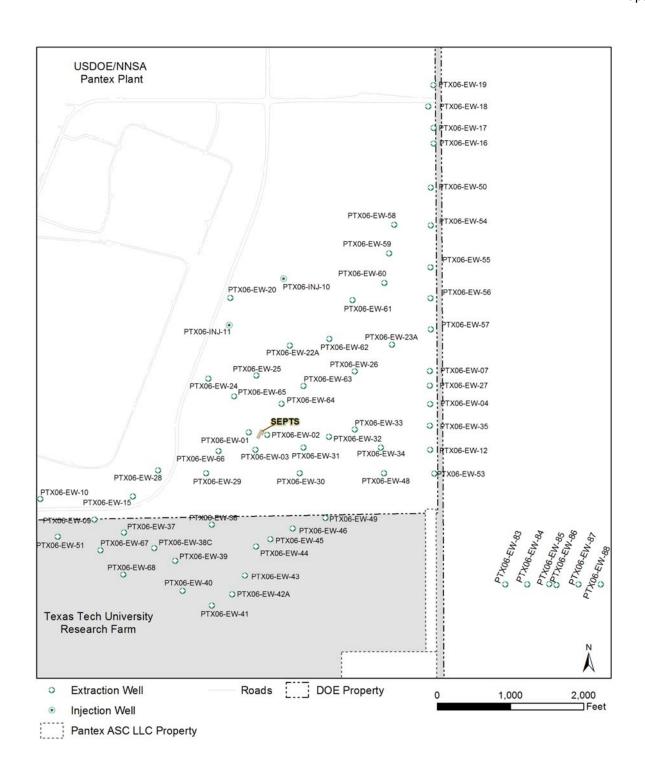
Southeast Pump and Treat System Wells

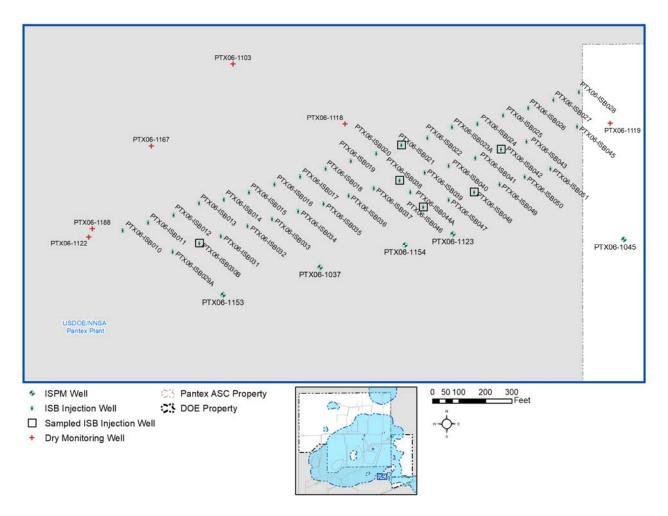
Southeast ISB Wells and Sampling Locations

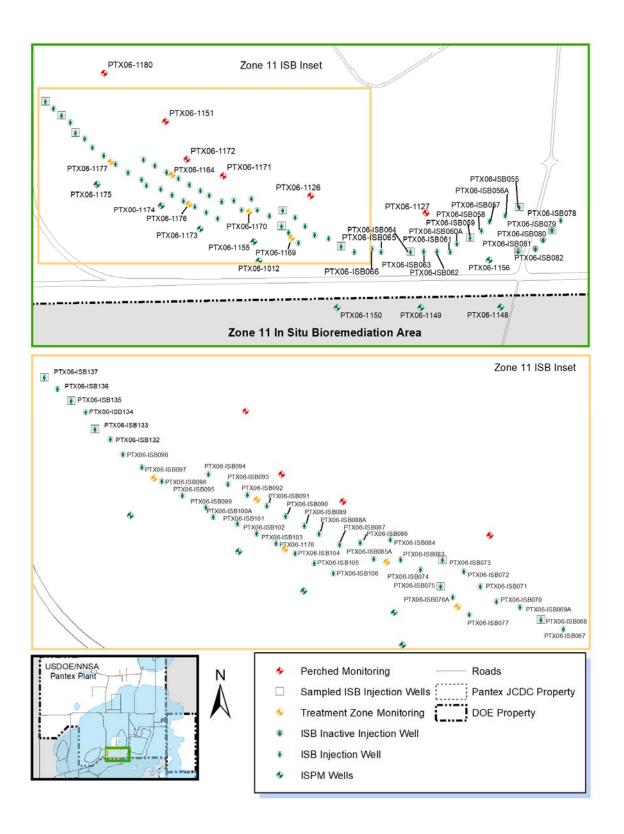
Zone 11 ISB Wells and Sampling Locations

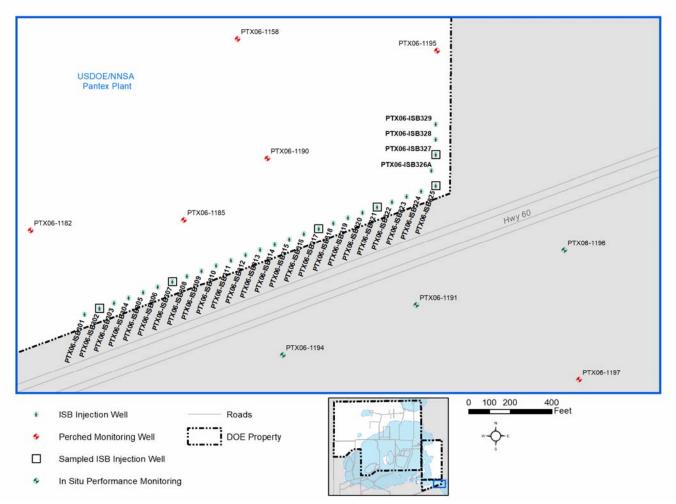
Southeast ISB Extension Wells and Sampling Locations

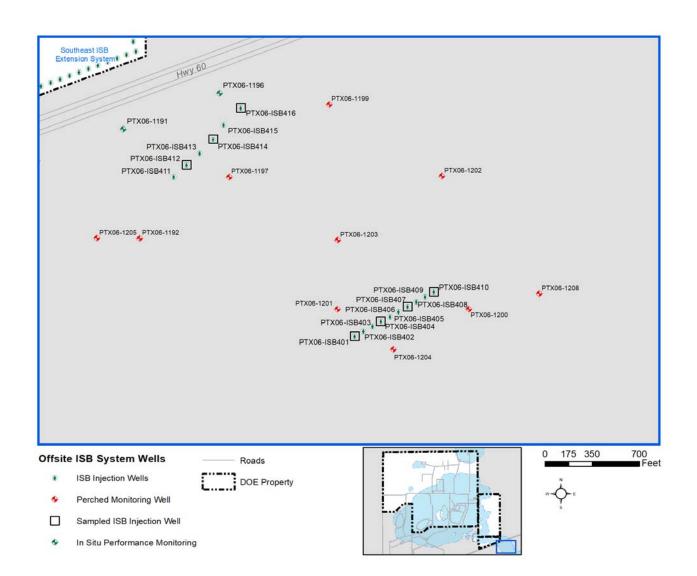
Offsite ISB Wells and Sampling Locations

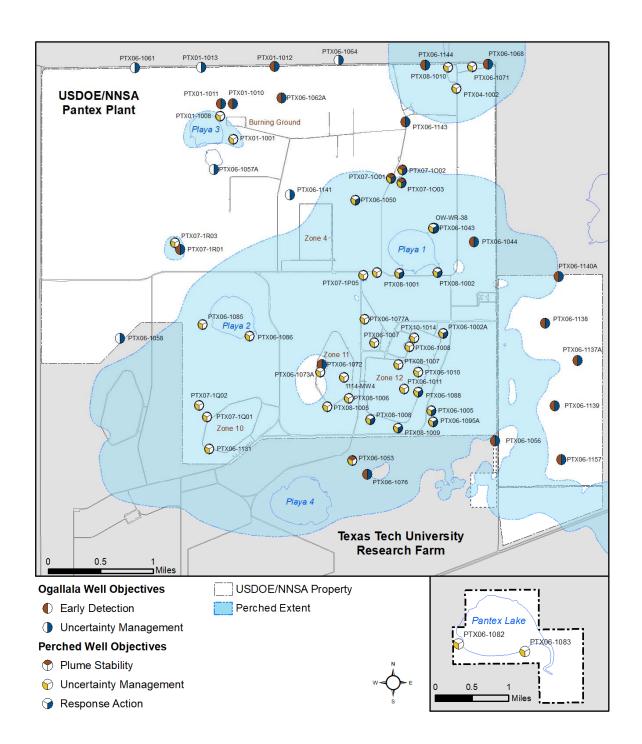
Uncertainty Management and Early Detection Wells Evaluated in the Quarterly Progress Report

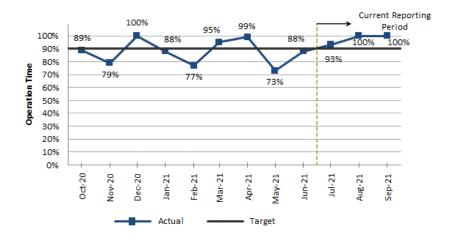
SEPTS Operation Time vs Target

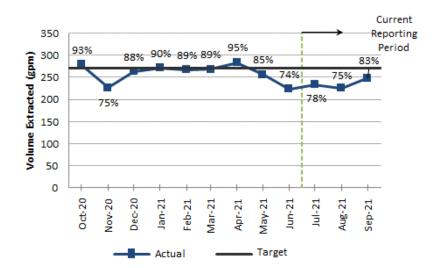
SEPTS Average GPM and % Capacity

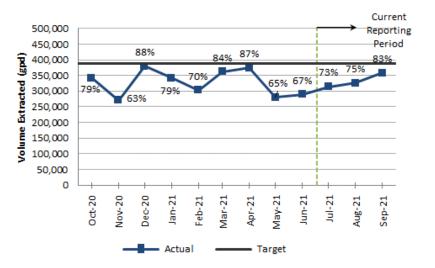
SEPTS GPD and % Capacity

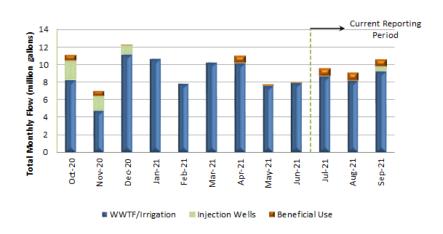
SEPTS Monthly Total Flow

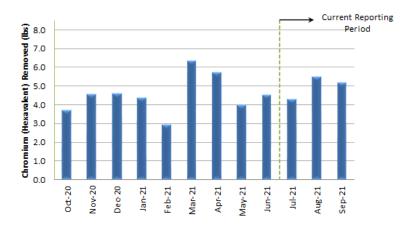
SEPTS Chromium Mass Removal by Month

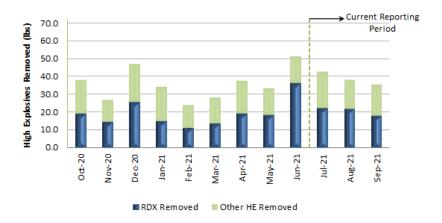
SEPTS HE Mass Removal by Month

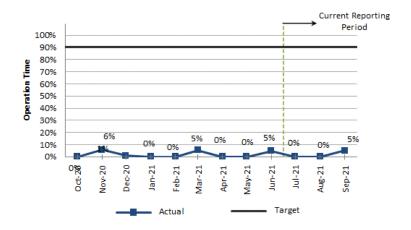
P1PTS Operational Time Vs Target

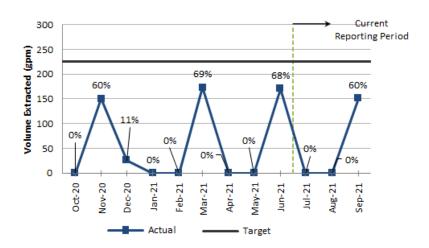
P1PTS Average GPM and % Capacity

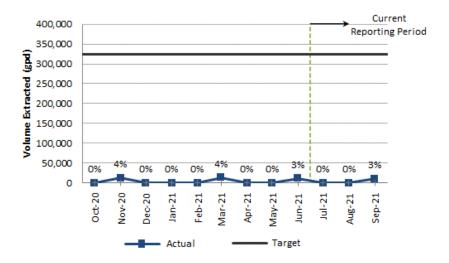
P1PTS Average GPD and % Capacity

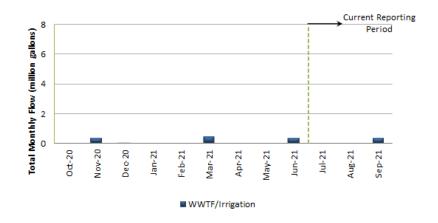
P1PTS Monthly System Total Flow

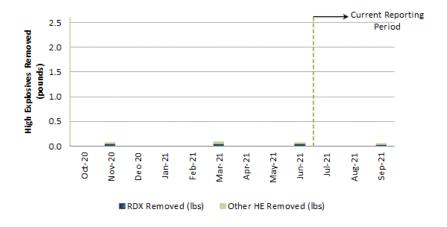
P1PTS HE Mass Removal by Month

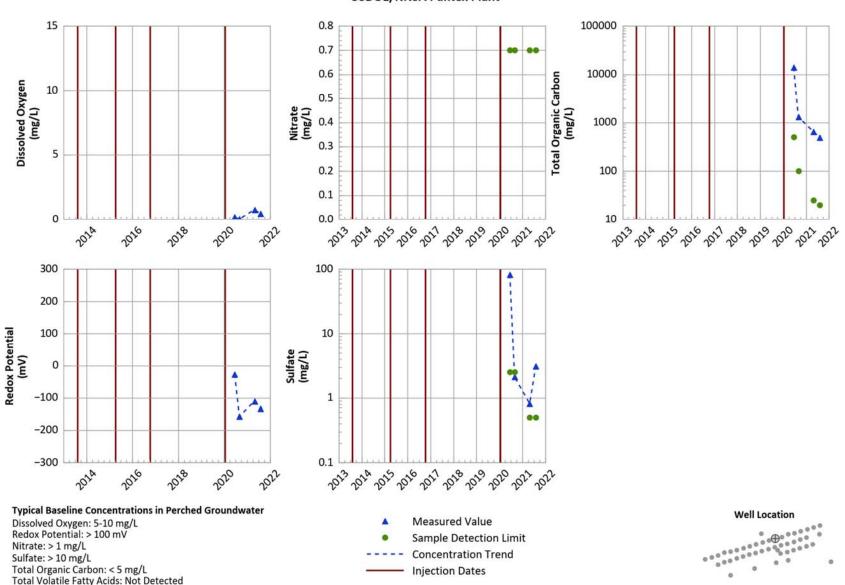
PTX06-ISB021 Treatment Zone Performance Indicators USDOE/NNSA Pantex Plant

Five injection wells and four downgradient ISPM wells were sampled at Southeast ISB in the 3rd quarter. One downgradient ISPM well has gone dry and can no longer be sampled. Analytical data indicate that reducing conditions continue at the treatment zone in four of five wells. Very mild reducing conditions were observed at PTX06-ISB048, a third row well, indicating that treatment may not be effective at that location. All wells have total organic carbon to allow continued treatment.

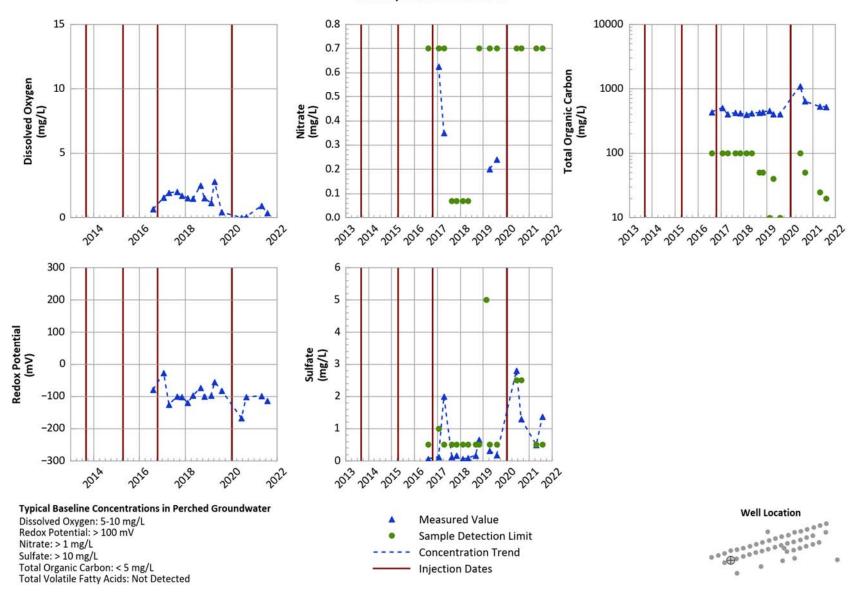
PTX06-ISB030B Treatment Zone Performance Indicators USDOE/NNSA Pantex Plant

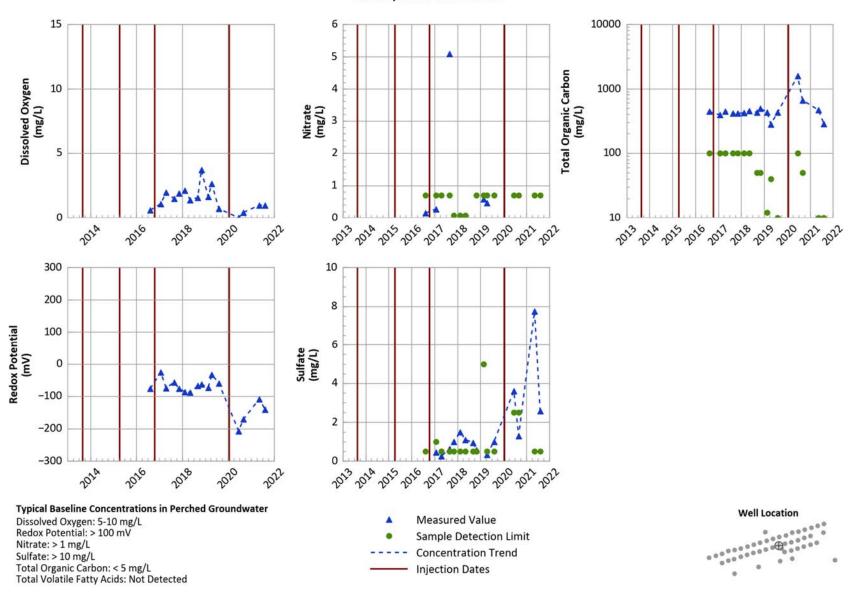
PTX06-ISB038 Treatment Zone Performance Indicators USDOE/NNSA Pantex Plant

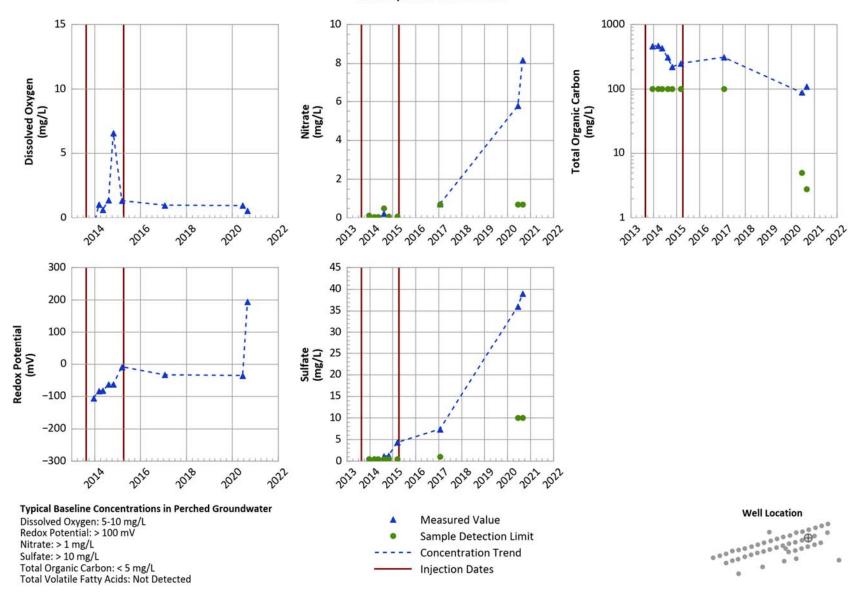
PTX06-ISB042 Treatment Zone Performance Indicators USDOE/NNSA Pantex Plant

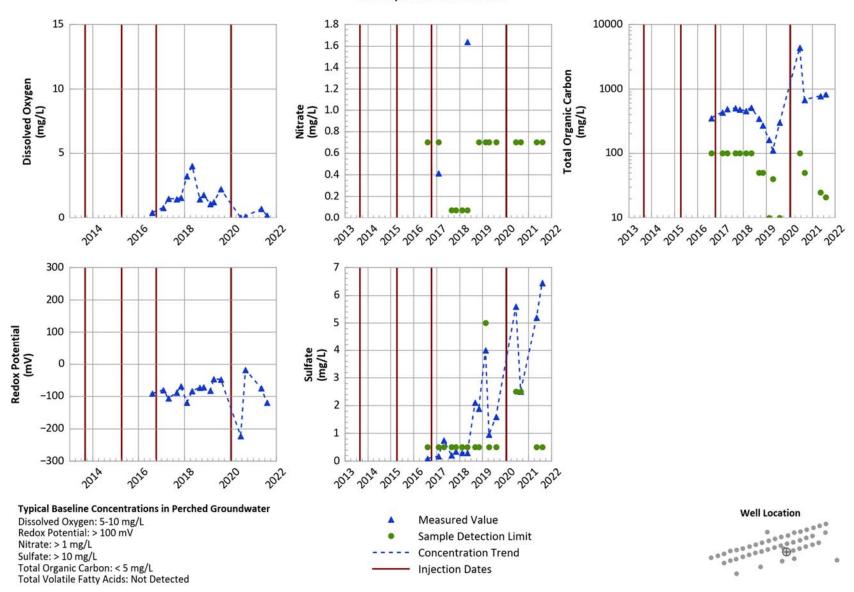
PTX06-ISB046 Treatment Zone Performance Indicators USDOE/NNSA Pantex Plant

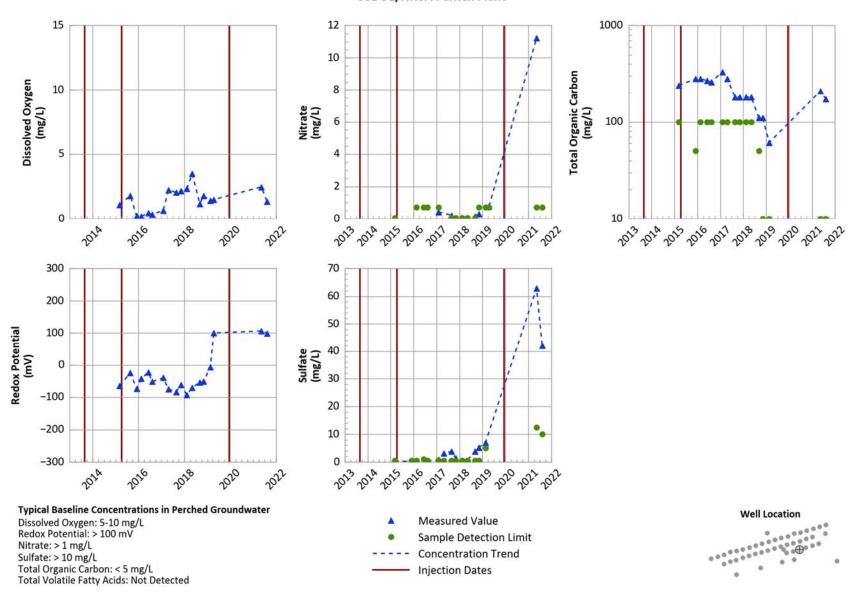
PTX06-ISB048 Treatment Zone Performance Indicators USDOE/NNSA Pantex Plant

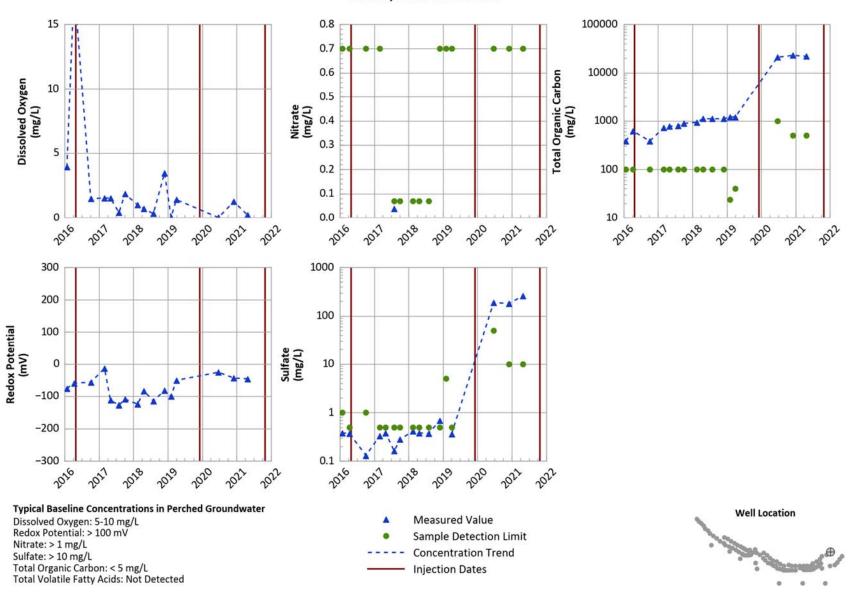
PTX06-ISB055 Treatment Zone Performance Indicators **USDOE/NNSA Pantex Plant**

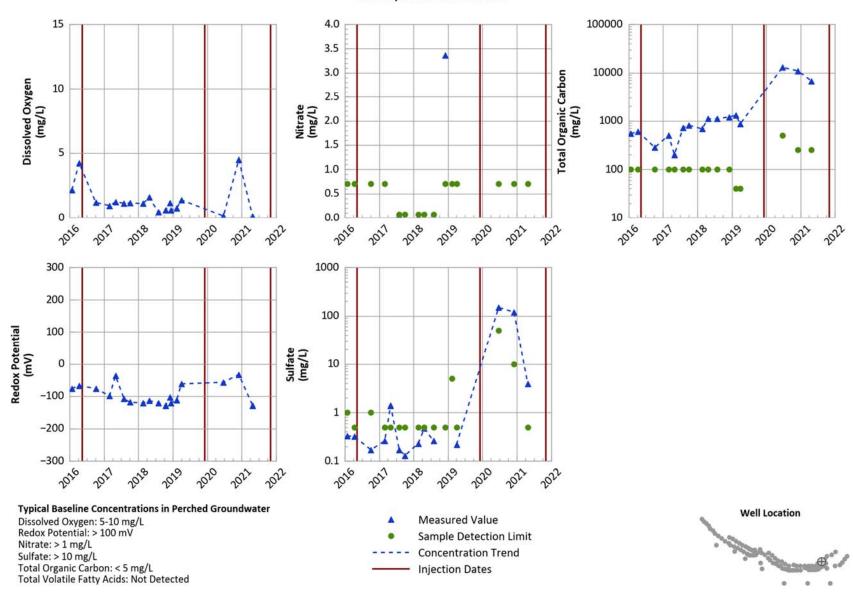
PTX06-ISB059 Treatment Zone Performance Indicators USDOE/NNSA Pantex Plant

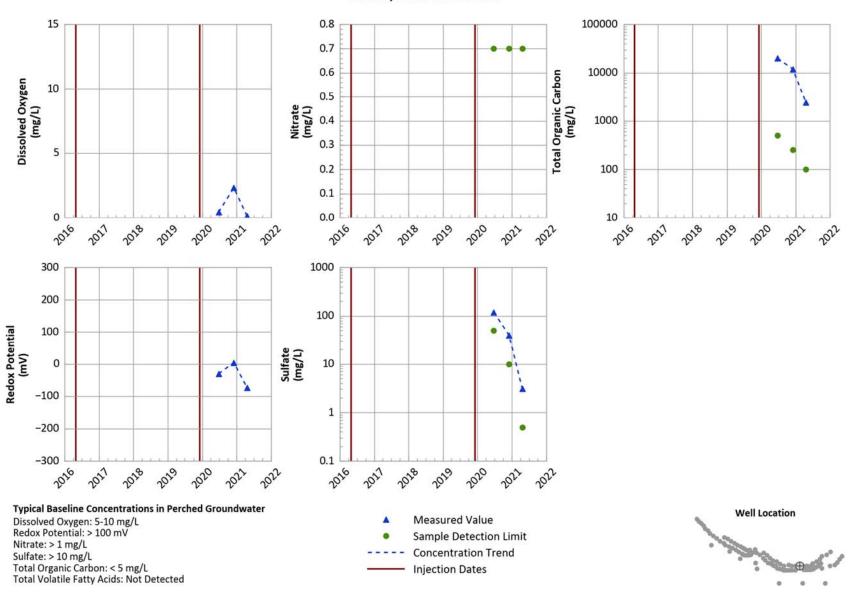
PTX06-ISB064 Treatment Zone Performance Indicators **USDOE/NNSA Pantex Plant**

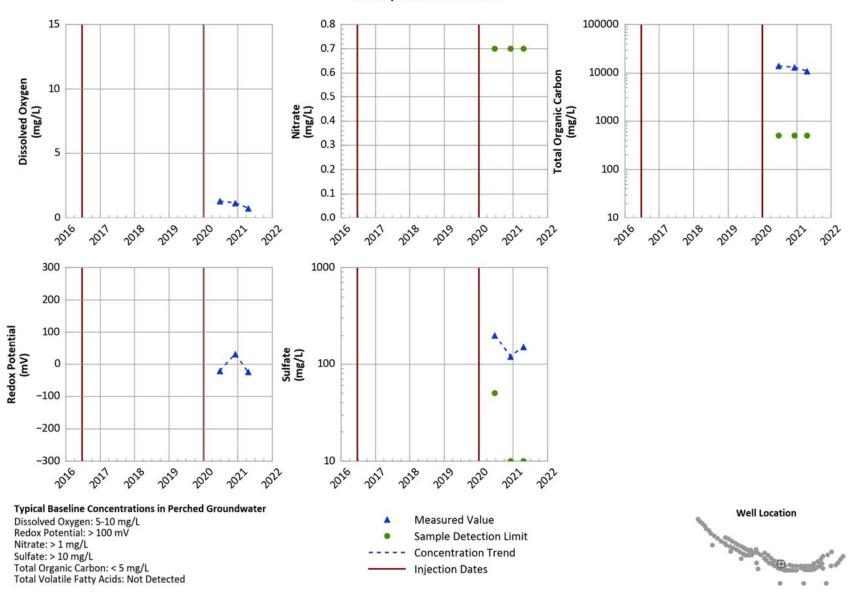
PTX06-ISB068 Treatment Zone Performance Indicators USDOE/NNSA Pantex Plant

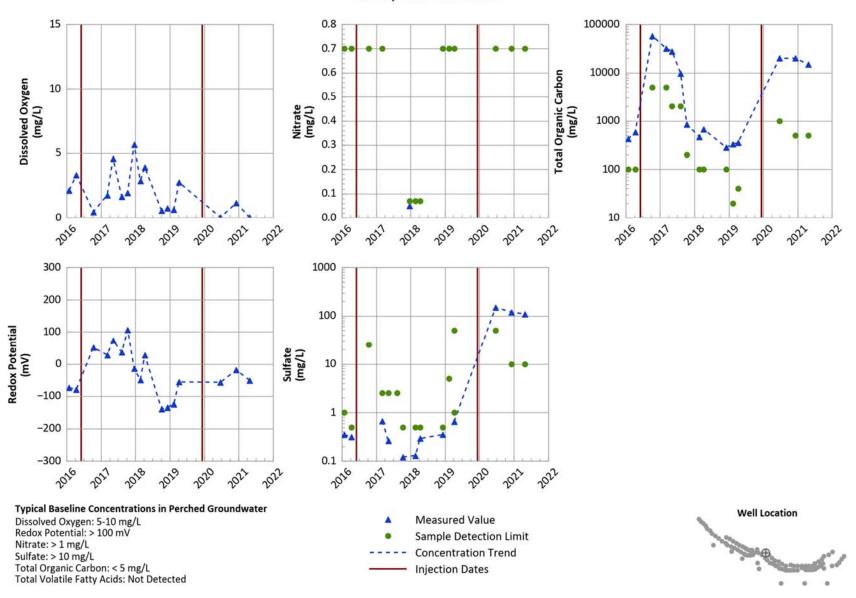
PTX06-ISB073 Treatment Zone Performance Indicators **USDOE/NNSA Pantex Plant**

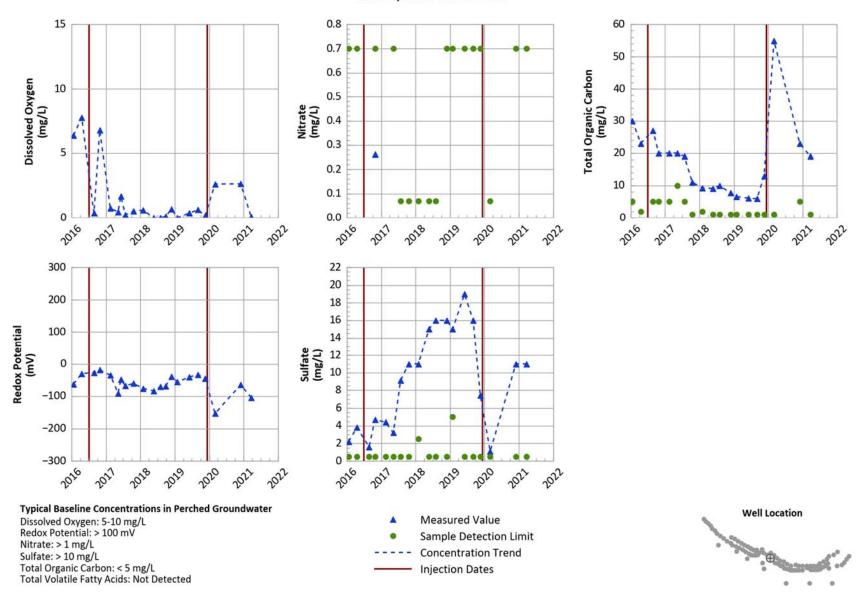
PTX06-ISB075 Treatment Zone Performance Indicators USDOE/NNSA Pantex Plant

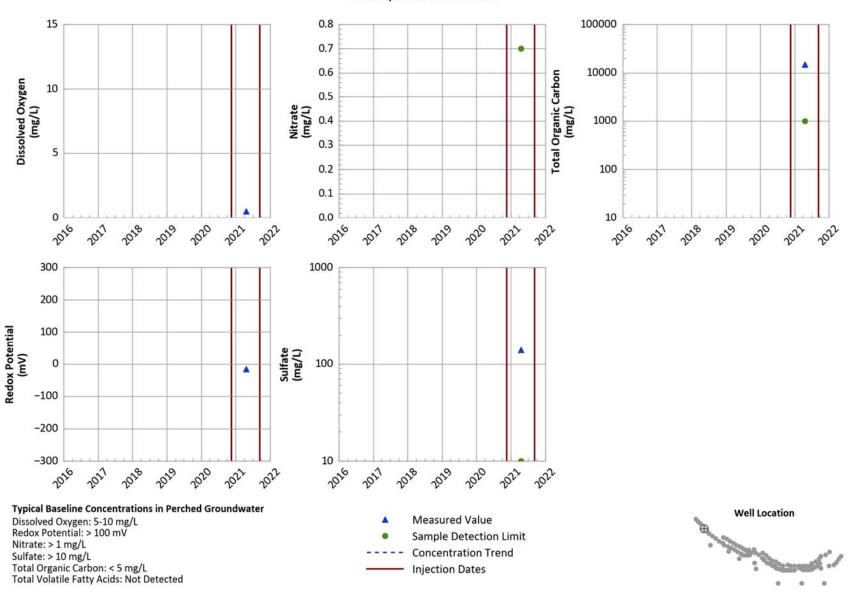
PTX06-ISB133 Treatment Zone Performance Indicators **USDOE/NNSA Pantex Plant**

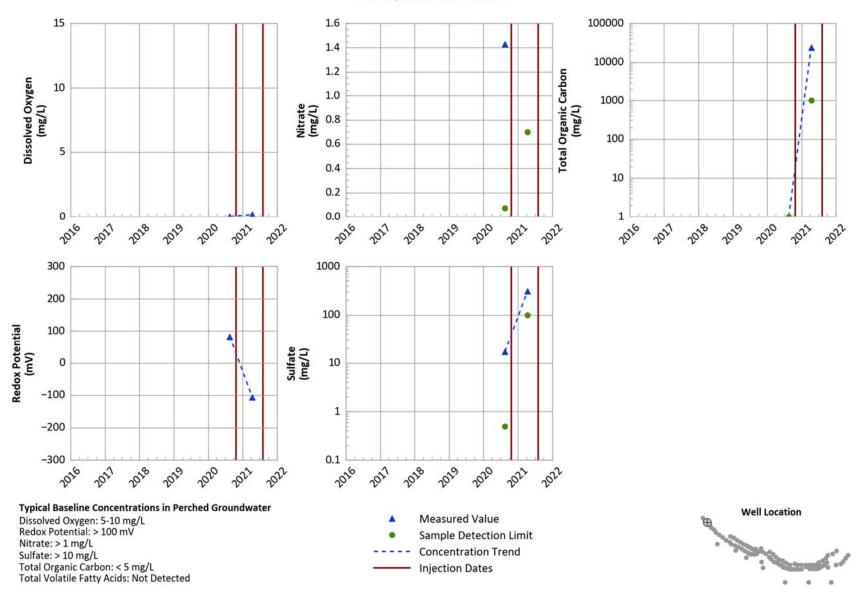
PTX06-ISB135 Treatment Zone Performance Indicators USDOE/NNSA Pantex Plant

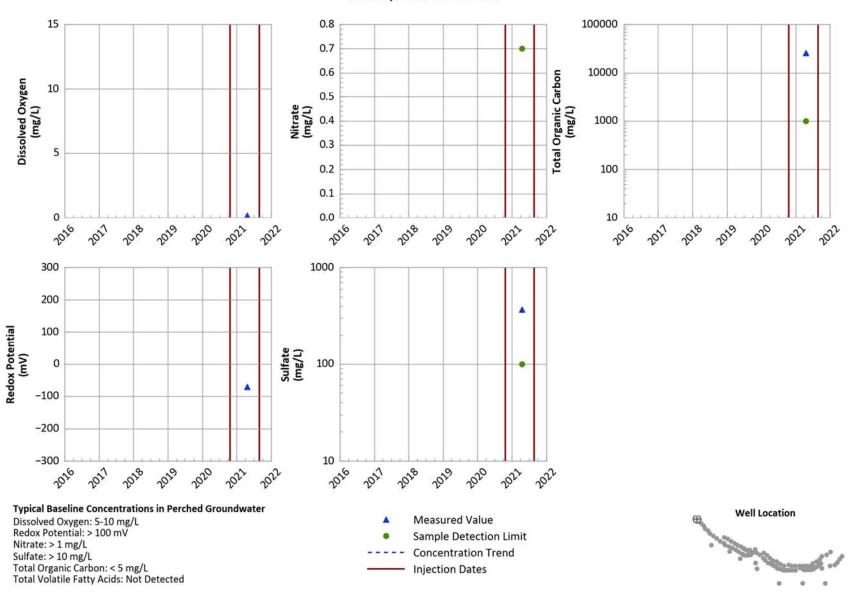
PTX06-ISB137 Treatment Zone Performance Indicators **USDOE/NNSA Pantex Plant**

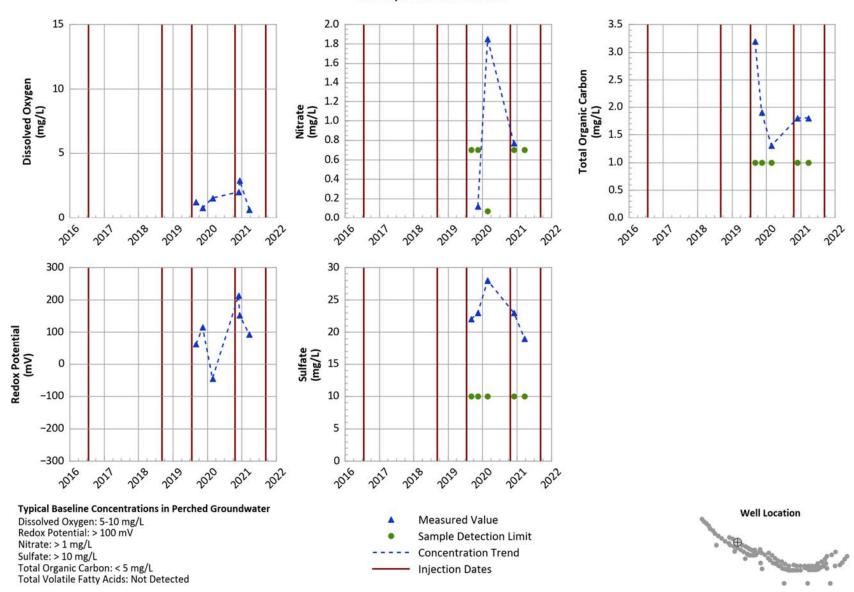
PTX06-1164 Treatment Zone Performance Indicators USDOE/NNSA Pantex Plant

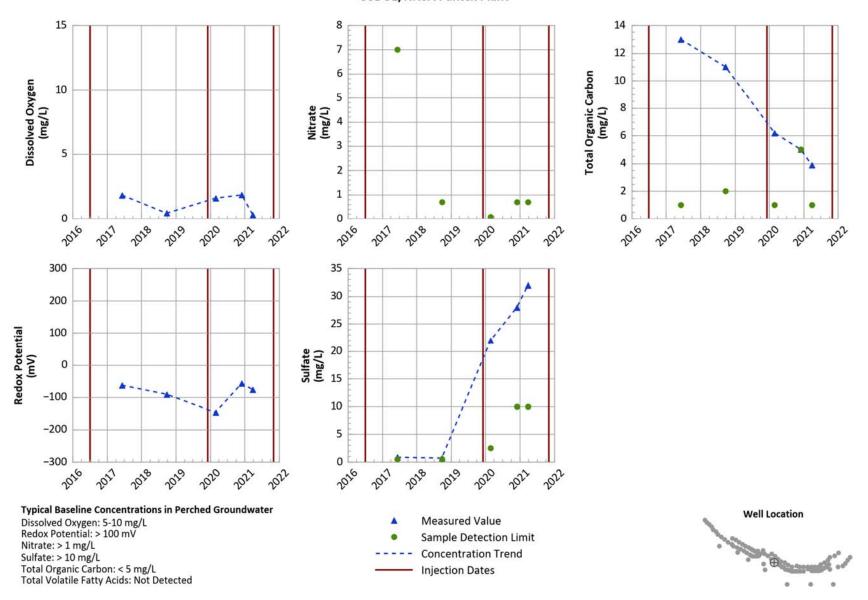
PTX06-1169 Treatment Zone Performance Indicators **USDOE/NNSA Pantex Plant**

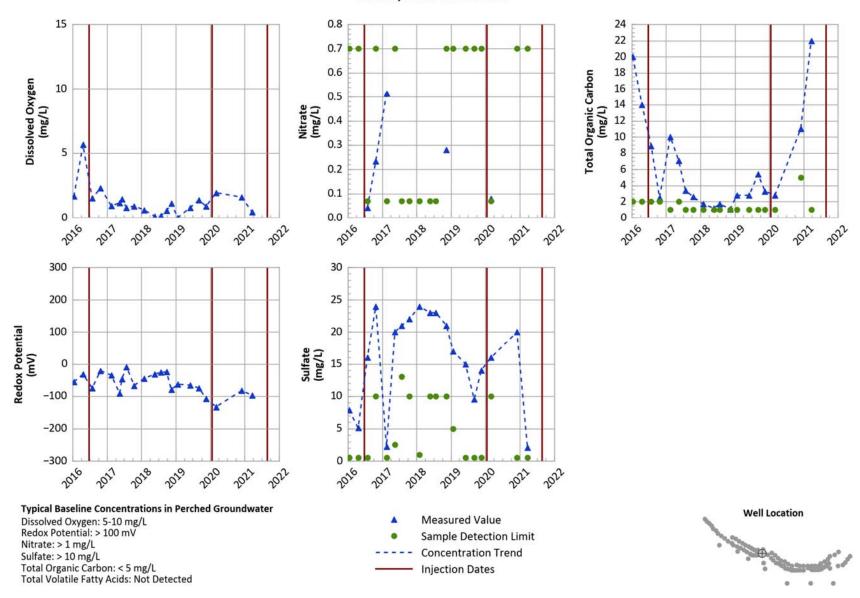
PTX06-1170 Treatment Zone Performance Indicators USDOE/NNSA Pantex Plant

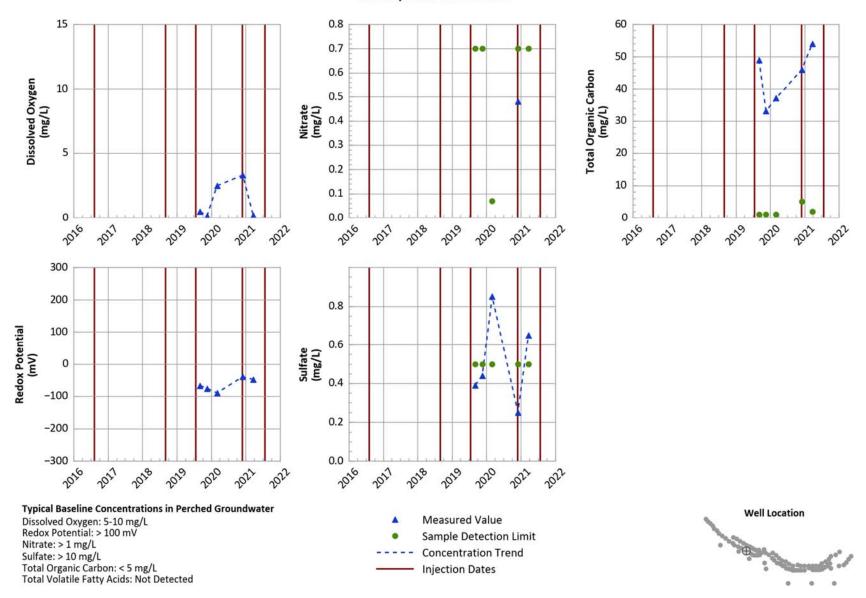
PTX06-1176 Treatment Zone Performance Indicators **USDOE/NNSA Pantex Plant**

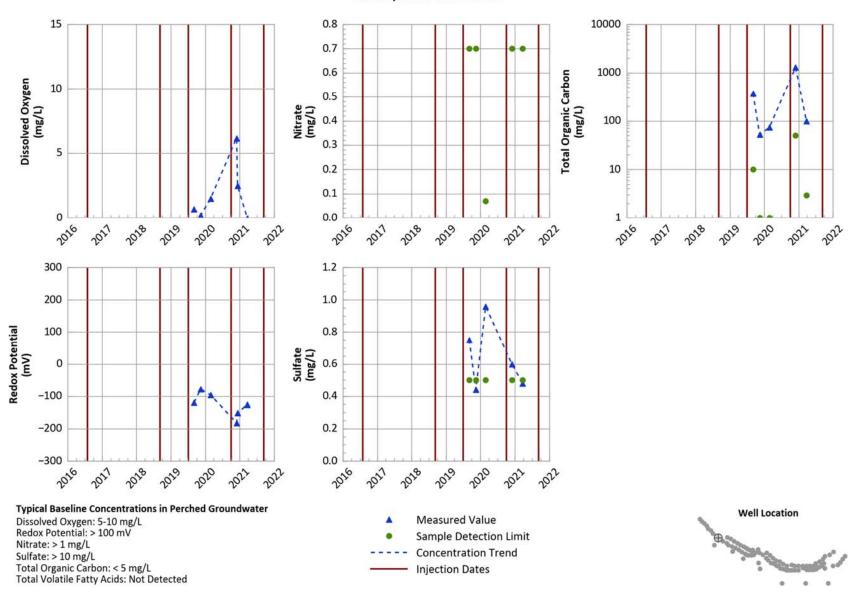
PTX06-1177 Treatment Zone Performance Indicators USDOE/NNSA Pantex Plant

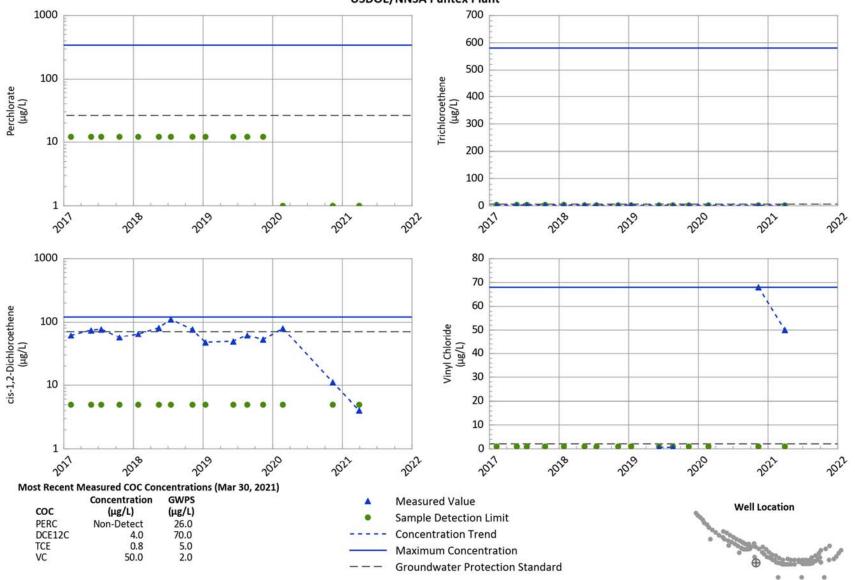
PTX06-1012 Downgradient Performance Indicators Zone 11 In Situ Bioremediation System **USDOE/NNSA Pantex Plant**

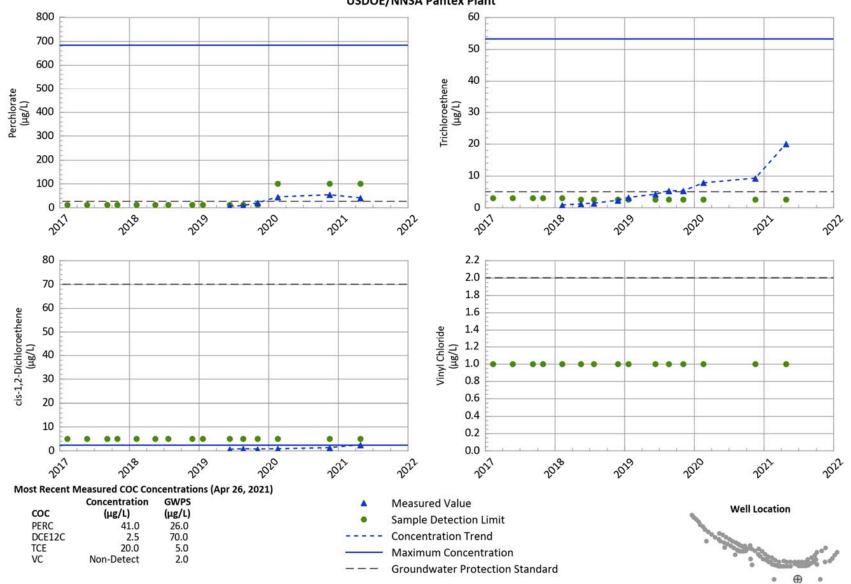
PTX06-1149 Downgradient Performance Indicators Zone 11 In Situ Bioremediation System USDOE/NNSA Pantex Plant

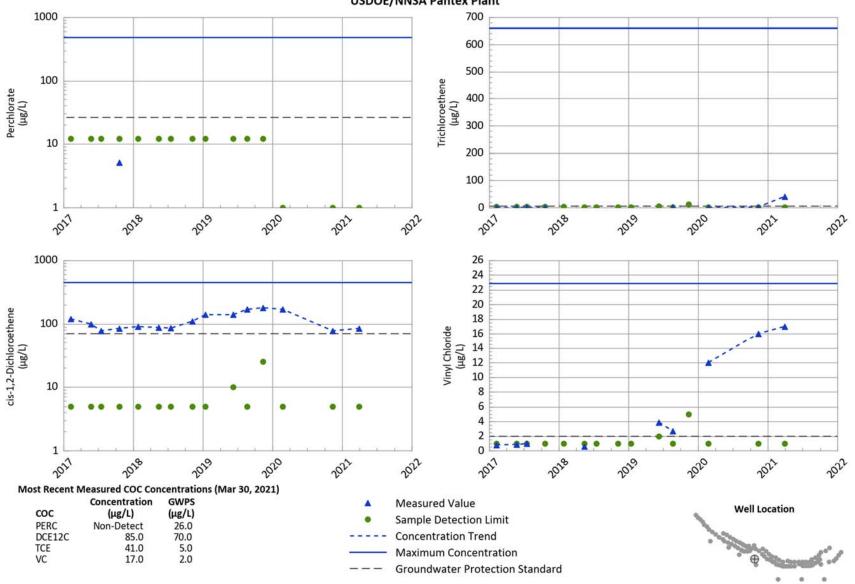
PTX06-1155 Downgradient Performance Indicators Zone 11 In Situ Bioremediation System **USDOE/NNSA Pantex Plant**

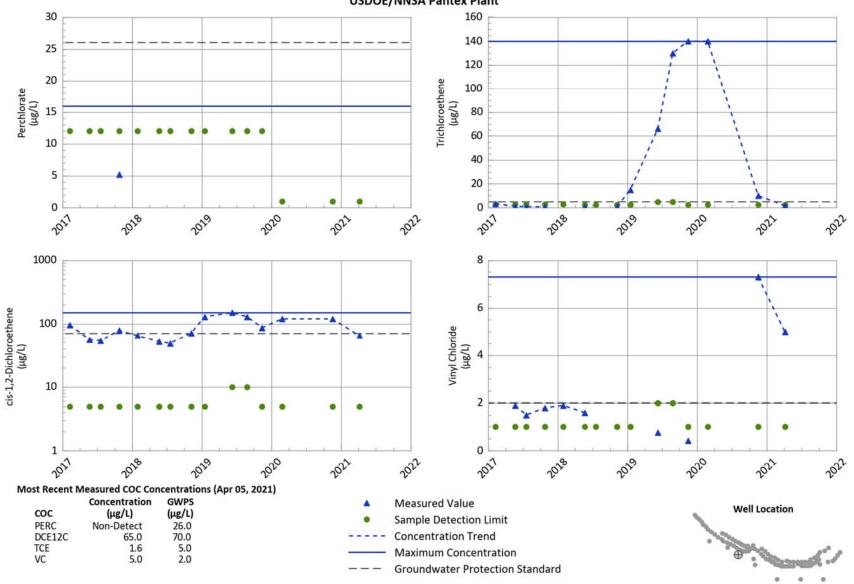
PTX06-1173 Downgradient Performance Indicators Zone 11 In Situ Bioremediation System USDOE/NNSA Pantex Plant

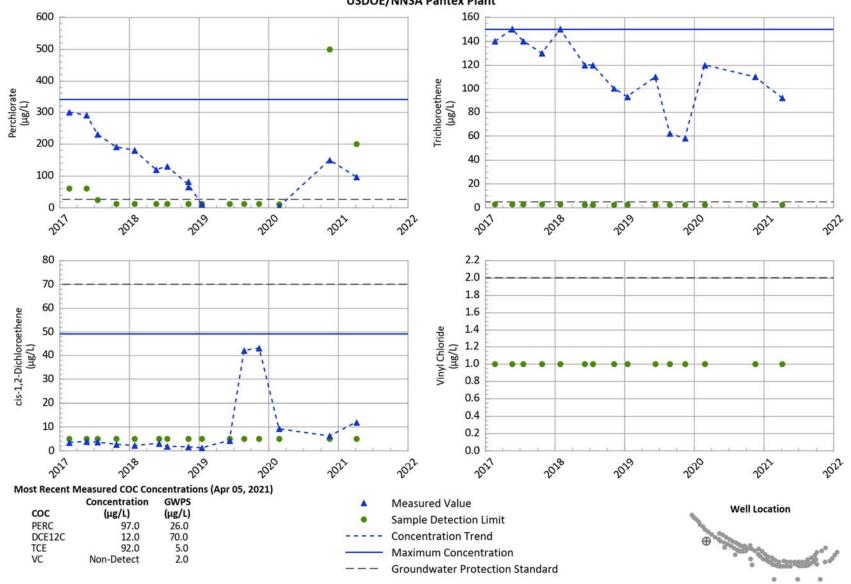
PTX06-1175 Downgradient Performance Indicators Zone 11 In Situ Bioremediation System **USDOE/NNSA Pantex Plant**

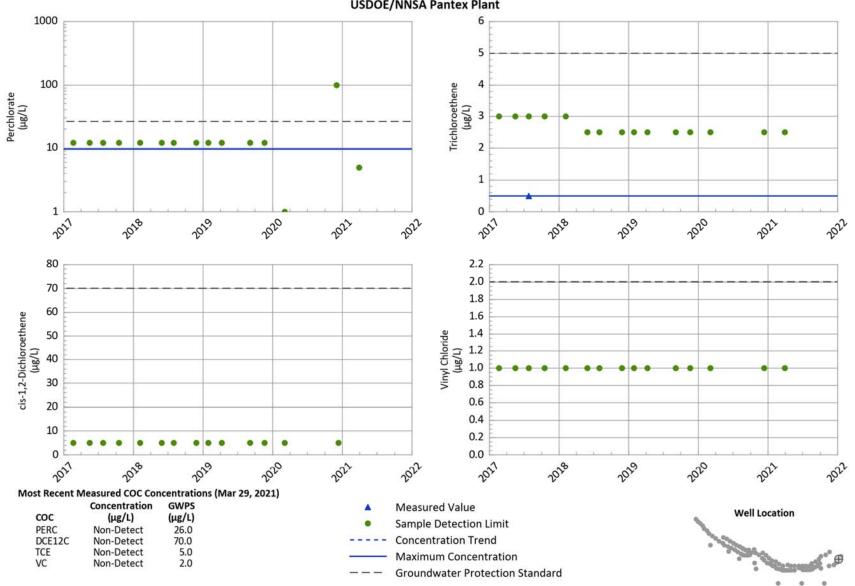
PTX06-ISB079 Downgradient Performance Indicators Zone 11 In Situ Bioremediation System USDOE/NNSA Pantex Plant

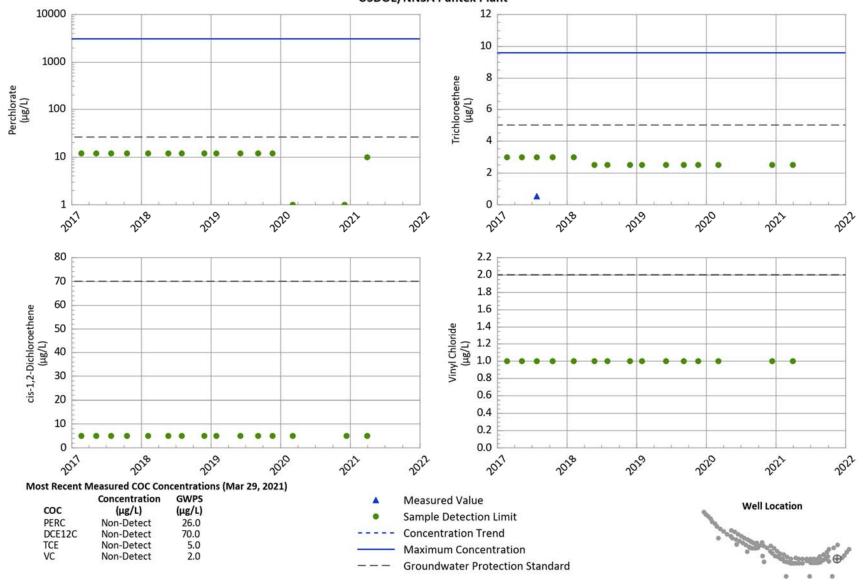
PTX06-ISB082 Downgradient Performance Indicators Zone 11 In Situ Bioremediation System USDOE/NNSA Pantex Plant

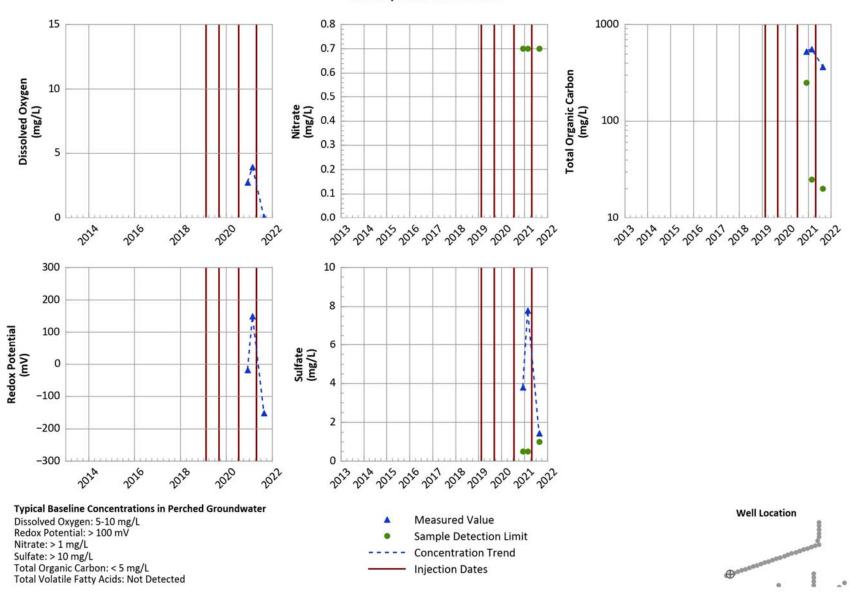
PTX06-ISB302 Treatment Zone Performance Indicators USDOE/NNSA Pantex Plant

The first post-injection treatment zone data were collected in 2nd quarter 2019. Six wells in the injected area of the ISB were sampled during the 3rd quarter of 2021. Treatment zone data indicates strong reducing conditions are present for treatment of HEs. ORP was between -205 mV and -97 mV, nitrate was reduced in all wells, and sulfate values ranged from 1.4 to 32 µg/L. Soluble metals (arsenic and manganese) increased, indicating that reducing conditions are being established. Total organic carbon results indicate that a sufficient food source is available to support establishment of reducing conditions at the wells. Sampling results from the ISB wells indicate HEs are not detected. Downgradient wells did not demonstrate treatment during this quarter. The downgradient wells in or near the faster moving core of the plume are expected to demonstrate treatment during 2021.

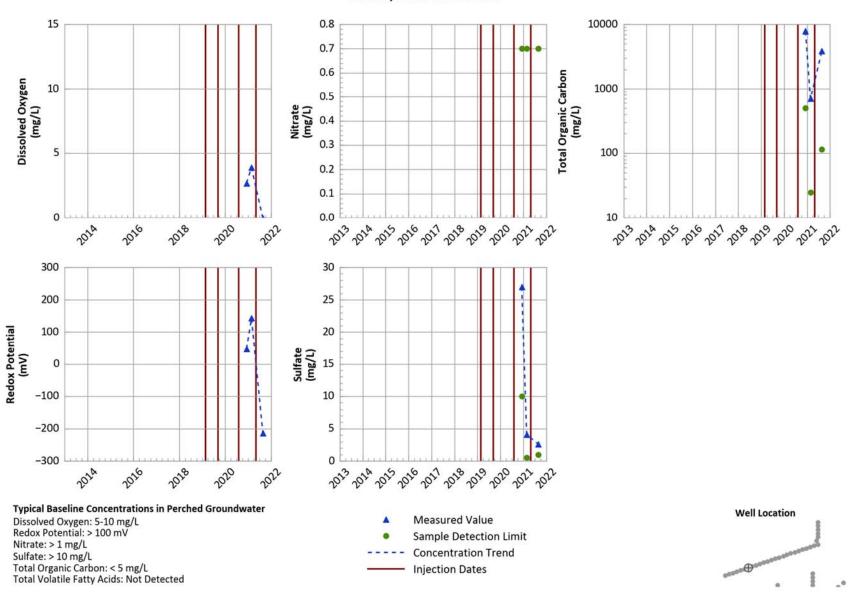
PTX06-ISB307 Treatment Zone Performance Indicators **USDOE/NNSA Pantex Plant**

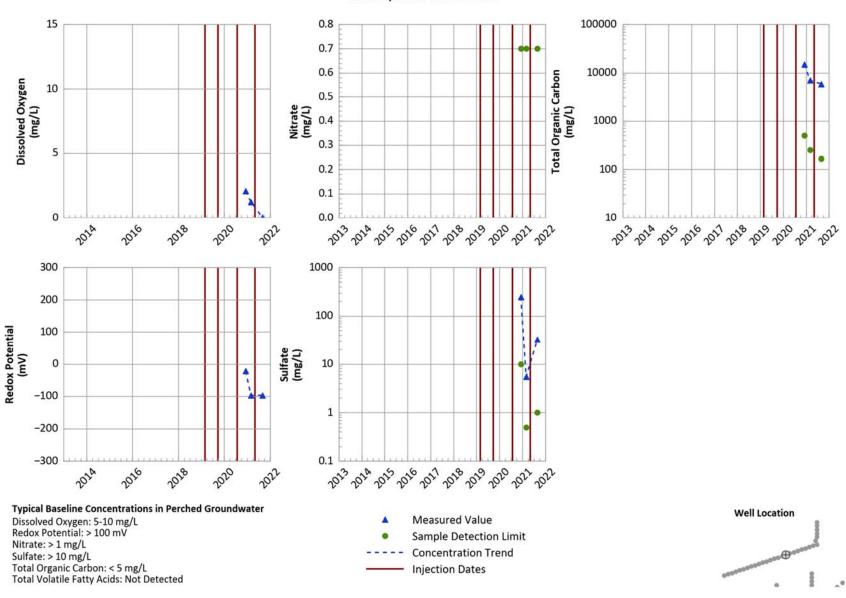
PTX06-ISB317 Treatment Zone Performance Indicators USDOE/NNSA Pantex Plant

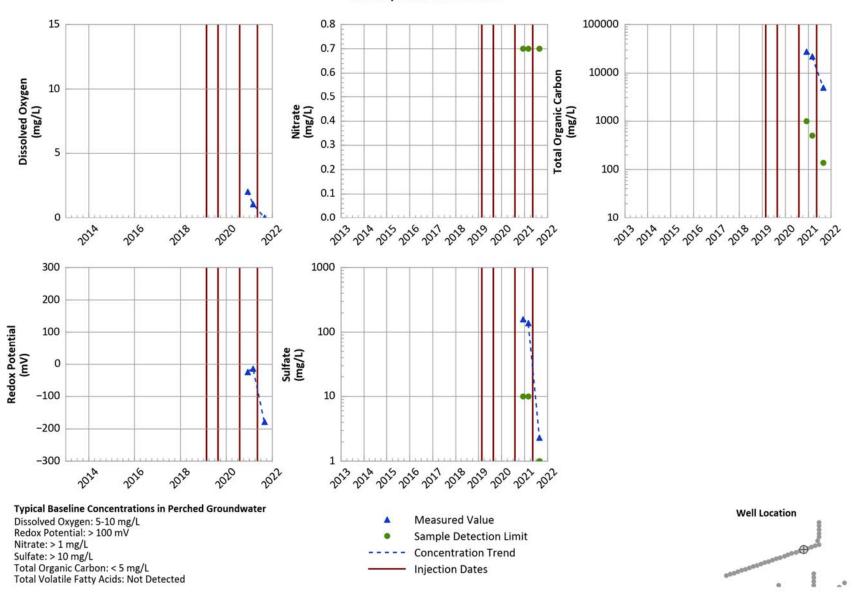
PTX06-ISB321 Treatment Zone Performance Indicators **USDOE/NNSA Pantex Plant**

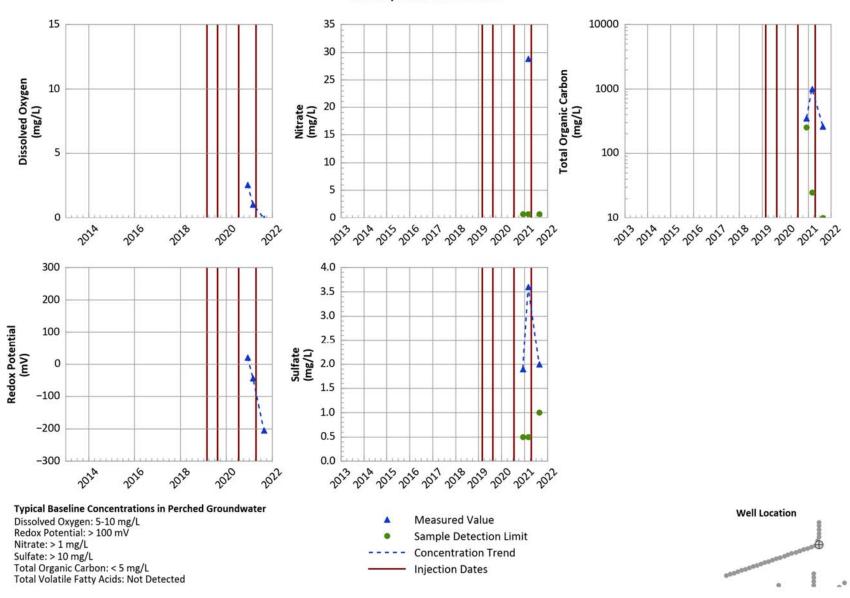
PTX06-ISB325 Treatment Zone Performance Indicators USDOE/NNSA Pantex Plant

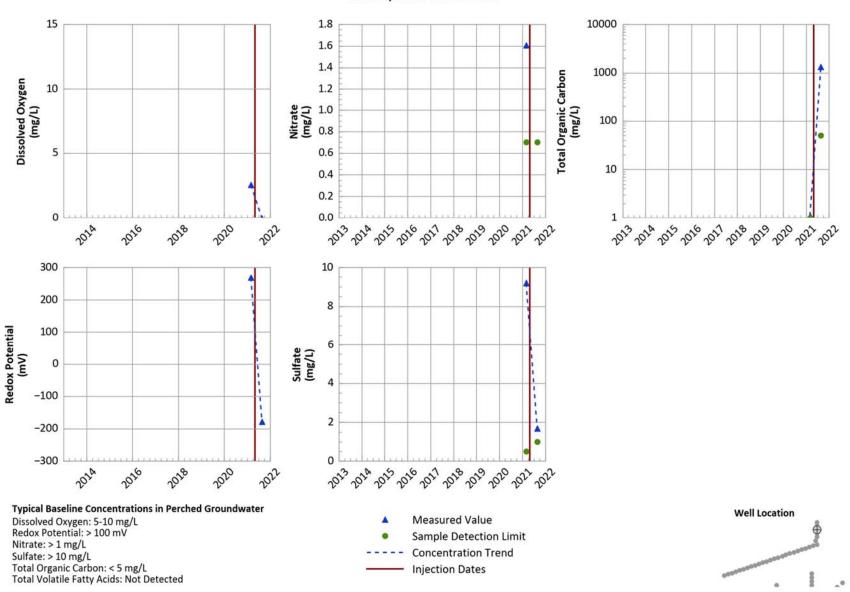
PTX06-ISB329 Treatment Zone Performance Indicators **USDOE/NNSA Pantex Plant**

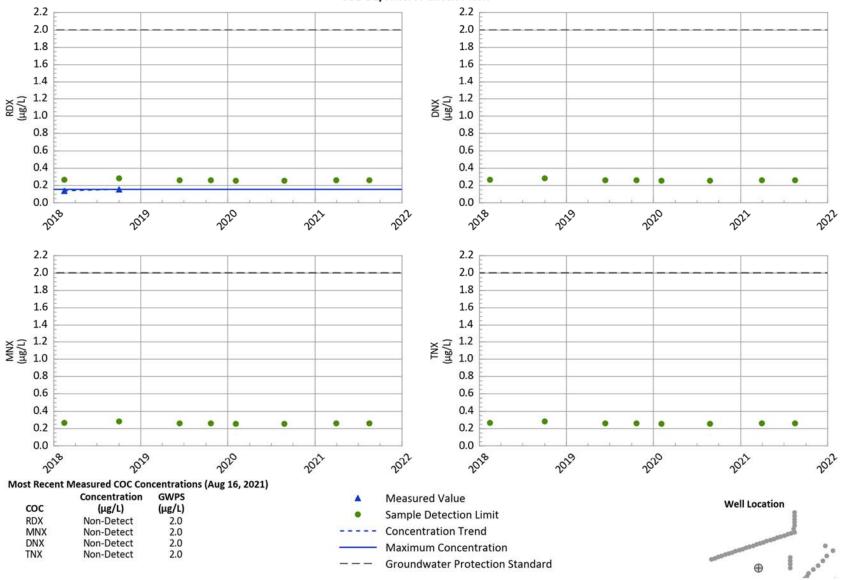
PTX06-1194 Downgradient Performance Indicators Southeast Ext In Situ Bioremediation System **USDOE/NNSA Pantex Plant**
