PANTEX QUARTERLY PROGRESS REPORT

Remedial Action Progress

3rd Quarter 2021

In support of Hazardous Waste Permit #50284 and Pantex Plant Interagency Agreement December 2021

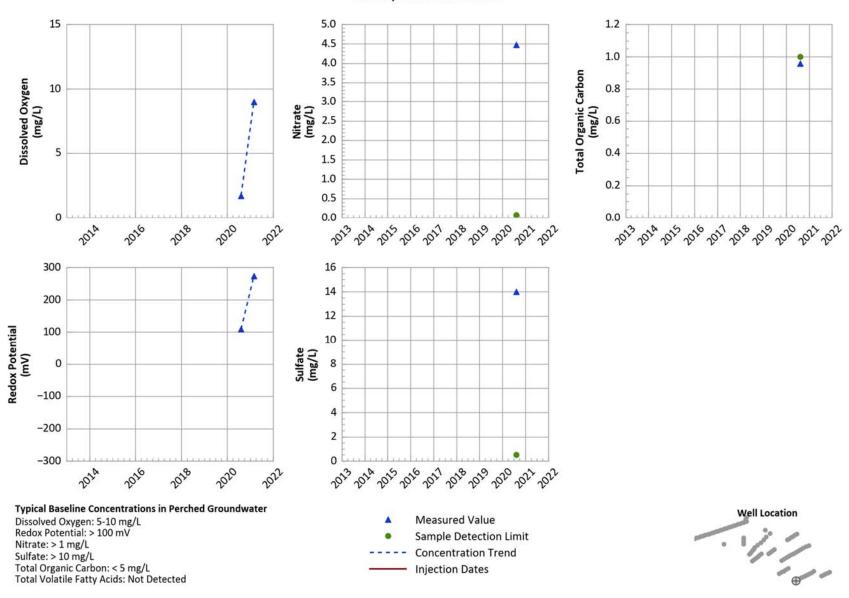
PTX06-ISB401 Treatment Zone Performance Indicators USDOE/NNSA Pantex Plant

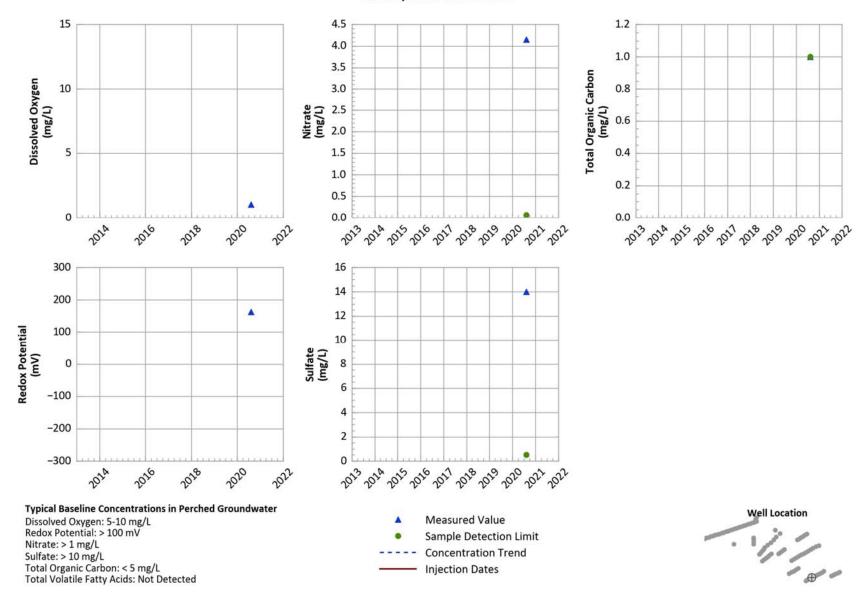
PTX06-ISB404 Treatment Zone Performance Indicators **USDOE/NNSA Pantex Plant**

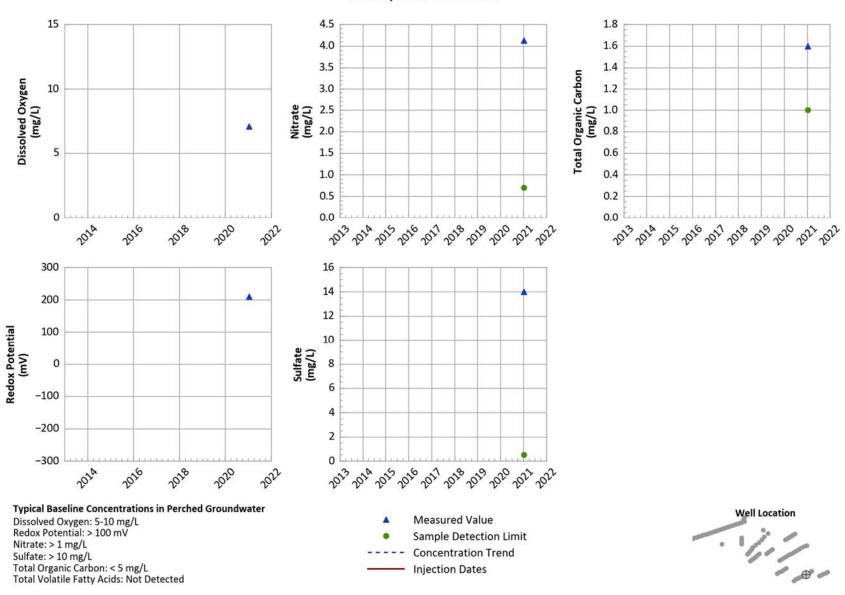
PTX06-ISB407 Treatment Zone Performance Indicators USDOE/NNSA Pantex Plant

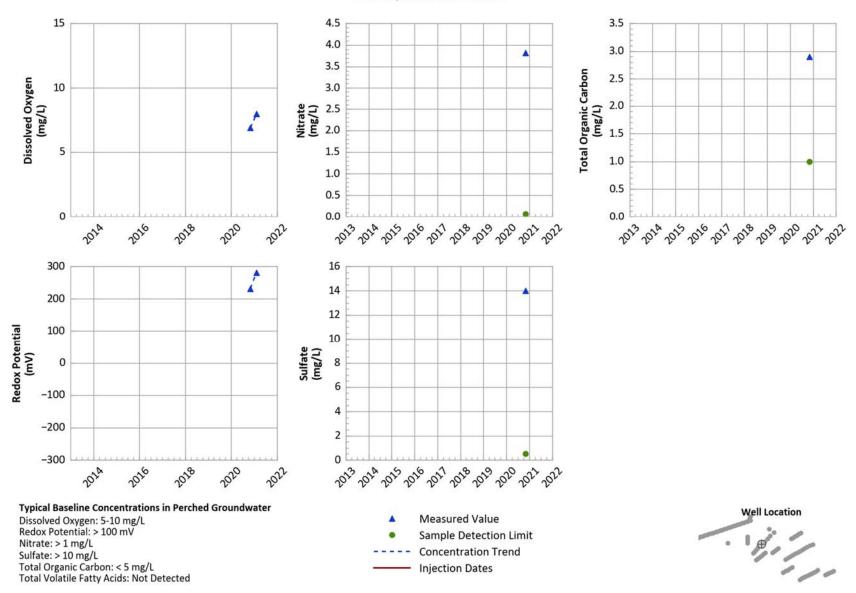
PTX06-ISB412 Treatment Zone Performance Indicators **USDOE/NNSA Pantex Plant**

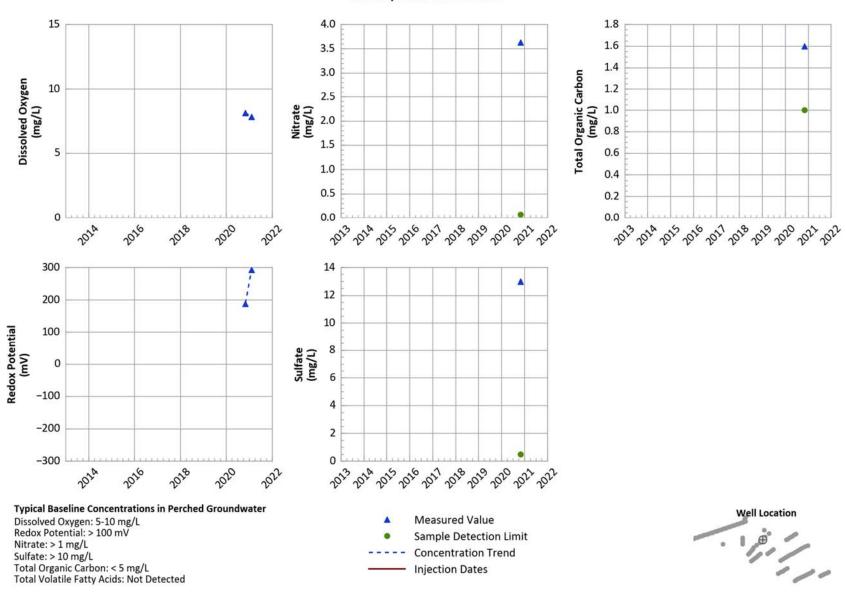
PTX06-ISB414 Treatment Zone Performance Indicators USDOE/NNSA Pantex Plant

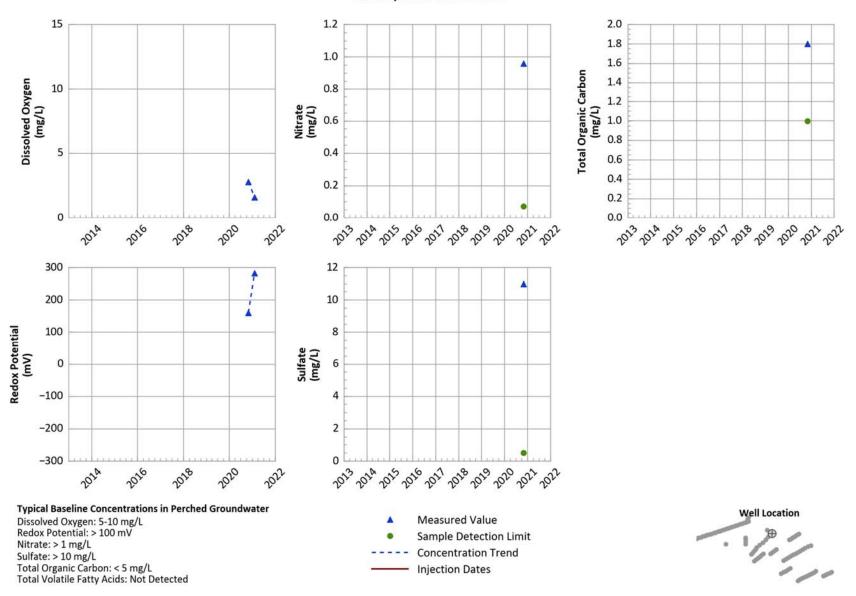
PTX06-ISB416 Treatment Zone Performance Indicators **USDOE/NNSA Pantex Plant**
