For Calendar Year 2019

# Annual Site Environmental Report

## Pantex Plant

# Site Environmental Report Pantex Plant 2019

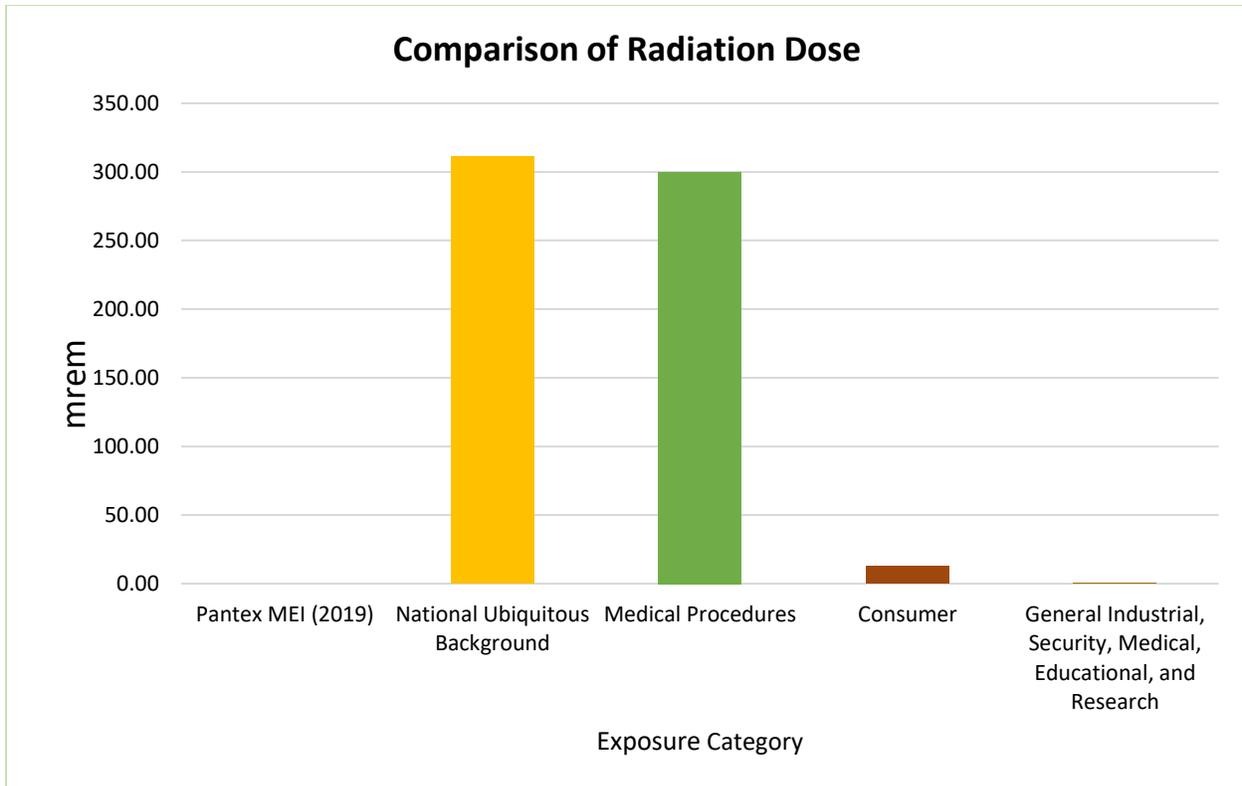
**Figure ES.1 – Comparison of Radiation Dose**

Pantex Plant Radiation Dose (mrem)	EPA Standard Air Pathway (mrem)	DOE Standard All Pathways (mrem)
0.0000000724 (7.24E-8)	10	100

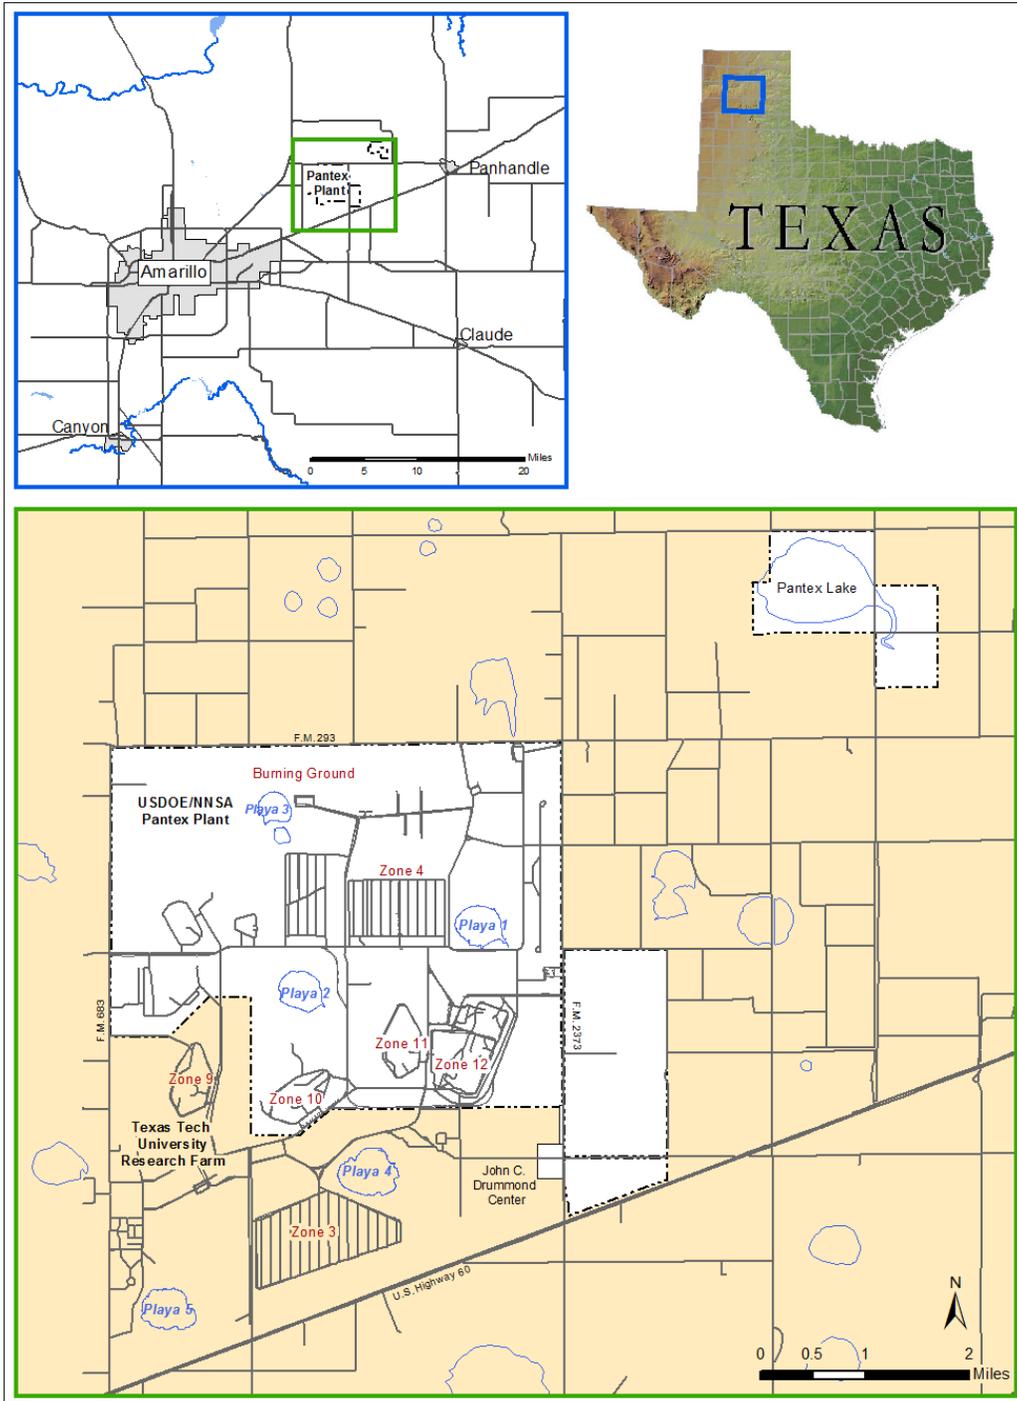
**Figure 1.1 – Pantex Plant Site Location and Zones**

Pantex Plant is composed of several functional areas, commonly referred to as numbered zones (refer to the lower portion of Figure 1.1). Included within the zones are a weapons assembly/disassembly area, a weapons staging area, an area for experimental explosives development, a drinking water treatment plant, a sanitary wastewater treatment facility (WWTF), a vehicle maintenance facility and administrative areas. Other functional areas include a utilities area for steam and compressed air, an explosives test-firing facility, a Burning Ground for thermally processing (i.e., burning or flashing) explosive materials, pump and treat groundwater remediation facilities, several agricultural tracts which are irrigated via a subsurface fluid distribution system, and landfills. Overall, there are more than 600 buildings at Pantex Plant.

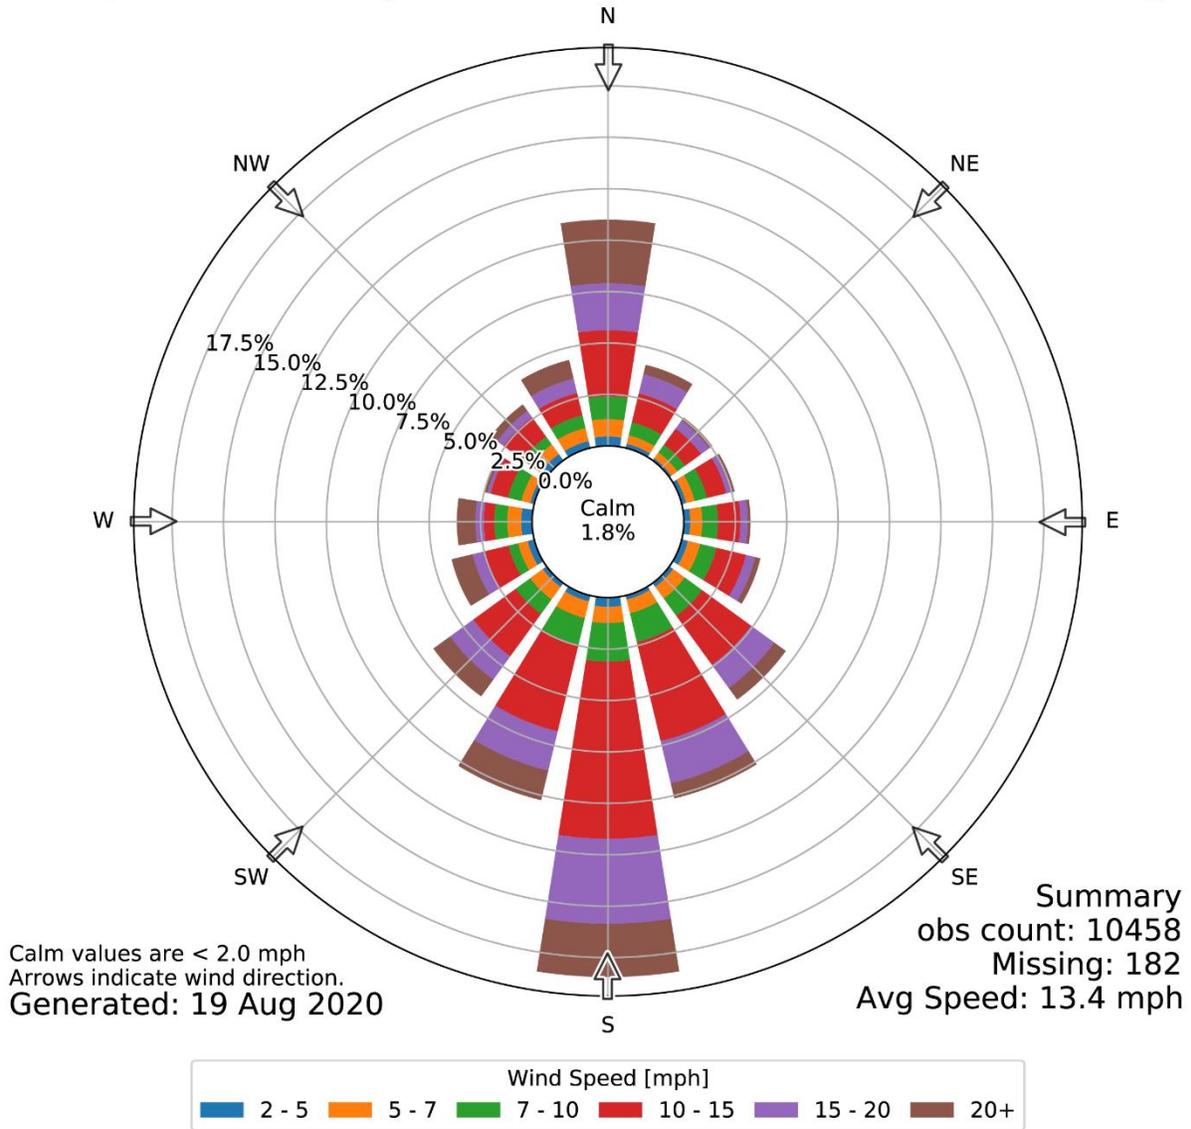
**Figure 1.2 – Pantex Plant Annual Wind Rose for 2019**

[AMA] AMARILLO ARPT(AWOS)  
 Windrose Plot  
 Time Bounds: 01 Jan 2019 12:53 PM - 31 Dec 2019 10:53 PM America/Chicago

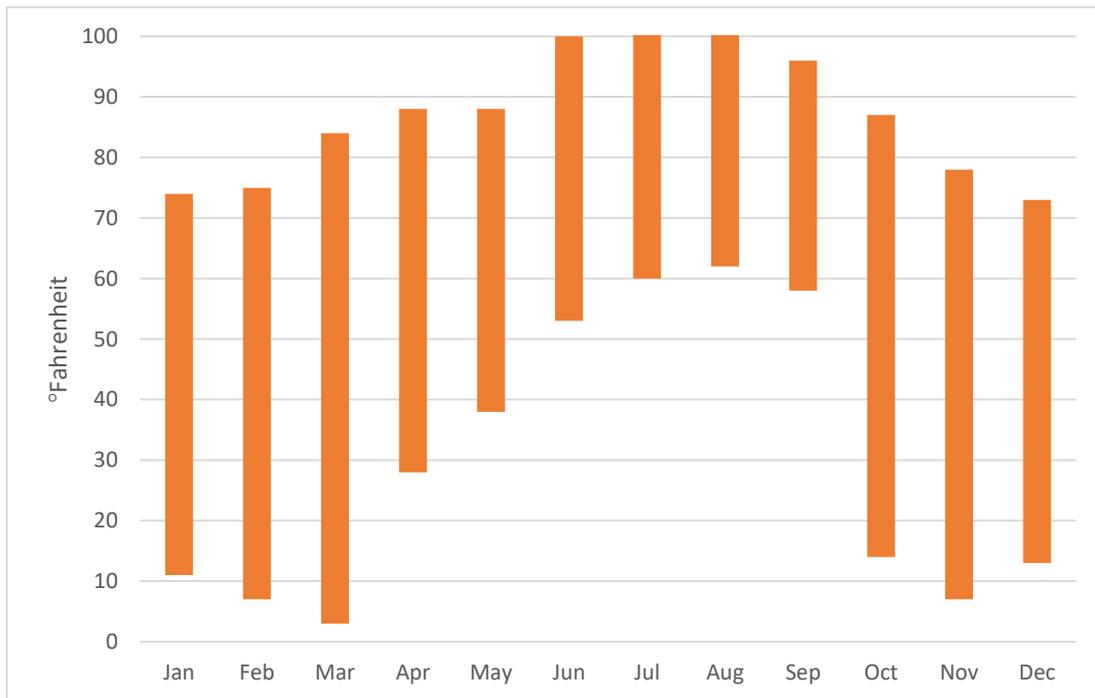
**Figure 1.3 – Pantex Plant Monthly Temperature Range During 2019**

Table 1.1 is a compilation of climatological data (temperature, relative humidity, precipitation; including the water equivalent of any snowfall and wind speed) for 2019 from Pantex Plant or Amarillo Airport NWS meteorological instrumentation. The range of mean monthly temperatures during the year measured at Pantex Plant’s meteorological tower and the monthly precipitation totals as measured at the Amarillo Airport NWS site are shown in Figures 1.3 and 1.4.

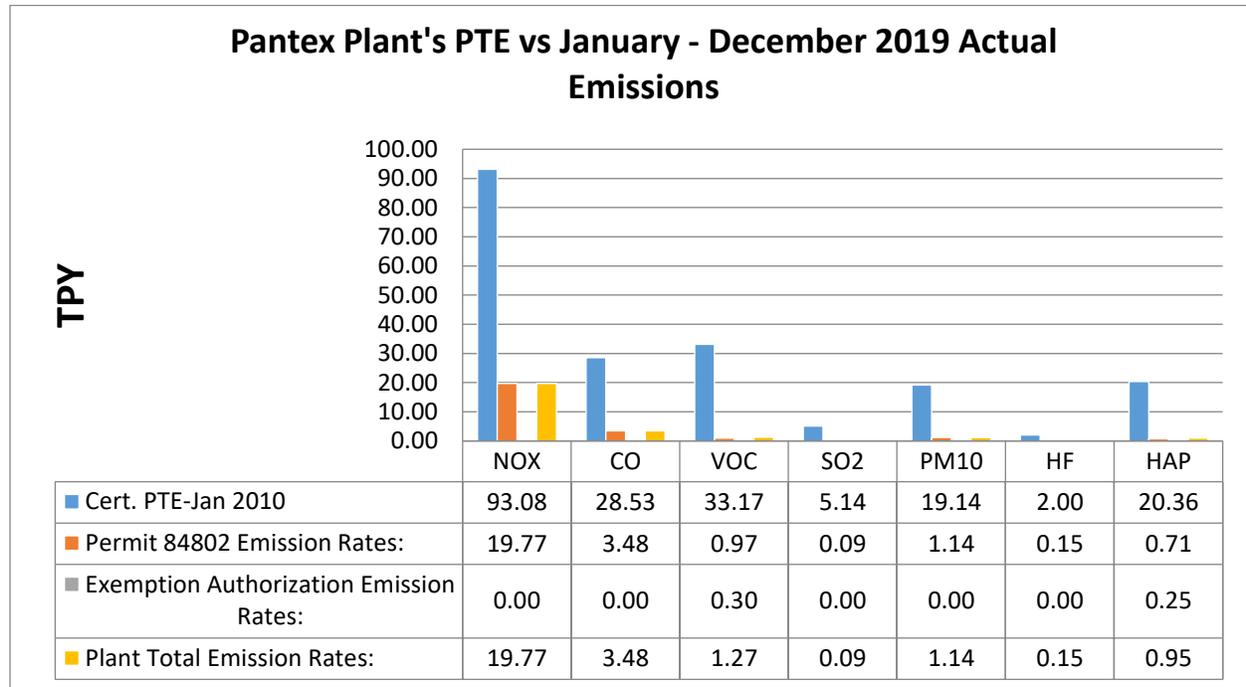
**Figure 2.1 – Pantex Plant’s PTE vs January – December 2019 Actual Emissions**

Over the 12 months of air emission tracking for 2019, operations at Pantex Plant remained well below the certified and authorized PTE levels for each of the pollutants tracked. Figure 2.1 is a graphic presentation of the emission information gathered from January through December 2019, expressed in relation to the PTE certification in Tons per Year (TPY). It provides a demonstration that Pantex Plant continues to meet the requirements of the Title V program for the designation as a Synthetic Minor Source.

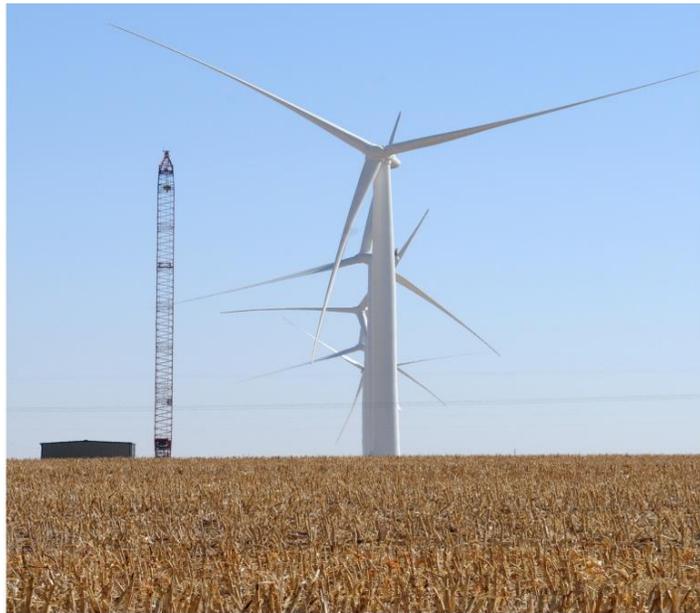
**Figure 3.1 – Pantex Renewable Energy Project<sup>3</sup>**

In 2019, Pantex Plant continued to use an alternate work schedule, which has helped reduce energy consumption for a large number of administrative personnel. In addition, a major source of reductions in energy intensity has been the installation of the Pantex Renewable Energy Project (PREP) (see Figure 3.1) in the summer of 2014.

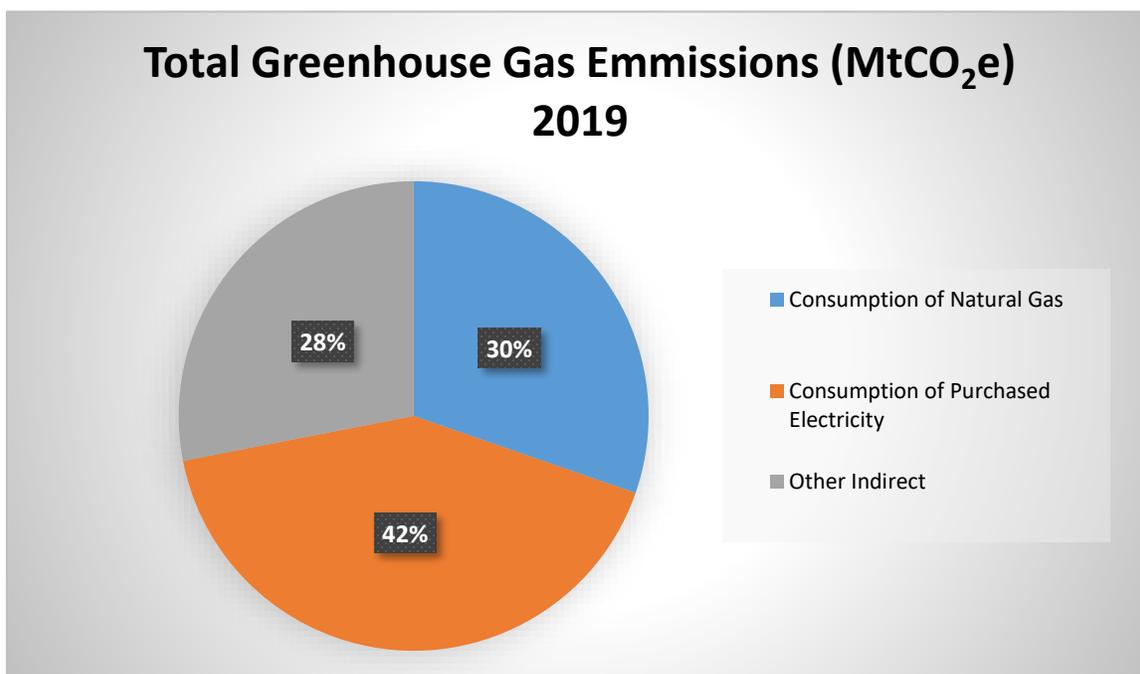
**Figure 3.2 – Total 2019 GHG Emissions**

During CY2019, the operation of Pantex Plant yielded a total of 72,983 MtCO<sub>2</sub>e. Of this total, 20,270 MtCO<sub>2</sub>e was due to the combustion of natural gas, 34,160 MtCO<sub>2</sub>e due to the purchase and use of electricity generated off-site and 18,760 MtCO<sub>2</sub>e was due to other indirect GHG emissions. These emissions are illustrated in Figure 3.2.

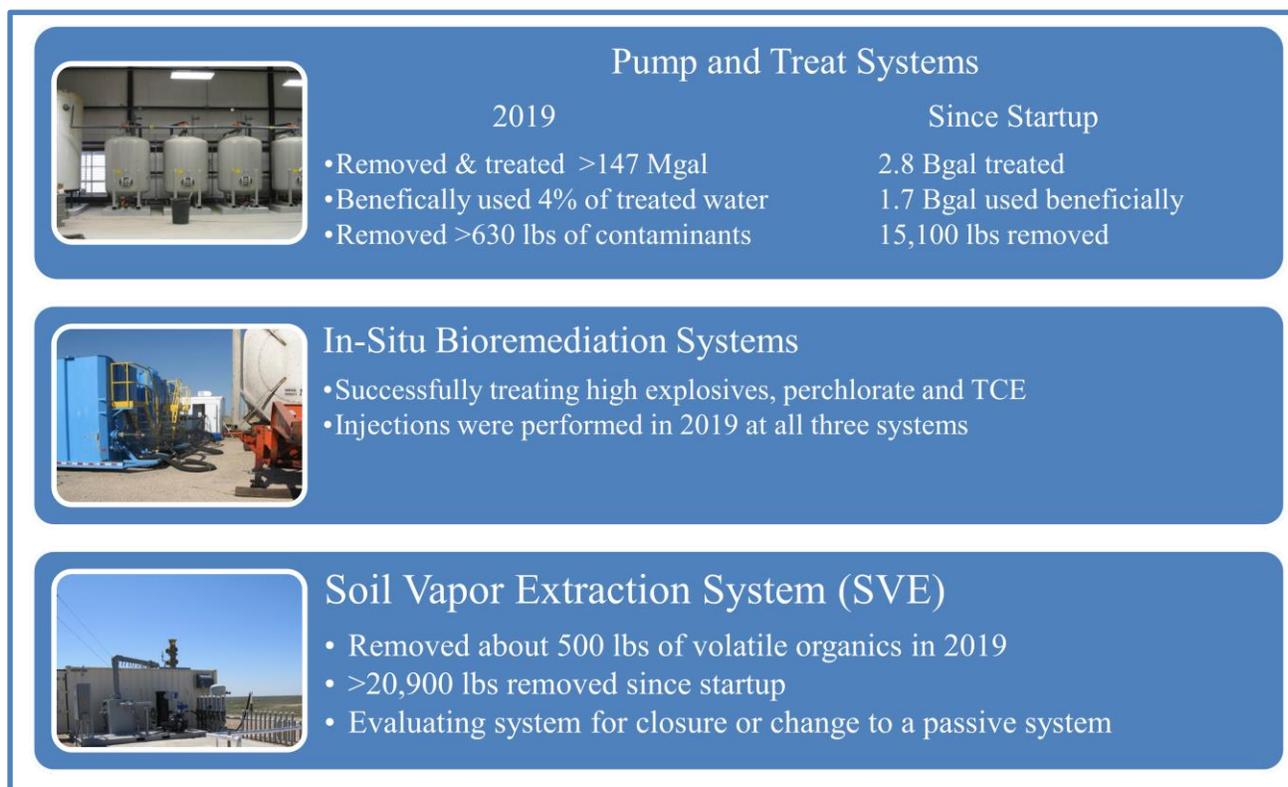
**Figure 3.7 – Major Milestones for 2019 Remedial Actions**

During 2019, Pantex Plant completed several milestones under the continued Long-Term Stewardship (LTS) of environmental units. LTS includes the long-term Operation and Maintenance (O&M) of the remediation systems, monitoring of the systems to ensure that cleanup goals established in the ROD and Compliance Plan will be met, maintenance of soil remedies and institutional controls, and reporting of that information to regulatory agencies and the public. Major Milestones for the 2019 Remedial Actions are shown in Figure 3.7 and Remedial Action Systems at Pantex Plant are depicted in Figure 3.8.

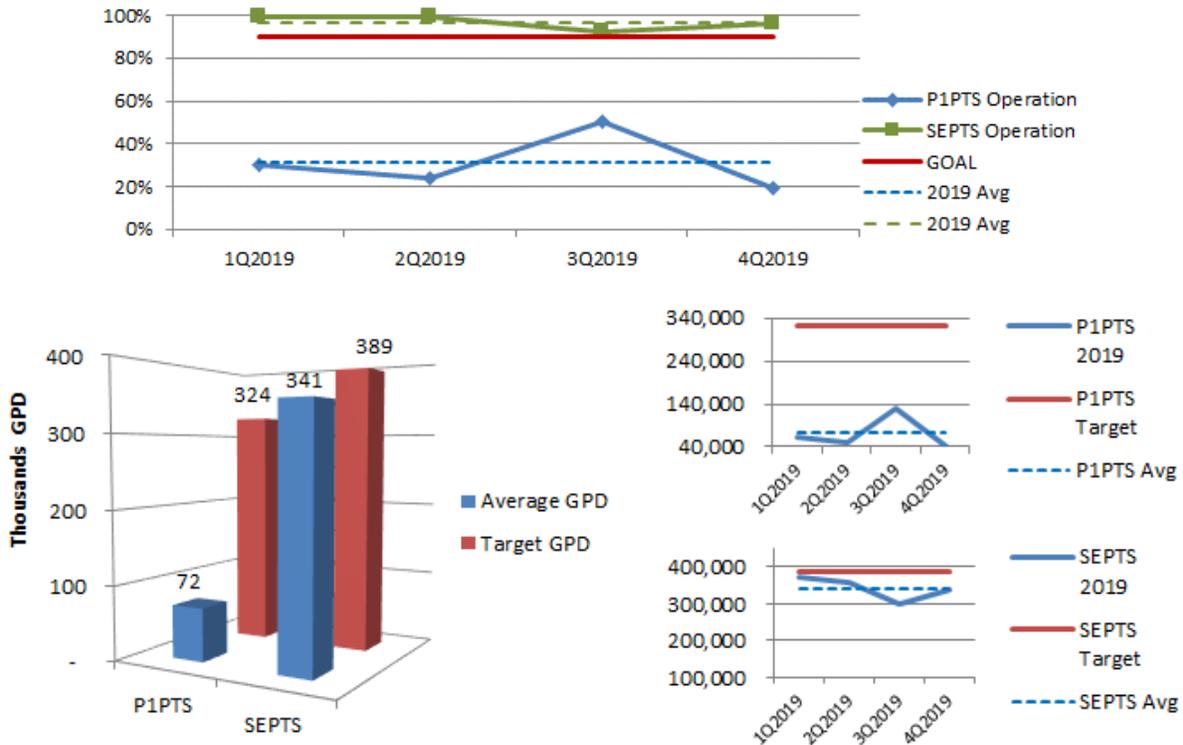
Figure 3.9 – Pump and Treat Systems Performance

In addition to removing impacted water from the perched aquifer, the pump and treat systems remove contaminant mass from the groundwater that is extracted from the aquifer. The Playa 1 Pump & Treat System (P1PTS) primarily removes the HE RDX and the SEPTS primarily removes RDX and hexavalent chromium. Figure 3.10 provides the mass removal for HEs and chromium for 2019, as well as totals since startup of the systems. The SEPTS has been operating longer, and the greatest concentrations of HEs are found in the SEPTS extraction well field, so mass removal is higher at that system.

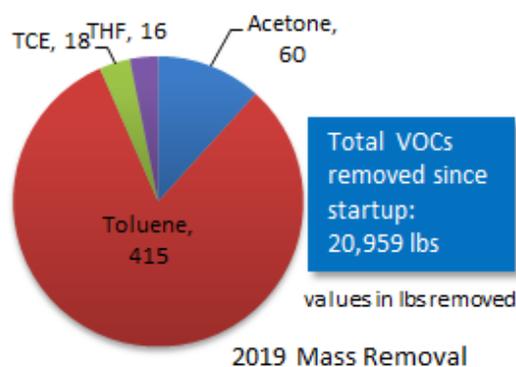
**Figure 3.11 – 2019 SVE Mass Removal**

A SVE system was installed and has been operating at the Burning Ground since February 2002. After a large-scale system remediated a significant area at the Burning Ground, a small-scale activated carbon system was installed in late 2006 after the large-scale system became inefficient at continued removal of remaining soil gas and residual non-aqueous phase liquids (NAPL). The current system, consisting of a small-scale catalytic oxidizer and wet scrubber, was installed in early 2012 to replace the activated carbon system. The system was modified in 2017 to increase air flow through the soils to increase remediation and evaluate the system for closure. The current system continues to focus on treating residual soil gas and NAPL at a single well (SVE-S-20) where soil gas concentrations continue to remain high. As depicted in Figure 3.11, the SVE system removed about 508 lbs. of volatile organic compounds (VOCs) during 2019. As expected, concentrations and mass removal of VOCs continues to decrease at the system.

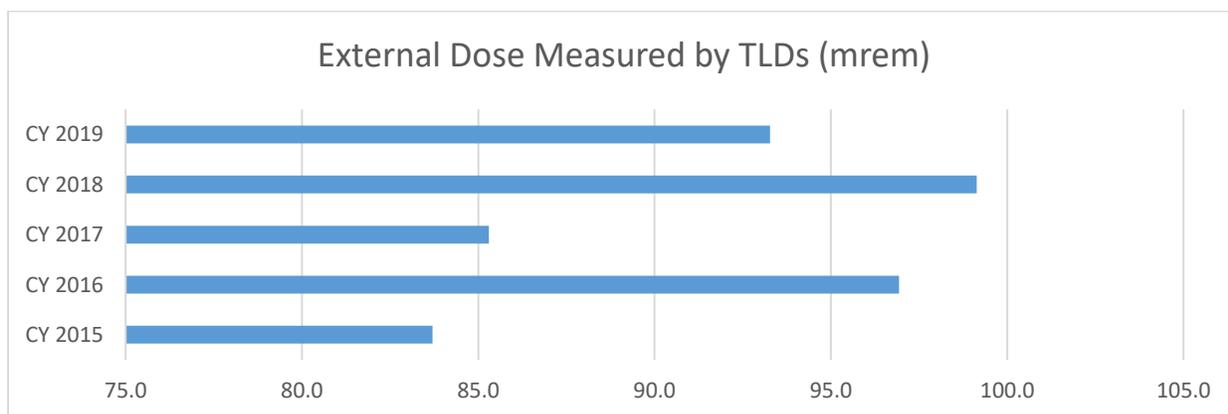
**Figure 4.2 – Environmental Doses Measured by TLDs CY 2015-2019**

<sup>a</sup> Includes ubiquitous background (i.e. cosmic radiation) and Pantex Plant operations

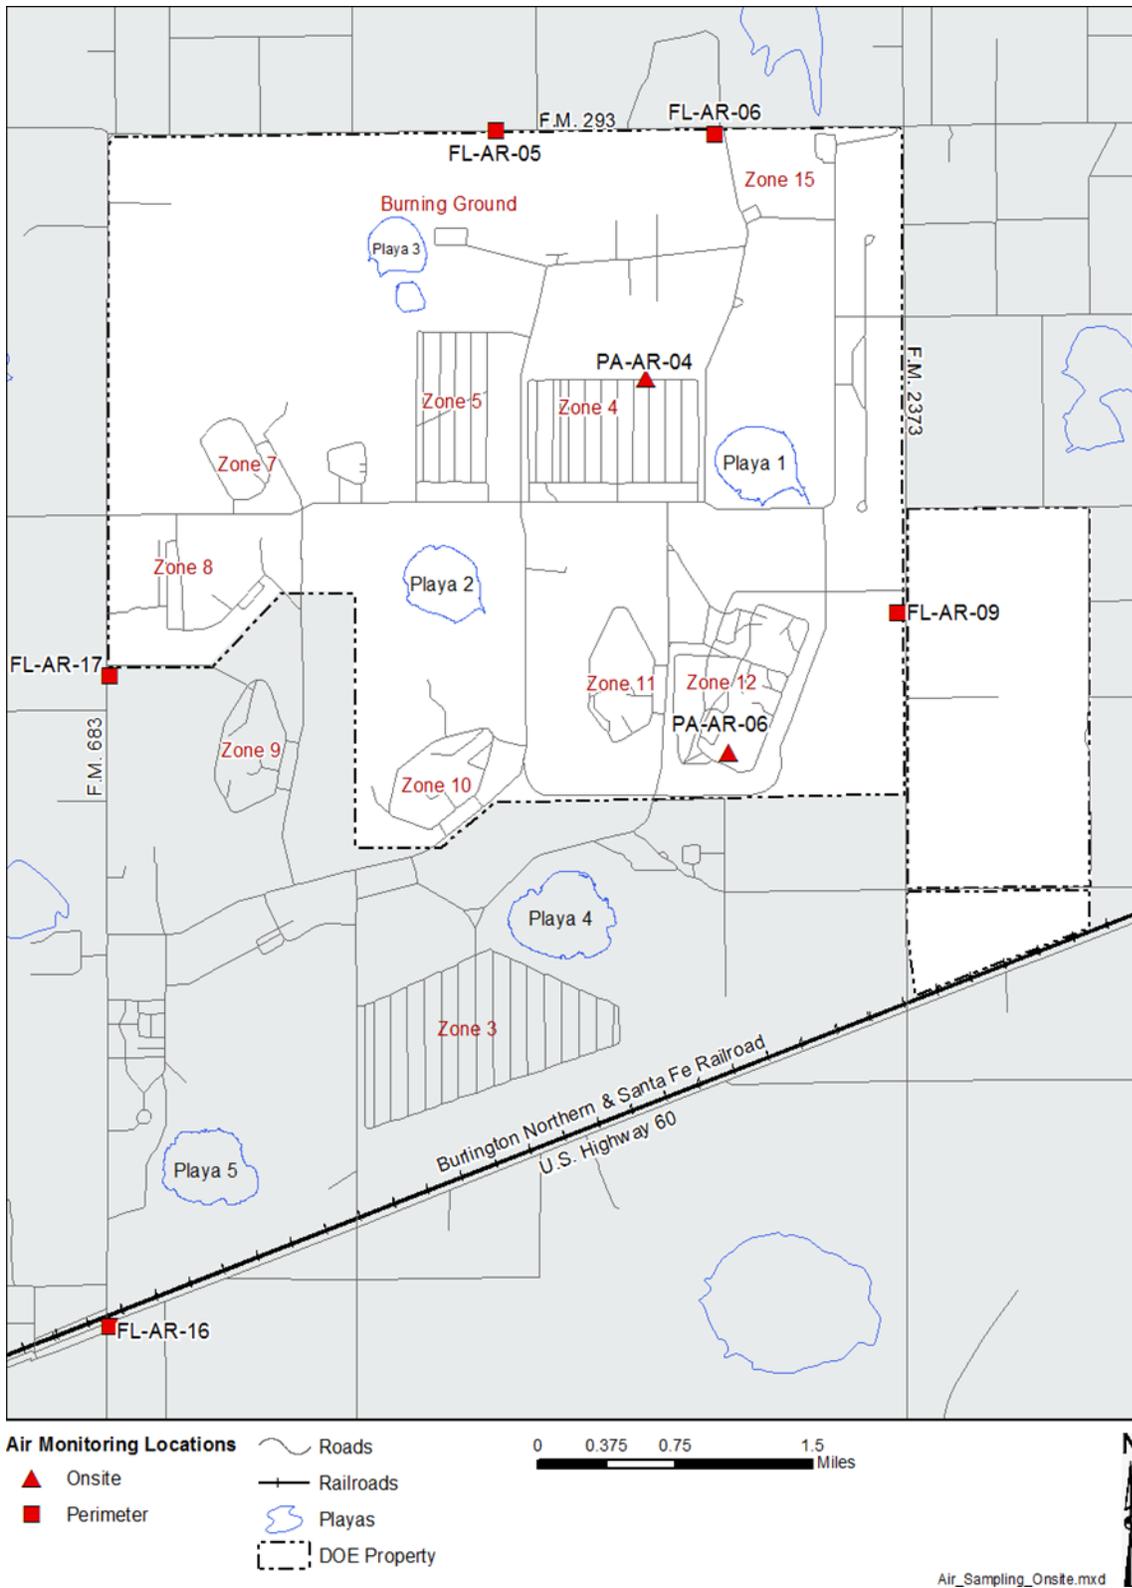
**Figure 5.1 – Locations of On-site and Fence Line Air Monitoring Stations**

Stations designated as FL-AR-XX are located along Pantex Plant perimeter. The perimeter is defined as the perimeter that existed prior to the purchase of the property east of FM 2373 in the latter part of 2008. Four fence line radiological monitoring stations are located along the perimeter. Stakeholders were considered in establishing the locations of the stations. Stations FL-AR-05, FL-AR-06, FL-AR-09, FL-AR-16 and FL-AR-17 are all located along the perimeter and are noted in Figure 5.1.

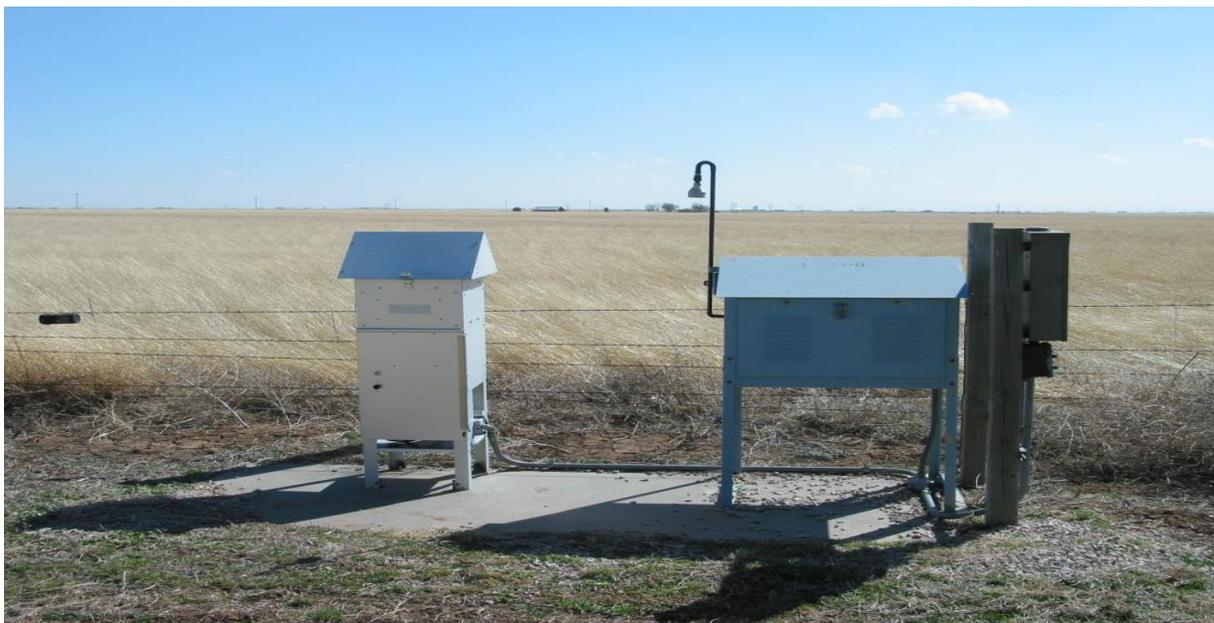
**Figure 5.3 – Typical Air Monitoring Site**

Each monitoring station was equipped with a high-volume air sampler and a low-volume air sampler (Figure 5.3). On the far-left of the figure is a container for the co-located thermoluminescent dosimeters (TLDs). The high-volume sampler is located on the left, and a “doghouse” containing the low-volume sampler is on the right. The samplers ran continuously, and filters or silica gel samples were collected from the samplers on a weekly basis. Sampler operational characteristics, such as sample collection period length, beginning flow rates, ending flow rates, and other parameters were recorded by the sampling technicians at the initiation and/or at the completion of the sampling activity.

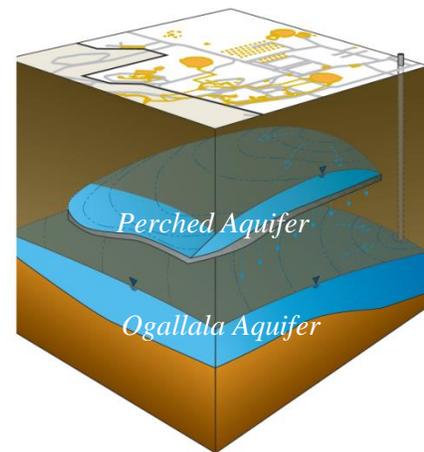
**Figure 6.1 – Groundwater Beneath Pantex**

Groundwater beneath Pantex Plant and vicinity occurs in the Ogallala and Dockum Formations at two intervals (Figure 6.1). The first water-bearing unit below Pantex Plant in the Ogallala Formation is a discontinuous zone of perched groundwater located at approximately 200 to 300 feet (ft.) below ground surface and 100 to 200 ft. above the drinking water aquifer. A zone of fine-grained sediment (consisting of sand, silt, and clay) that created the perched groundwater is found between the perched groundwater and the underlying drinking water aquifer. The fine-grained zone (FGZ) acts as a significant barrier to downward migration of contaminated water. The perched groundwater ranges in saturated thickness from less than a foot at the margins to more than 75 ft. beneath Playa 1. Perched groundwater forms by surface water in the playas that initially migrates down to the fine-grained zone. It then flows outward in a radial manner away from the playa lakes and becomes influenced by the regional south to southeast gradient. The largest area of perched groundwater beneath Pantex Plant is associated with natural recharge from Playas 1, 2, and 4, treated wastewater discharge to Playa 1, historical releases to the ditches draining Zones 11 and 12, and storm water runoff that drains to the unlined ditches and playas. Two hydraulically separate, relatively small, perched zones occur around Playa 3 (near the Burning Ground in the north central portion of Pantex Plant) and near the Old Sewage Treatment Plant in the northeast corner of Pantex Plant.

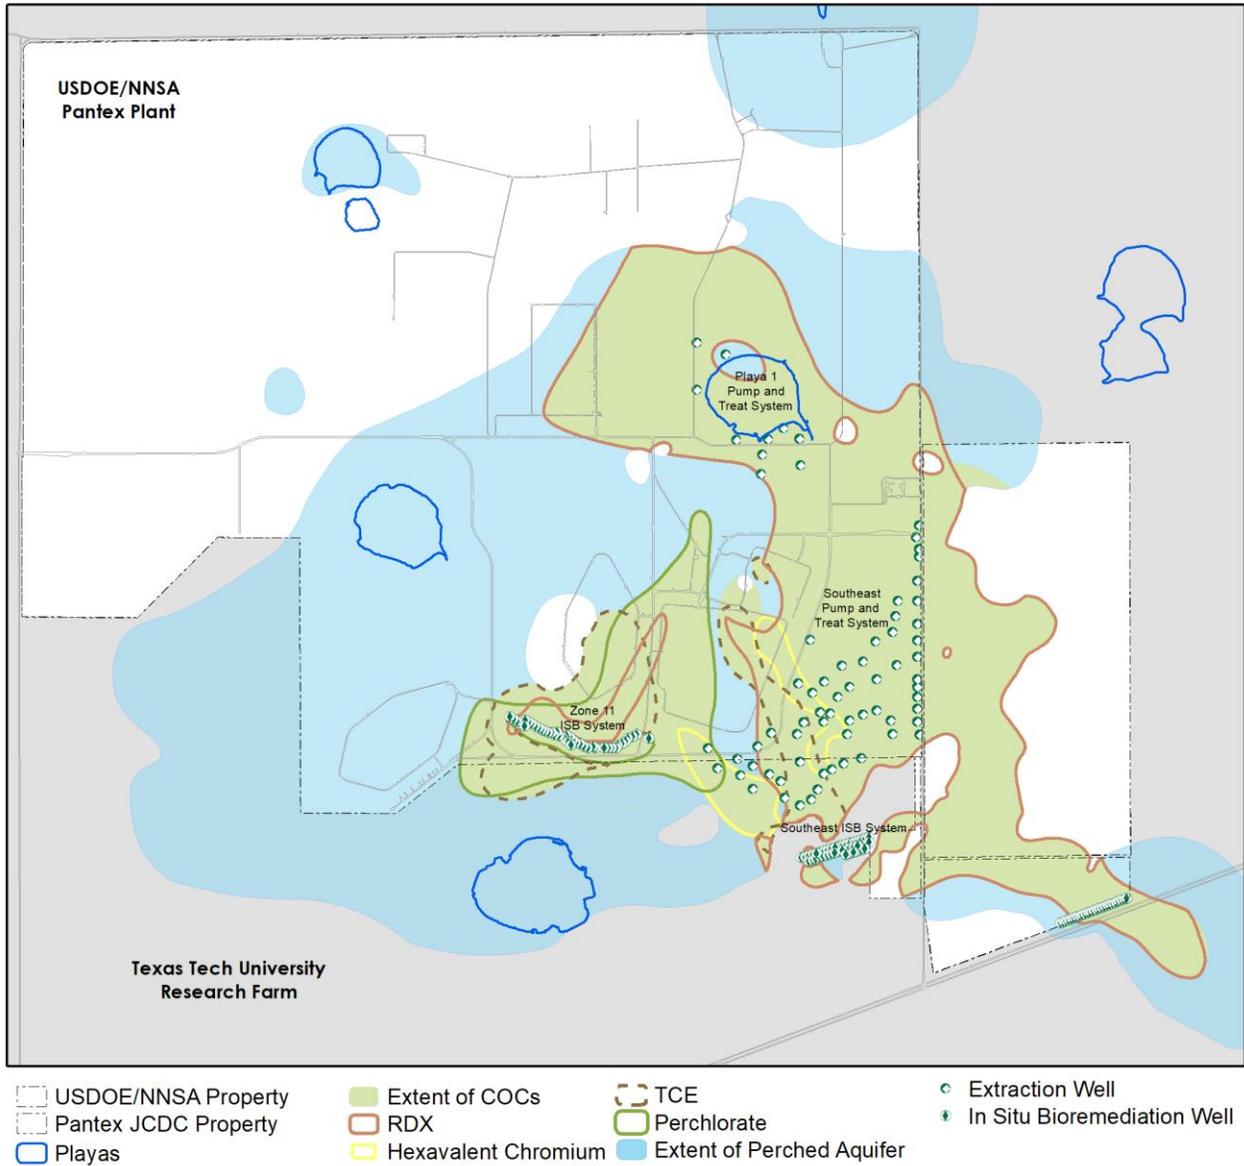
**Figure 6.2 – Major Perched Groundwater Plumes and Remediation Systems**

Remedial Action Objectives	LTM Network Monitoring Objectives
<ul style="list-style-type: none"><li>❖ Reduce risk of exposure to perched groundwater through contact prevention</li><li>❖ Achieve cleanup standard for perched COCs</li><li>❖ Prevent growth of perched groundwater contaminant plumes</li><li>❖ Prevent COCs from exceeding cleanup standards in the drinking water aquifer</li></ul>	<ul style="list-style-type: none"><li>❖ Remedial action effectiveness</li><li>❖ Plume stability</li><li>❖ Uncertainty management</li><li>❖ Early detection</li></ul>

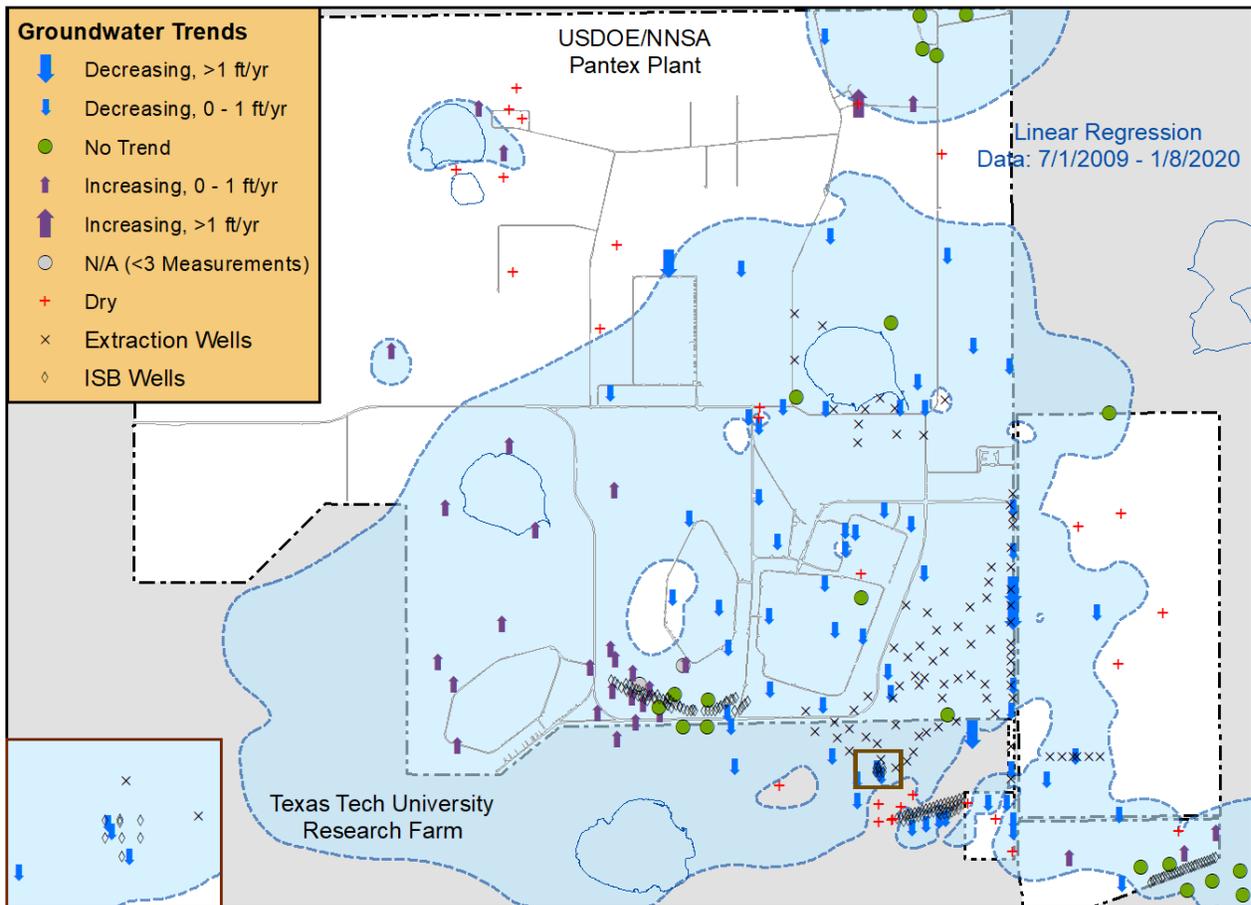
Figure 6.3 – Water Level Trends in the Perched Aquifer

The SEPTS system has operated at a higher capacity using injection, release to Playa 1, and intermittent shutdowns of the PIPTS to allow full treatment at the system. SEPTS operations focus on removing water in high priority locations that help control migration of the plume to the southeast. New extraction wells were drilled east of FM 2373 to provide additional control of plume movement. Pantex Plant has completed tie-in of the new extraction wells east of FM 2373 to SEPTS in April 2019, with full operation of the wells beginning in July 2019. Water levels are continuing to decline in the areas downgradient of the pump and treat systems, with declines exceeding one foot per year in several wells as depicted in Figure 6.3.

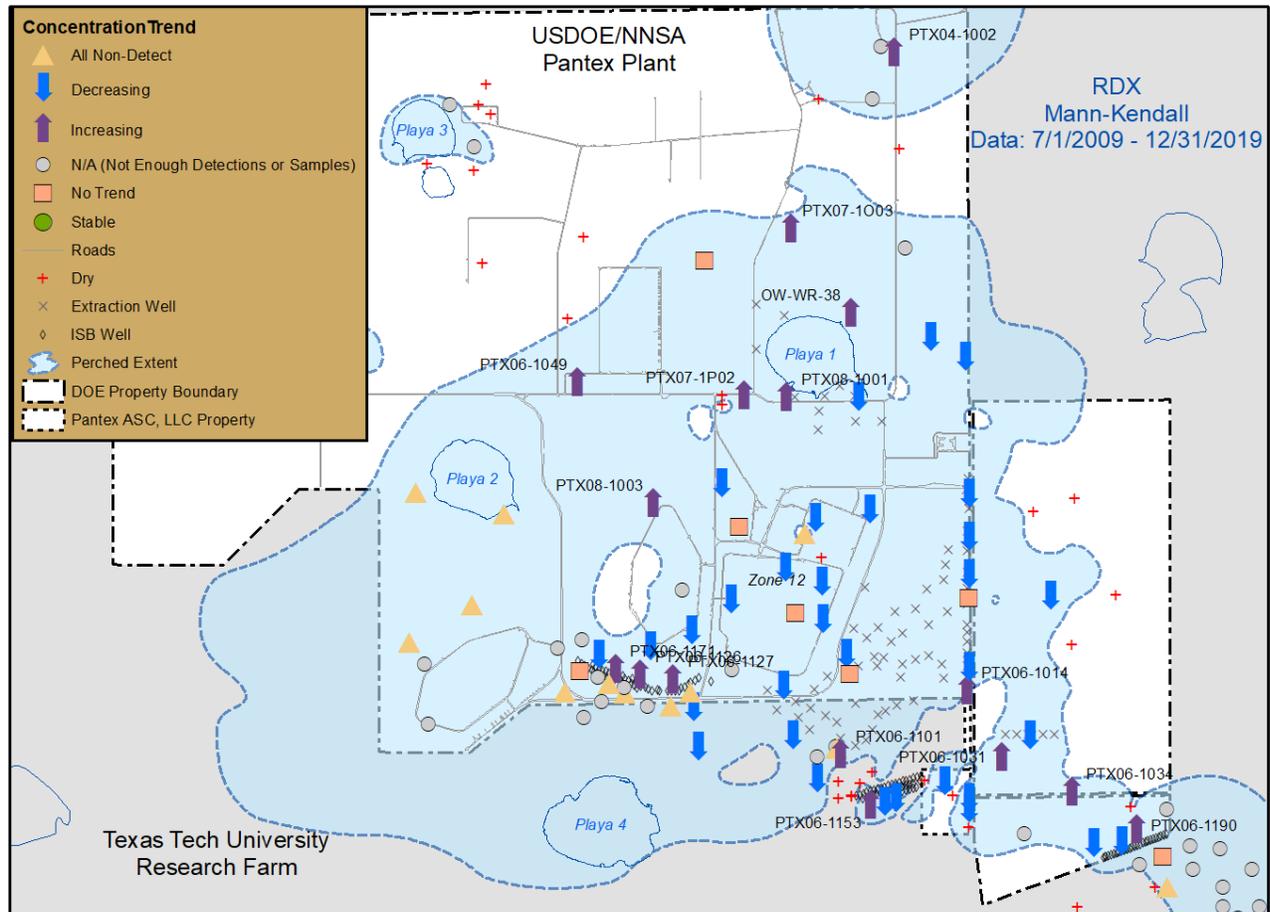
**Figure 6.4 – RDX Concentration Trends in the Perched Aquifer**

RDX concentration trends since the start of remedial action in July 2009, depicted in Figure 6.4, generally indicate that RDX is decreasing or does not demonstrate a trend at the source areas (Playa 1 and the ditch along the eastern side of Zone 12). The SEPTS has affected the plume as the majority of COC concentrations are declining or not demonstrating a trend along the outer margins of the system. To the southeast, only one (PTX06-1153) of the five wells indicating a long-term increasing trend currently exhibits an increasing trend based on recent data. PTX06-1153 is the only well downgradient of the Southeast ISB System that is not indicating effective treatment. Pantex Plant continues to evaluate conditions in the area of this well; further recommendations will be made based on evaluation of data over time.

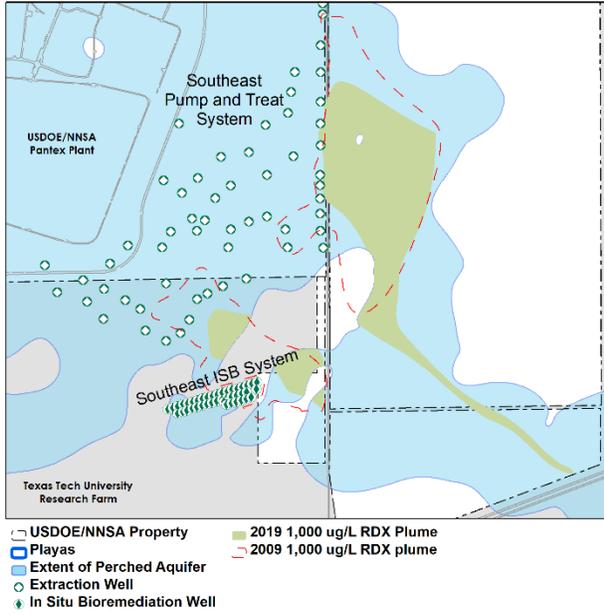
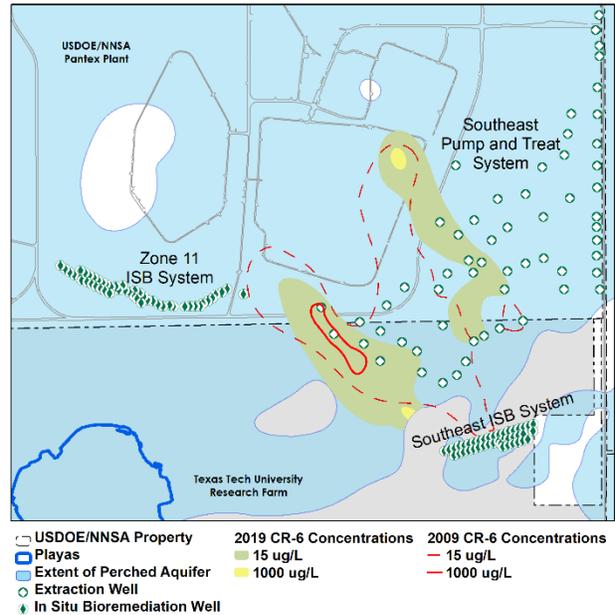
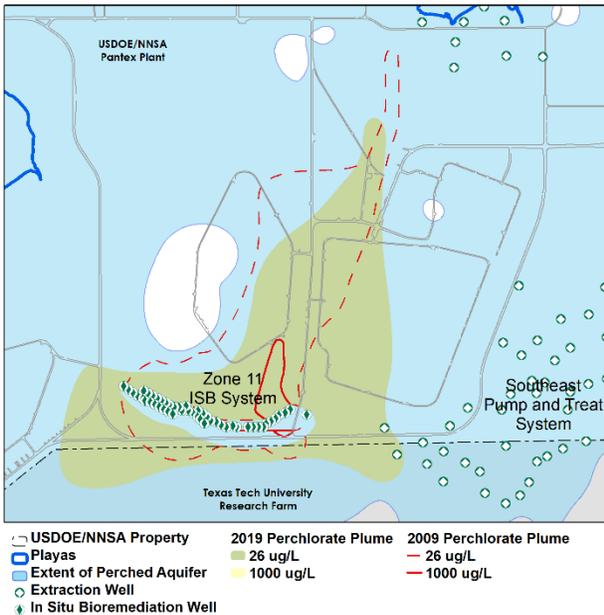
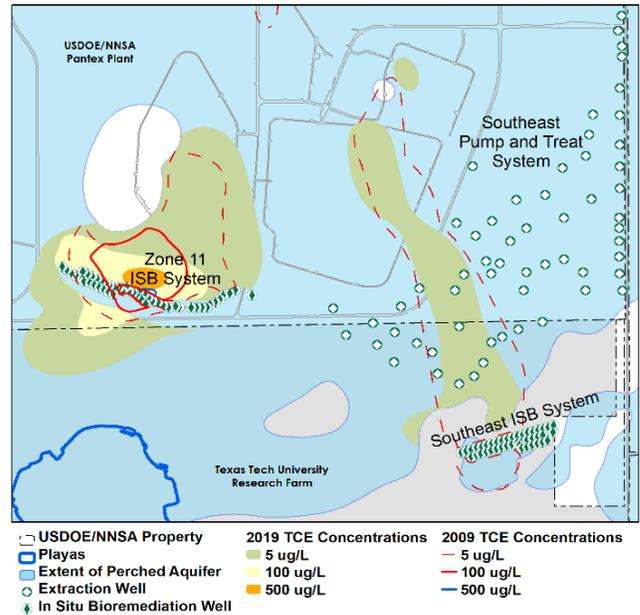
Concentration trends for the remaining major COCs (perchlorate, TCE, and hexavalent chromium) are discussed in the 2019 Annual Progress Report. Figure 6.5 shows plume movement in perched groundwater of major COCs for the time period of 2009 to 2019. Figure 6.6 shows the annual maximum concentrations of the major COCs observed in the perched aquifer since 2009. Continued declining trends are demonstrated for TCE and hexavalent chromium through 2019. However, perchlorate and RDX both showed an increase in annual maximum concentrations in 2019. The perchlorate increase is associated with plume movement in the area southwest of Zone 11, while increase in RDX is associated with plume movement towards the southeast. Areas outside the influence of the remedial action systems are also

RDX Plumes

Hexavalent Chromium Plume

Perchlorate Plume

TCE Plume

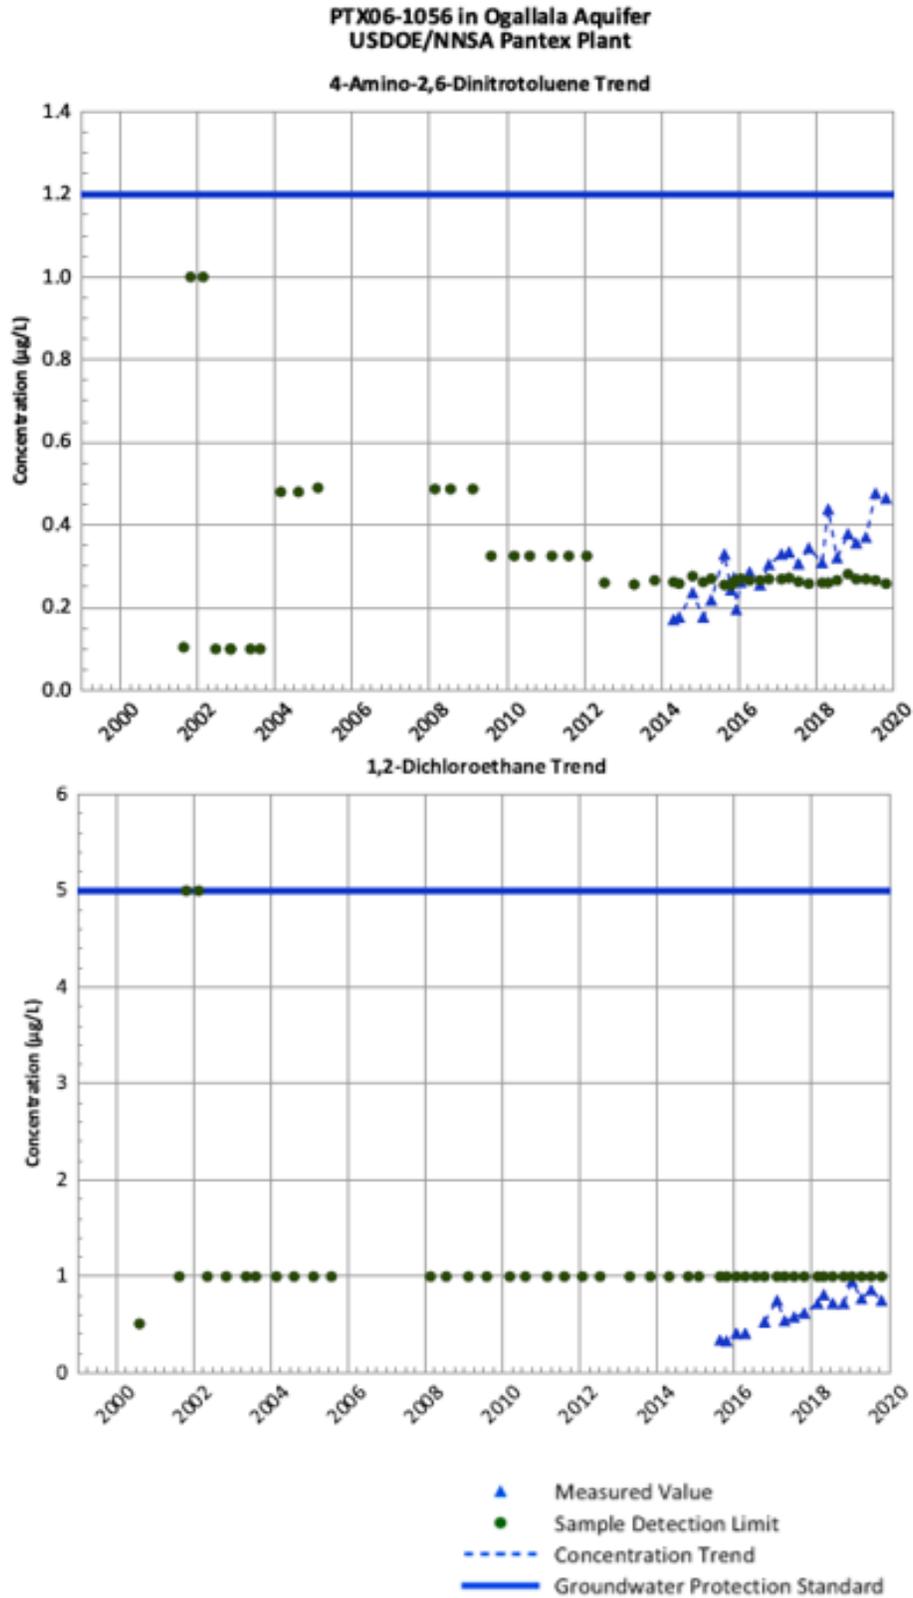
Figure 6.8 – Summary of Unexpected Conditions in Ogallala Aquifer Well PTX06-1056

Natural attenuation is the result of processes that naturally lower concentrations of contaminants over time. This process is monitored at Pantex Plant to help determine where natural attenuation is occurring, under what conditions it is occurring, and to eventually determine rates of attenuation for various constituents.
