For Calendar Year 2019

# Annual Site Environmental Report

## Pantex Plant

# Site Environmental Report Pantex Plant 2019

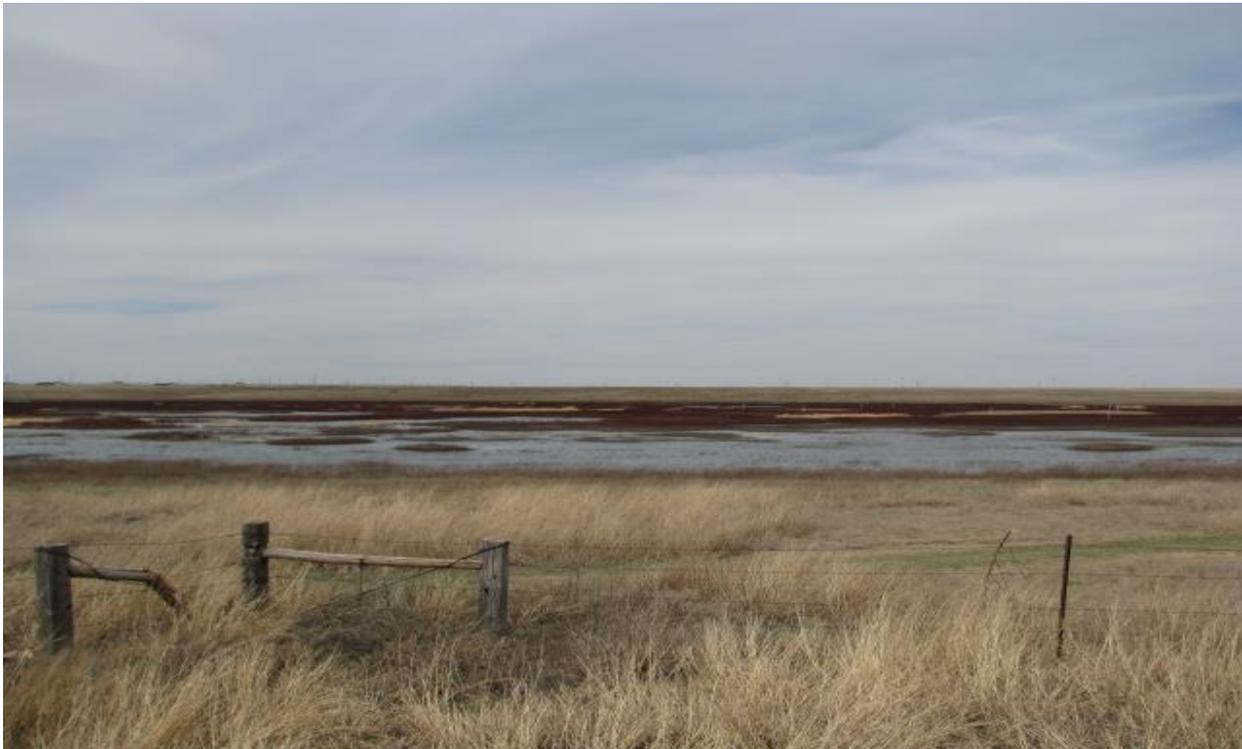
**Figure 8.1 – Playa 1**

Domestic and industrial wastewaters generated at Pantex Plant are treated at an on-site WWTF. Industrial effluents from Pantex Plant operations are generally pre-treated and directed into the WWTF for further treatment. All such effluents are collected in the sanitary sewer, managed in the WWTF, and can be discharged through permitted outfalls to either an underground irrigation system or an on-site playa lake. The playa is an ephemeral lake and is not connected to any other lakes, rivers, or streams (Figure 8.1).

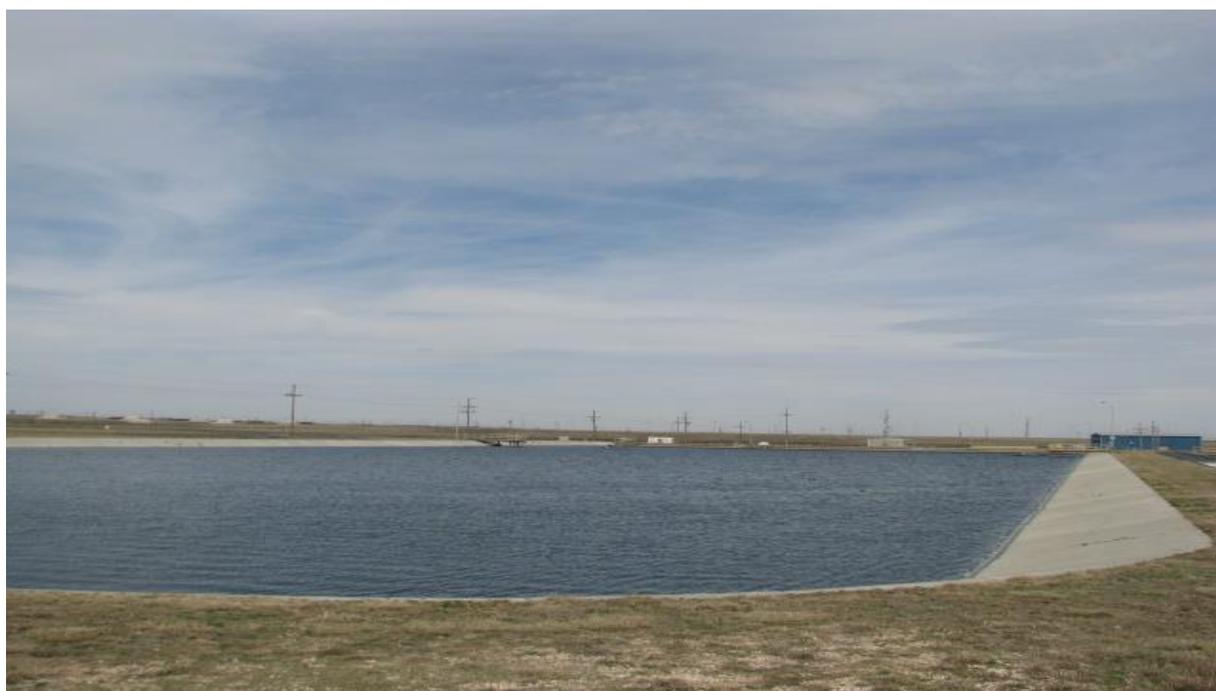
**Figure 8.2 – Wastewater Treatment Facility, Facultative Lagoon**

The treatment process in the facultative lagoon involves a combination of aerobic, anaerobic, and facultative bacteria. At the surface, aerobic bacteria and algae exist in a symbiotic relationship. Oxygen is provided by natural aeration processes, algal photosynthesis, and by solar-powered mechanical aerators. Bacteria utilize the oxygen for the aerobic degradation of organic matter, while algae utilize the nutrients and carbon dioxide released in the degradation process. Facultative bacteria within the water column are used in the treatment and degradation of organic matter. Anaerobic bacteria decompose organic matter that is deposited in a sludge layer at the bottom of the lagoon. The wastewater treatment process in a facultative lagoon is complex and nearly all treatment is accomplished by biological activity.

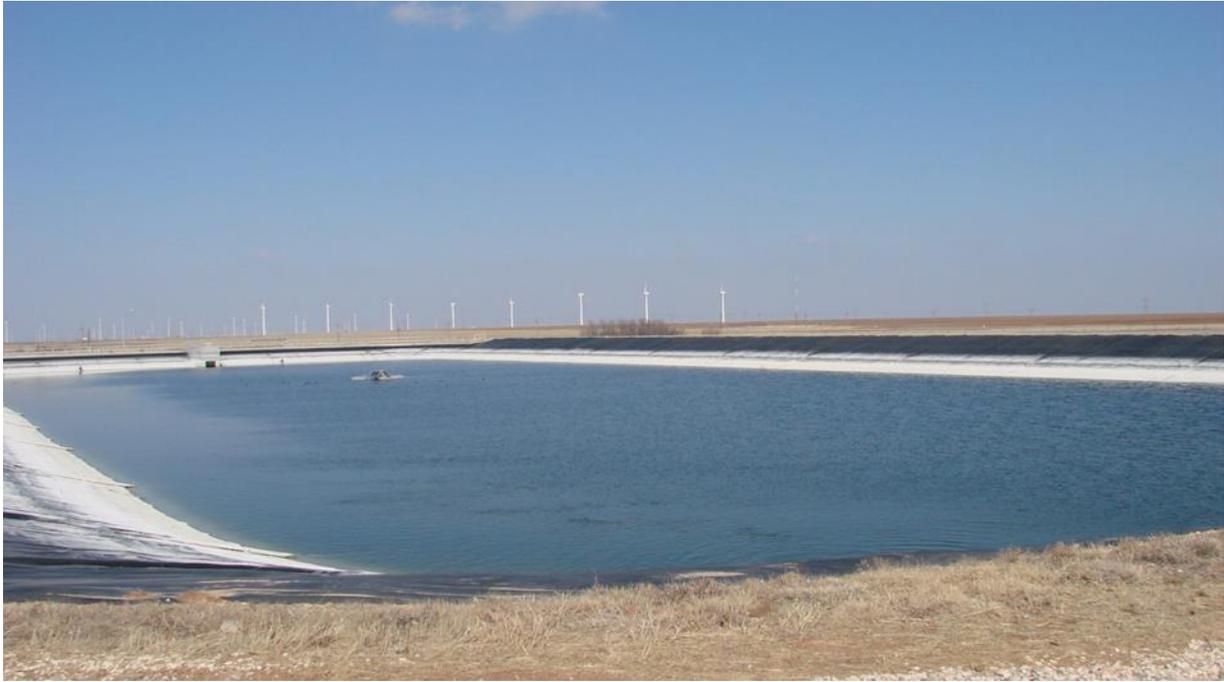
**Figure 8.3 – East Wastewater Storage Lagoon**

The WWTF (Figure 8.2) is a clay-lined, facultative lagoon that covers approximately 3.94 acres (ac) and has a capacity of 11 million gal. In addition to the WWTF, there are two storage lagoons (Figure 8.3 and 8.4) that are utilized for the storage and retention of treated wastewater. The east lagoon (Figure 8.3) is a storage lagoon that is lined with a polyethylene liner and has similar dimensions and capacity to the facultative lagoon. This lagoon receives treated domestic and industrial wastewater, as well as treated groundwater from environmental remediation projects. If necessary, the east lagoon can serve as a facultative lagoon.

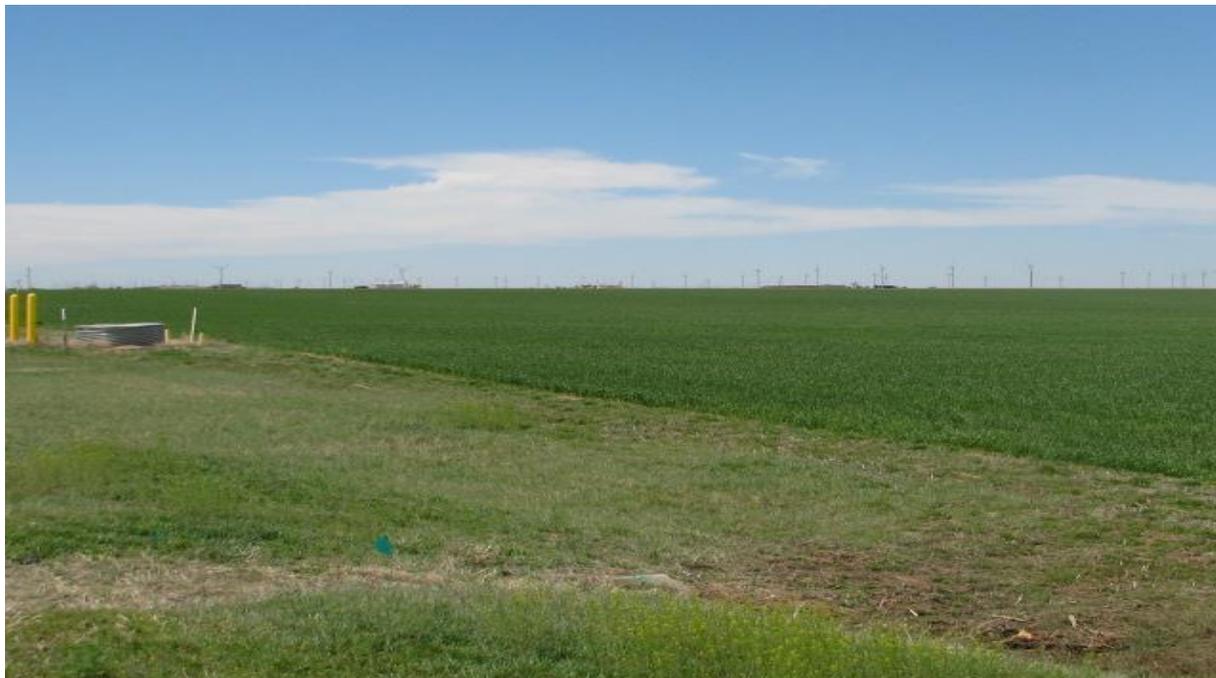
**Figure 8.5 – Irrigation Tract 101**

The irrigation area consists of agricultural land owned by the Department of Energy and farmed by Texas Tech University (TTU). Crops grown in this area may include winter wheat, sorghum, soybeans, cotton, corn, oats, and opportunity wheat. Crops will vary from field to field, depending on the cropping needs of TTU. The subsurface irrigation system was not utilized during 2019 due to ongoing repairs. However, two of the four tracts were planted as dry land crops with winter wheat (Figure 8.5).

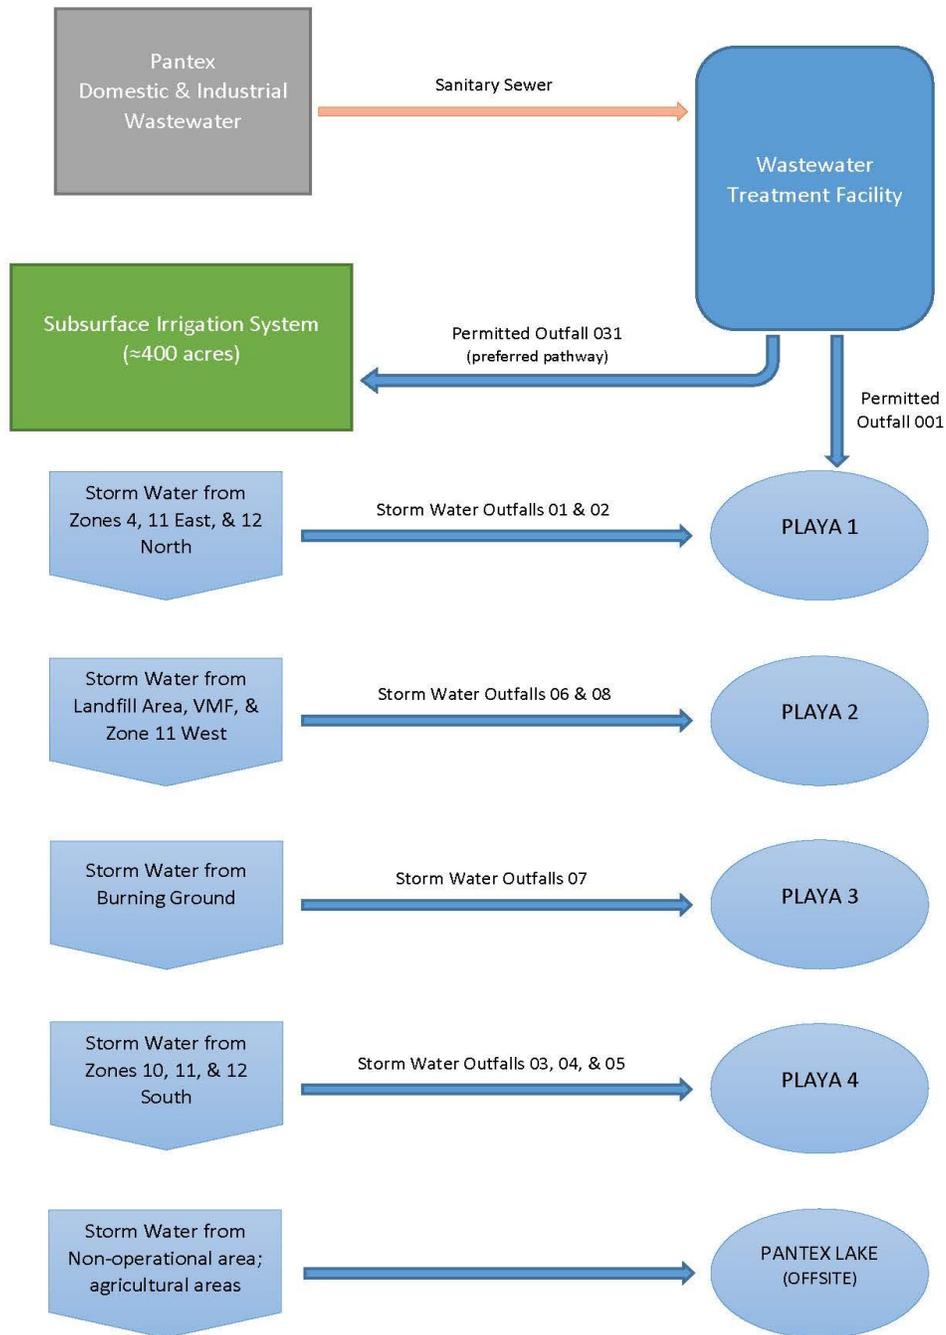
**Figure 9.2 – Pantex Plant Surface Water Schematic**

Storm water monitoring required by the TPDES MSGP in 2019 consisted of both visual monitoring and analytical monitoring. Both are required each year for the duration of the MSGP. Visual monitoring involves the examination of the physical properties of storm water including color, clarity, odor, oil sheen, solids, and foam. Visual samples taken and examined in 2019 appeared to be of good quality, and none showed any abnormalities based on the criteria specified in the MSGP. Analytical monitoring consisted of metals (Inland Water Quality Parameters [IWQPs]) listed in Title 30 of the Texas Administrative Code (TAC), Chapter 319 and sector-specific analytes required by the MSGP. Metal concentrations were compared with IWQPs, and sector-specific analytes were compared to benchmark levels listed in the MSGP. Table 9.1 lists the results for metals from the storm water outfalls in 2019 and compares them with the IWQPs.

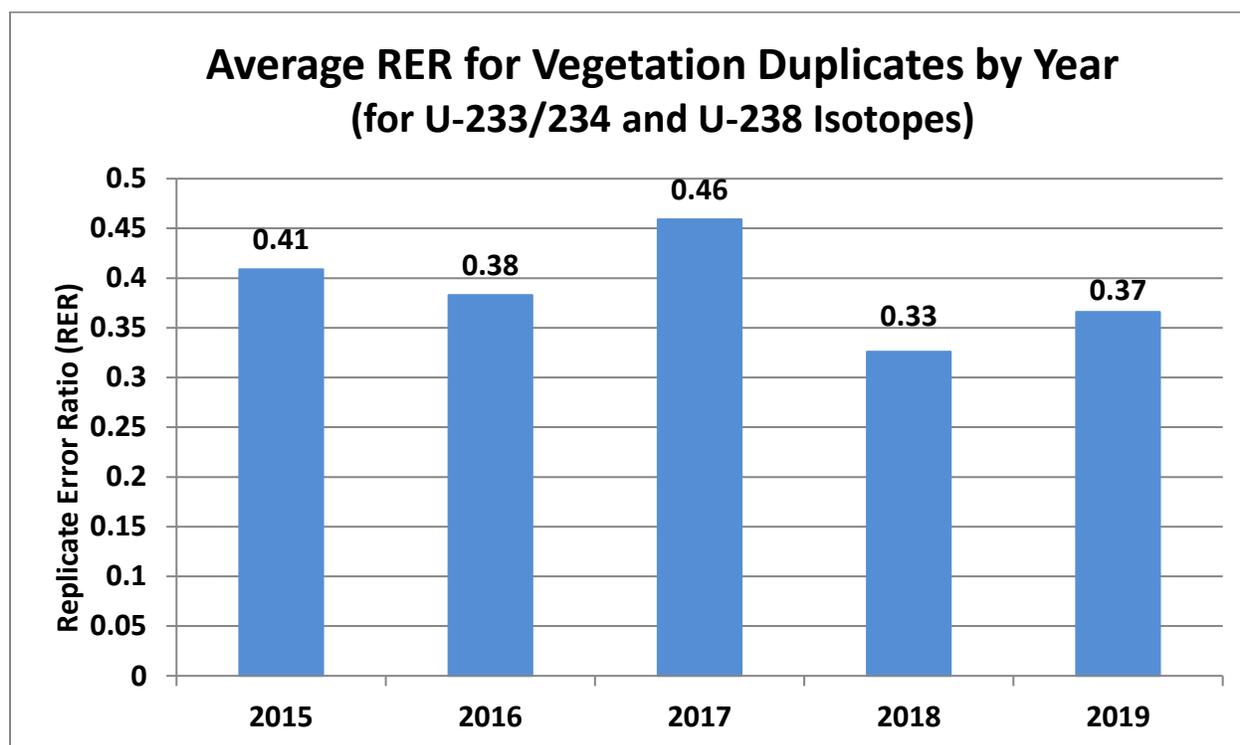
**Figure 13.3 – Five Year Average Replicate Error Ratio for Vegetation Duplicates**

An RER of less than or equal to one indicates that the replicates are comparable within the 95 percent confidence interval. For 2019, the average RER value for vegetation data was 0.366 with an associated standard deviation of 0.308. The 2019 vegetation sample RER analysis indicated that field replicate sample precision accurately reflects the actual sample value. Figure 13.3 summarizes the RER data.
