# ANNUAL SITE ENVIRONMENTAL REPORT PANTEX PLANT

**Annual Site Environmental Report  
Pantex Plant  
Calendar Year 2023**

**September 2024**

Prepared for  
U.S. Department of Energy/National Nuclear Security Administration Pantex Field Office

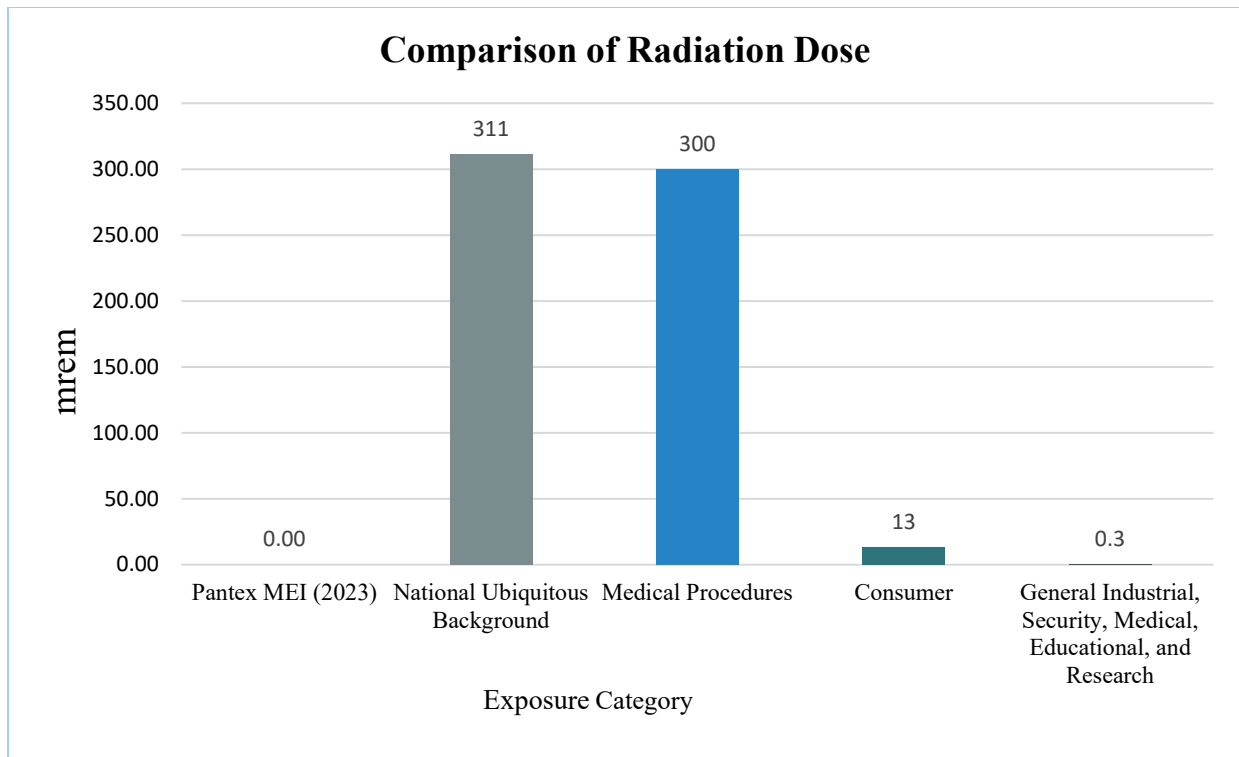
**Fig. ES.1. Comparison of radiation dose.**

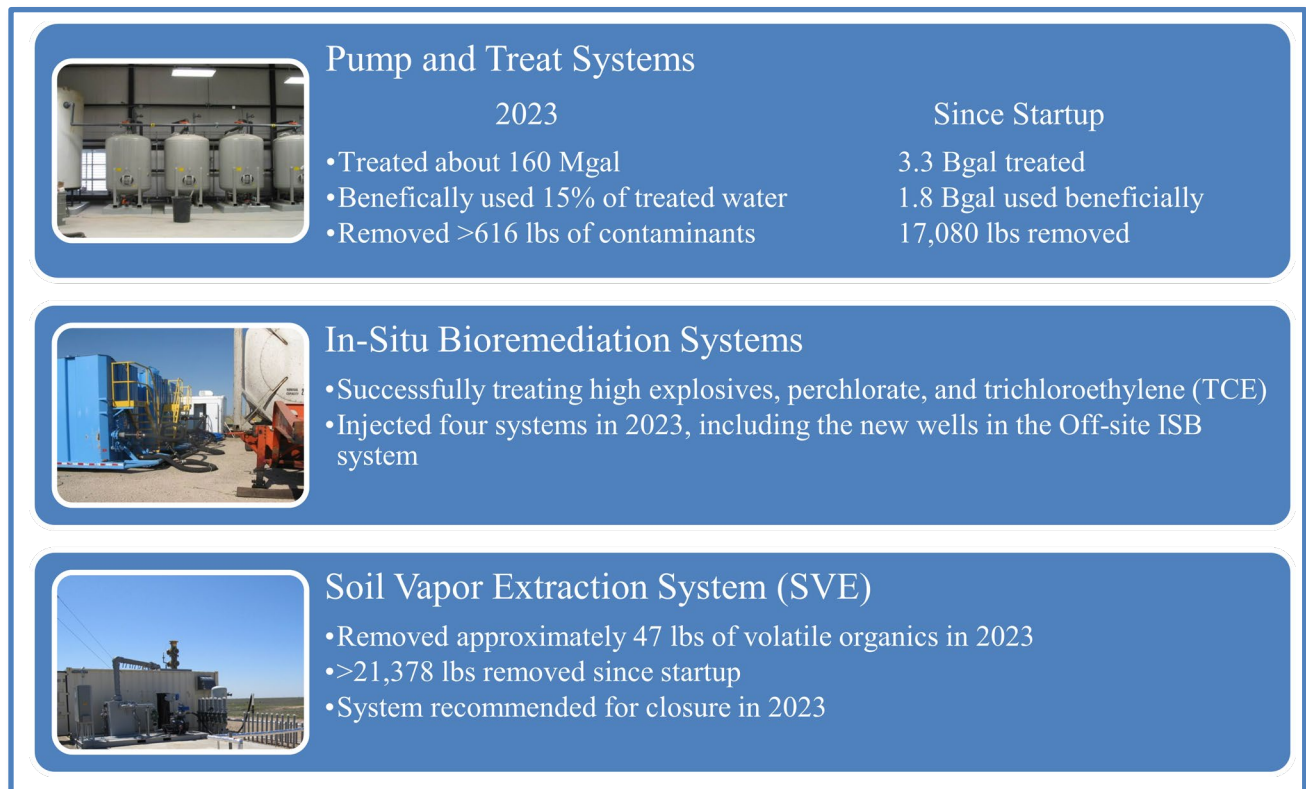
**Fig. 3.14. Major Milestones for 2023 remedial actions.**

During 2023, Pantex completed several milestones under the continued long-term stewardship (LTS) of environmental units. LTS includes the long-term O&M of the remediation systems, monitoring of the systems to ensure that cleanup goals established in the ROD and Pantex Hazardous Waste Permit will be met, maintenance of soil remedies and institutional controls, and reporting of that information to regulatory agencies and the public. Major milestones for the 2023 remedial actions are shown in Fig. 3.14. and remedial action systems at Pantex are depicted in Fig. 3.15.

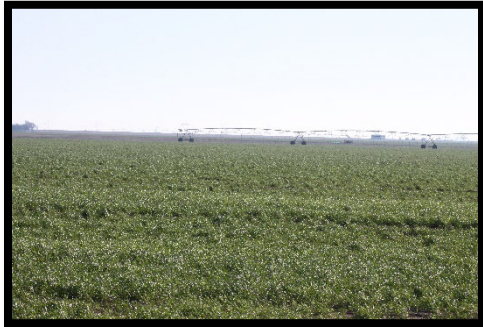
**Fig. 3.19. Center pivot irrigation sprinkler system at Pantex.**

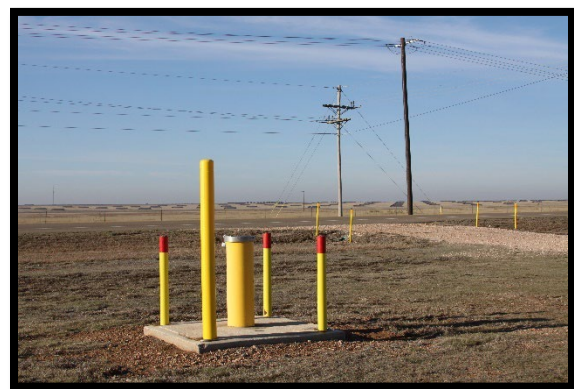
**Fig. 3.20. In-situ bioremediation system well near Zone 11.**

occurring microorganisms. The new system was designed to cleanup COCs that have moved to off-site areas. Pantex started injecting into the available wells at the new Off-Site ISB Extension in 2021. Full installation of the Off-Site ISB was completed in 2023.

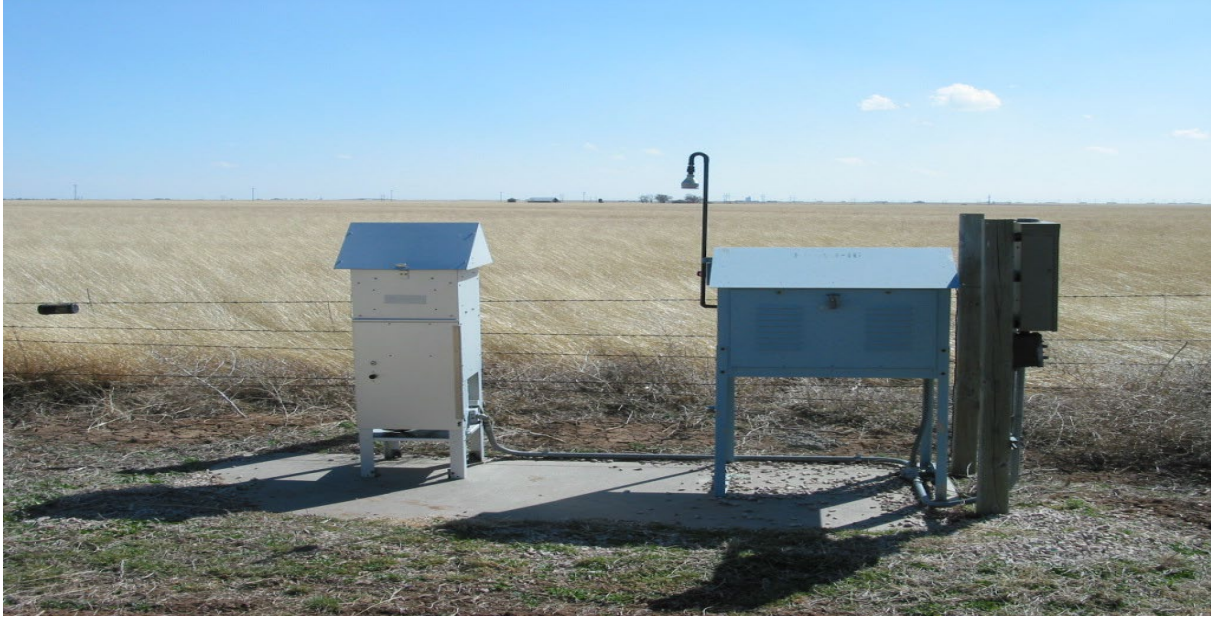
**Fig. 5.3. Typical air-monitoring site.**

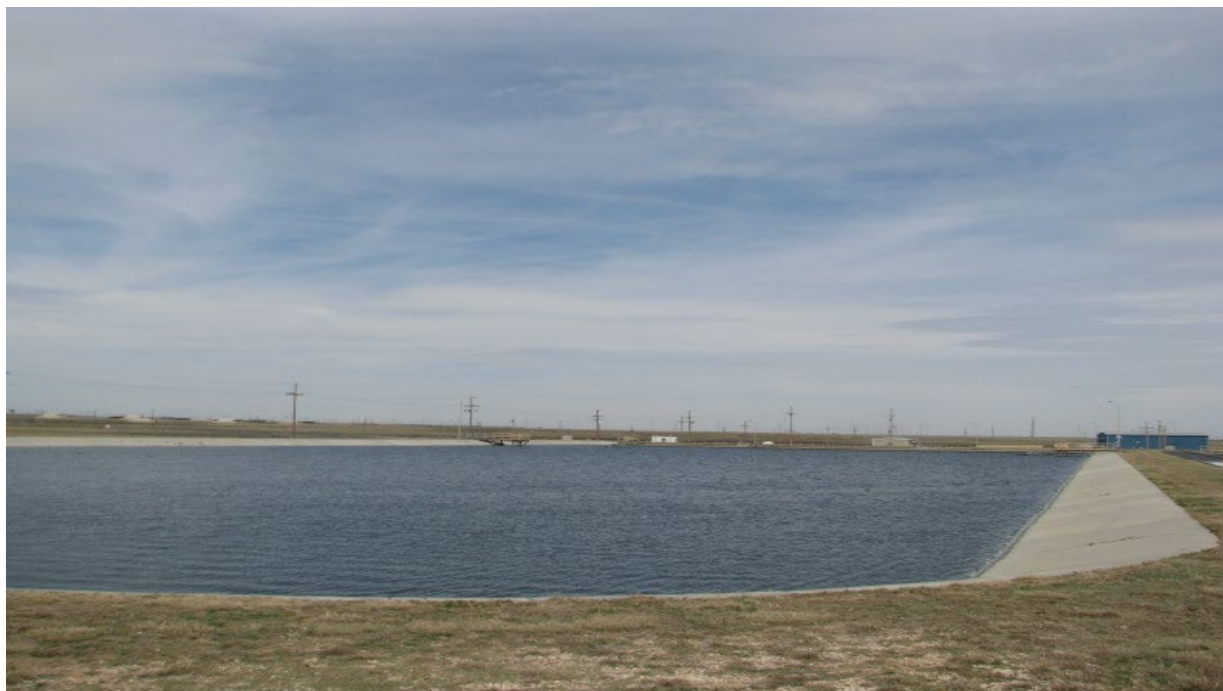
**Fig. 8.2. Wastewater Treatment Facility, facultative lagoon.**
