For Calendar Year 2017

# Annual Site Environmental Report

## Pantex Plant

# Site Environmental Report Pantex Plant 2017

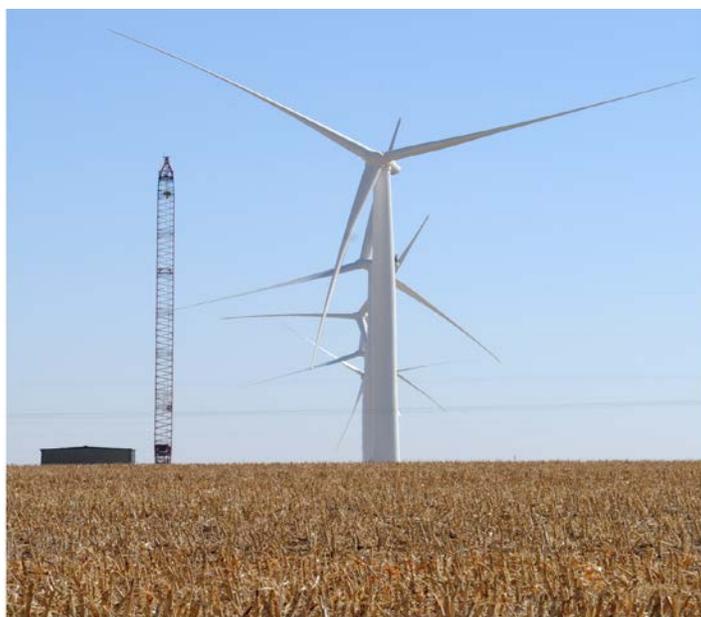
**Figure 3.2 – Pantex Renewable Energy Project<sup>1</sup>**

Success in reducing energy use at Pantex has historically been realized from energy savings activities such as: (1) utilizing the Energy Management Control System (EMCS) to implement and maintain night, weekend and holiday setbacks; (2) installation of occupancy sensors to control lighting in areas in several facilities with low occupancy rates (conference rooms, break rooms, restrooms); (3) installation of new or retrofitted advanced meters that are integrated with a communication network and dedicated server that stores the meter readings for use with the U.S. EPA’s Portfolio Manager building benchmarking system; (4) procurement of equipment such as Energy Star products that are more energy efficient and (5) continuous and retro-building commissioning. Other innovative building strategies, such as cool roofs and low-flow fixtures, are also used to minimize the consumption of energy, water, and materials. In 2017, the Pantex Plant continued to use an alternate work schedule (9X80s) which has helped reduce energy consumption for a large number of administrative personnel. Relocation of approximately 1,100 employees to a newly constructed energy-efficient facility (John C. Drummond Center) during April 2018 and the resulting reduction of “footprint” after the demolition of legacy facilities over the next 10 years will also reduce energy consumption in the future. However, the major source of reductions in energy intensity has been the installation of the Pantex Renewable Energy Project (PREP) (see Figure 3.2) in the summer of 2014.

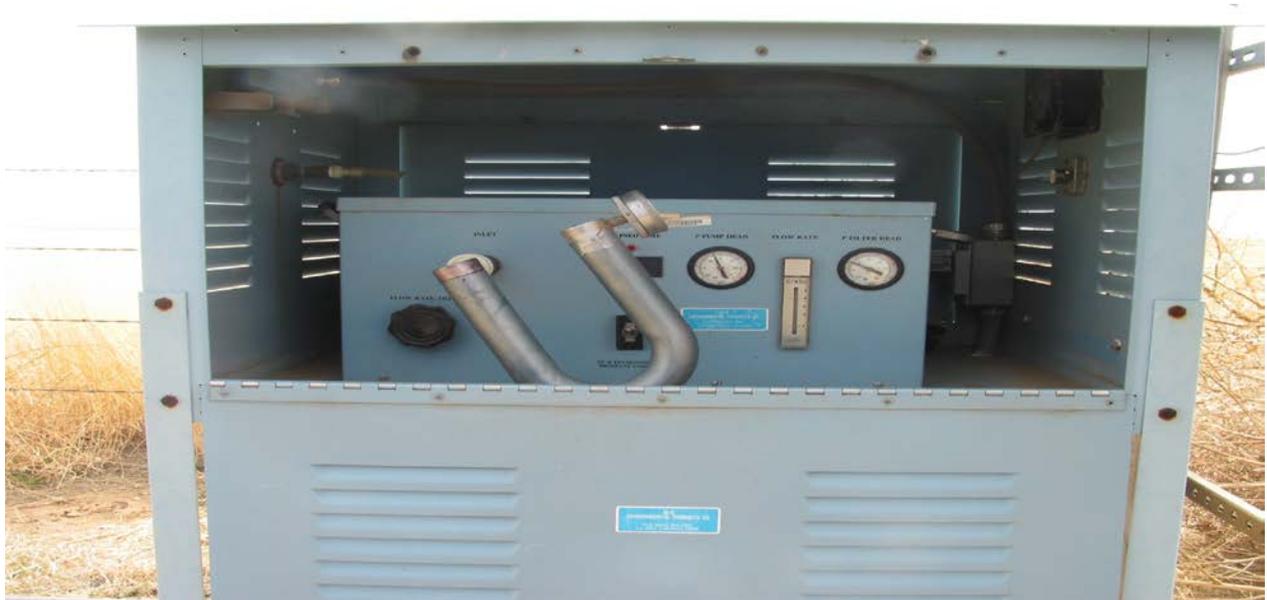
**Figure 5.4 – Low-Volume Sampling Apparatus**

Nominal airflow through the low-volume air samplers was much smaller than that for the high-volume samplers, being 42.5 liters per minute (1.5 ft.<sup>3</sup>/min). Each low-volume sampler contained silica gel within the “U-tube” illustrated in Figure 5.4. The silica gel acted as a desiccant, removing water vapor from air as it flowed through the sampler. The silica gel samples were collected at the same time as the individual filters were collected from the high-volume samplers. Any tritiated water vapor present in the sampled air was recovered and quantified during analysis of the silica gel by a radiological analysis laboratory.

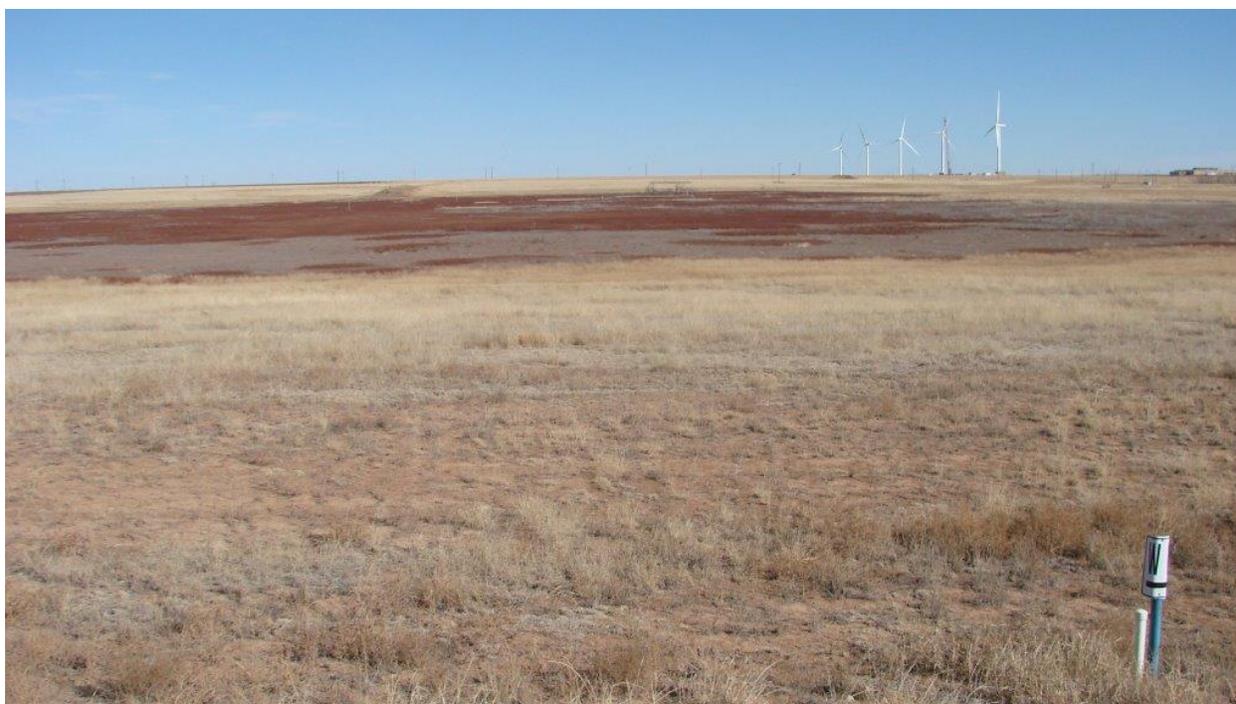
**Figure 8.1 – Playa 1 (in previous years)**

Domestic and industrial wastewaters generated at the Pantex Plant are treated at an on-site wastewater treatment facility (WWTF). Industrial effluents from Plant operations are generally pre-treated and are directed into the WWTF for further treatment. All such effluents are collected in the sanitary sewer, managed in the WWTF, and are either disposed through a permitted outfall to an underground irrigation system or discharged through a permitted outfall to an on-site playa lake. The playa is an ephemeral lake and is not connected to any other lakes, rivers, or streams (Figure 8.1).

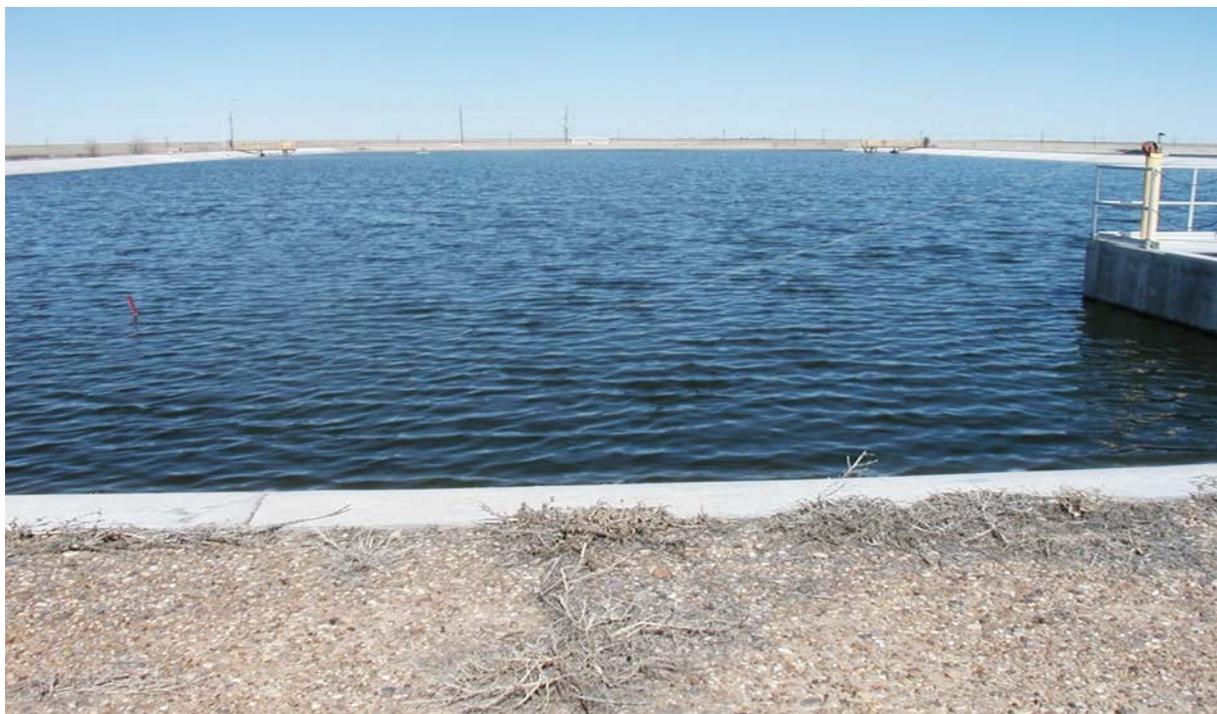
**Figure 8.2 – Wastewater Treatment Facility, Facultative Lagoon**

The WWTF (Figure 8.2) is a clay-lined, facultative lagoon that covers approximately 1.58 hectares (3.94 acres) and has a capacity of 42 million liters (11 million gallons). Pantex also has two storage lagoons used for storage and retention of treated wastewater. The east lagoon is a storage lagoon with a polyethylene liner with similar dimensions and capacity as the facultative lagoon and can serve as the facultative lagoon should the need arise (Figure 8.3). In addition to the treated domestic and industrial wastewater, this lagoon receives treated groundwater from environmental remediation projects.

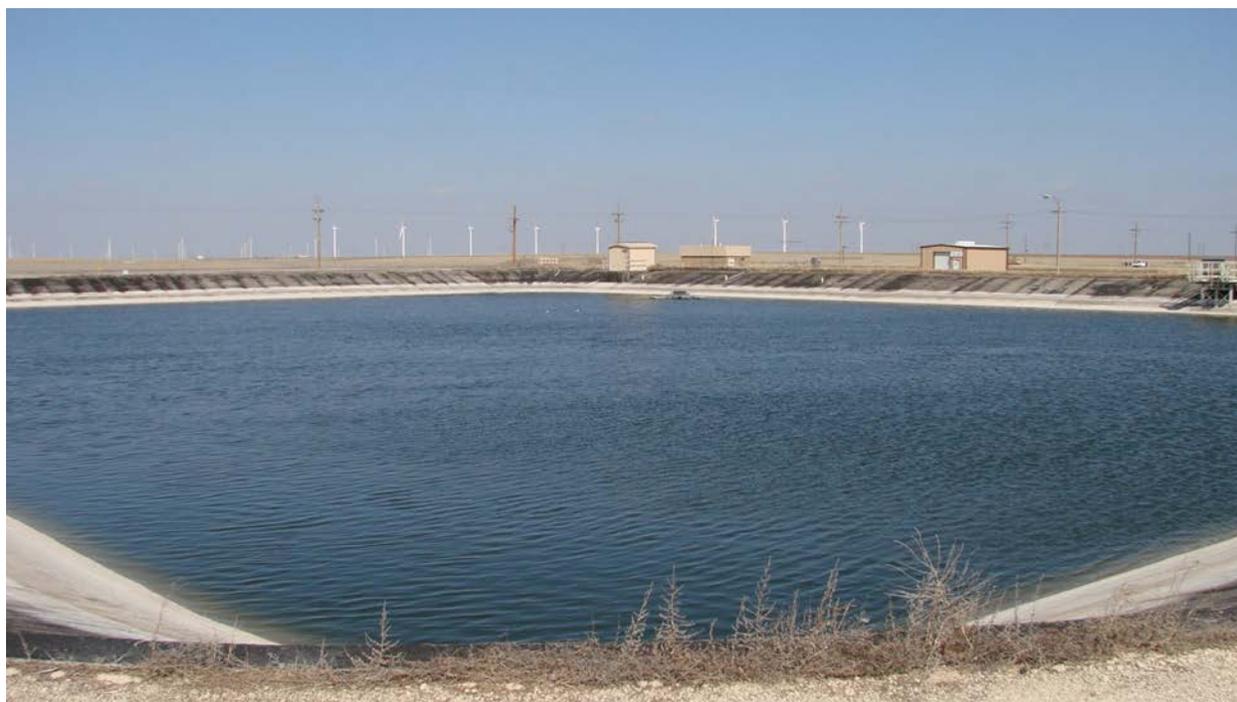
**Figure 8.4 – Wastewater Storage Lagoon**

The northern storage lagoon is a clay-lined lagoon, which covers approximately 1.05 hectares (2.6 acres) and has a capacity of 25.54 million liters (6.7 million gallons). This lagoon is used only for the storage of treated wastewater (Figure 8.4).

The treatment process in the facultative lagoon involves a combination of aerobic, anaerobic, and facultative bacteria. At the surface, aerobic bacteria and algae exist in a symbiotic relationship. Oxygen is provided by natural aeration processes, algal photosynthesis, and by solar-powered mechanical aerators. Bacteria use the oxygen for the aerobic degradation of organic matter. Nutrients and carbon dioxide released in the degradation process are used by the algae. Below the surface and above the bottom of the lagoon, treatment and degradation of organic matter is accomplished with facultative bacteria. At the bottom of the facultative lagoon, organic matter is deposited in a sludge layer and is decomposed by anaerobic bacteria. The wastewater treatment process in a facultative lagoon is complex and nearly all treatment is provided by biological activity.

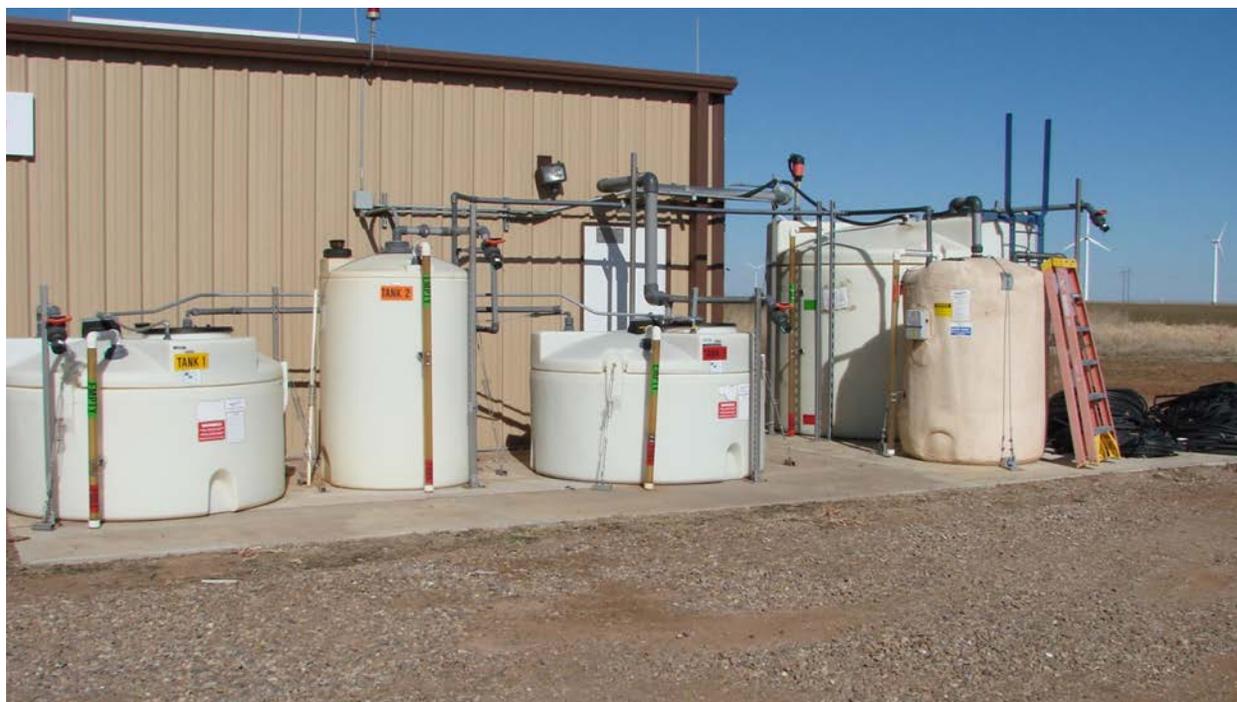
**Figure 8.5 – Agricultural Chemical Injection Tanks**

When discharging to the subsurface irrigation system and prior to application in the fields, the treated wastewater passes through a series of filters designed to remove dirt, debris, and particulate matter. After filtration, the water is pumped to a field filter building where it is filtered again. From this point, water is distributed through manifold pipes to individual zones located within four tracts of land that are each approximately 100 acres in size. Fertilizers and maintenance chemicals are injected into the system through chemical tanks at the field filter building (Figure 8.5). This irrigation system consists of hundreds of miles of piping, tubing, and pressure-compensating drip emitters. The irrigation area consists of agricultural land owned by DOE and farmed by TTU. Crops grown in this area may include winter wheat, sorghum, soybeans, cotton, corn, oats, and opportunity wheat. Crops will vary from field to field, depending on the cropping needs of TTU.

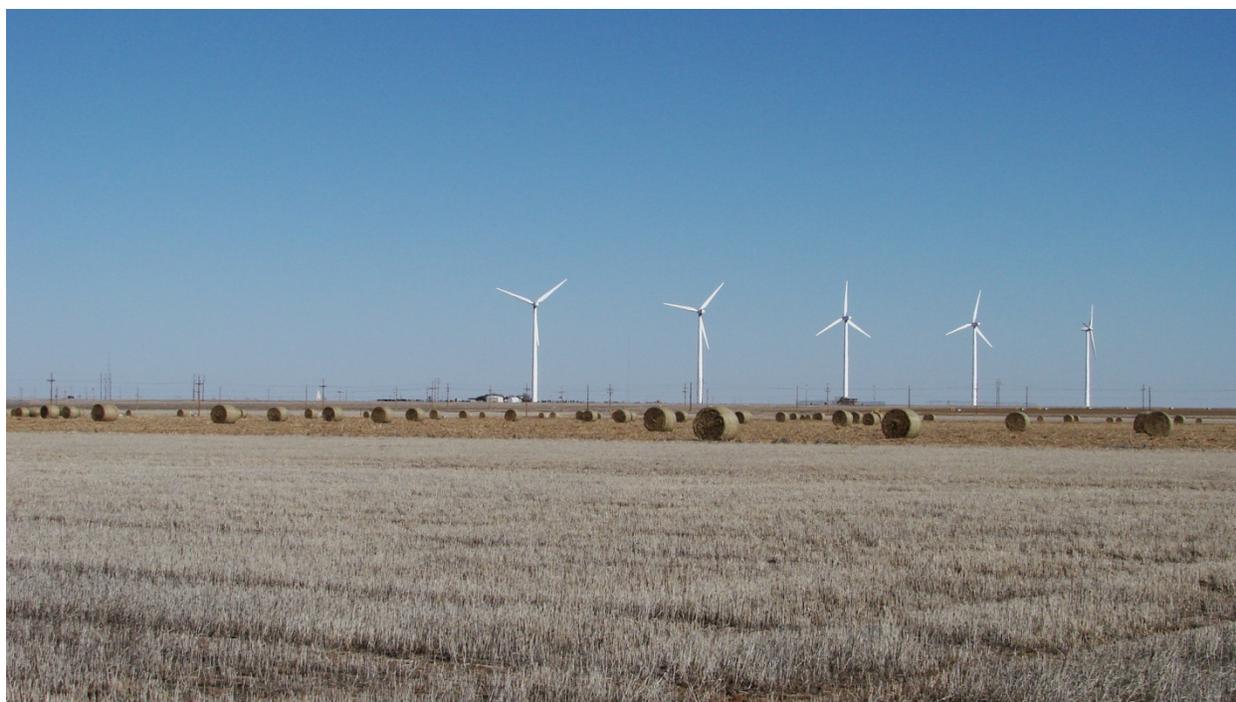
**Figure 8.6 – Irrigation Tract 101**

During 2017, Pantex beneficially applied approximately 91 million gallons of treated wastewater to crops managed by TTU (Figure 8.6). This is a decrease of 144 million gallons compared to operations during 2016. The reason for the reduction in beneficial reuse was major filter leaks in the irrigation system. At the end of 2017, efforts were still underway to restore this system to full operation. Table 8.1 shows the volume of water applied for each irrigation tract.

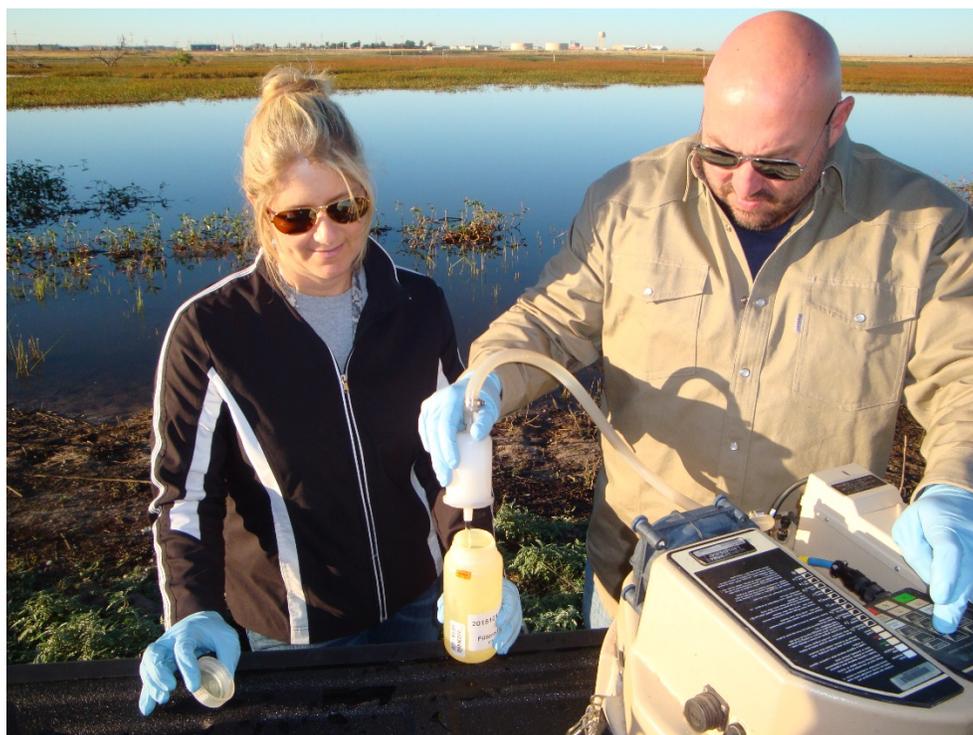
**Figure 9.4 – Sampling Technicians at Playa 1**

Technicians collected water in Playa 1 during the third quarter of 2017 (Figure 9.4). Metals analyses were all consistent with historic levels found at the playa; all were below the IWQPs. VOCs, and SVOCs were below their respective MDLs. Isotopic radiological analyses for uranium was below the DCGs for ingested water. Explosives were detected in trace amounts. Both explosives (HMX and RDX) have been detected at these levels historically at Playa 1 and are legacy contaminants from operations conducted years ago.

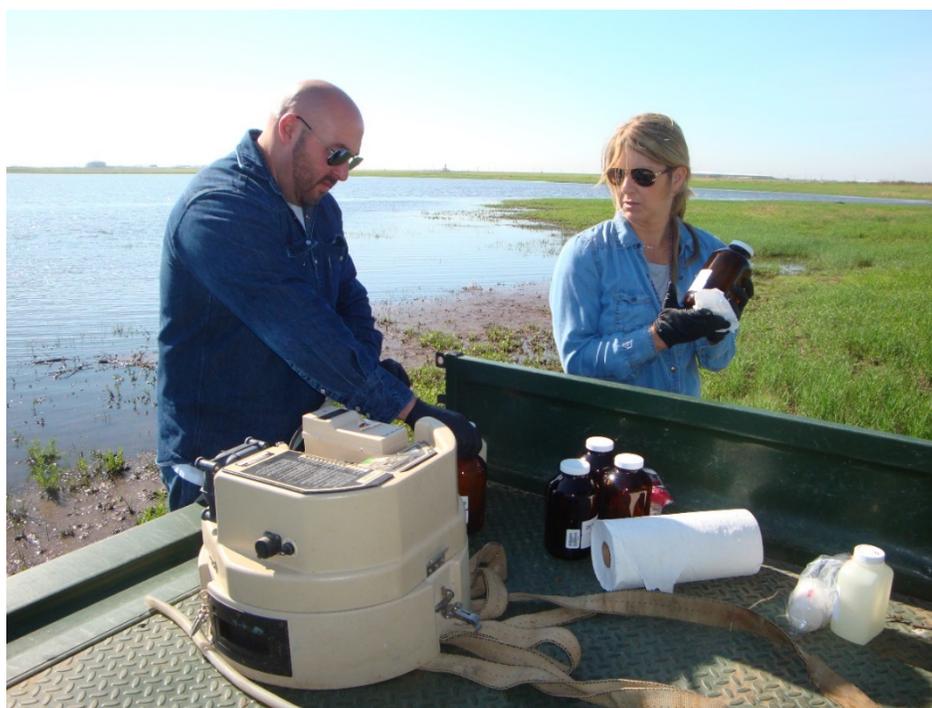
**Figure 9.5 – Technicians Sampling at Playa 2**

Playa 2 was sampled during October 2017 (Figure 9.5). Sampling included metals, VOC's and SVOC's. Metals analyses during the year were all consistent with historic levels found at the playa and all were below the IWQPs. VOCs, and SVOCs were below their respective MDLs. Analysis for the organic compound Benzidine was rejected by the laboratory, due to extremely low spike matrix recovery. Tritium was below the MCL for drinking water. Explosives were below their respective MDLs.

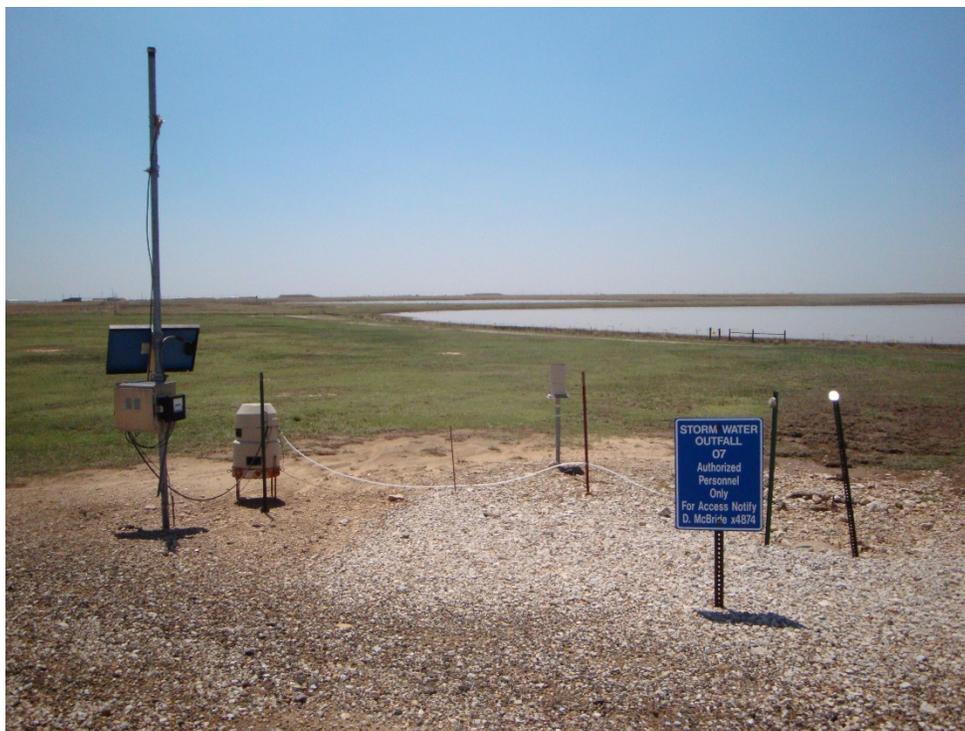
**Figure 9.6 – Storm Water Outfall 07; Playa 3 in the Background**

**Storm Water Outfall 07 – Burning Ground.** This outfall receives only storm water runoff from the Burning Ground operational area through a culvert under a circumferential road around the Burning Ground, a relatively small land area (Figure 9.6). For this reason, sampling at the outfall can be a challenge.

Permit-required monitoring at Storm Water Outfall 07 was conducted during the first quarter of 2017. Monitoring included visual monitoring, pH evaluation and metals analysis. Visual examinations showed no abnormalities based on the visual criteria described in the MSGP and pH was normal. All metals were below IWQPs.

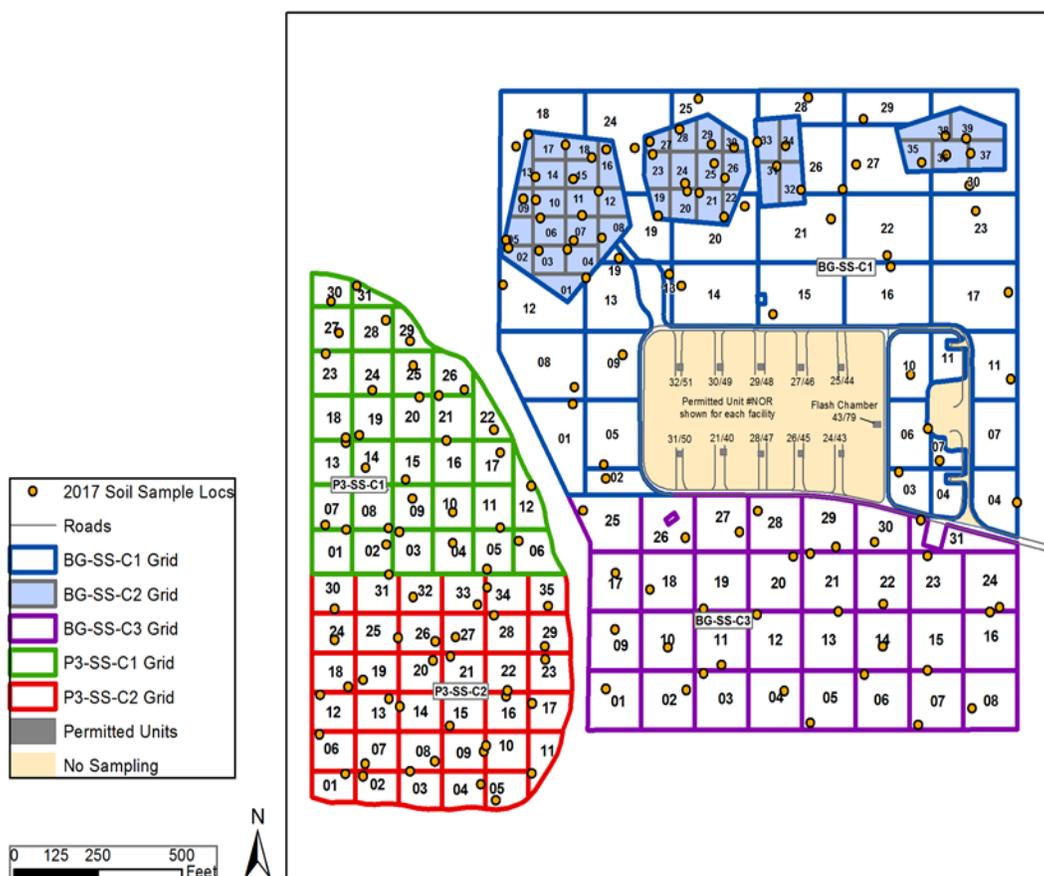
**Figure 10.1 – Burning Ground Multi-Incremental Soil Sampling Locations for 2017**

In 2017, surface soil samples were collected from two general landscape positions: playa bottoms and inter-playa uplands. The characteristic soil types for these landscape positions are Randall clay in playas, and Pullman clay loam in the uplands. During 2017, soil was sampled at five on-site locations, representing three upland and two playa sampling areas associated with the Burning Ground. Samples were collected from a depth of zero to two inches from each associated grid area, and combined to form individual composite samples (Figure 10.1).

Soil samples collected from the Burning Ground and Playa 3 were analyzed for 10 metals (See the “BG Soil” column in Appendix A). With the exception of chromium at sampling location BG-SS-C2, all of the metal concentrations observed in 2017 were below the established permit background concentrations. The initial sampling results indicated a potential statistically significant increase (SSI) for chromium (17.0 mg/kg) at sampling location BG-SS-C2. The established background concentration is 16.23 mg/kg for chromium at BG-SS-C2. The results from confirmation sampling, as provided for in Provision VI.F.1.a of Permit HW-50284 was 13.0 mg/kg. The confirmation sample result was below established background concentration. Sample results are reported in Tables 10.1 through 10.5 in this report.
