# Pantex Plant

## Third Five-Year Review Report Remedial Action Progress Pantex Plant

August 2023  
Final

**THIRD FIVE-YEAR REVIEW REPORT  
PANTEX PLANT SUPERFUND SITE  
CARSON COUNTY, TEXAS  
EPA ID NO: TX4890110527**

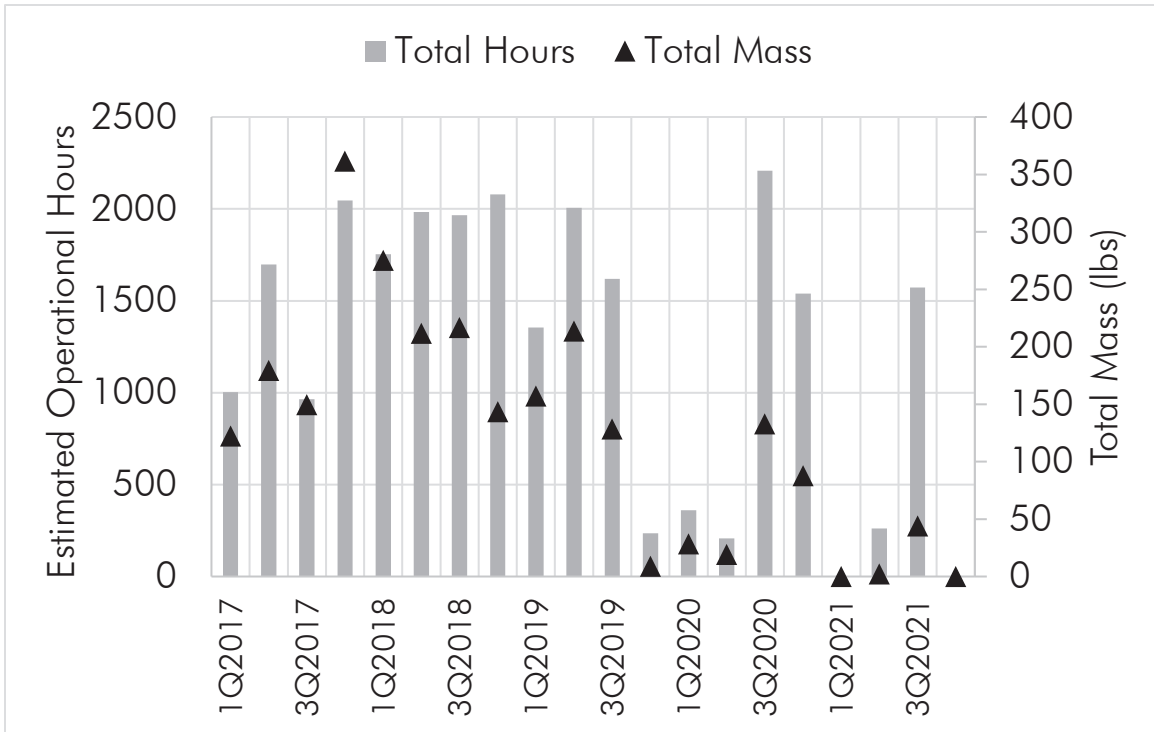
Figure 4.7. BG SVE System Operational Time and Total Mass Removal

The BG SVE system, which addresses SWMU 47, operated fairly consistently for the first three years of the current FYR period and in a pulsed manner for the final two years of the FYR period. **Figure 4.7** and **Figure 4.8** summarize the SVE system operations over the FYR period. The system removed more than 2,400 lbs of soil gas VOCs during this period. Soil gas recovery has been declining throughout the review period, ranging from 133 lbs in Quarter 3 2020 to 361 lbs in Quarter 4 2017 (when the systems

operated for roughly the same number of hours). Estimated recovery is affected by system operational time, air flow rates, and influent analytical data.

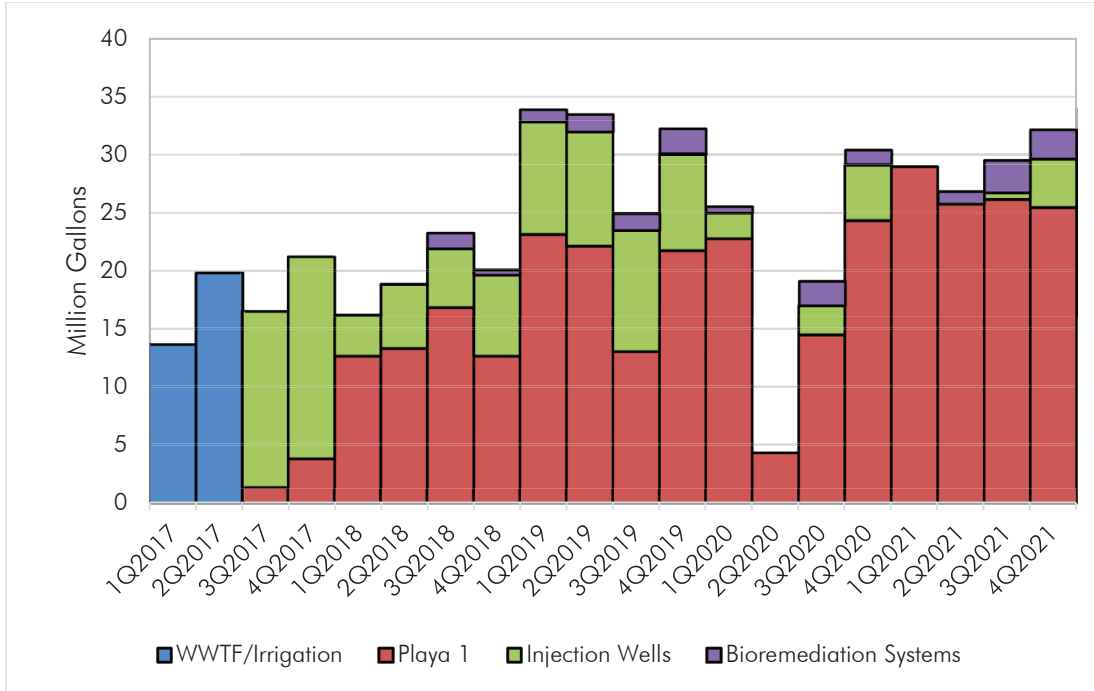
Figure 4.12. Disposition of SEPTS Effluent

As shown on **Figure 4.12**, almost all treated water was discharged through the irrigation system until Quarter 3 2017. After Quarter 3 2017, treated water from the SEPTS was discharged to IWs and increasingly discharged to Playa 1 in accordance with TCEQ Permit #WQ00002296000. A portion of treated water was used for injections in the SEISB system, SEISB Extension system, and Zone 11 ISB system.

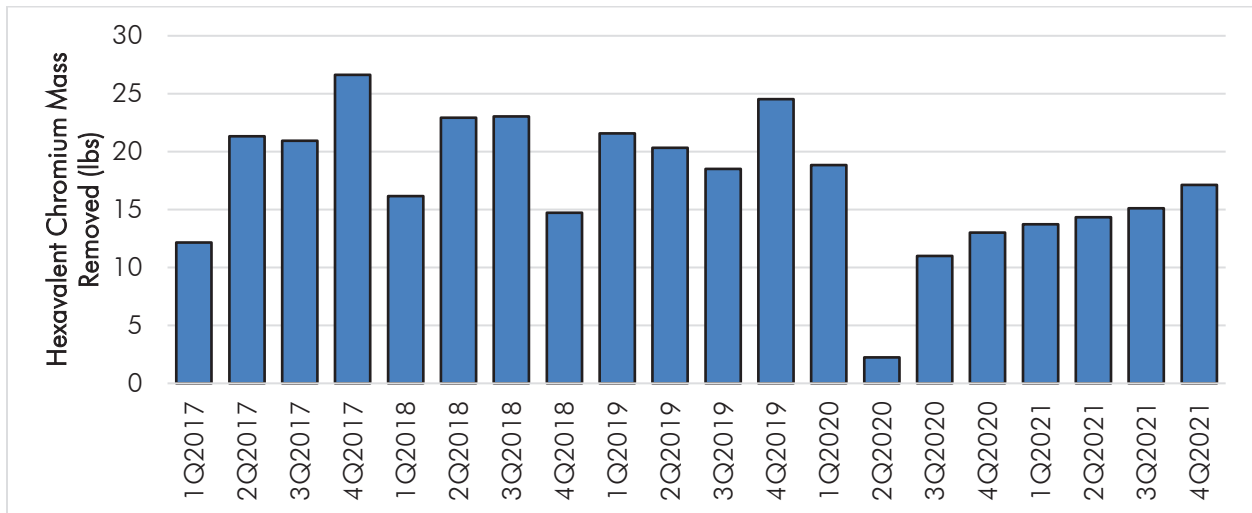
Figure 4.13. SEPTS Hexavalent Chromium Removal

System mass recovery has been variable over the FYR period as recovery is based on system throughput, as well as measured influent concentrations. The system removed a total of 348 lbs of Cr(VI) during the FYR period. As depicted on **Figure 4.13**, limited Cr(VI) was removed during Quarter 2 2020 because of COVID-19- related shutdowns. As depicted on **Figure 4.14**, 1,181 lbs of RDX and 805 lbs of other HEs were removed during the Third FYR period. All COCs were treated to concentrations below the GWPS. Comparison to previous FYR periods is provided in **Table 4.2**.
