Pantex Plant

2015 Annual Progress Report

Remedial Action Progress

In Support of Hazardous Waste Permit 50284 and
Pantex Plant Interagency Agreement

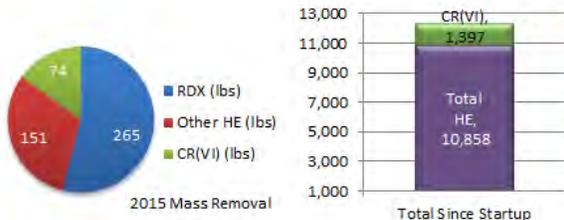
Figure E-3. SEPTS Mass Removal

In addition to removing impacted water from the perched aquifer, the pump and treat systems remove contaminant mass from the groundwater that is extracted from the aquifer. The P1PTS primarily removes the high explosive RDX and the SEPTS primarily removes RDX and hexavalent chromium (CR(VI) in Figure E-3). The figures below provide the mass removal for high explosives (HEs) and chromium for 2015, as well as totals since startup of the systems. The SEPTS has been operating longer than the P1PTS and the greatest concentrations of HEs are found in the SEPTS extraction well field, so mass removal is much higher at that system. During 2015, SEPTS removed about 489 lbs of contaminants and P1PTS removed about 62 lbs of contaminants.

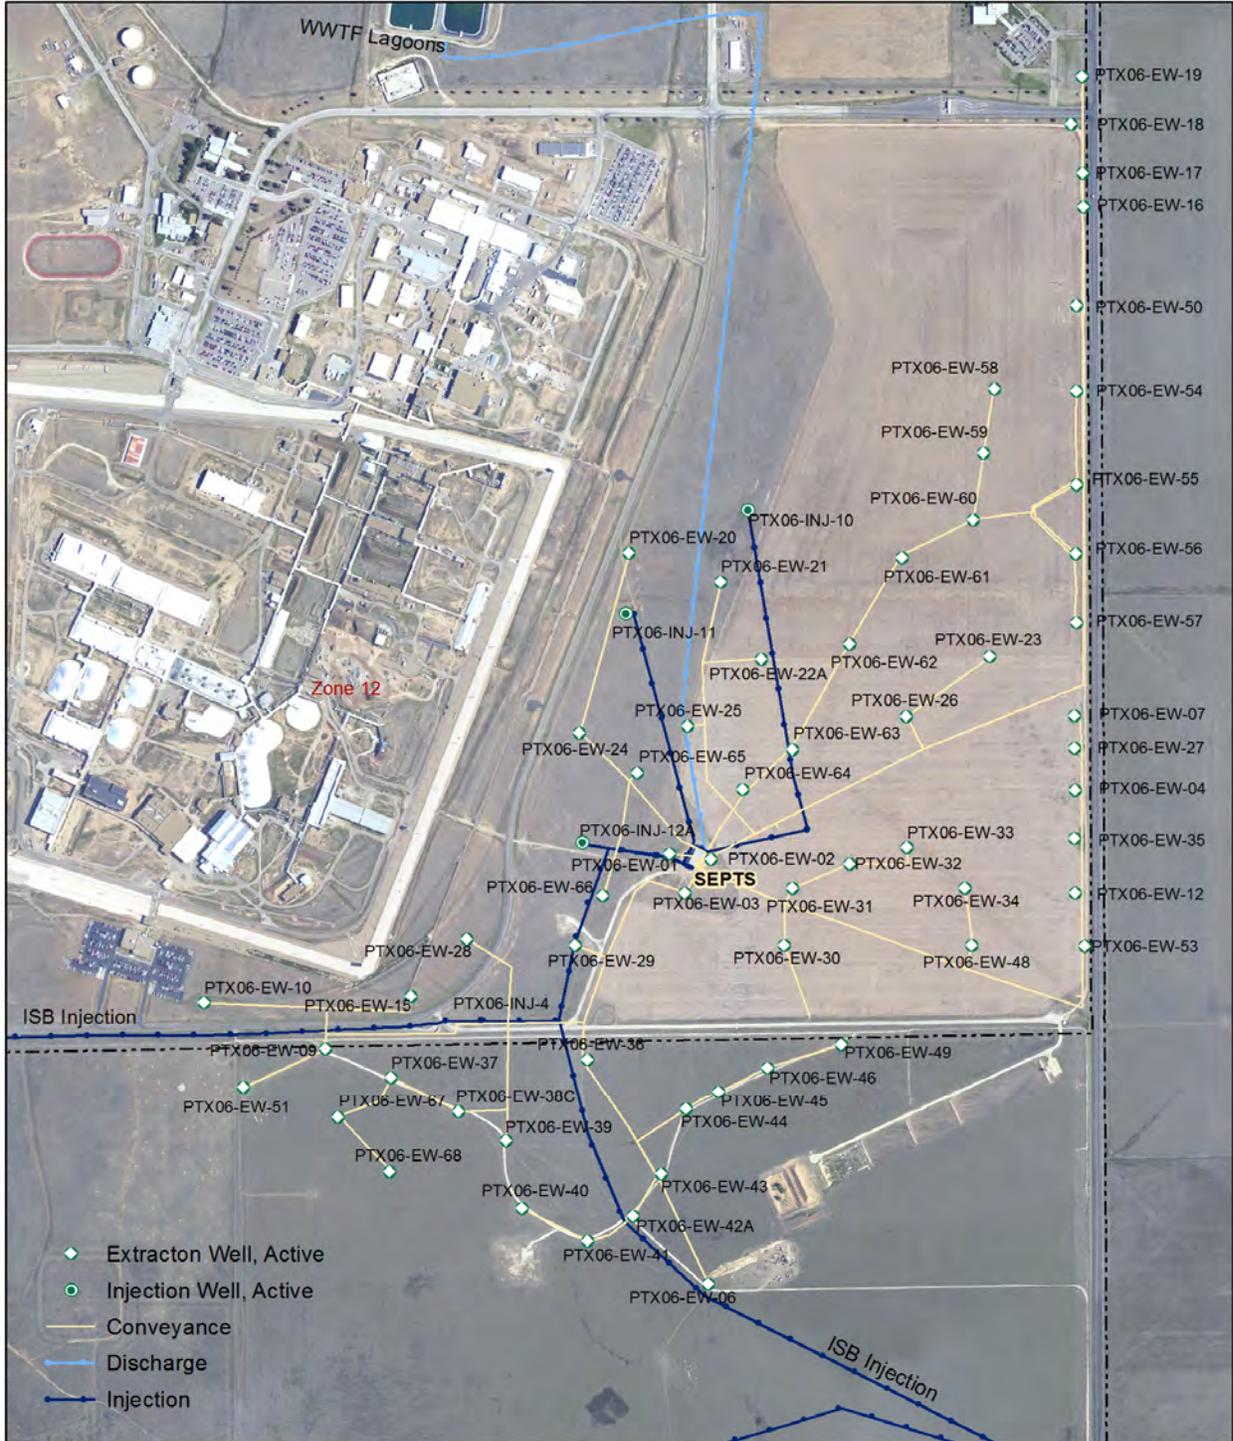
Figure 2-8. SEPTS Wells and Conveyance Lines

The SEPTS was originally installed at Pantex in 1995 as part of a treatability study. Since then, the pump and treat system has been expanded to meet the objectives of the environmental restoration project and final remedy established in the ROD and HW-50284. The SEPTS currently consists of a treatment building, 61 extraction wells, and 3 injection wells (see Figure 2-8). This system treats the water through a series of GAC vessels and ion exchange resin beds to reduce concentrations below the GWPS established in the ROD and HW-50284.

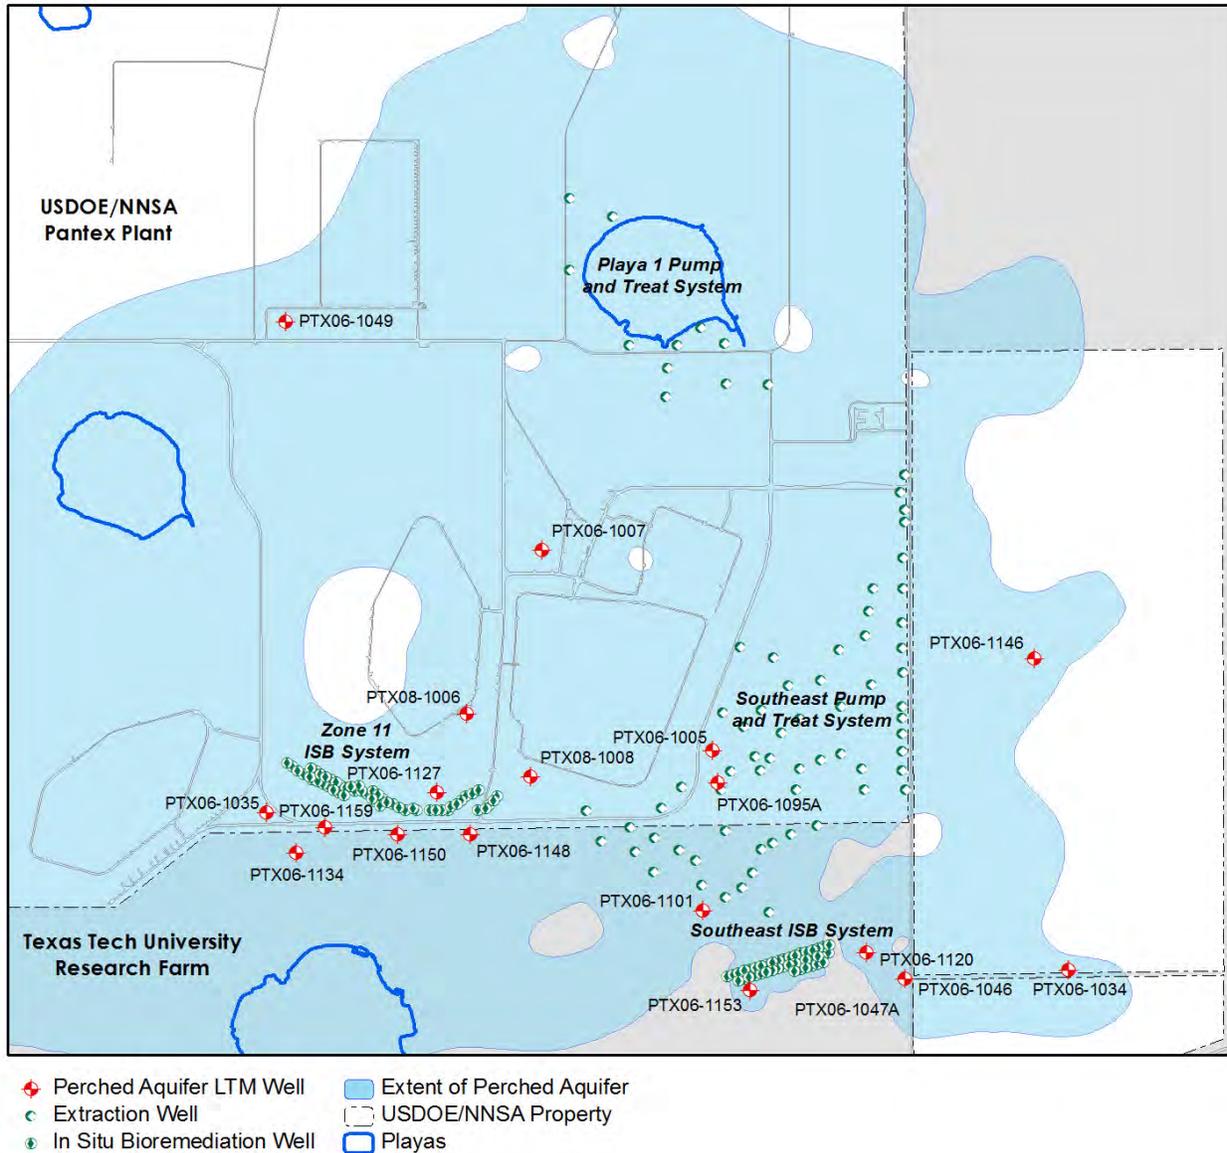
Figure 3-5. Perched Wells with Unexpected COC Trends

The following 18 monitoring wells (depicted in Figure 3-5), PTX06-1005, PTX06-1007, PTX06-1034, PTX06-1035, PTX06-1046, PTX06-1049, PTX06-1095A, PTX06-1101; PTX06-1120, PTX06-1127, PTX06-1134, PTX06-1146, PTX06-1148, PTX06-1150, PTX06-1153, PTX06-1159, PTX08-1006, and PTX08-1008, exhibited trends that were not consistent with

the expected conditions and were previously discussed in Section 3.1.1. Additional detail on all LTM wells is located in Table E-1 in Appendix E.

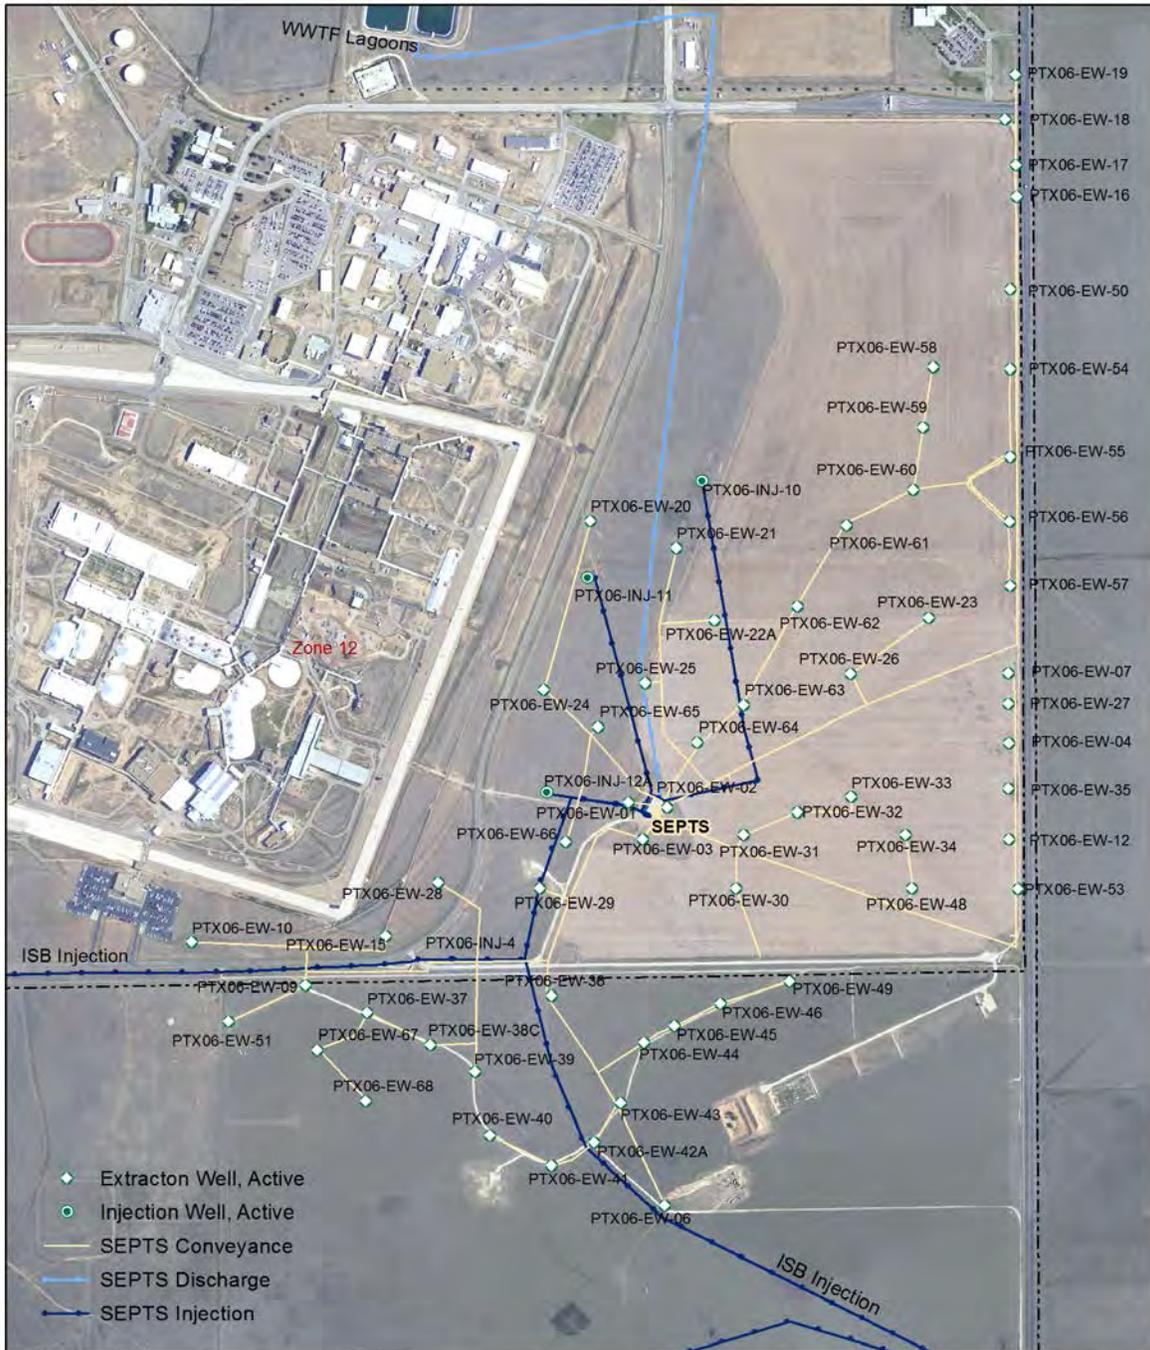
Figure 3-49. SEPTS Extraction Wells and Conveyance Lines

The objective of the SEPTS (Figure 3-49) is to remove contaminated perched groundwater and treat it for industrial and/or irrigation use. While the capability is being maintained for injection of treated water back into the perched zone, the intent is to permanently remove perched groundwater to gradually reduce the saturated thickness in this zone in order to achieve two important goals:

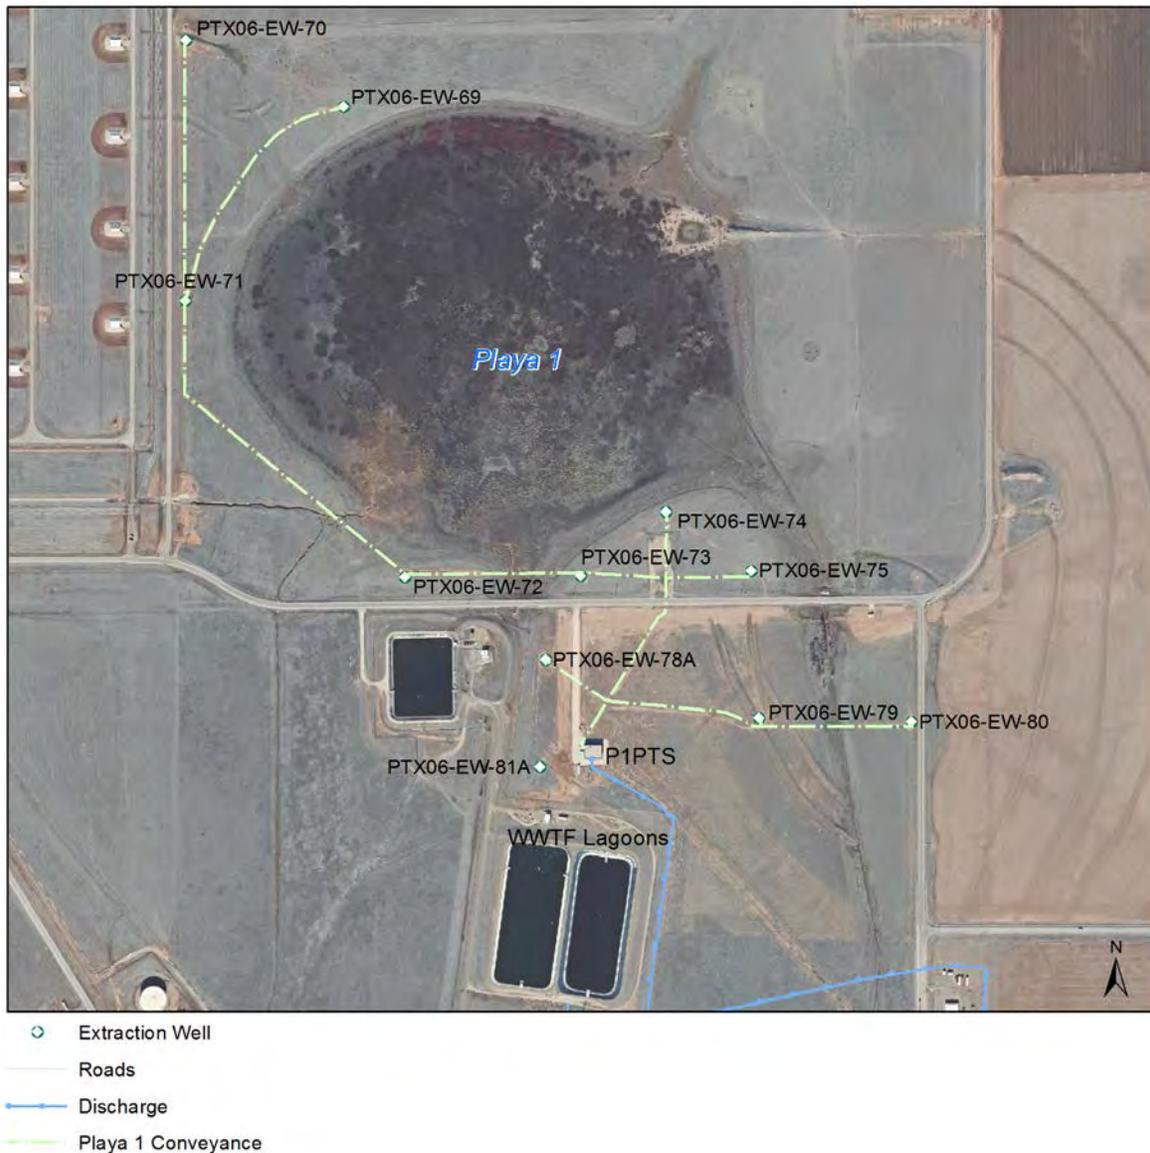
Figure 3-51. P1PTS Extraction Wells and Conveyance Lines

The P1PTS was completed during 2008 with operations starting in September 2008. This system extracts water from 10 wells near Playa 1 (see Figure 3-51) and treats the water through a series of GAC beds and ion exchange process units to reduce HEs and metals below the GWPS established in HW-50284 and the ROD. The objective of this system is to reduce the mound of perched groundwater associated with Playa 1, affecting the movement of the southeast plume by reducing the hydraulic head, as well as achieving mass removal.
