Pantex Plant

2019 Annual Progress Report

Remedial Action Progress

In Support of Hazardous Waste Permit 50284 and
Pantex Plant Interagency Agreement

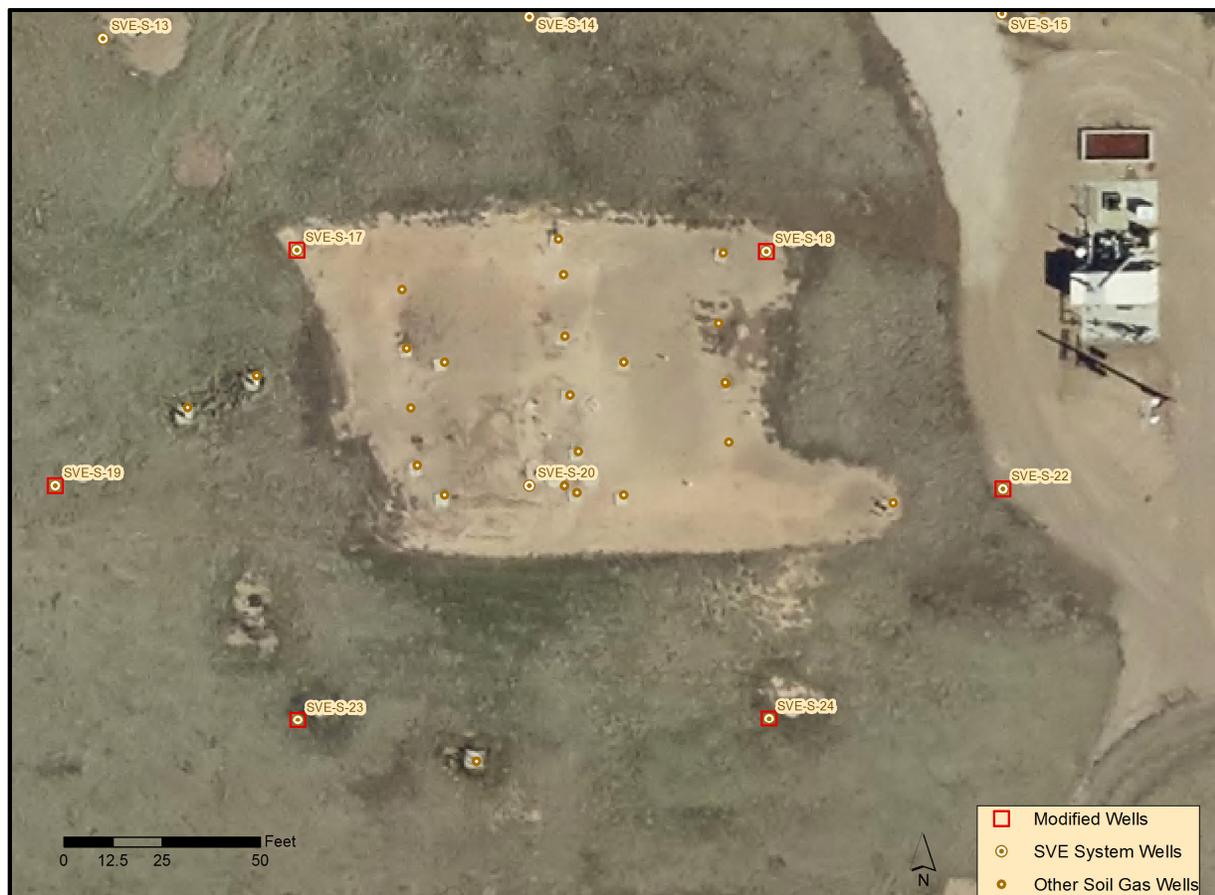
The system was modified in May 2017 to increase air flow through the area surrounding SVE-S-20 to promote increased volatilization and bioremediation of the remaining soil NAPL. Six wells surrounding SVE-S-20 were modified to include above-ground piping that would allow air flow through the wells while the system is operating and pulling air from SVE-S-20 (see Figure 1-4). Pantex increased influent flow to the SVE by 40% (from 32 scfm

Figure 1-4. Burning Ground SVE System Wells and Modifications

to about 45 scfm), close to the maximum design flow of 50 scfm. Pantex also increased monitoring and evaluation of influent air to the SVE system and evaluation of the individual wells that were modified to gain baseline information as well as continued monitoring of changes. The evaluations, presented in Section 4, will be used to help provide a path to closure of the Burning Ground SVE.

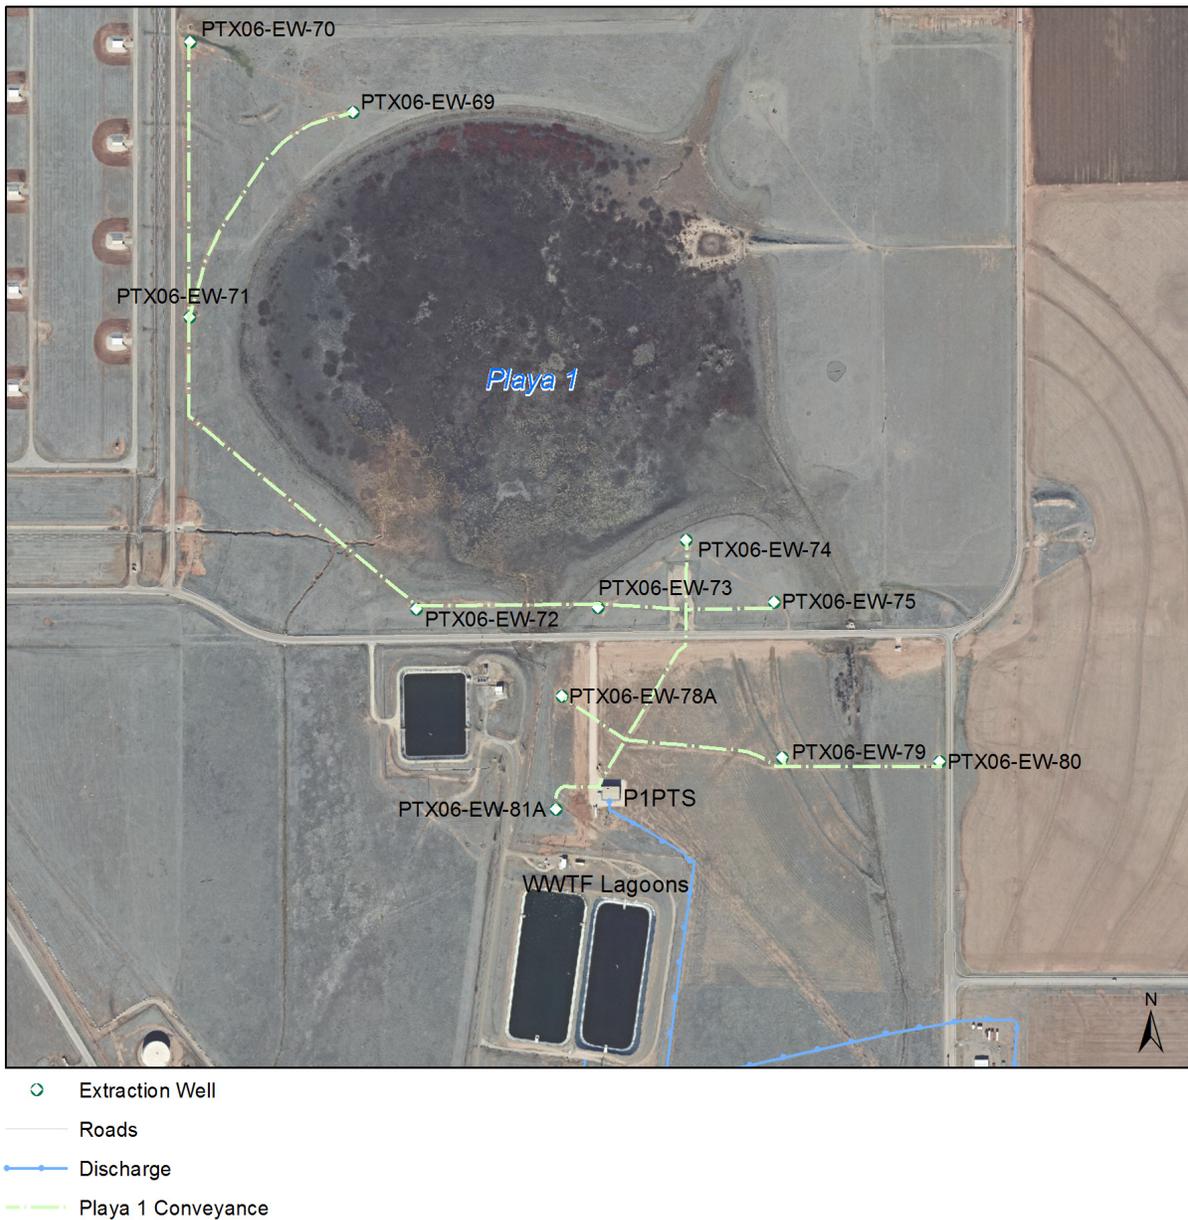
The P1PTS extracts water from eleven wells near Playa 1 and treats the water through a series of granular activated carbon (GAC) beds and ion exchange process units to reduce HEs and metals below the GWPS established in the ROD and HW-50284. This system focuses on reducing the mound of perched groundwater associated with Playa 1, affecting the movement of the southeast plume by reducing the hydraulic head, as well as achieving mass removal. This system treats high explosives and volatile organics such as TCE. Boron is treated below the GWPS when the water will be used for irrigation purposes. Figure 1-11 depicts the P1PTS wells and conveyance.

Figure 1-6. P1PTS Wells and Conveyance Lines

The P1PTS was completed during 2008 with operations starting in September 2008. This system extracts water from 11 wells near Playa 1 (see Figure 1-6) and treats the water through a series of GAC beds and ion exchange process units to reduce HEs and metals below the GWPS established in HW-50284 and the ROD. The objective of this system is to reduce the mound of perched groundwater associated with Playa 1, affecting the movement of the southeast plume by reducing the hydraulic head, as well as achieving mass removal.

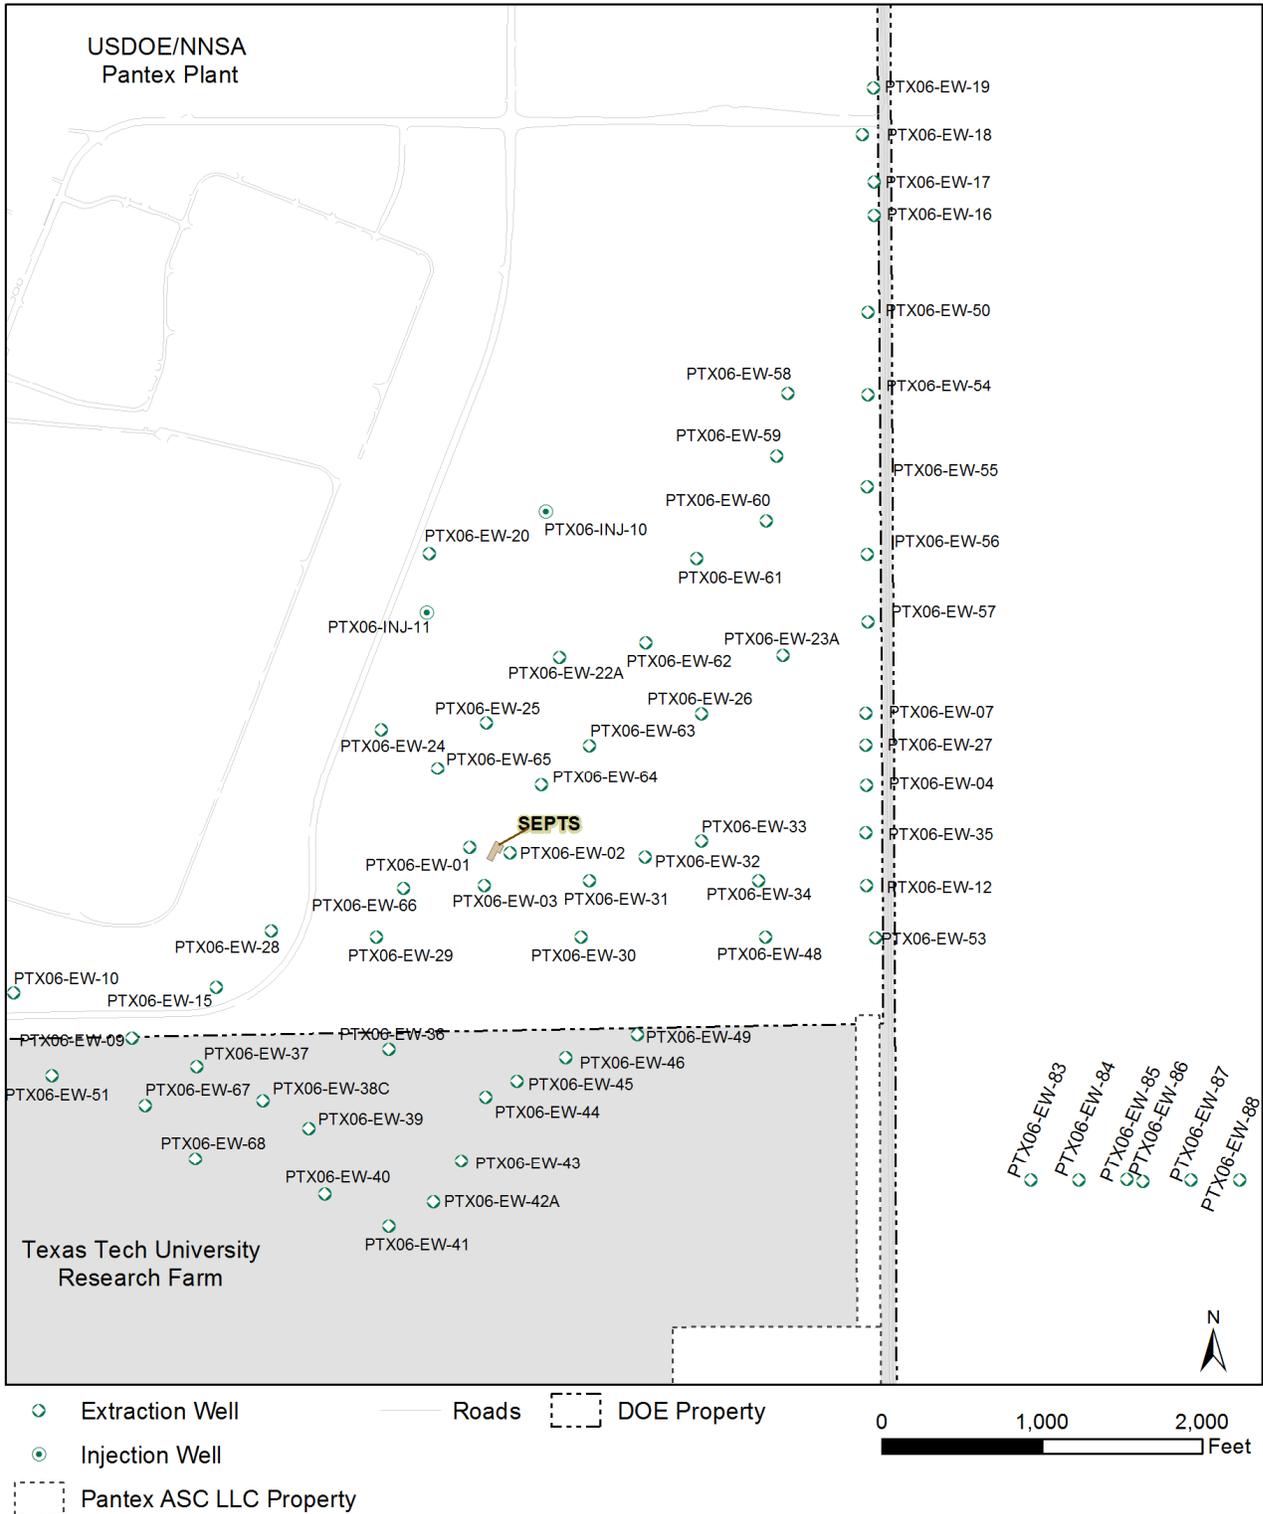
Figure 1-13. SEPTS Wells
