Pantex Plant

2022 Annual Progress Report

Remedial Action Progress

In Support of Hazardous Waste Permit 50284 and
Pantex Plant Interagency Agreement

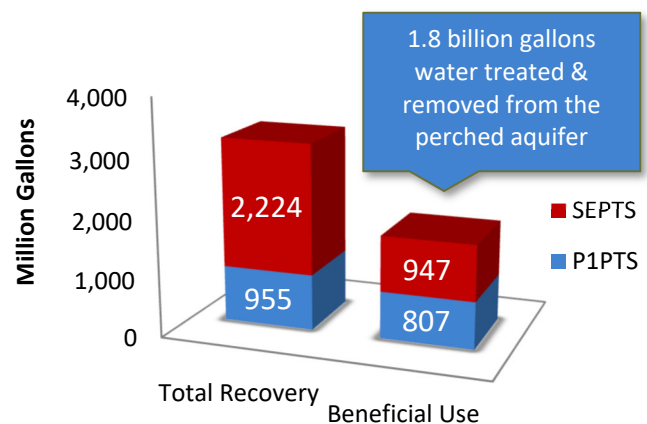
In 2022, the systems treated about 1.8 million gallons. Overall, the systems have operated efficiently to treat contamination and reduce saturated thickness. As depicted in Fig. E-2, Pantex has treated over 3.0 billion gallons since the startup of the systems, with about 1.8 billion gallons removed and beneficially used. Pantex continues to reduce reliance on the injection of treated water where possible. As recommended in the *First Five-Year Review Report (FYR)* (Pantex, 2013c) completed in 2013, Pantex had previously implemented new throughput goals to align operations with the goal of reducing saturated thickness. During 2022, only 6% of the treated water was beneficially used, 9% was injected back into the perched aquifer, and the rest was sent to Playa 1.

Fig. E-2. Pump and Treat recovery.

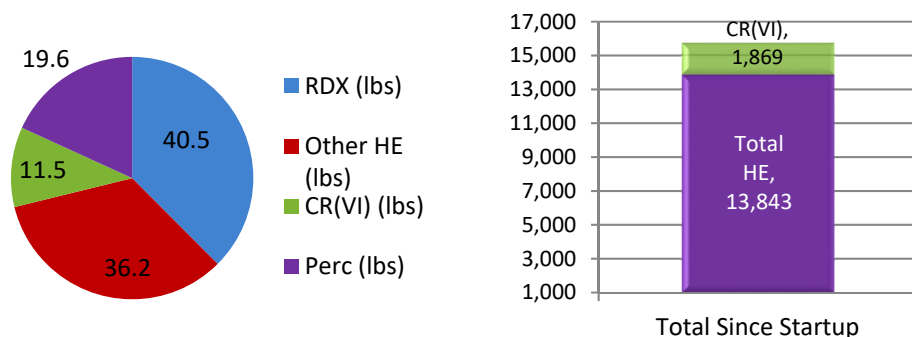
The SEPTS has been operating longer than the P1PTS, and the greatest concentrations of HEs are found in the SEPTS's extraction well field, so mass removal is much higher at that system. During 2022, the SEPTS removed approximately 456 pounds (lbs) of contaminants, and the P1PTS removed approximately 1.5 lbs of contaminants.

Fig. E-4. P1PTS mass removal.

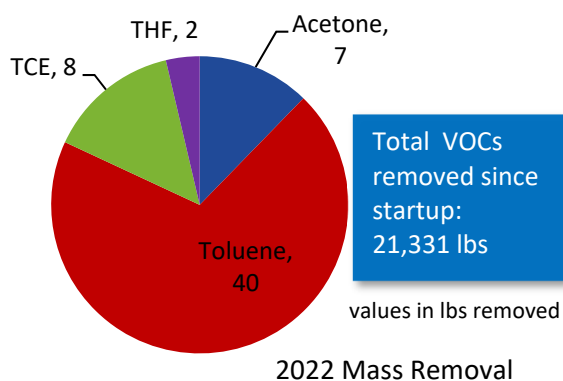
The system was variably operated in 2022 due to shut down for repairs and planned pulsing periods, with an overall operation of approximately 32%. The system began operating in January; however, the system was impacted due to a heater failure on March 7. After repairs were completed, the system operated from early August through October, when another failure occurred and the system was shut down. The unplanned pulsing periods continued to provide information for closure of the system. Fig. E-5 presents the mass removal calculated for the major VOCs contributing to the total VOC concentration in 2022 as well as the total mass removed since the SVE system was installed as an interim

Fig. E-5. Burning Ground SVE mass removal.

action in 2022. The system removed approximately 58 lbs of VOCs during 2022. This system demonstrated significant reductions in influent concentrations beginning in 2020, continuing through 2022. The drop in influent concentrations and removal rates indicate that the NAPL source is near depletion. Pantex is planning to prepare a closure report for the system in 2023, to support removal of the system from HW-50284.

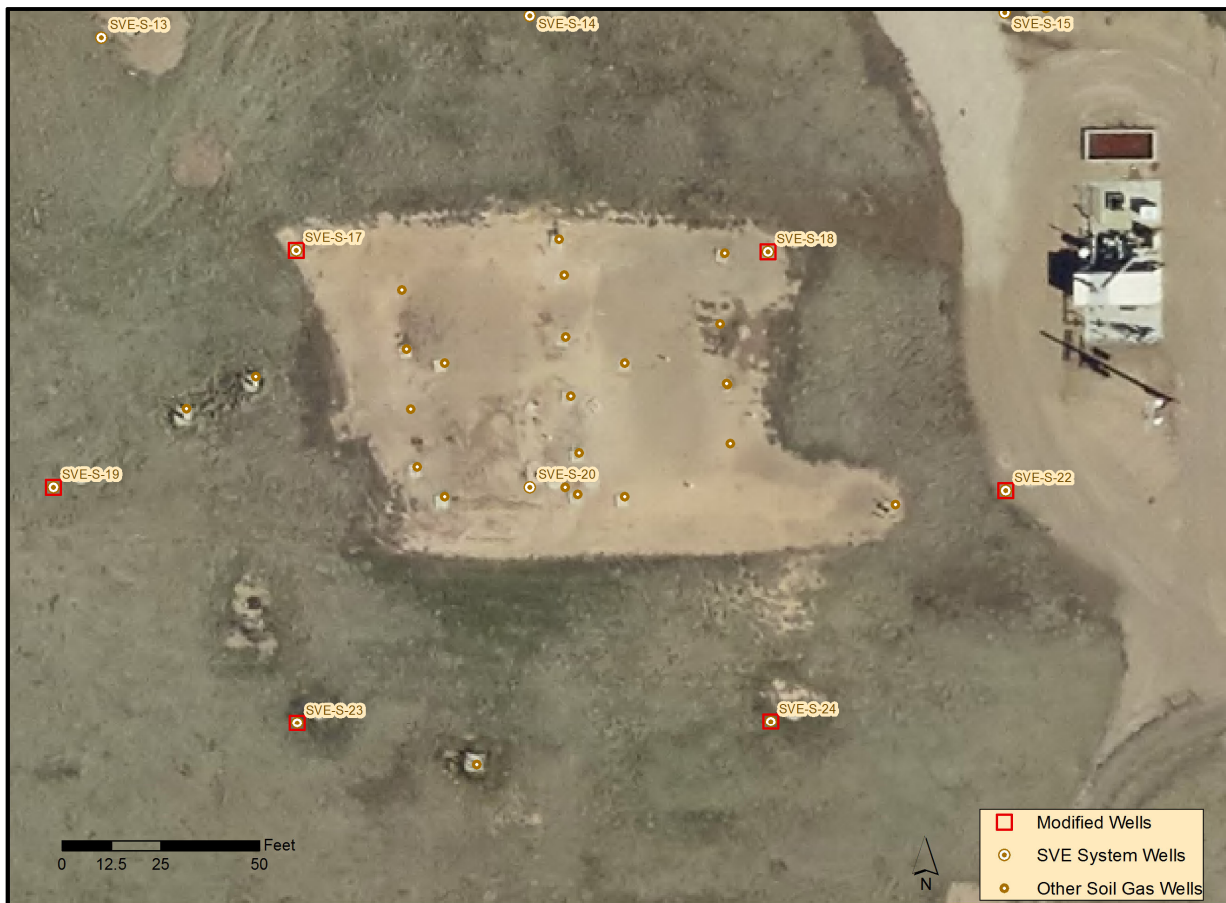
The system was modified in May 2017 to increase air flow through the area surrounding SVE-S-20 and promote increased volatilization and bioremediation of the remaining soil NAPL. Six wells surrounding SVE-S-20 were modified to include aboveground piping that would allow airflow through the wells while the system is operating and pulling air from SVE-S-20 (see Fig. 1-4). Pantex increased influent flow to the SVE by 40% from 32 standard cubic ft per minute (scfm) to approximately 45 scfm, close to the maximum design flow of 50 scfm. To gain baseline information, Pantex also increased monitoring and evaluation of influent air to the SVE system and of the individual wells that were modified. The evaluations, presented in Section 4, will be used to help provide a path to closure of the Burning Ground SVE.

Fig. 1-4. Burning Ground SVE System wells and modifications.

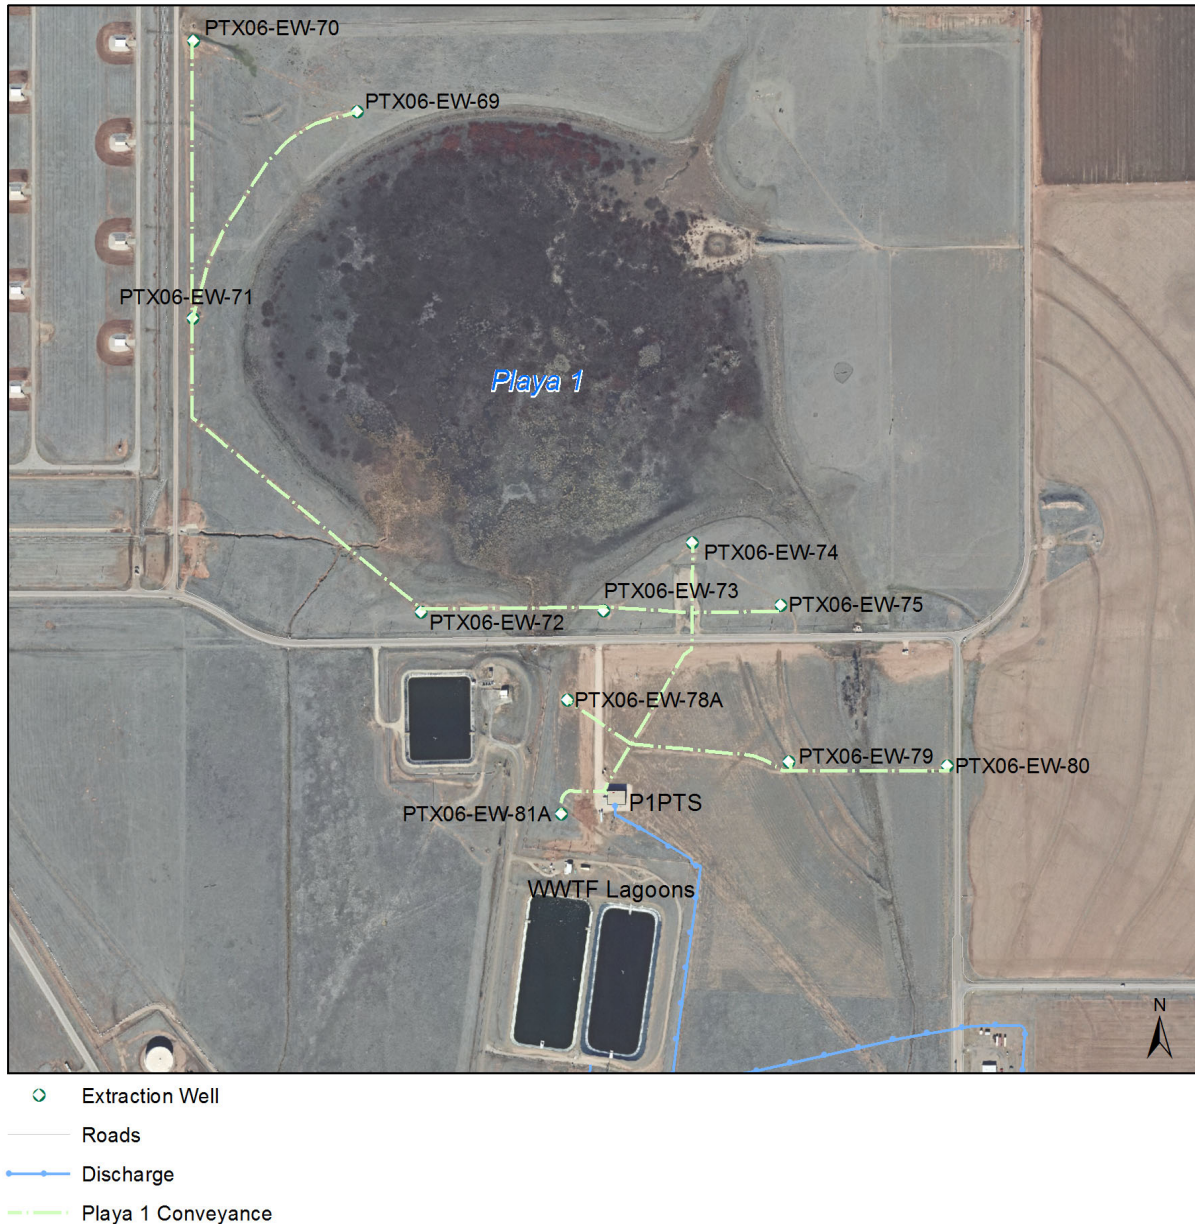
P1PTS beneficially uses all treated water by sending it through the WWTF to the irrigation system. Because this system cannot inject the treated water back into the perched aquifer, the treatment throughput must be temporarily adjusted or discontinued based on the demands of the WWTF or irrigation system. In 2017, a break occurred at the irrigation system, so all irrigation usage was discontinued.

Fig. 1-6. P1PTS wells and conveyance lines.

The P1PTS was completed in 2008 with operations starting in September 2008. This system extracts water from 11 wells near Playa 1 (see Fig. 1-6) and treats the water through a series of GAC beds and ion exchange process units to reduce HEs and metals below the GWPS established in HW-50284 and the ROD. The objective of this system is to achieve mass removal and reduce the mound of perched groundwater associated with Playa 1, which affects the movement of the Southeast Plume by reducing the hydraulic head.

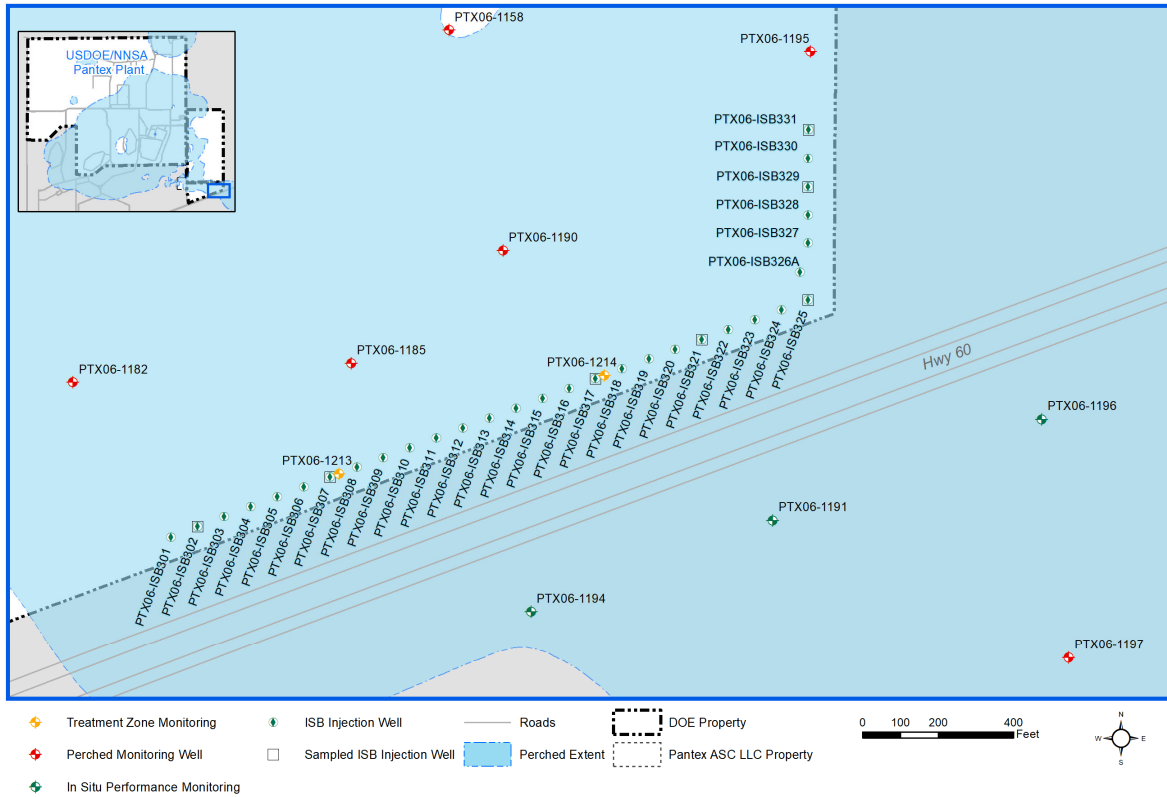
Fig. 1-10. Southeast ISB Extension treatment zone and performance-monitoring wells

The system consists of 31 ISB injection wells, 2 TZM wells, and 3 ISPM wells. The system was originally installed in 2017 with 24 new injection wells and one monitoring well that was converted for use as an injection well. The system was expanded northward with four new ISB injection wells in 2020 and further expanded in 2021 with two new ISB injection wells and two new TZM wells. Further expansion to the north is anticipated in the future, due to observed and modeled expansion of the plume to the east.

The system was positioned to treat HE contaminants, particularly RDX, that are moving to offsite landowner property. Due to the new extraction wells' upgradient removal of water, water levels are anticipated to decline in this system over time, and future injections will be unnecessary or limited. Fig. 1-10 depicts the Southeast ISB Extension.

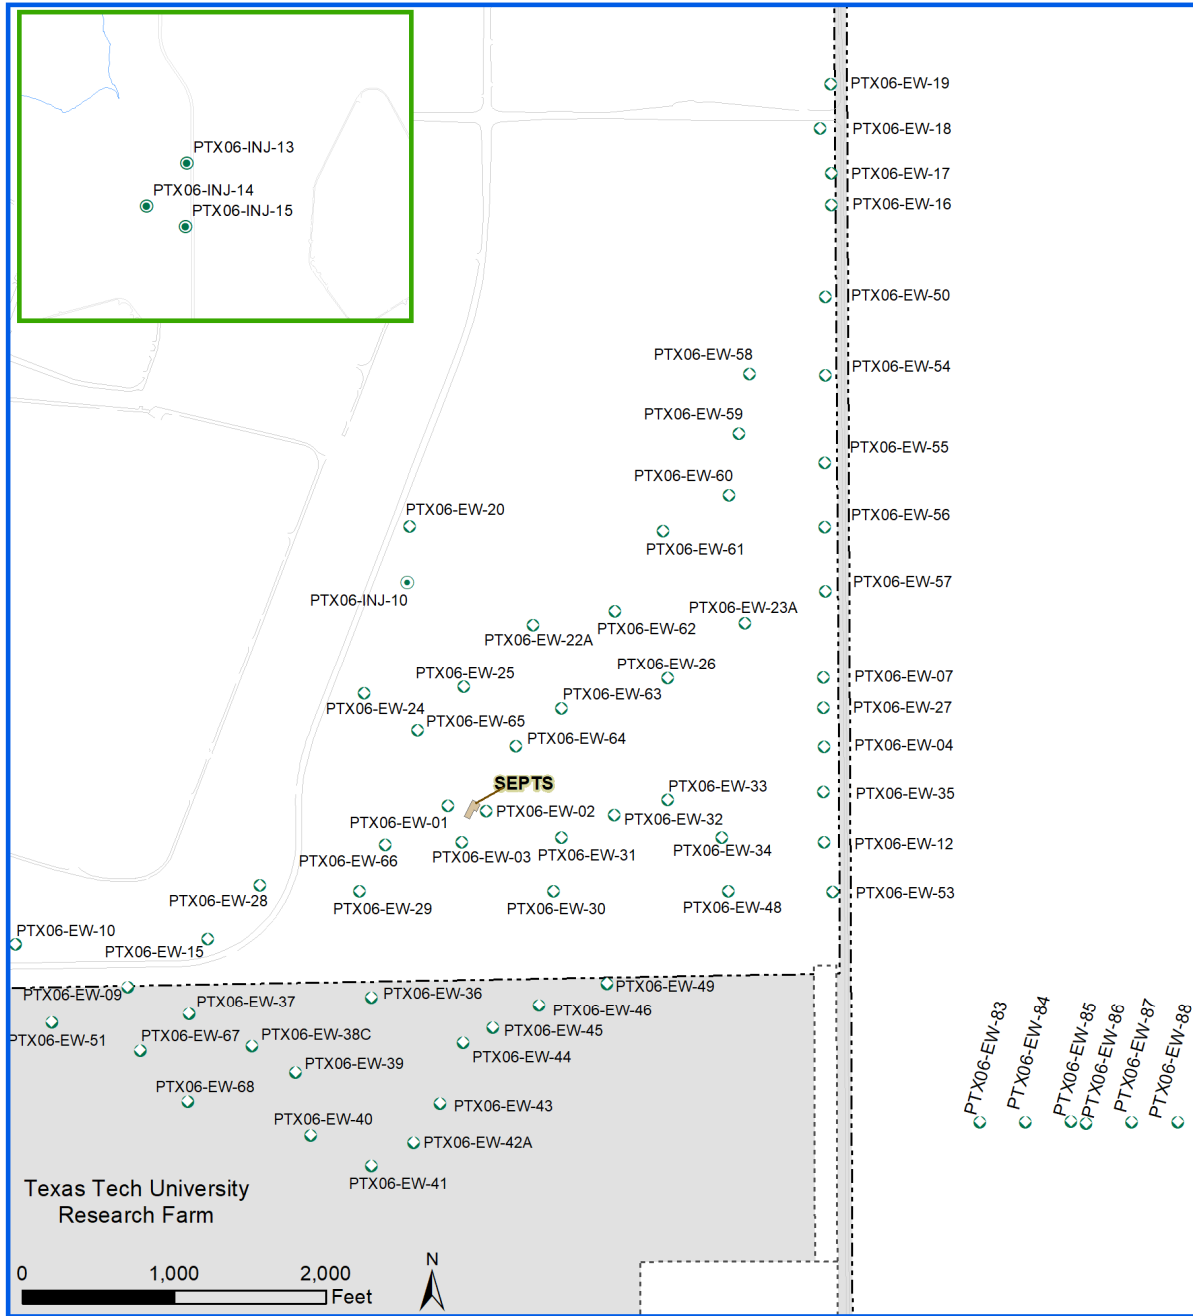
Fig. 1-14. SEPTS wells.

- Extraction Well
 Roads
 DOE Property
- Injection Well
 Pantex ASC LLC Property

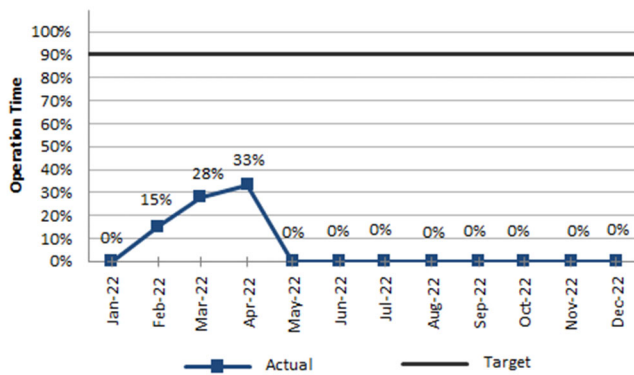
Fig. 2-1. P1PTS operation time vs target.

The P1PTS was operational for 35 days during 2022 with an average annual operational rate of 6%, based on total hours operated versus total possible operation time. The actual percentage of monthly system operational time versus the target percentage is depicted in Fig. 2-1.

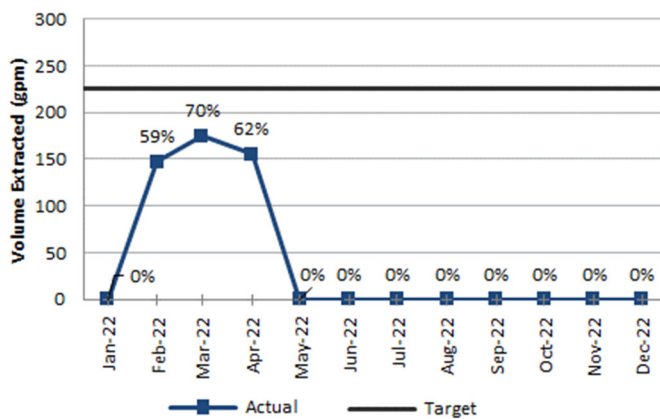
Fig. 2-2. P1PTS average GPM and % capacity.

Fig. 2-2 depicts the average gpm extracted from all wells by month. The P1PTS system extracted an average of 159 gpm (about 64% of design throughput) from the well field while operating in 2022. The calculated gpm accounts for water extracted from the well field when the system operated and is affected by each well’s yield, downtime, or reduced flow required by the WWTF/irrigation system.

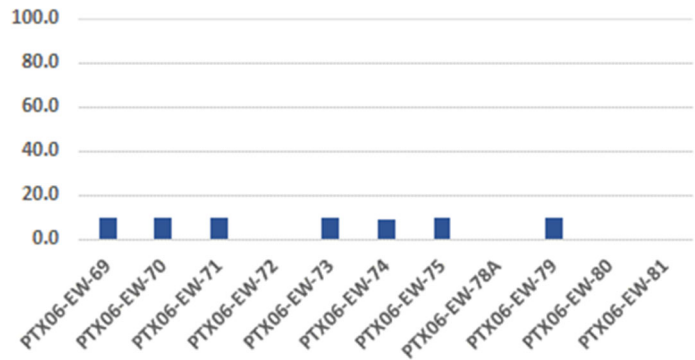
Fig. 2-3. P1PTS well operation time.

Fig. 2-3 reflects the operation time by well. PTX06-EW-72, EW-78A, EW-80, and EW-81 were not operated during 2022 due to communication problems at the well which can cause potential leaks. Most other wells were running when the system was operated, if flow was not restricted.

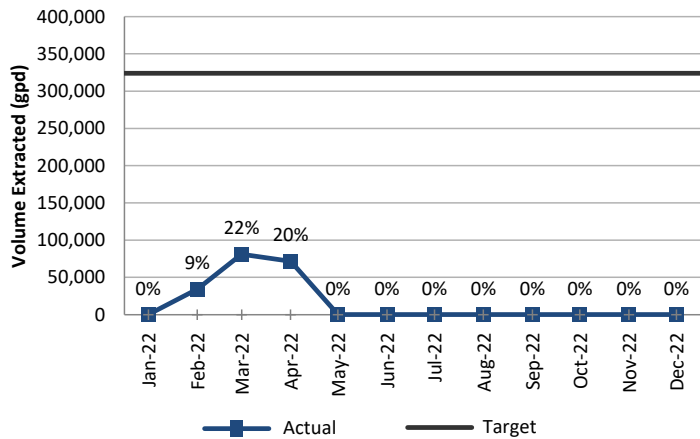
Fig. 2-4. P1PTS average GPD and % capacity.

Fig. 2-4 reflects the P1PTS’s overall system efficiency considering system and well operation. The system treated an average of about 62,200 gpd when operating during 2022, which is approximately 17% of design capacity. The gpd is affected by system operational time, ability to extract water from the wells, and reduced flow to the WWTF and irrigation system. The system treated approximately 5.5 Mgal during 2022, with an average treatment volume of about 1.8 Mgal per month when operating.

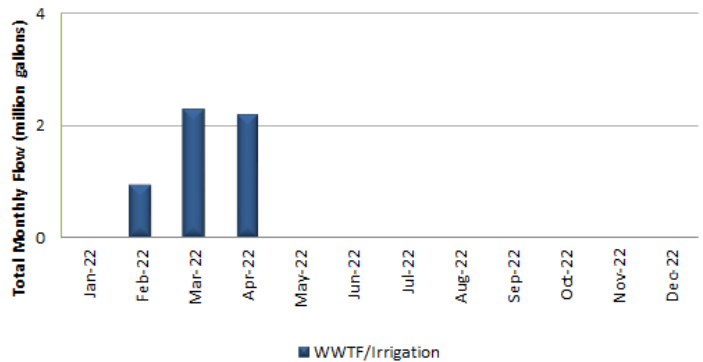
Fig. 2-5. P1PTS system monthly total flow.

The monthly treatment flow volumes and treated water usage are depicted in Fig. 2-5.

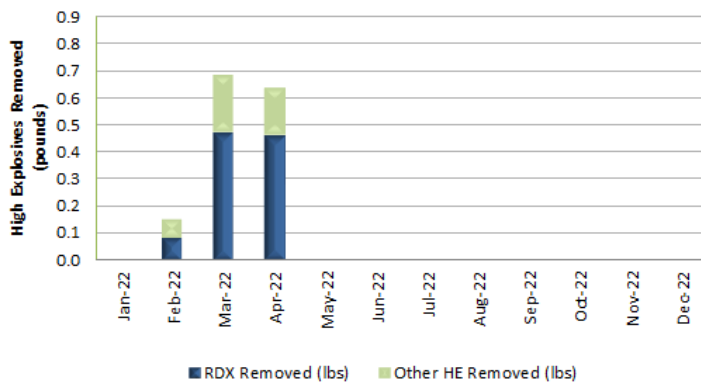
Fig. 2-6. P1PTS mass removal by month.

During 2022, the system removed approximately 1.0 lbs of RDX and 0.5 lbs of all other HEs (see Fig. 2-6). The average removal rate of HEs was approximately 0.74 lbs/Mgal of treated water. Since startup in September 2008, the system has removed a total of 550 lbs of RDX and 222 lbs of all other HEs.

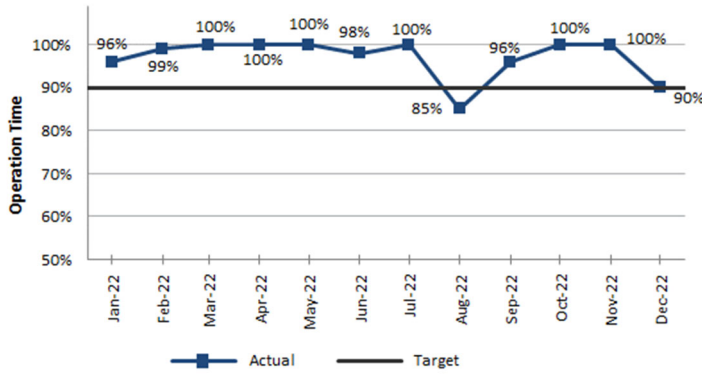
Fig. 2-7. SEPTS operation time vs target.

During 2022, the SEPTS operated all or part of 362 days with an average operational rate of 97%, based on total hours operated versus total possible operation time. The percent operation time (i.e., hours per day) versus the target operation time is depicted in Fig. 2-7.

System operation was affected by power outages, paging issues, and carbon/resin change-outs. Operation was consistent at the SEPTS due to shutdown of P1PTS. When P1PTS was operating, flow was reduced at the SEPTS to meet discharge permit limits to Playa 1 and minimize injection into the perched aquifer.

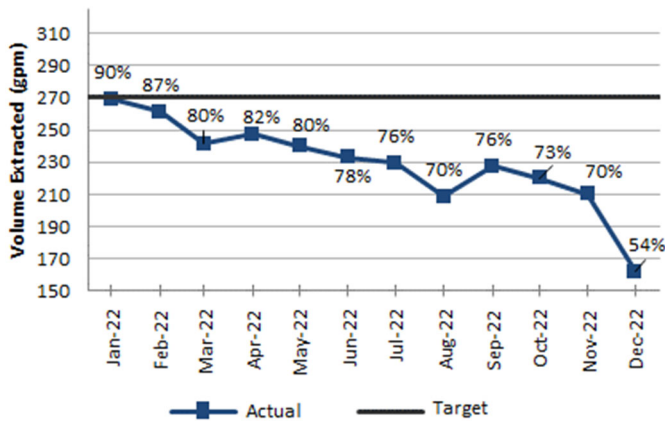
Fig. 2-8. SEPTS average GPM and % capacity.

As a measure of well operation efficiency, Fig. 2-8 depicts the average gpm extracted from all wells by month, the percentage of design capacity achieved, and system goals. Unless flow is affected by the WWTF or other issues, the system’s operational rate has been the prioritized goal since June 2014. In 2022, the system was operated fully, except when P1PTS was operated. Even though the 90% throughput goal was not applicable during portions of 2022, it is still depicted in the graphs, and well throughput is evaluated to identify potential issues. Throughput was below the 90% goal after January 2022.

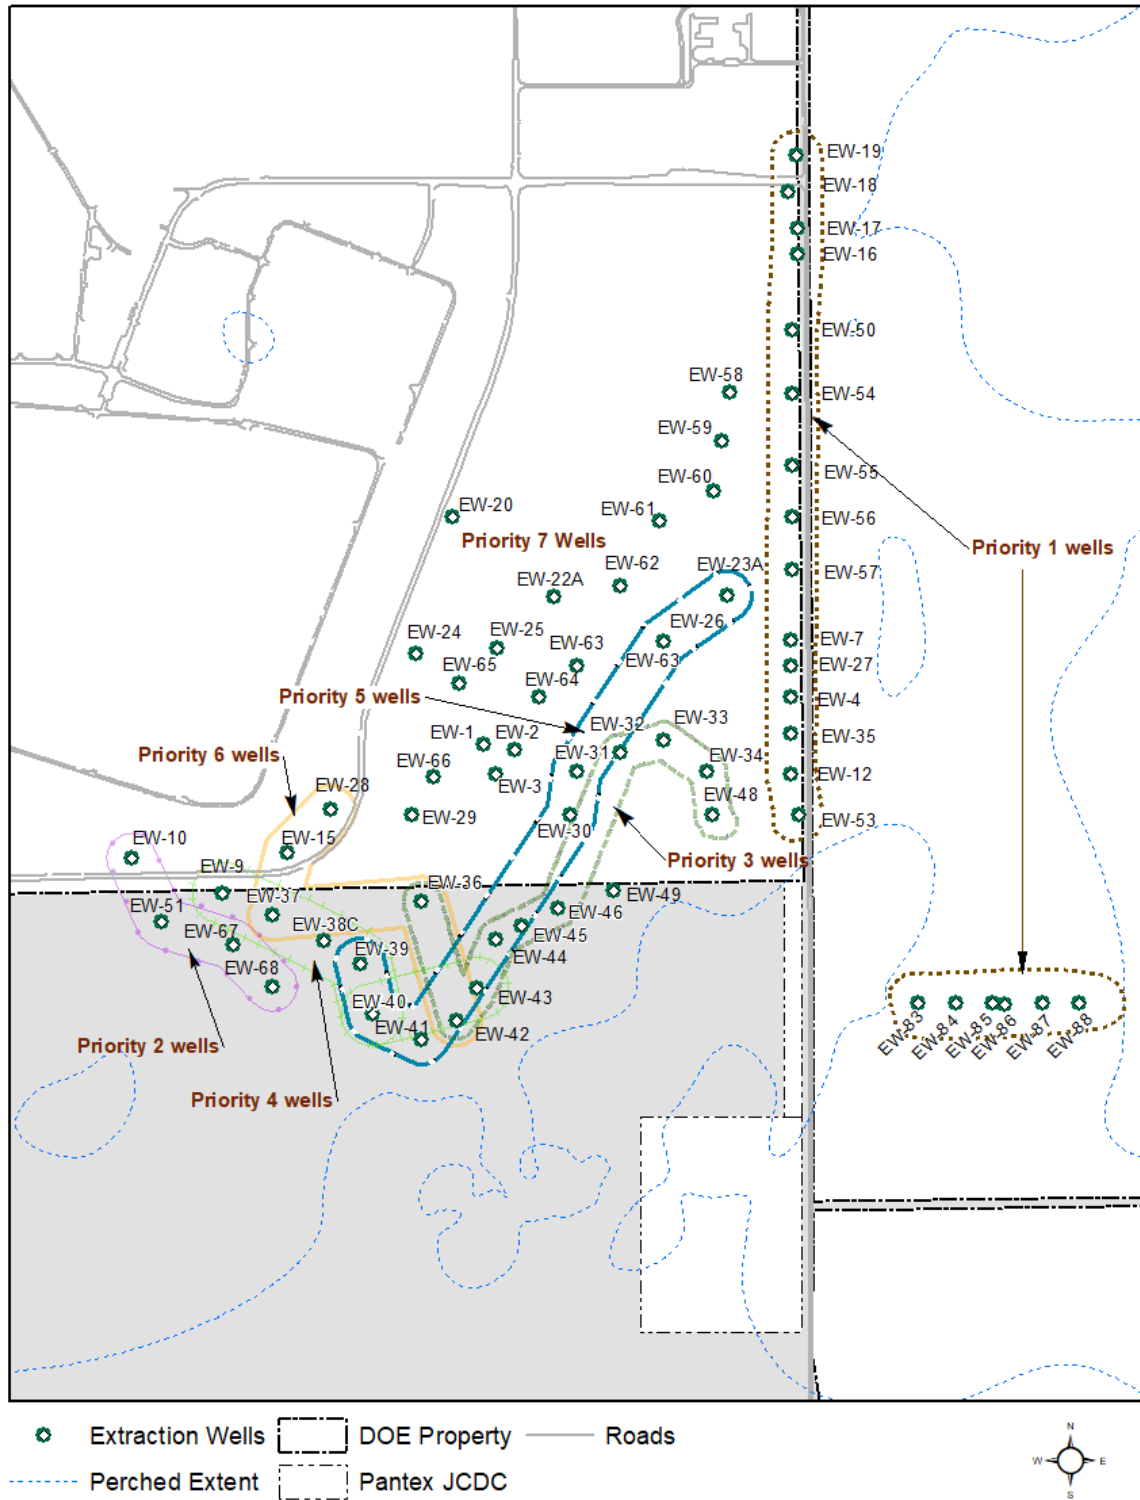
Fig. 2-9. Extraction well prioritization.

Although perched groundwater levels are declining, the extraction rates from the well field currently exceed the treatment system's capacity. Pantex extracts from the well field according to set priorities that best meet long-term objectives. The well-extraction priorities for operating wells are as follows and depicted in Fig. 2-9:

- **Priority 4 wells:** Wells along the northern edge of the hexavalent chromium plume from the Zone 12 South area.
- **Priority 5 wells:** Wells close to the highest concentrations of RDX. These wells will continue to capture the RDX plume movement when the Priority 3 wells are not pumping.

- **Priority 6 wells:** Wells that capture the center of the hexavalent chromium plume from the former cooling tower on the eastern side of Zone 12.
- **Priority 7 wells:** All other wells in the SEPTS. With the exception of EW-49, these wells help reduce saturated thickness in the perched aquifer and remove head that pushes the groundwater horizontally and vertically but will not be as effective at controlling plume movement. EW-49 is in a low-transmissivity zone and, thus, is a very low-producing well. For this reason, it was not placed in a high priority for pumping.

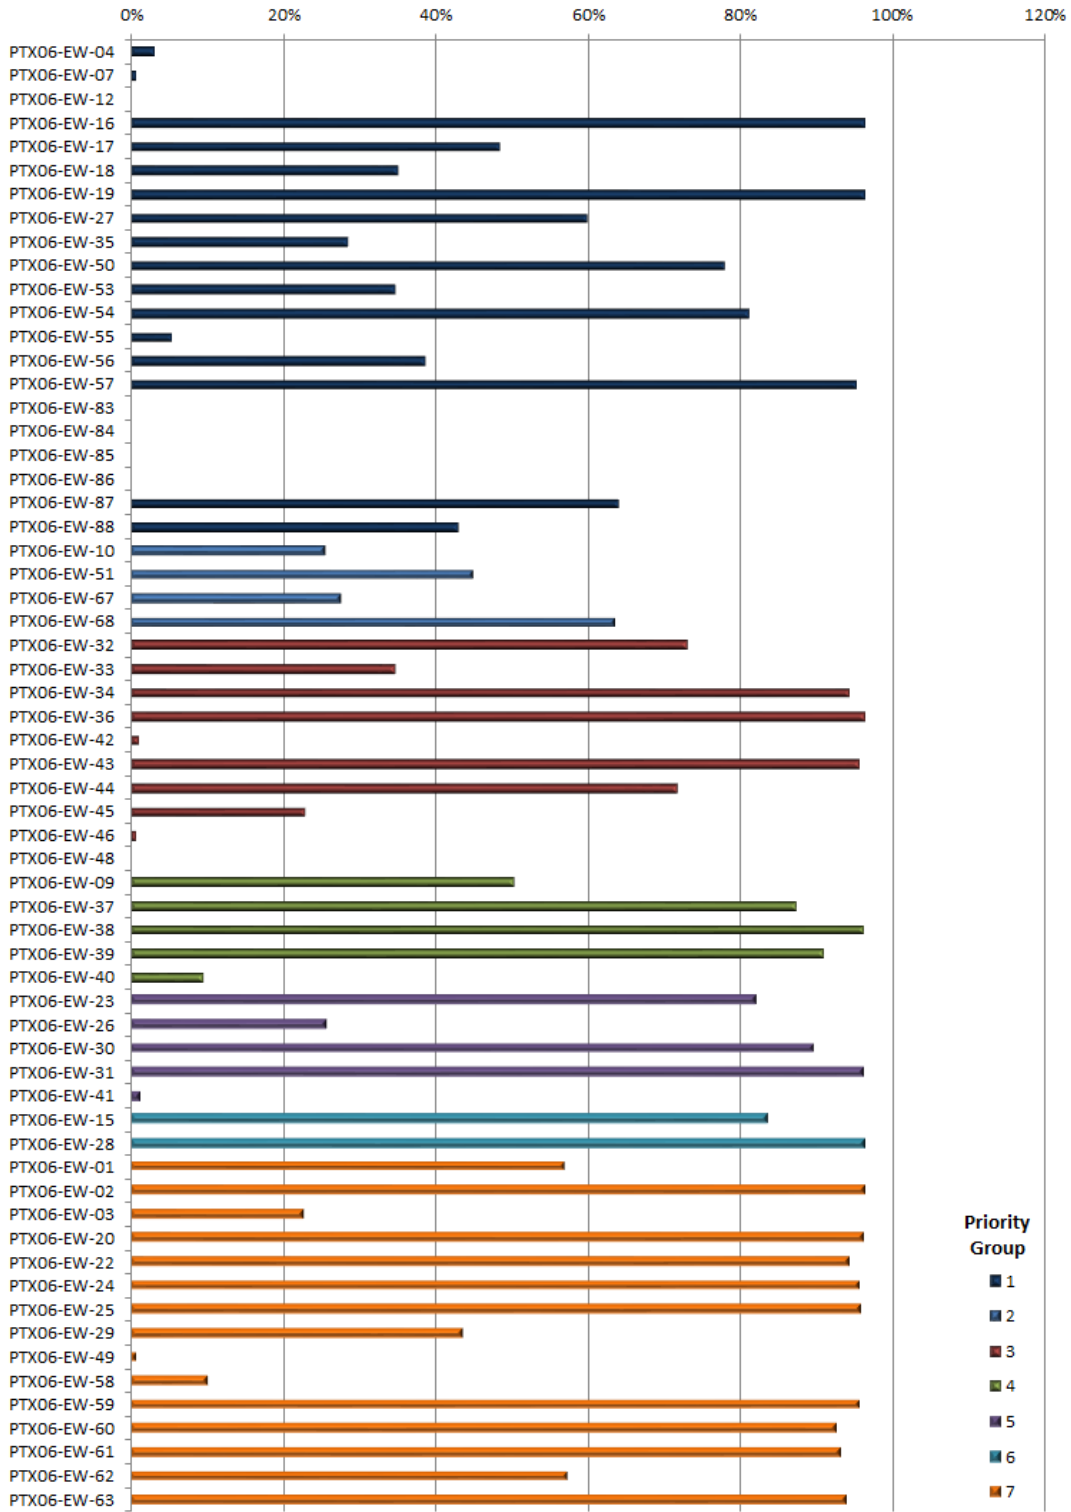
Fig. 2-10. SEPTS well operation time.

This prioritization scheme was implemented in 2009 after the system was expanded. Fig. 2-10 provides the percentage of days on which the wells were operated in the SEPTS. Priority 1 – Priority 5 wells were operated at higher frequencies with the exception of wells that had repair issues, were locked out due to repair issues with wells on the same line, or had low water levels that prevent them from operating properly. Two wells in the perchlorate plume, PTX06-EW-10 and PTX06-EW-51, were shut down while contracting for the design and installation of a perchlorate pre-treatment occurred. Those wells were turned back on in August 2022 when the perchlorate system became operational. Due to a plant electrical failure, those two wells plus several other wells in the vicinity stopped operating in December 2022. Electrical repairs were completed and the wells were back online in spring 2023.

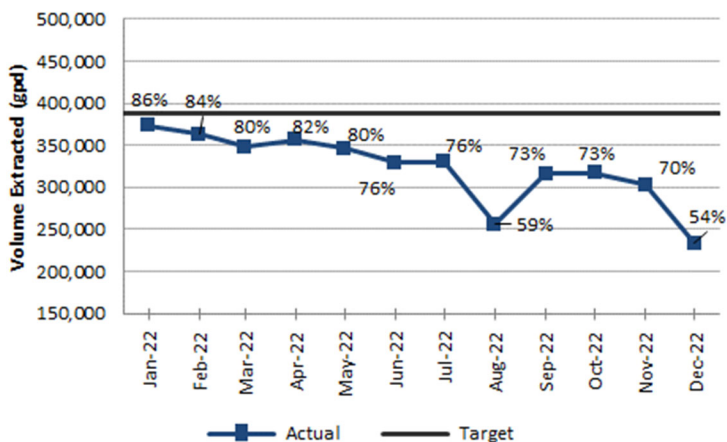
Fig. 2-11. SEPTS average GPD and % capacity.

Fig. 2-11 reflects the SEPTS's overall efficiency considering system and well operation. The figure depicts the average daily treatment rate in gpd by month, the target, and the percentage of total capacity achieved at the SEPTS. In 2022, the SEPTS treated an annual average of approximately 322,957 gpd (about 75% of design capacity), based on total possible hours of operation and total inflow from the well field. System operation time was high, but flow was impacted by well downtime and limited outlets for treated water.

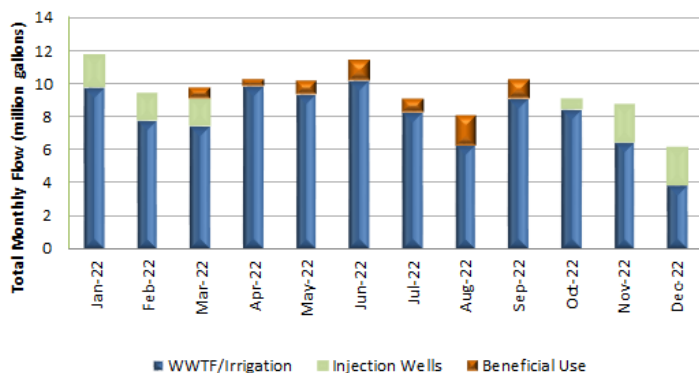
Fig. 2-12. SEPTS total flow volume and disposition of effluent.

The system treated approximately 117.7 Mgal of extracted water during 2022. The total volume treated by month and the final disposition of the treated water are depicted in Fig. 2-12. Approximately 6% of the treated water was injected into the perched aquifer, 9% was used beneficially for ISB injection, and the remainder was released to Playa 1 via the WWTF.

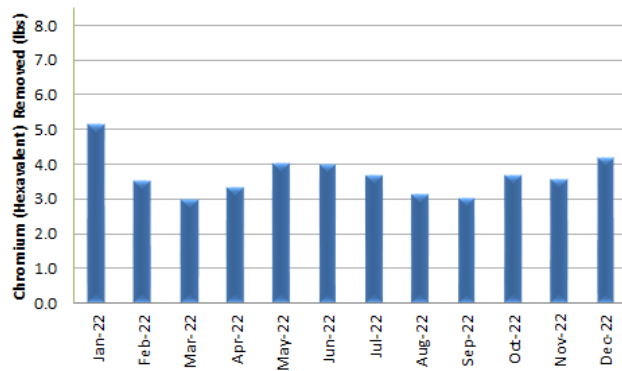
Fig. 2-13. SEPTS chromium mass removal by month.

The SEPTS primarily removes RDX, hexavalent chromium, and perchlorate from the perched groundwater. The system removed approximately 45 lbs of hexavalent chromium, 27 lbs of perchlorate, 216 lbs of RDX, and 169 lbs of all other HEs during 2022. The total mass removed for hexavalent chromium, perchlorate, and HEs, by month, is depicted in Fig. 2-13, Fig. 2-14, and Fig. 2-15. The average removal rate of hexavalent chromium was 0.39 lbs/Mgal of water and the average removal rate for perchlorate was 0.77 lbs/Mgal. The average removal rate for HEs was 3.0 lbs/Mgal of water.

Hexavalent chromium mass removal is declining because concentrations in PTX06-EW-51 and nearby extraction wells continue to decline. PTX06-EW-51 was located in the heart of the hexavalent chromium plume south of Zone 12 and contributed heavily to the hexavalent chromium influent concentrations at the SEPTS. The plume has moved downgradient, and other extraction wells now capture portions of it even though concentrations are much lower at these wells. Average influent

concentrations of hexavalent chromium were approximately 214 ug/L in 2009 and approximately 42.1 ug/L in 2022.

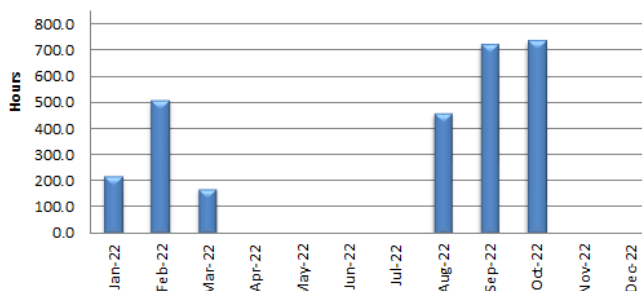
Fig. 2-17 depicts the SVE system's operation for 2022. The system was restarted in January, as part of the pulsing plan, but was shut down at the end of January due to freezing conditions. The system was restarted in early February and ran until March, when a failure at the catalytic oxidizer occurred. The system was repaired in August and operated through October, when another catalytic oxidizer failure occurred. The system remained down for the remainder of 2022. Overall, the system operated approximately 32% of the year. Fig. 2-17 depicts the system operation for 2022.

Fig. 2-17. SVE System operation.

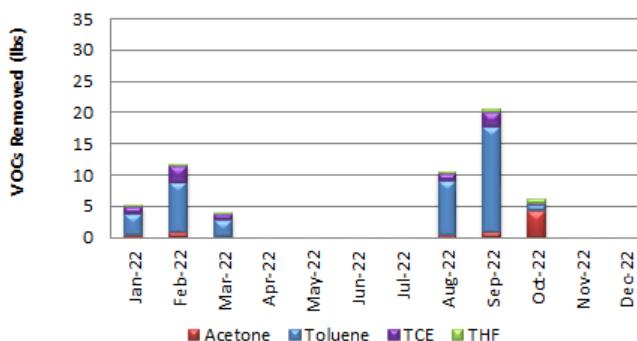
Calculated mass removal for 2022 is presented in Fig. 2-18. Mass removal was estimated based on concentrations reported from analytical sampling, system operation time, and system flow rates. VOC constituents contributing to the majority of the total VOC concentration were included in the calculation. The system removed approximately 58 lbs of VOCs during 2022, and since its inception the SVE system has removed about 21,331 lbs of VOCs. Trends of removal rates, concentrations, and general effectiveness of the SVE are provided in Section 4.

Fig. 2-18. Burning Ground SVE mass removal.

Since system modifications were completed in May 2017, the influent flow rate was increased from 32 scfm to approximately 44 scfm before the end of 2017. The 44-scfm flow rate has been generally maintained since late 2017. Flow rates increased from 13% to 24% from 2017's first quarter baseline, causing a rise in mass removal as well. However, data collected from 2018 to 2022 indicate that, although flow rate remained steady, mass removal rates declined due to lower influent concentrations.

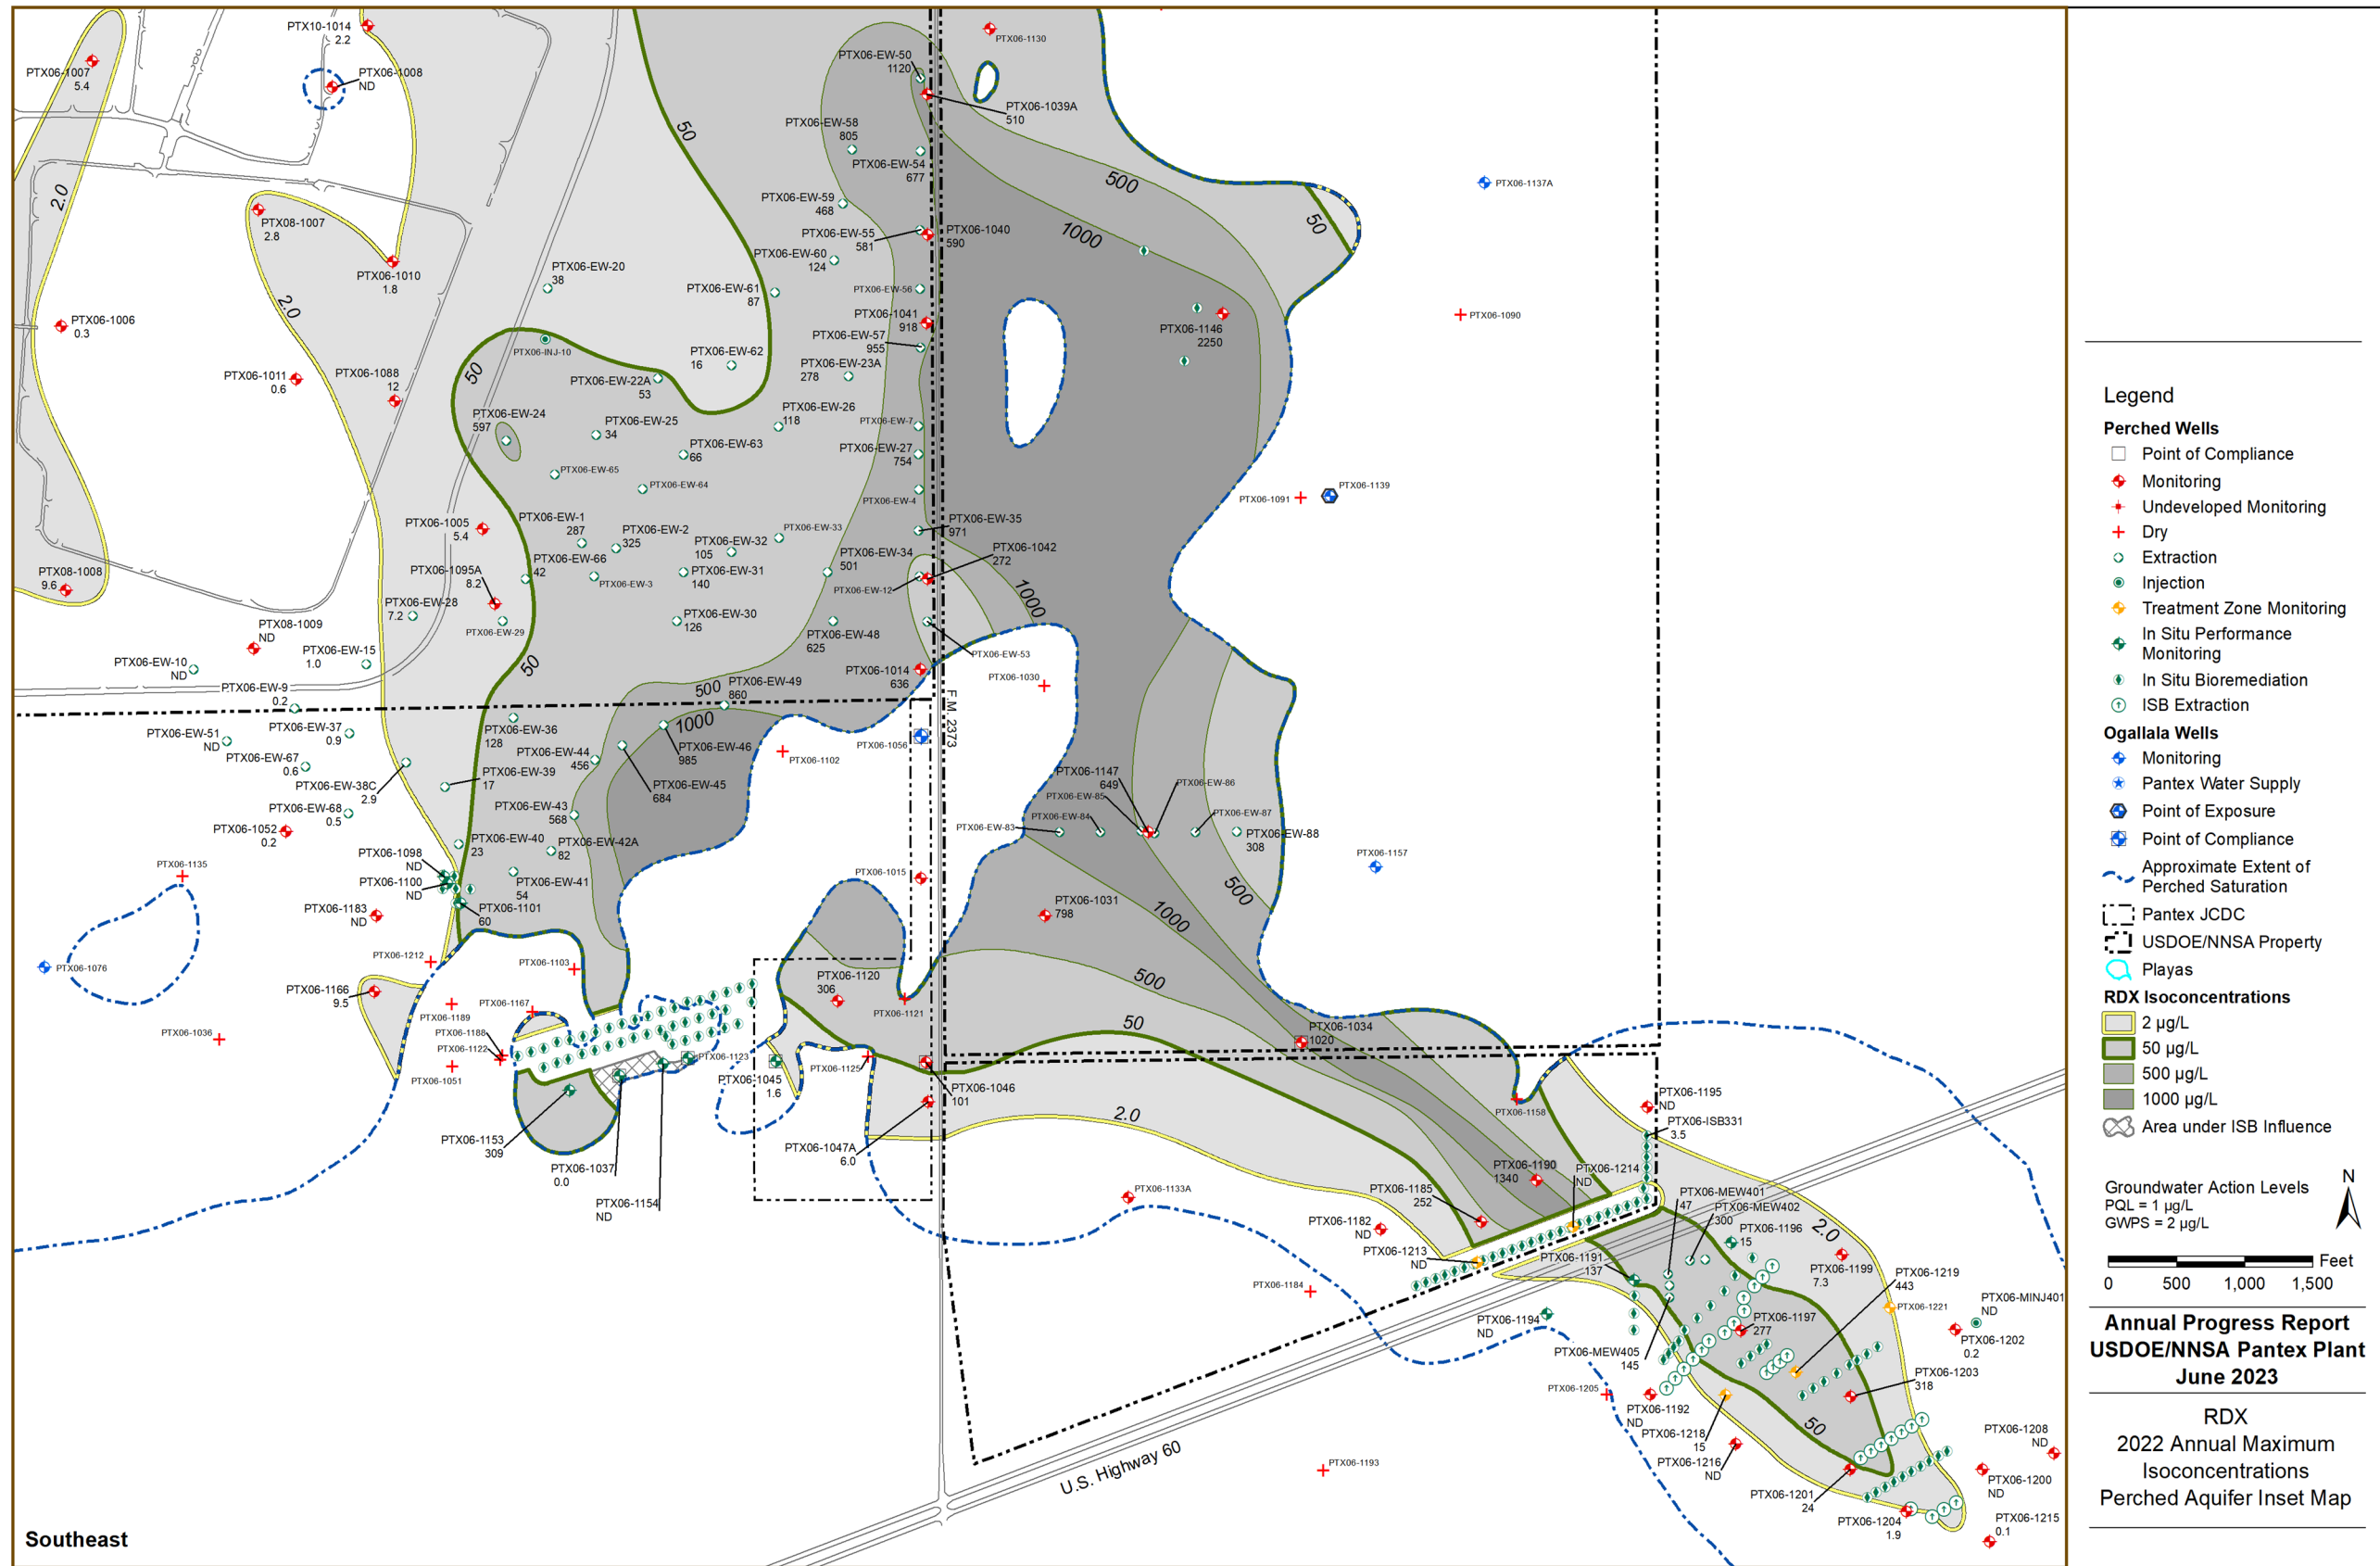
Fig. 3-13. RDX isoconcentration southeast inset map.

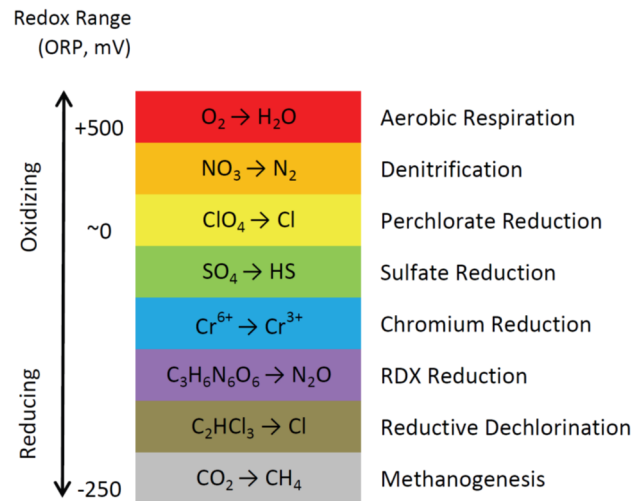
Fig. 3-32. Typical geochemical redox ranges.

Geochemical conditions can be evaluated to determine if adequate reducing conditions exist to achieve reduction. Figure 3-32 presents the redox ranges for the reduction of various COCs. TCE and perchlorate are the primary COCs in the Zone 11 area while HEs, primarily RDX, and hexavalent chromium are the primary COCs in the southeast area. Perchlorate degradation does not require as strongly reduced conditions as RDX or TCE.

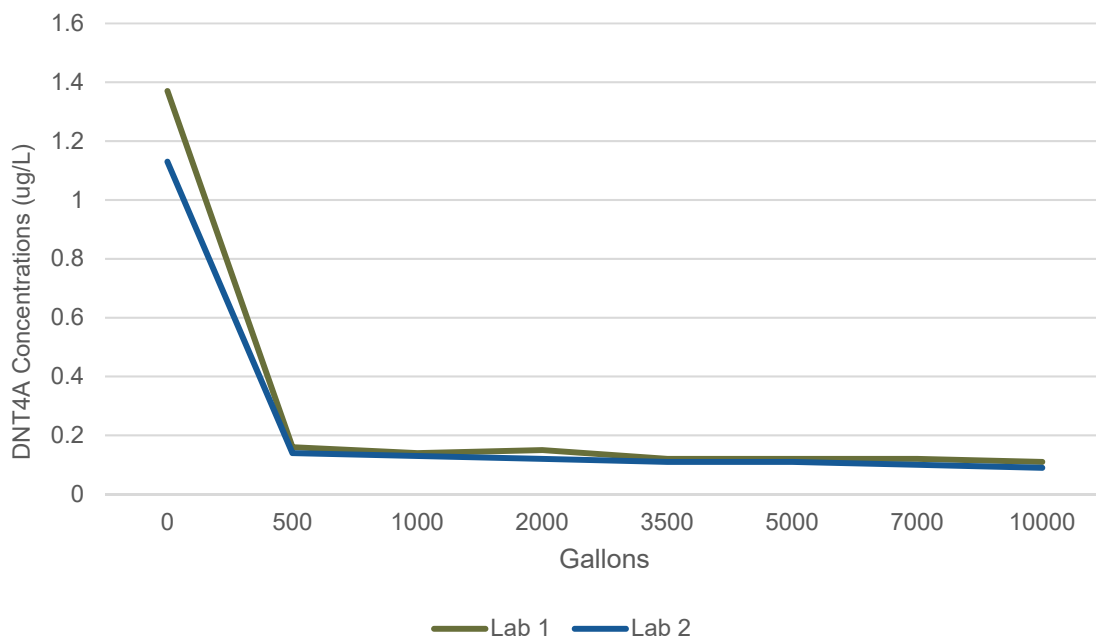
Fig. 3-36. High volume purge/time-series sampling results at PTX06-1056.

As of May 2020, Pantex went back to semi-annual sampling for PTX06-1056 as approved by regulatory agencies. The first quarter (February 2022) result detected DNT4A at 1.1 ug/L, just below the GWPS. RDX was not detected in this sample. The third quarter (July 2022) result detected DNT4A above the PQL at 1.22 ug/L and RDX below the PQL (0.26 ug/L) at 0.09 ug/L. As a result, Pantex performed a high volume purge, time-series sampling event in August 2022. Results from that study are summarized below in Fig. 3-36.

PTX06-1056 was resampled for DNT4A and RDX six weeks following the high volume purge to verify previous concentrations. Results from the verification samples confirmed DNT4A above the GWPS and detections of RDX below the PQL. Pantex is responding by installing two additional Ogallala monitoring wells to help understand nature and extent. These wells are anticipated to be installed in 2023. Notifications to regulators, Pantex Plant personnel, and the public have been sent. Further actions will be determined based on future sampling results and in accordance with the *Pantex Plant Ogallala Aquifer and Perched Groundwater Contingency Plan*.

PTX06-1056 continues to demonstrate detections of DNT4A, a breakdown product of TNT, first detected in April 2014, and the VOC, 1,2-DCA, detected for the first time in August 2015. DNT4A was detected in both semi-annual samples in 2022 at values up to 1.22 ug/L, above the PQL (0.26 ug/L) and the GWPS (1.2 ug/L). 1,2-DCA was detected in both samples in 2022; both detections were near or below the PQL of 1.0 ug/L and below the GWPS. Trends of these analytes were performed using Mann-Kendall statistics; both DNT4A and 1,2-DCA continue to demonstrate increasing trends across all data.

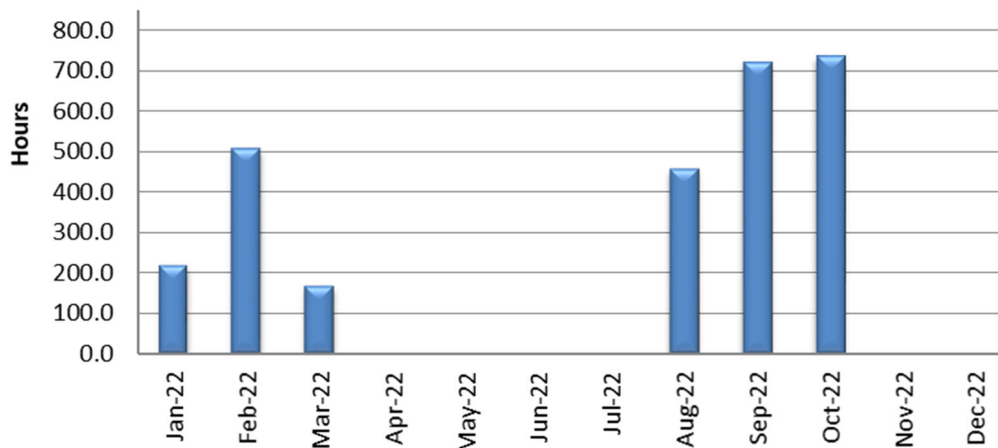
Fig. 4-1. SVE system operational hours in 2022.

Fig. 4-1 depicts the operation of the SVE. The system was operated at 100% in September and October. Operation of the system was impacted early in the year due to late start-up in January, freezing conditions that impacted operation, and a heater failure in March that shut the system down. The system was repaired and restarted in August.

The Burning Ground SVE system operated during two events in 2022, with the first event occurring from January into March and the second event occurring from August through October, with an operational rate of 32%, or about 2801 hours of operation for the year. A pulsing plan was implemented in 2021 to evaluate system closure. The system began operation on January 18 for the first pulsing event of 2022; however, the system was negatively impacted due to a heater failure on March 7 and was shut down until repairs were contracted and completed. The system was operated from the beginning of August through October and then shut down due to another failure.
