Pantex Plant

2022 Annual Progress Report

Remedial Action Progress

In Support of Hazardous Waste Permit 50284 and
Pantex Plant Interagency Agreement

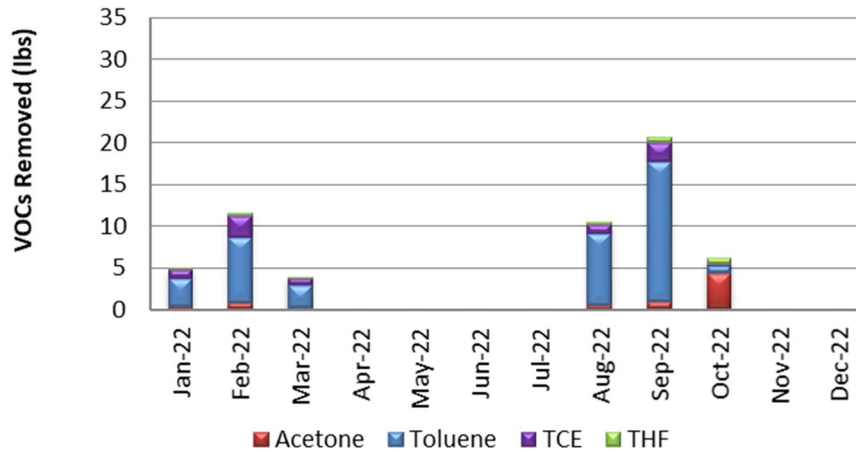
Fig. 4-2. SVE System 2022 VOC removal.

Figure 4-2 shows the mass of the four highest VOC compounds [i.e., acetone, toluene, TCE, and tetrahydrofuran (THF in the figure)], removed each month of 2022. The hourly VOC removal rate has declined significantly since modifications occurred in 2017. Data in 2021 and 2022 indicated the greatest drop since the system began operating.

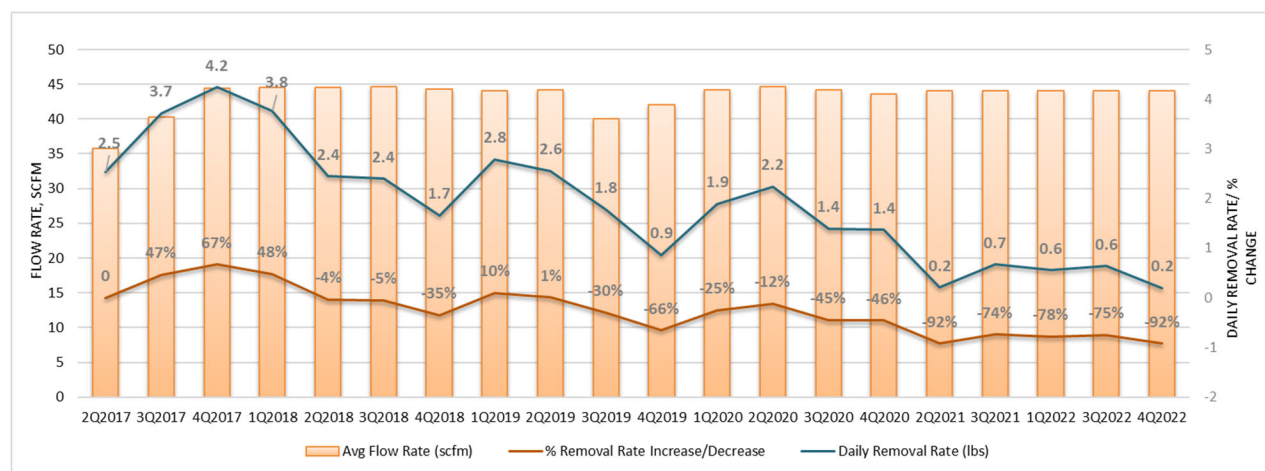
Fig. 4-3. Daily removal rate change since 2017 modification of the SVE system.

Fig. 4-3 demonstrates the change in daily removal rates since modification of the system occurred in May 2017. Removal rates have declined to 0.2 lbs/day, or a 92% decrease from May 2017 removal rates. The removal rate has dropped 95% from the peak removal rate in fourth quarter 2017.

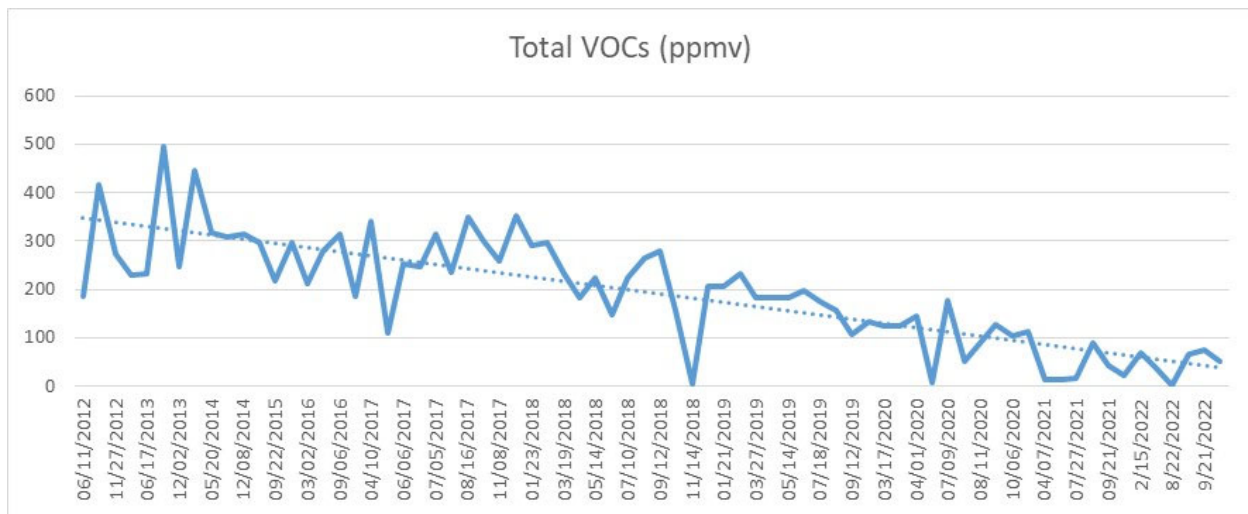
Fig. 4-4. Total VOCs since installation of current CatOx system.

Concentrations were also evaluated to determine whether concentrations would increase after a long pause in operations. Samples collected in 2022 are indicating that a low total VOC concentration is observed at start-up (22 ppmv in January and 0.5 ppmv in August). With continued operation, concentrations increased slightly, remaining below 100 ppmv, then dropped off again in a short period of time. This pattern has been observed since the start of 2021. These data demonstrate the source at SVE-S-20 is significantly depleted. A small nearby source may be indicated by the rise in concentrations over time, but the data indicate that those concentrations also decline quickly, suggesting a minor source that is also near depletion. Total VOC concentrations since the installation of the current system are depicted in Fig. 4-4.

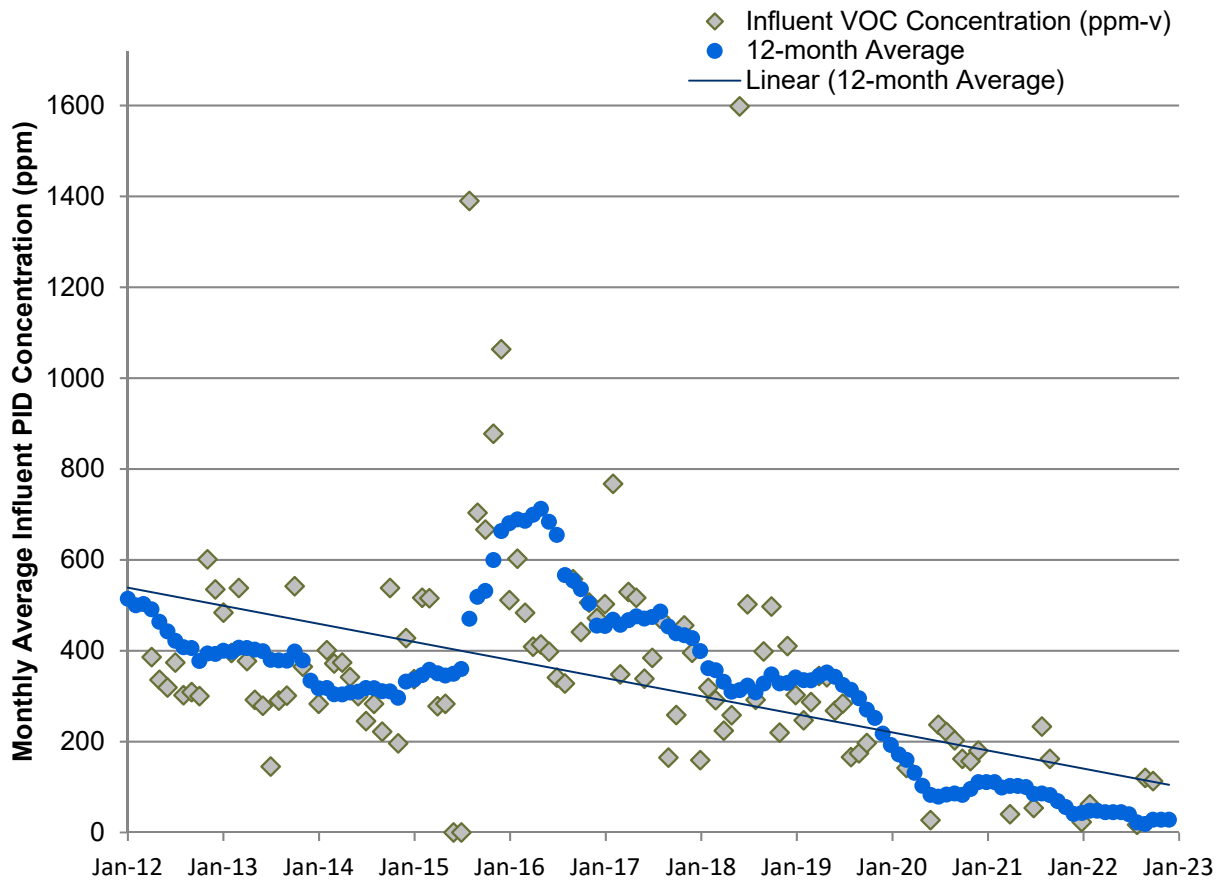
Fig. 4-5. Influent average PID VOC concentrations vs. time.

The average monthly PID measurements collected at the system influent, summarized in Fig. 4-5, show some variability, but 2022 monthly averages ranged between approximately 17 to 113 ppm. The orange circles on the chart show the 12-month rolling average, which illustrates a strong decline in average concentrations since the system modification in mid-2017. Two very high PID readings in June 2018 that were determined to be unrepresentative were omitted from the 12-month averages. Through the end of 2022, average PID readings were lower than observed since the small-scale system began operating in 2012. The observed decline in influent PID readings was expected and indicates NAPL source depletion.
