# Pantex Plant

# 2018 Annual Progress Report

## Remedial Action Progress

In Support of Hazardous Waste Permit 50284 and  
Pantex Plant Interagency Agreement

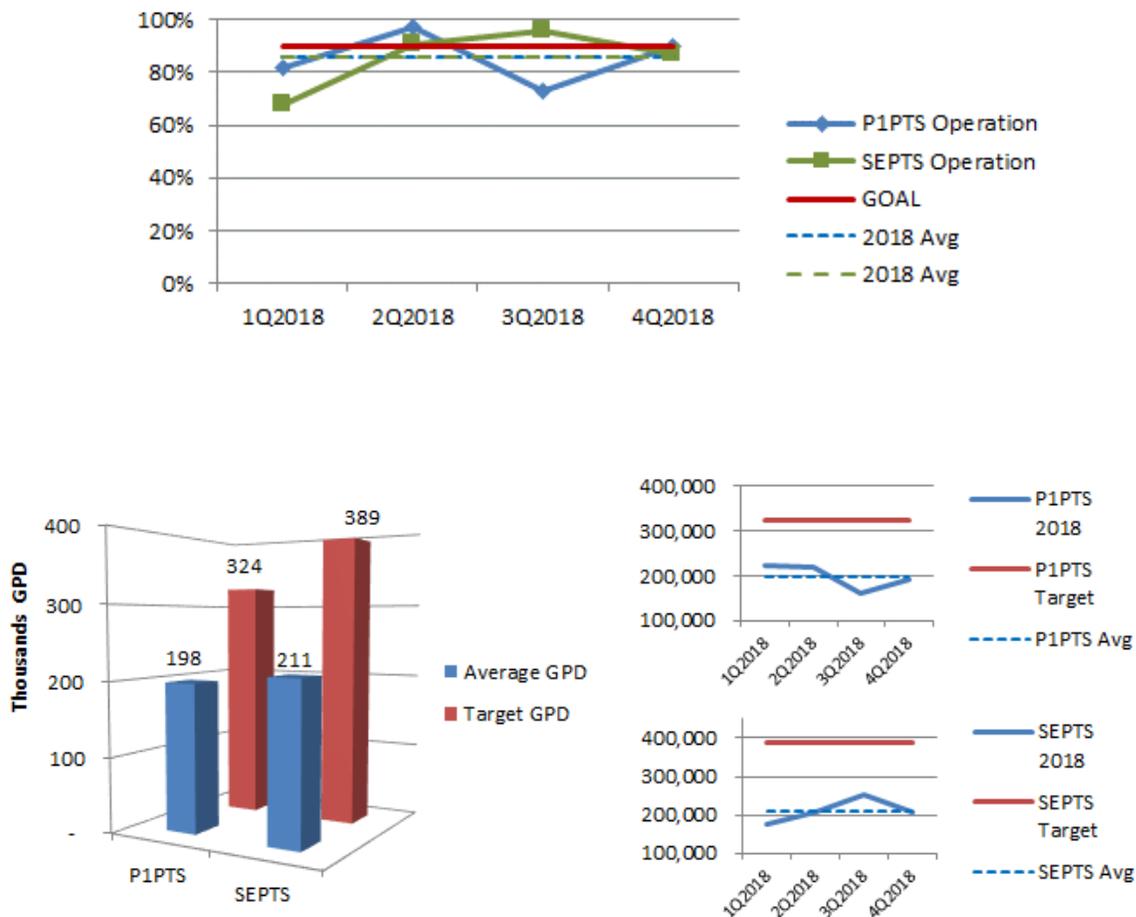
Operational goals have been developed to promote mass removal and continued removal of perched groundwater to reduce saturated thickness of the perched aquifer. The first goal of 90% system operation was not applicable at all times during the year due to shutdowns for maintenance of the system, maintenance of the wastewater treatment facility (WWTF), and in response to the break at the filter bank at the irrigation system. The average operational rate across 2018 was 86% at the Playa 1 Pump and Treat System (P1PTS) and 86% at the Southeast Pump and Treat System (SEPTS). The pump and treat system performance for 2018 is depicted in Figure E-1.

While treatment throughput was not a primary goal after June 2017 due to the break at the irrigation system filter bank, the 90% goal is still depicted in the graphs and throughput is evaluated. When the systems operated, daily treatment throughput varied due to reduced flow to the WWTF and irrigation system. P1PTS was heavily impacted by the shutdown of the irrigation system after the filter bank break at the end of June 2017. Treated water from P1PTS can only be released to the WWTF, so flows are impacted when the WWTF cannot receive the water. Treated water from the WWTF are now routed to Playa 1 until repairs can be made. SEPTS was also impacted by the break at the irrigation system and while it remained operational most of the time, flows were reduced as injection into the perched groundwater was required. SEPTS operation focused on removal of water in high priority well locations to control plume movement to the southeast.

Figure E-1. Pump and Treat System Performance

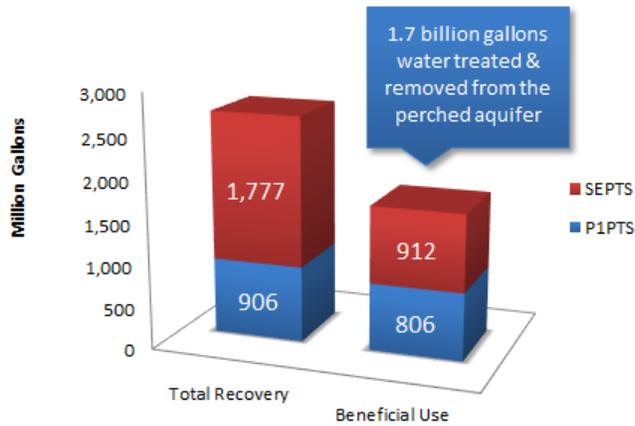
**Figure E-2. Pump and Treat Recovery**

Overall, the systems have operated efficiently to treat contamination and reduce saturated thickness. As depicted in Figure E-2, Pantex has treated over 2.6 billion gallons since the startup of the systems, with more than 1.7 billion gallons removed and beneficially used. Pantex continues to reduce reliance on injection of treated water as possible, and as recommended in the Five-Year Review, Pantex has implemented new throughput goals to align operations

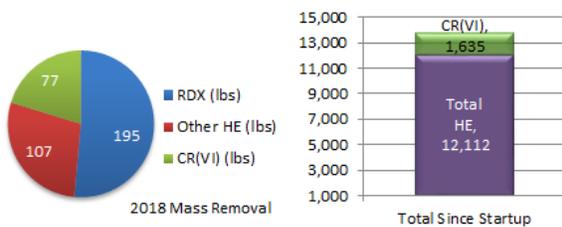
In addition to removing impacted water from the perched aquifer, the pump and treat systems remove contaminant mass from the groundwater that is extracted from the aquifer. The P1PTS primarily removes the high explosive RDX and the SEPTS primarily removes RDX and hexavalent chromium (CR(VI) in Figure E-3). The figures below provide the mass removal for high explosives (HEs) and chromium for 2018, as well as totals since startup of the systems. The SEPTS has been operating longer than the P1PTS and the greatest concentrations of HEs are found in the SEPTS extraction well field, so mass removal is much higher at that system. During 2018, SEPTS removed about 378 lbs of contaminants and P1PTS removed about 38 lbs of contaminants.

**Figure E-3. SEPTS Mass Removal**

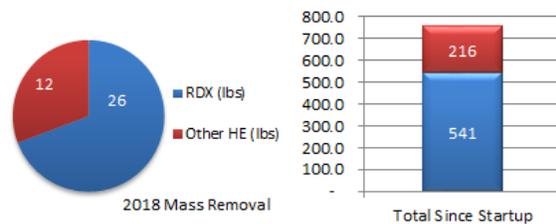
**Figure E-4. P1PTS Mass Removal**

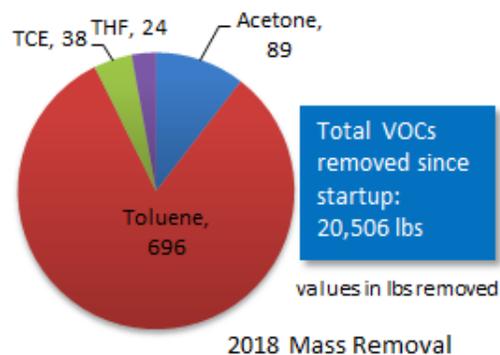
for VOCs contributing the majority of the total VOC concentration is presented in Figure E-5 along with total mass removed since the SVE was installed as an interim action in 2002. The system removed about 847 lbs of VOCs during 2018.

**Figure E-5. Burning Ground SVE Mass Removal**

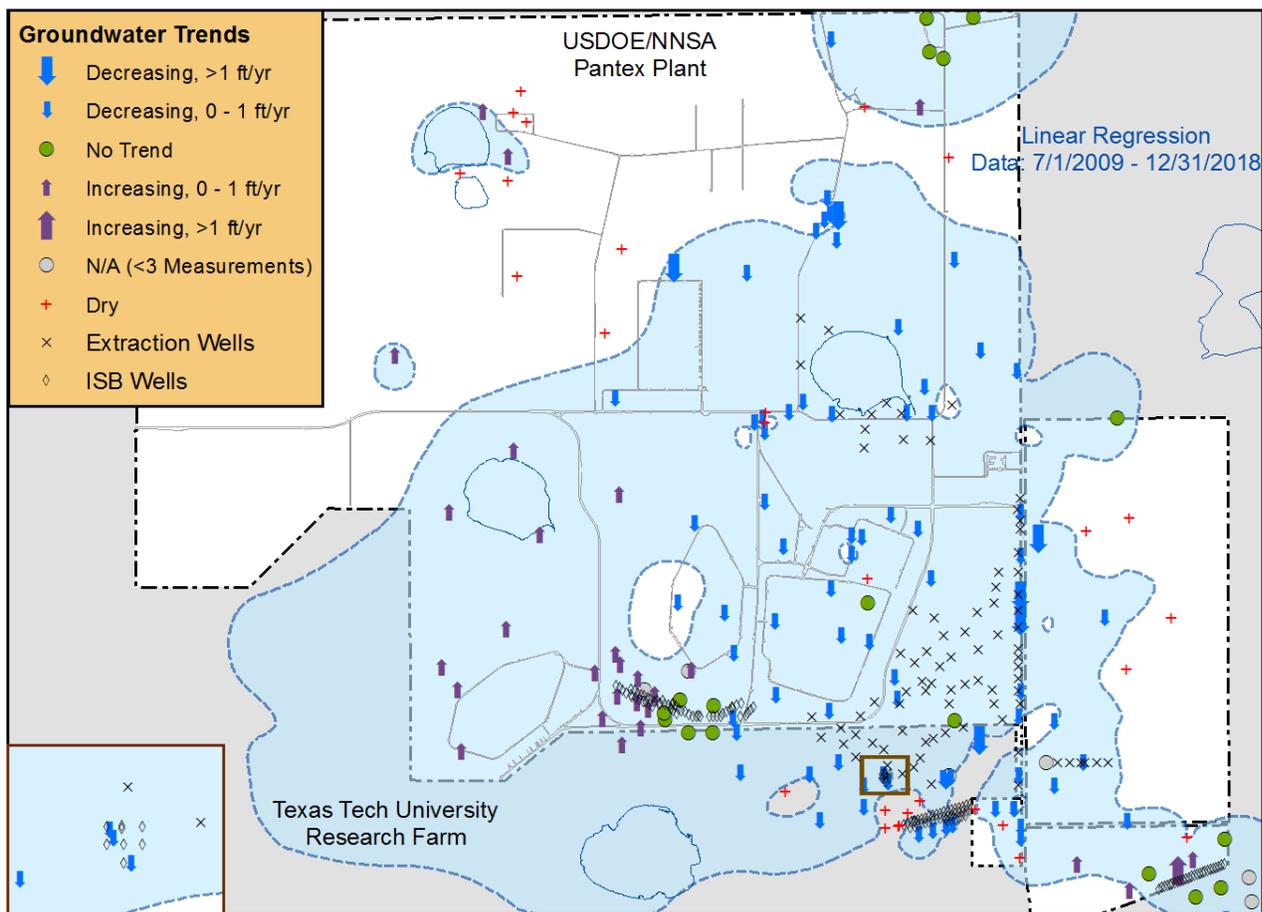
Overall, calculated concentration and groundwater level trends were consistent with expected conditions defined in the Long-Term Monitoring (LTM) Design Report. Figure E-6 depicts recent water level trends in the perched aquifer LTM wells. Of the 48 monitor wells with expected decreasing water level trends, limited water, or dry conditions defined in the LTM Design Report, 16 wells exhibited conditions inconsistent with the current expected conditions or trends. Most of these wells exhibited recently increasing trends in response to increased precipitation and resulting recharge through unlined ditches and playas along with decreased extraction of perched groundwater. The long-term water level trend is decreasing for 14 of these wells, and it is expected that water levels will continue to decline.

The remaining two wells with increasing water levels trends are both historically dry wells that are now showing fluctuating water levels. The appearance of water in these wells does not represent movement of impacted perched groundwater into these areas. One well is near the Southeast ISB and had a maximum of 0.15 ft of water measured in 2017; the water level was below the bottom of the screen in 2018. The other well is located near the southern extent of perched groundwater; the sudden appearance of water in this well may be associated with the above normal precipitation during 2015 and 2016 and increased recharge through a large borrow pit to the south.

Figure E-6. Perched Aquifer Water Level Trends

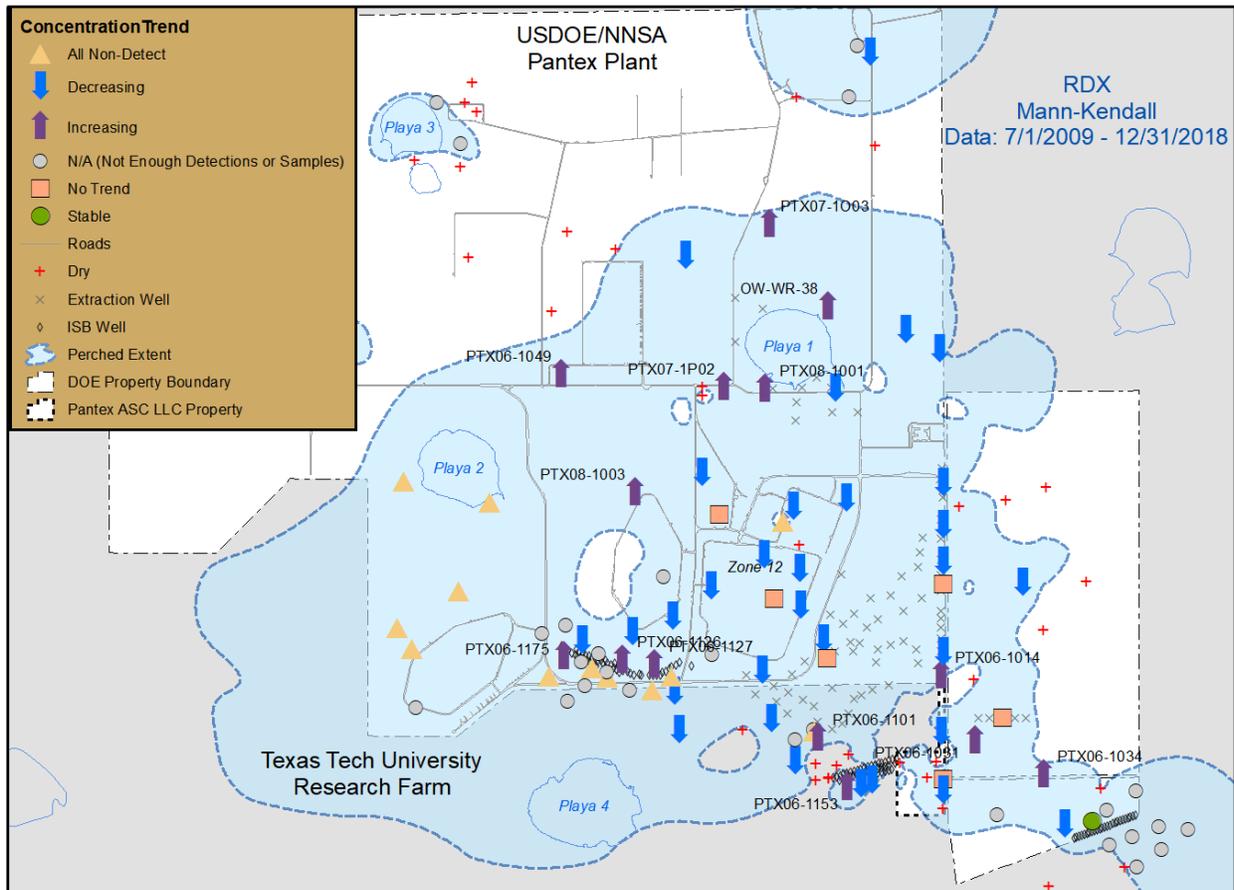
Of the 103 monitor wells with expected COC concentration conditions defined in the LTM Design Report, 32 wells did not exhibit trends consistent with the expected conditions for the four major COCs (RDX, hexavalent chromium, TCE, and perchlorate). It is anticipated these trends will meet expected conditions as the corrective actions continue to operate in the perched aquifer. Figure E-7 depicts RDX trends since the start of the full remedial action in the perched aquifer LTM wells. Wells in the southeast lobe of the perched aquifer are not under the influence of a remedial action.

**Figure E-7. RDX Trends in the Perched Aquifer**

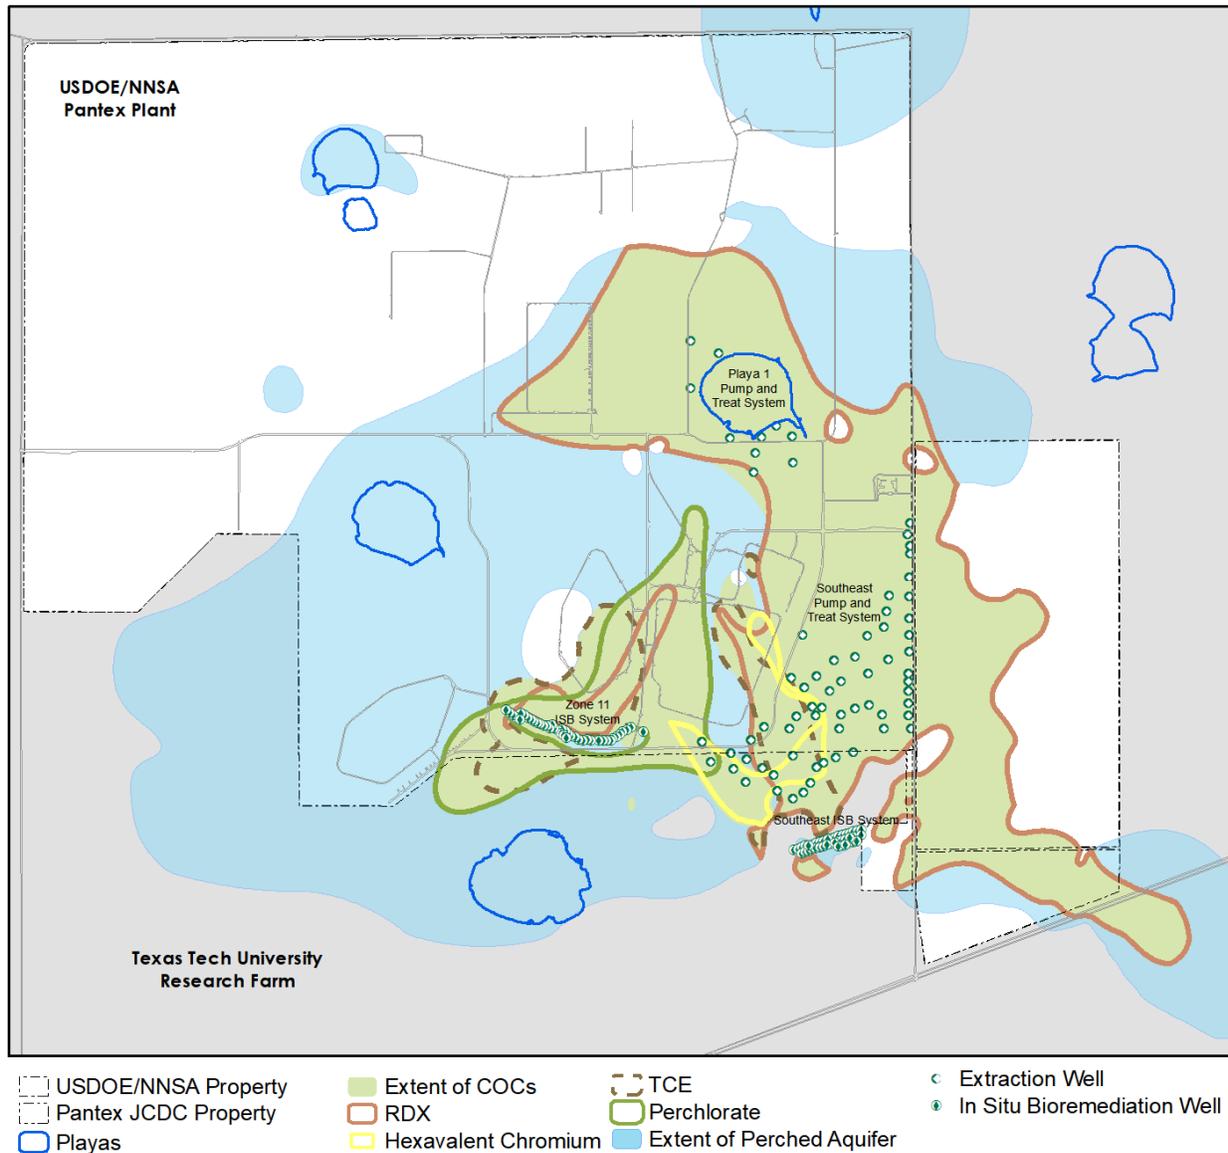
Generally, 2018 plume shapes are similar to the 2009 COC plumes with the greatest difference being the change in the extent of perched saturation in the extreme southeast lobe of perched groundwater and HE plumes in that area because of the new information collected from PTX06-1182 and other recently drilled wells. A shift in the hydraulic gradient eastward in the area between the southern parts of Zones 11 and 12 has allowed perchlorate to migrate east and southeast into the SEPTS well field; this portion of the perchlorate plume is being actively remediated by SEPTS at this time. Other changes in

plume size and shape were due to general plume movement downgradient, slight changes in concentrations that define the boundaries of the plumes, newly installed wells, or effects of the pump and treat systems. The major COC plumes of interest are depicted in Figure E-8.

**Figure E-8. Major COC Plumes in the Perched Aquifer**

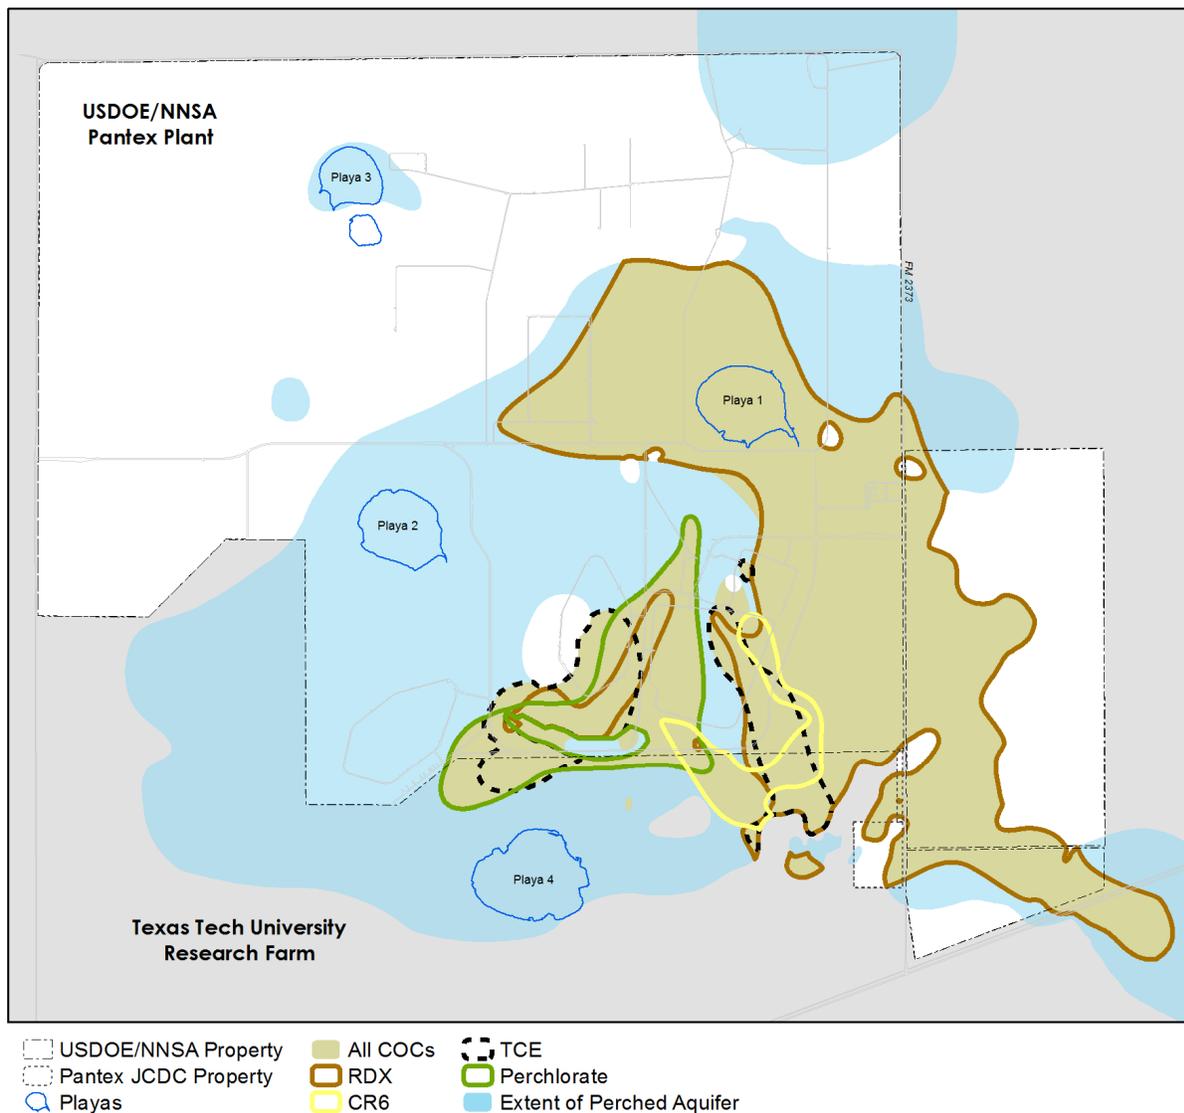
Historical waste management practices at Pantex resulted in the release of contaminants through various waste streams. Treated and untreated industrial wastewater released to the ditches and playas resulted in the contamination of perched groundwater beneath Playa 1, portions of Zone 11, Zone 12, Texas Tech University property to the south, and property east of FM 2373. The extent of perched groundwater and the major contaminant plumes are depicted in Figure 1-2. Pantex has implemented remedial actions to mitigate perched groundwater contamination and to prevent contamination of the deeper drinking water aquifer.

**Figure 1-2. Extent of Perched Groundwater and Contaminant Plumes Exceeding GWPS**

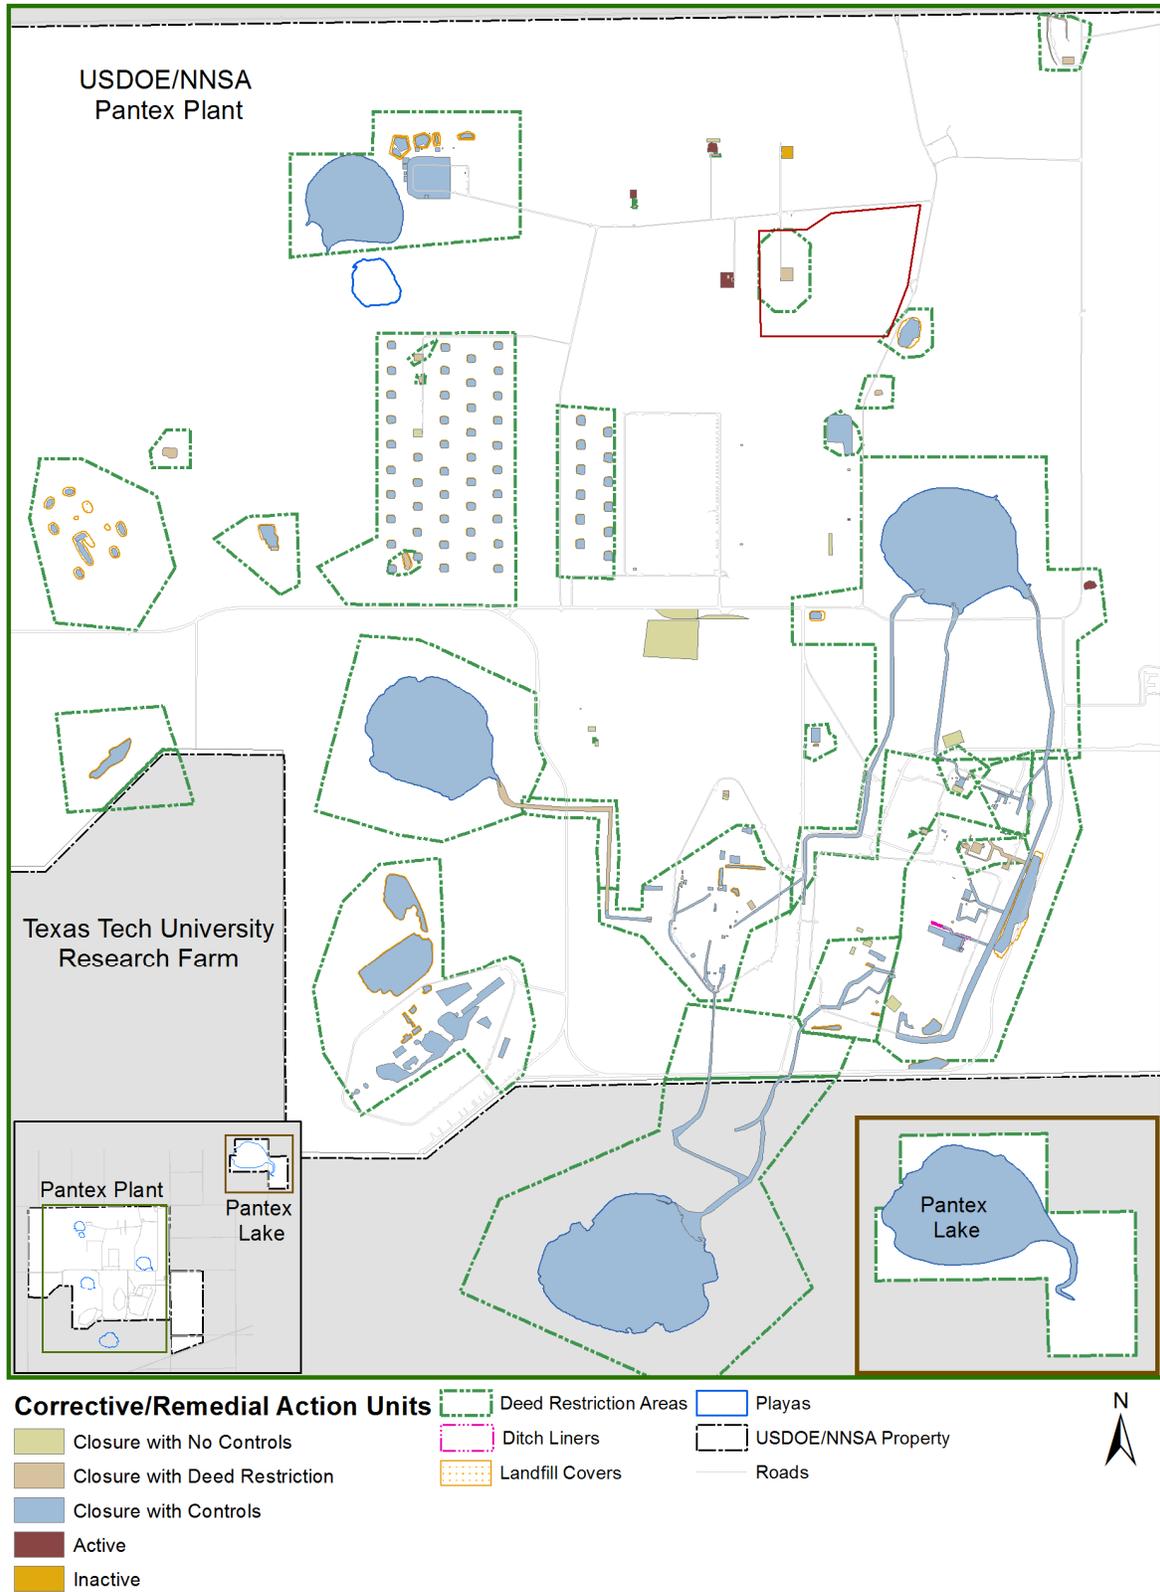
In accordance with RCRA and CERCLA, Pantex and regulatory agencies identified 254 units at the Pantex Plant for further investigation and cleanup. Investigations that identified the nature and extent of contamination at solid waste management units and associated groundwater were submitted to the TCEQ and EPA in the form of RCRA Facility Investigation Reports. Those investigation reports closed many units through interim remedial actions and no further controls other than deed recordation are necessary for those units. Other units were evaluated in human health and ecological risk assessments to identify units that required further remedial actions to protect human health and the environment. Figure 1-3 depicts the location and status of the 254 units. The 15 units still in active use will be closed in accordance with CERCLA and RCRA permit provisions when they become inactive, are determined to be of no further use, and funding is identified for investigation and cleanup of the site. One active facility has been changed to inactive and Pantex has requested funding to address the site. A detailed summary of actions for the 254 units can be found in the ROD (Pantex and Sapere Consulting, 2008).

Those units requiring further remedial actions were then assessed in a corrective measures study to identify and recommend final remedial actions. The final approved remedial actions are detailed in the ROD. A detailed status table of the SWMUs is included in Appendix A of this report.

**Figure 1-3. Status of Corrective/Remedial Action Units**

The remedial action for landfills included installation and maintenance of protective covers for the Former Burning Ground Ash Disposal Trench (SWMUs 14- through 24), the former operational area of Firing Site (FS-5), and 27 landfill units depicted in Figure 1-3. These protective covers were either placed after landfilling operations ceased, or were installed as ICMs under State RCRA Authority to prevent worker contact and infiltration of water through the landfill materials that could lead to migration of contaminants to the underlying aquifer without mitigation. Construction of all the protective covers was completed and approved in 2009. All but two covers are constructed of soil, with the two landfills (Landfill 1 and 2) having Closure Turf installed over the soil cover. Closure Turf was installed at Landfill 1 in 2013. Closure Turf was also installed at Landfill 2 during 2017. Refer to the respective annual reports for the closure turf installation information.

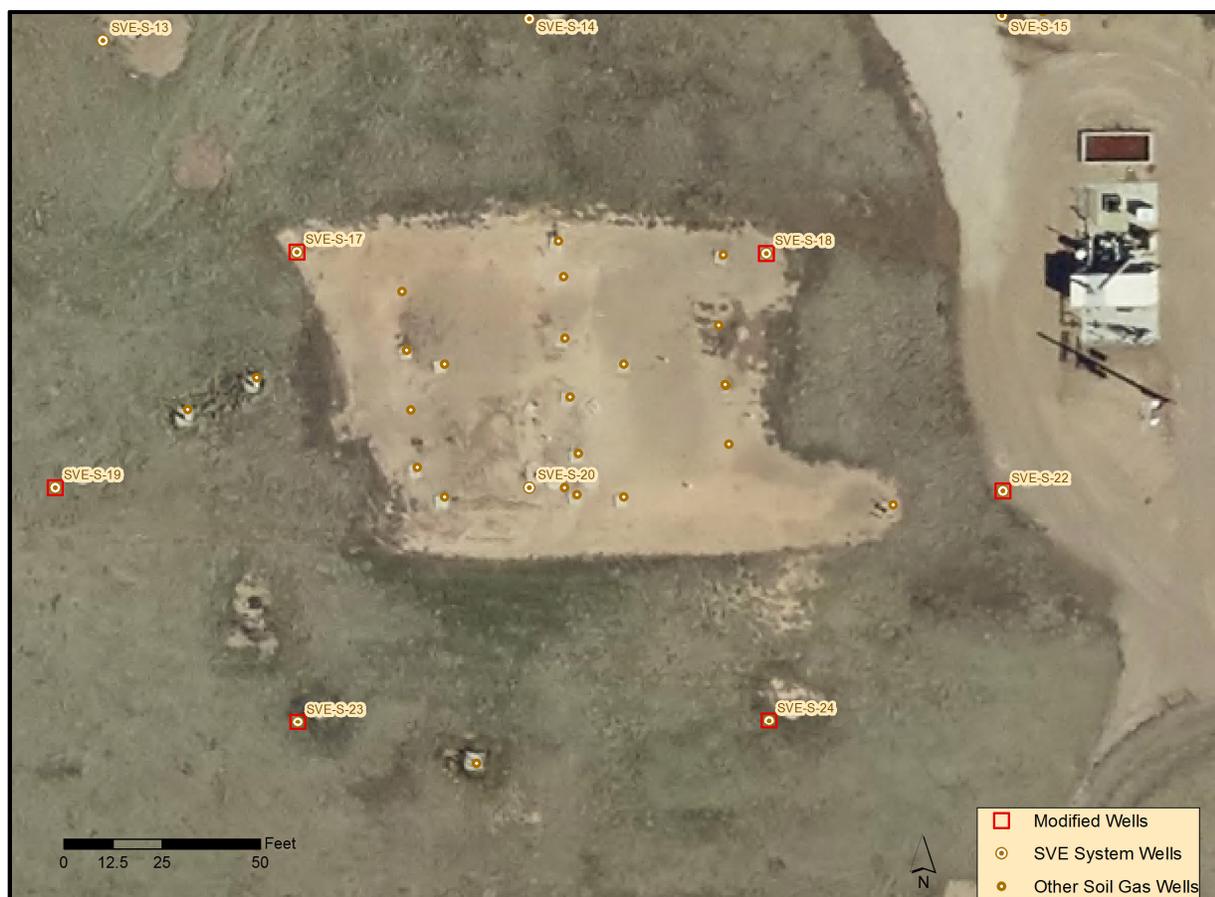
where soil gas concentrations continue to remain above 100 ppm. The system consisted of a series of activated carbon drums and a smaller blower motor for extraction. The activated carbon system was shut down at the end of January 2012 to allow installation of a small-scale CatOx system that continues to focus remediation on SVE-S-20. The new system is more cost efficient and will effectively treat all detected COCs at the Burning Ground. System construction and installation began in February 2012. System startup and testing began on April 5, with normal operations commencing on April 19, 2012.

The system was modified in May 2017 to increase air flow through the area surrounding SVE-S-20 to promote increased volatilization and bioremediation of the remaining soil NAPL. Six wells surrounding SVE-S-20 were modified to include above-ground piping that would allow air flow through the wells while the system is operating and pulling air from SVE-S-20 (see Figure 1-4). Pantex increased influent flow to the SVE by 40% (from 32 scfm to about 45 scfm), close to the maximum design flow of 50 scfm. Pantex also increased

**Figure 1-4. Burning Ground SVE System Wells and Modifications**

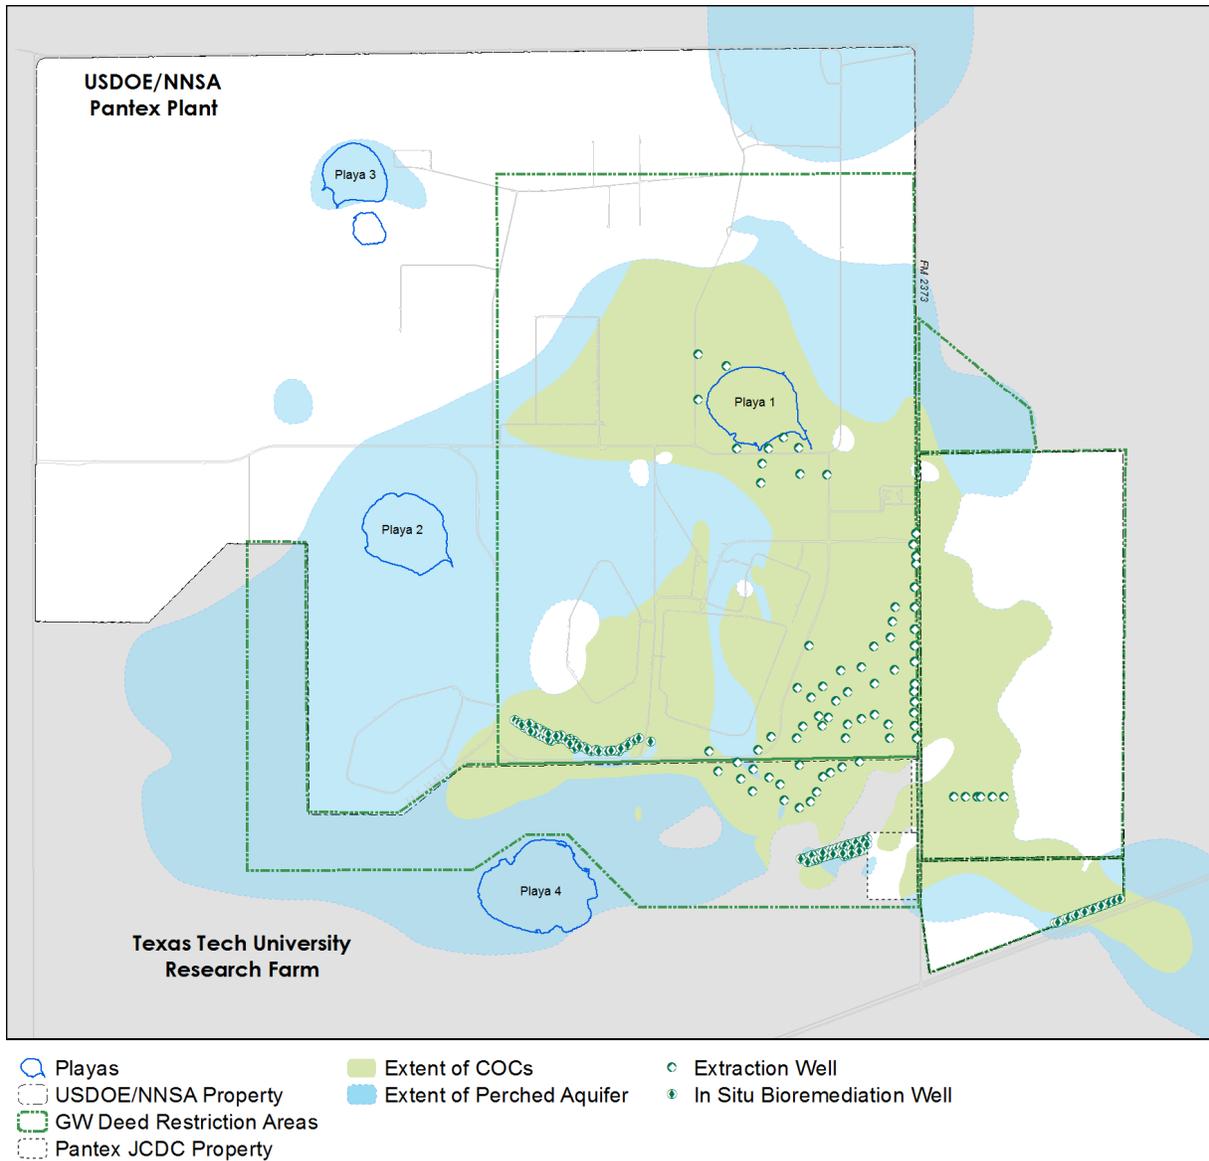
In accordance with the IAG and HW-50284, Pantex has implemented remedial actions to remediate the contaminated perched groundwater. Two types of active remediation systems (see Figure 1-5) were installed to address the contamination: pump and treat systems and in situ bioremediation (ISB) systems. Institutional controls are also part of the final remedy for groundwater.

Pantex has installed in situ bioremediation systems to reduce the concentration of contaminants as they migrate through the remediation zone in targeted areas of the groundwater plumes.

**Figure 1-5. Groundwater Remedial Actions**

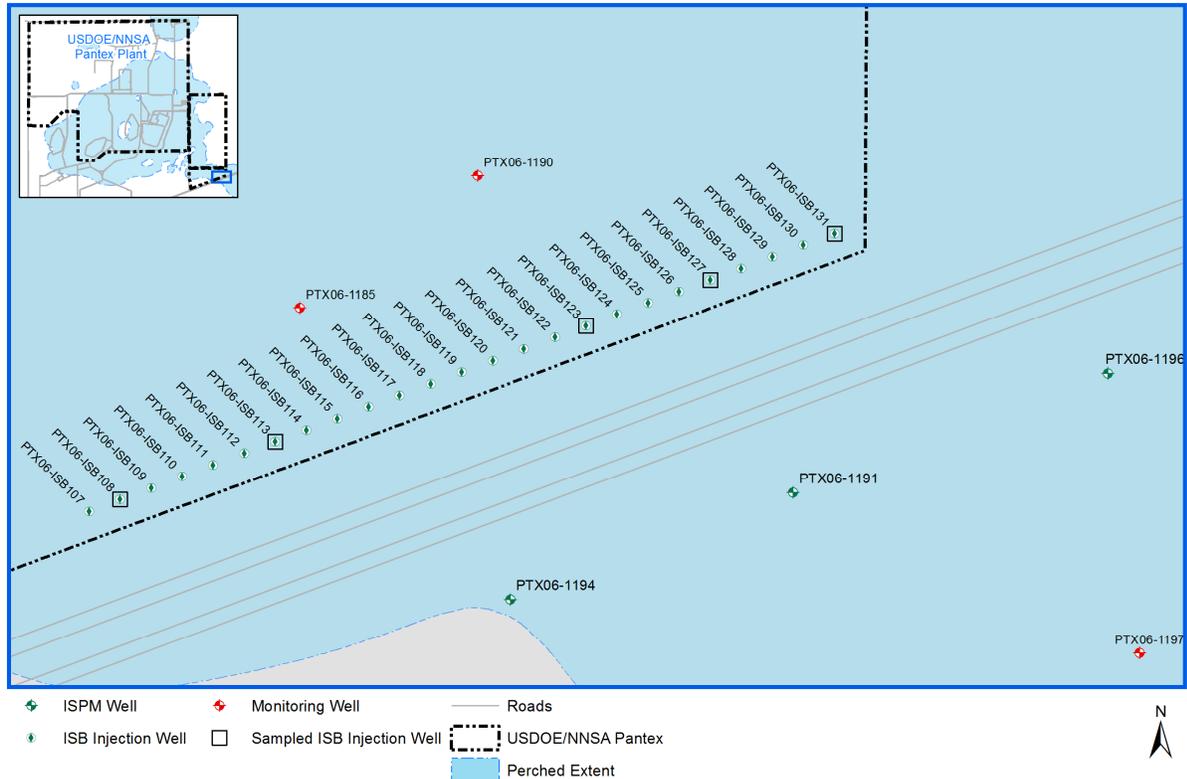
Pantex installed a new system in 2018 to address another area of contamination in the southeast perched groundwater. The new system is an extension of the original ISB remedy for the southeast perched groundwater plume as provided in the Pantex ROD. The system consists of 25 injection wells and 3 downgradient monitoring wells. A new line of wells along the Pantex southeast boundary east of FM 2373, including 24 new wells completed in 2017 and one monitoring well that was converted for use as an injection well, was positioned to treat the contaminants in the southeast plume moving to offsite landowner property. The system will address the continued migration of the high explosive plume, particularly RDX.

Based on the rate of perched groundwater flow and estimated amendment longevity, injections are estimated to be necessary every 6-9 months, based on the use of a more soluble amendment, molasses. Because Pantex was building the infrastructure for injection into early 2019, the system was not injected in 2018. Figure 1-10 depicts the Southeast ISB Extension.

**Figure 1-10. Southeast ISB Extension Treatment Zone and In Situ Performance Monitoring Wells**

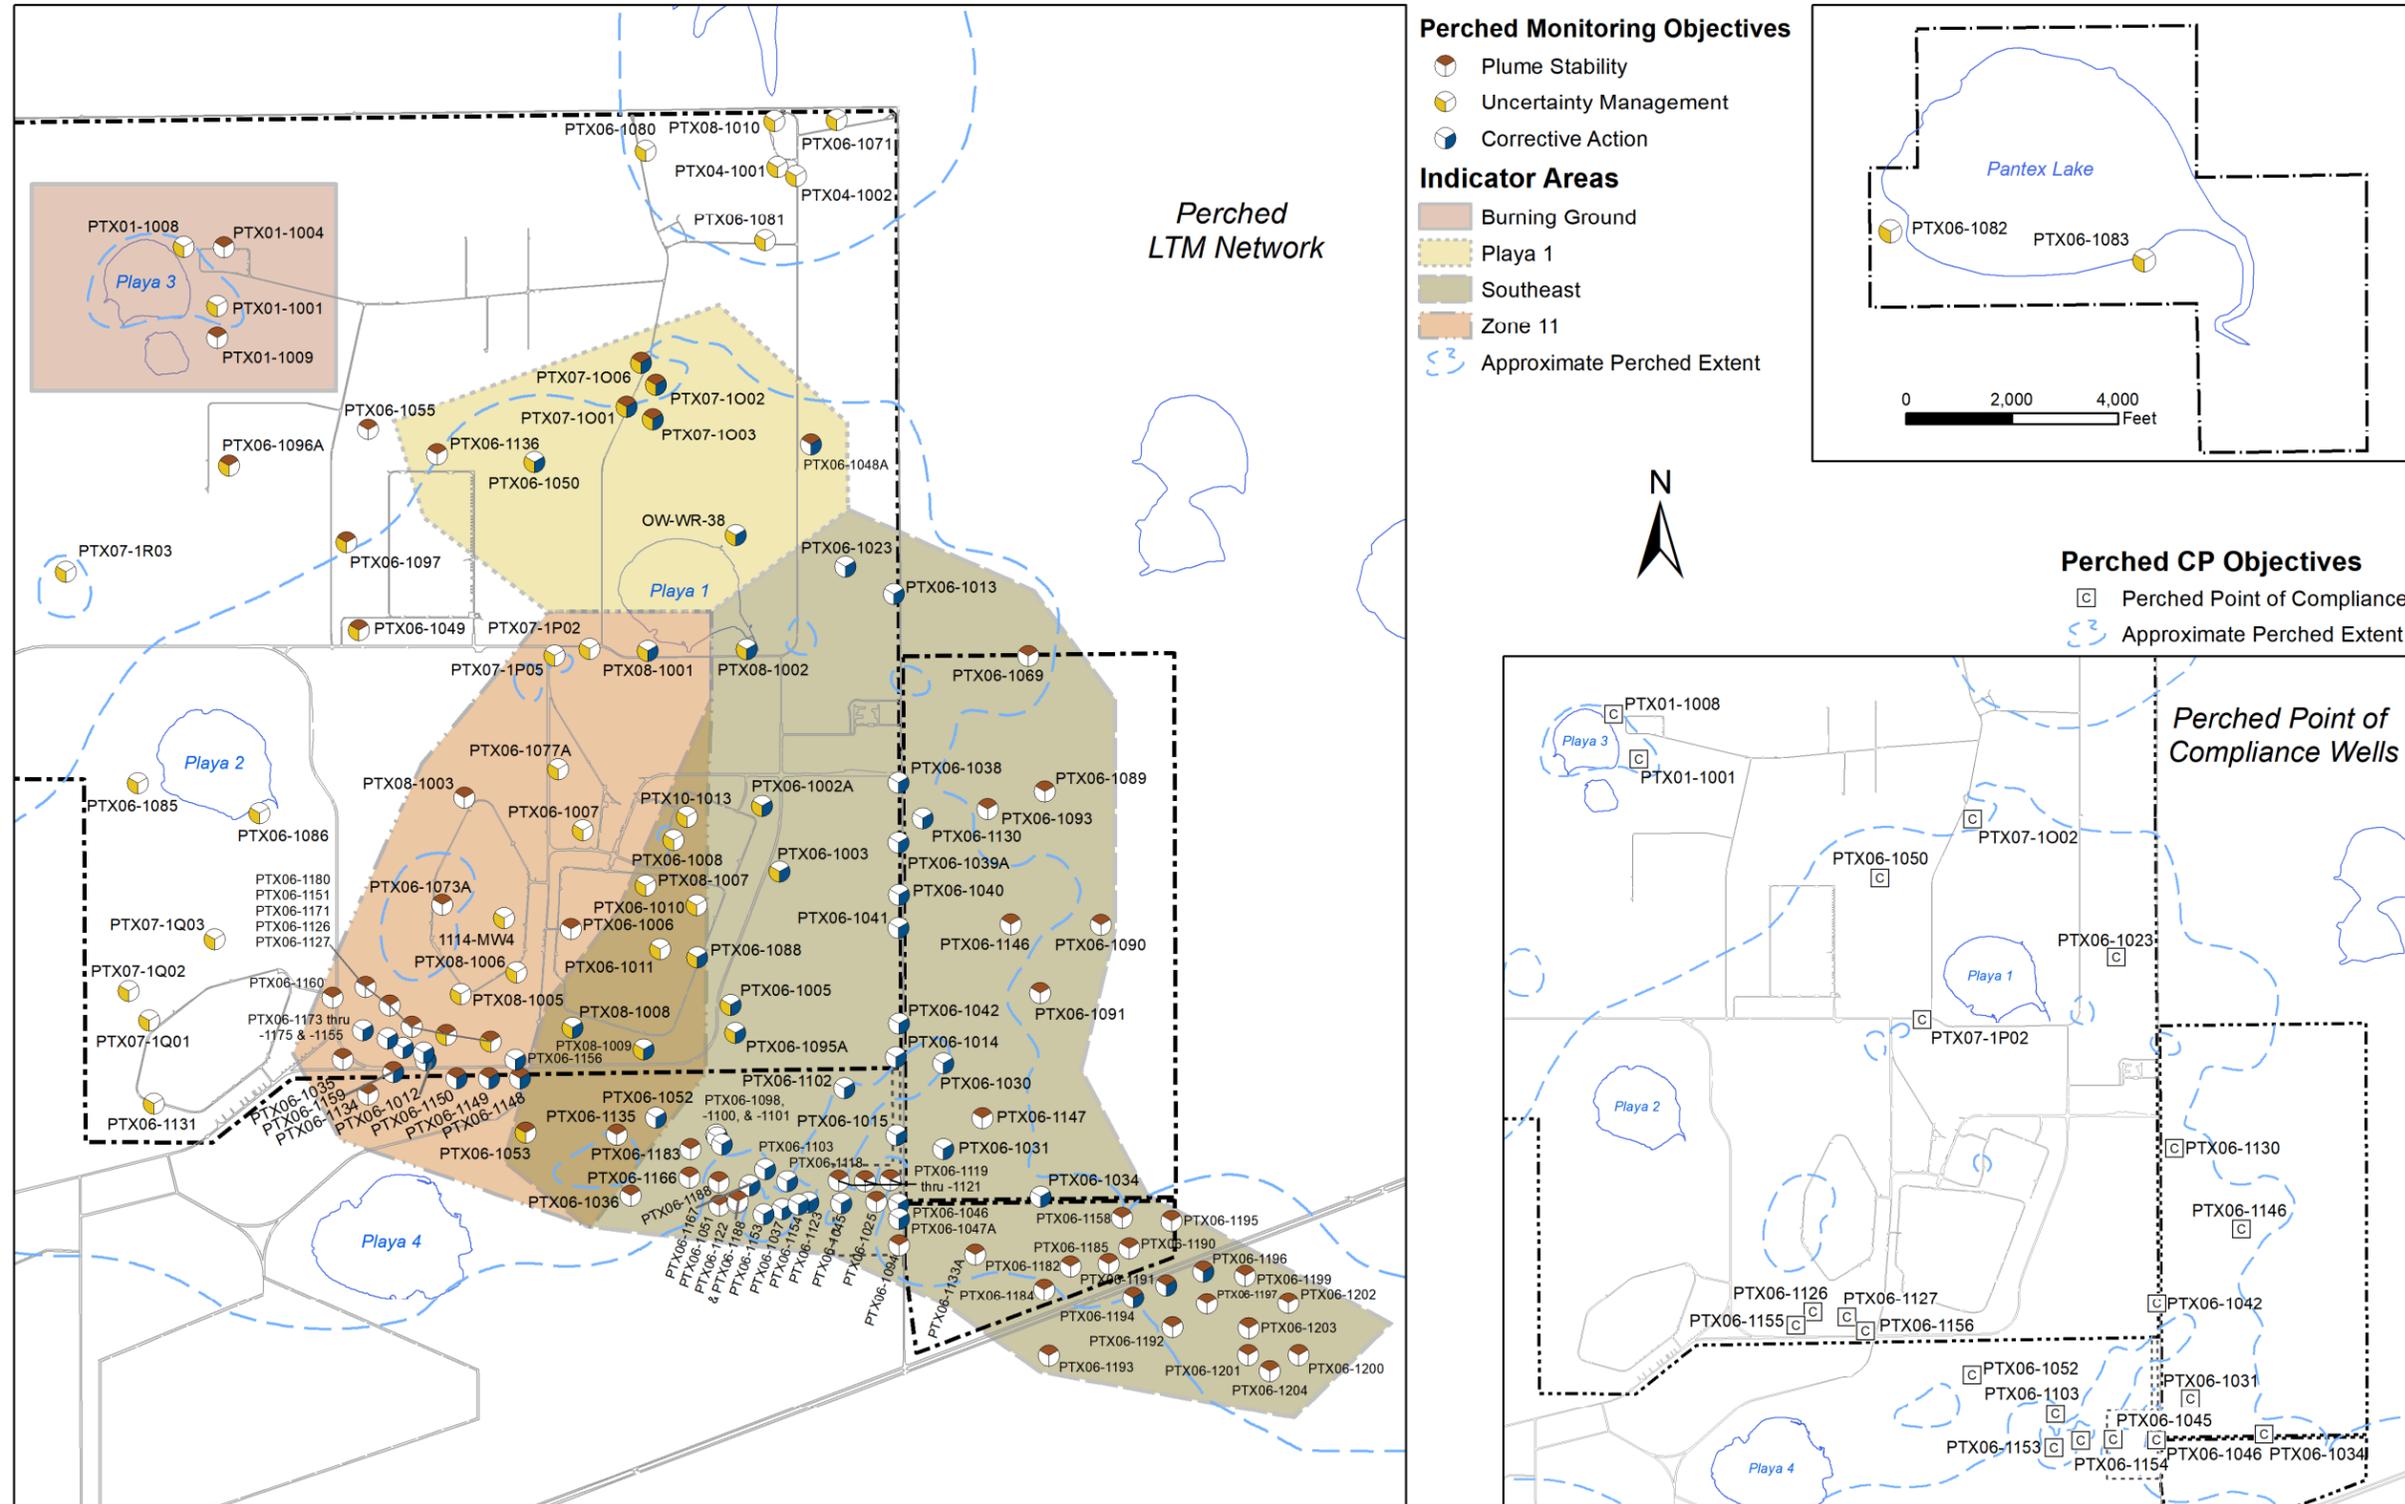
Table 1-5 lists all wells in the perched LTM network and HW-50284, their LTM objective, indicator monitoring area, Compliance Plan objective (point of compliance/point of exposure [POC/POE] well), date of inclusion or removal from HW-50284, and coordinates. The wells are listed in chronological order according to the date of inclusion in HW-50284, in accordance with HW-50284 CP Table VII requirements. Figure 1-11 depicts the current active LTM wells listed in Table 1-5.

Figure 1-11. Perched LTM Network and Compliance Plan Wells

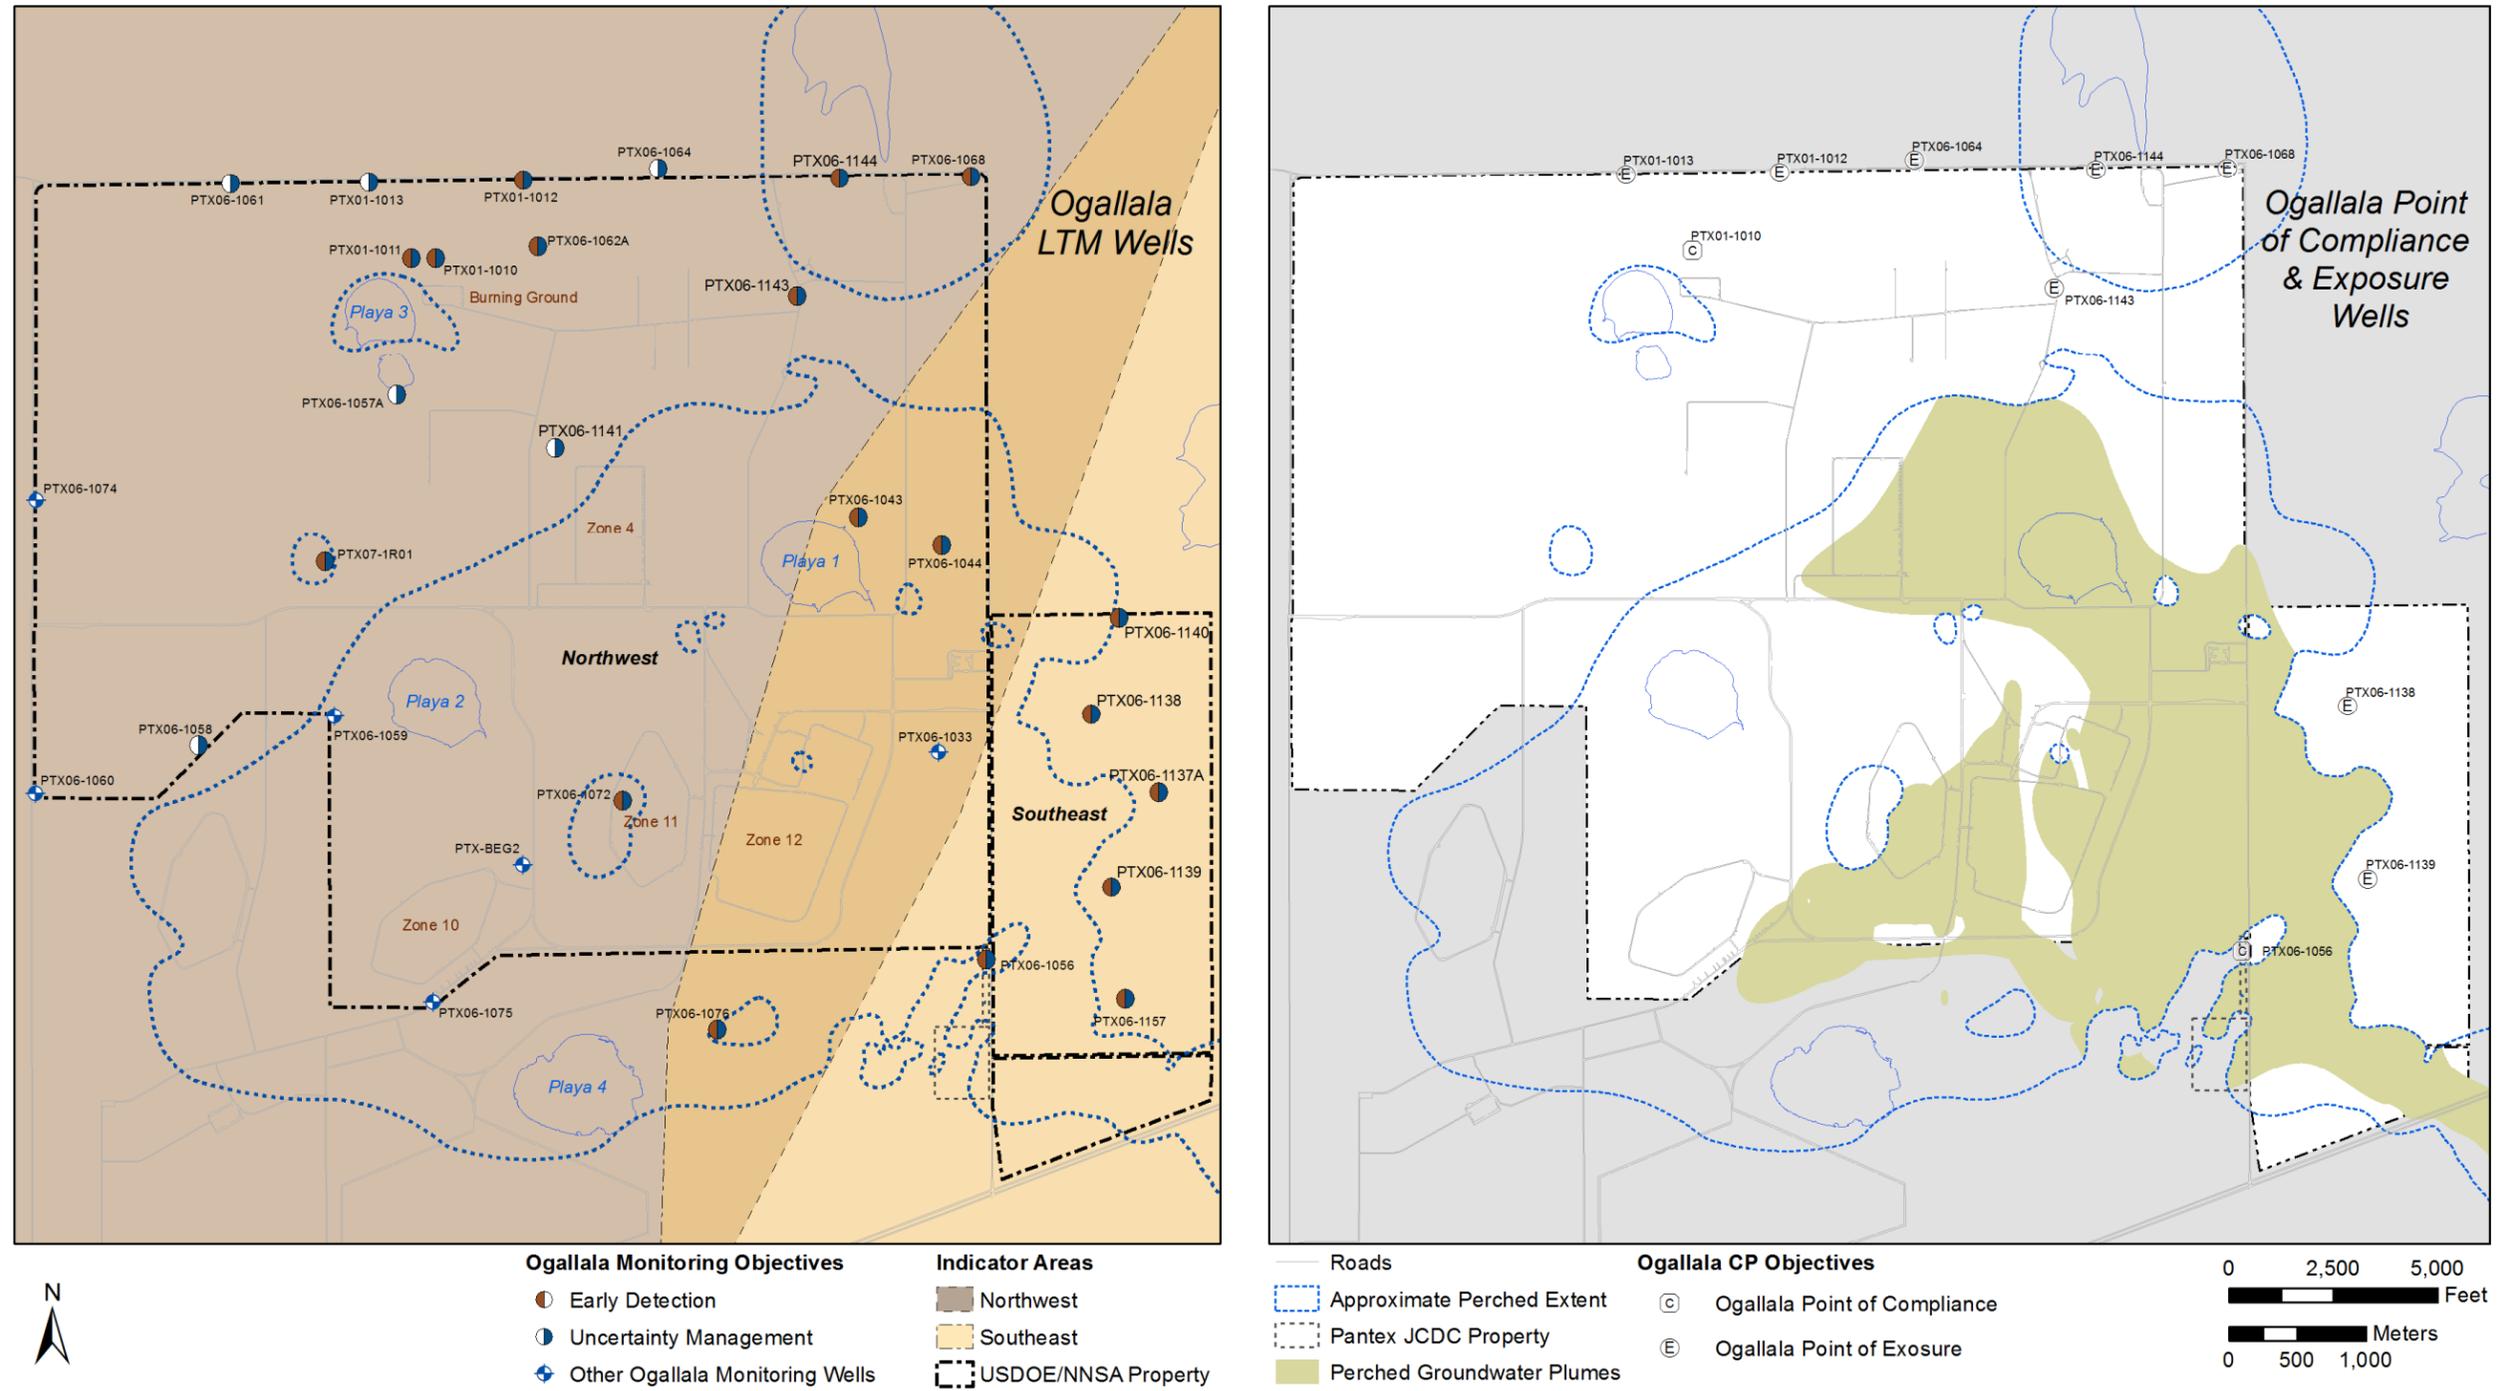
Table 1-6 lists all wells in the LTM network and HW-50284, with the corresponding LTM objective, indicator monitoring area, CP objective (POC/POE well), date of inclusion or removal from HW-50284, and coordinates. Figure 1-12 depicts the current active monitor wells listed in Table 1-6, as well as the additional four wells monitored along the southern and western boundaries. The wells are listed in chronological order according to the date of inclusion in HW-50284, in accordance with CP Table VII requirements.

Figure 1-12. Ogallala Aquifer LTM and Compliance Plan Wells
