# Pantex Plant

# 2018 Annual Progress Report

## Remedial Action Progress

In Support of Hazardous Waste Permit 50284 and  
Pantex Plant Interagency Agreement

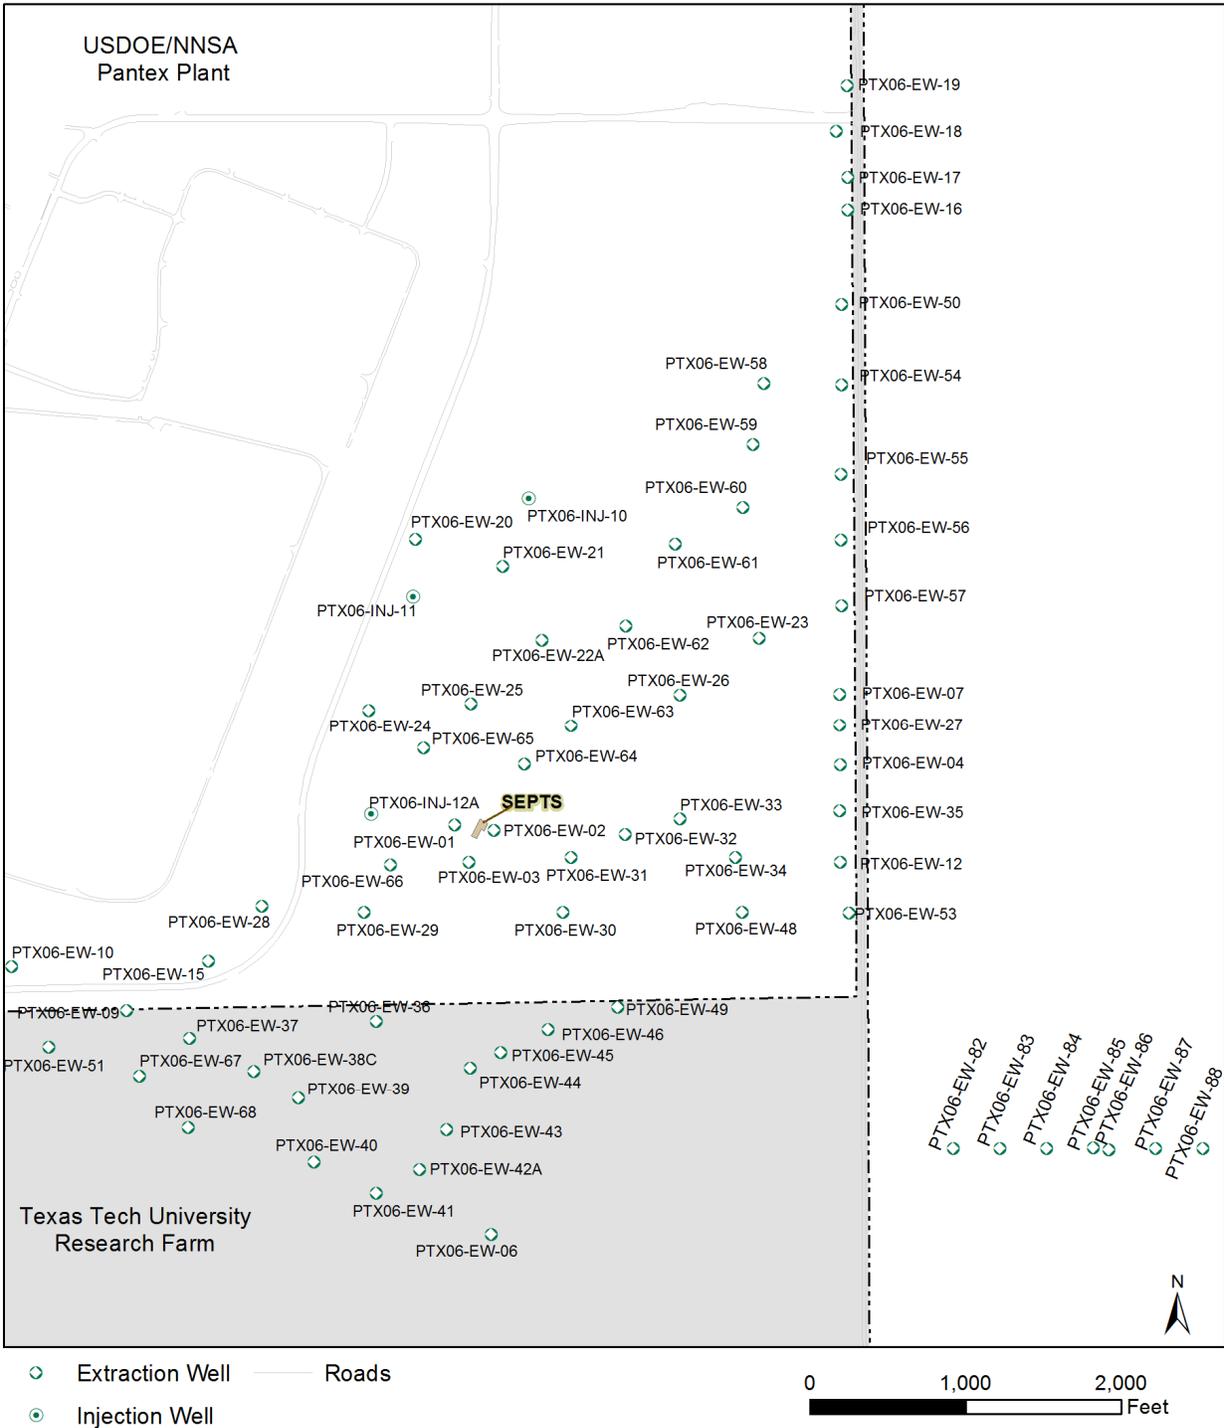
Figure 1-13. SEPTS Wells

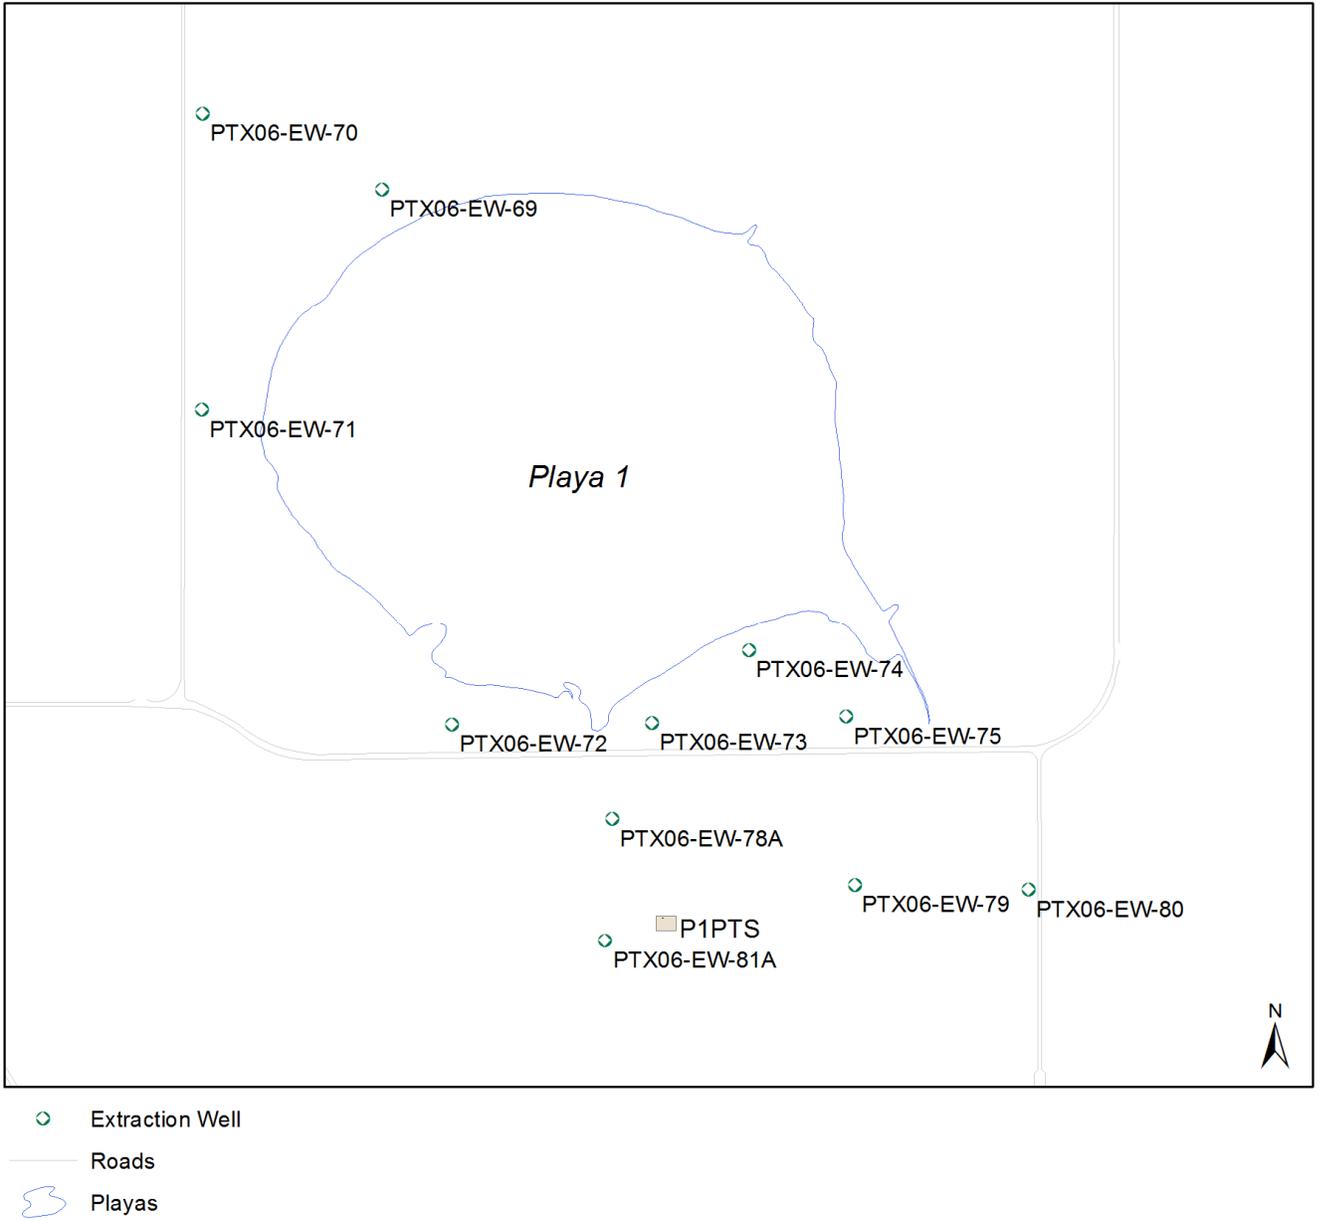
**Figure 1-14. P1PTS Wells**

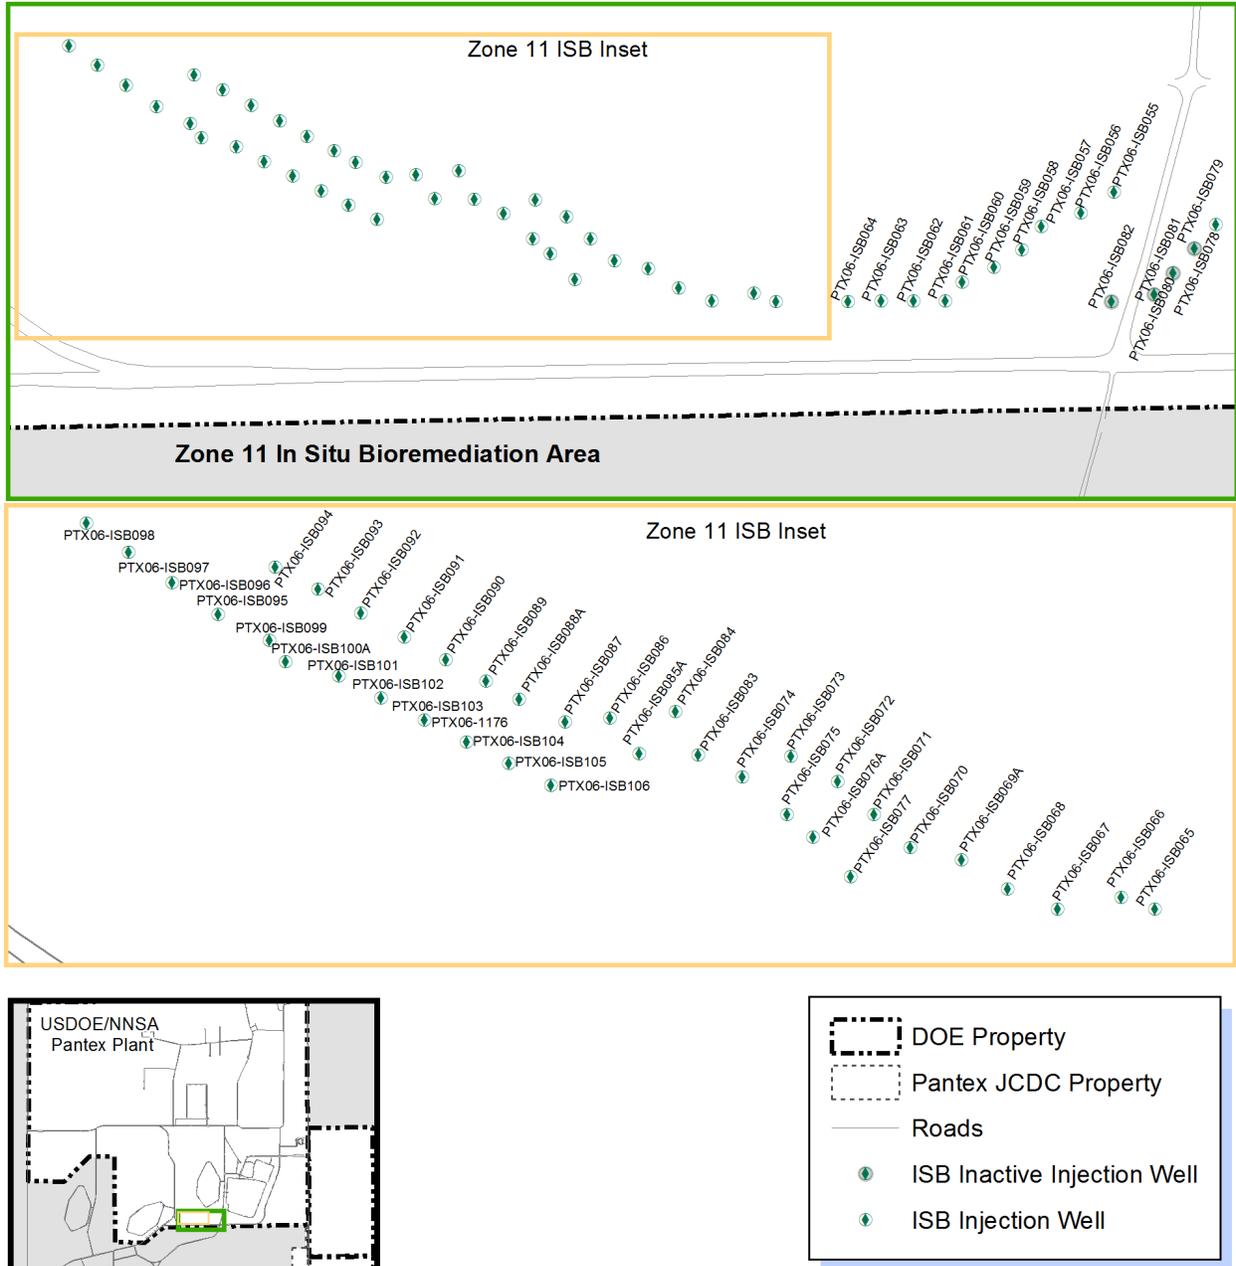
Figure 1-15. Zone 11 ISB System Wells

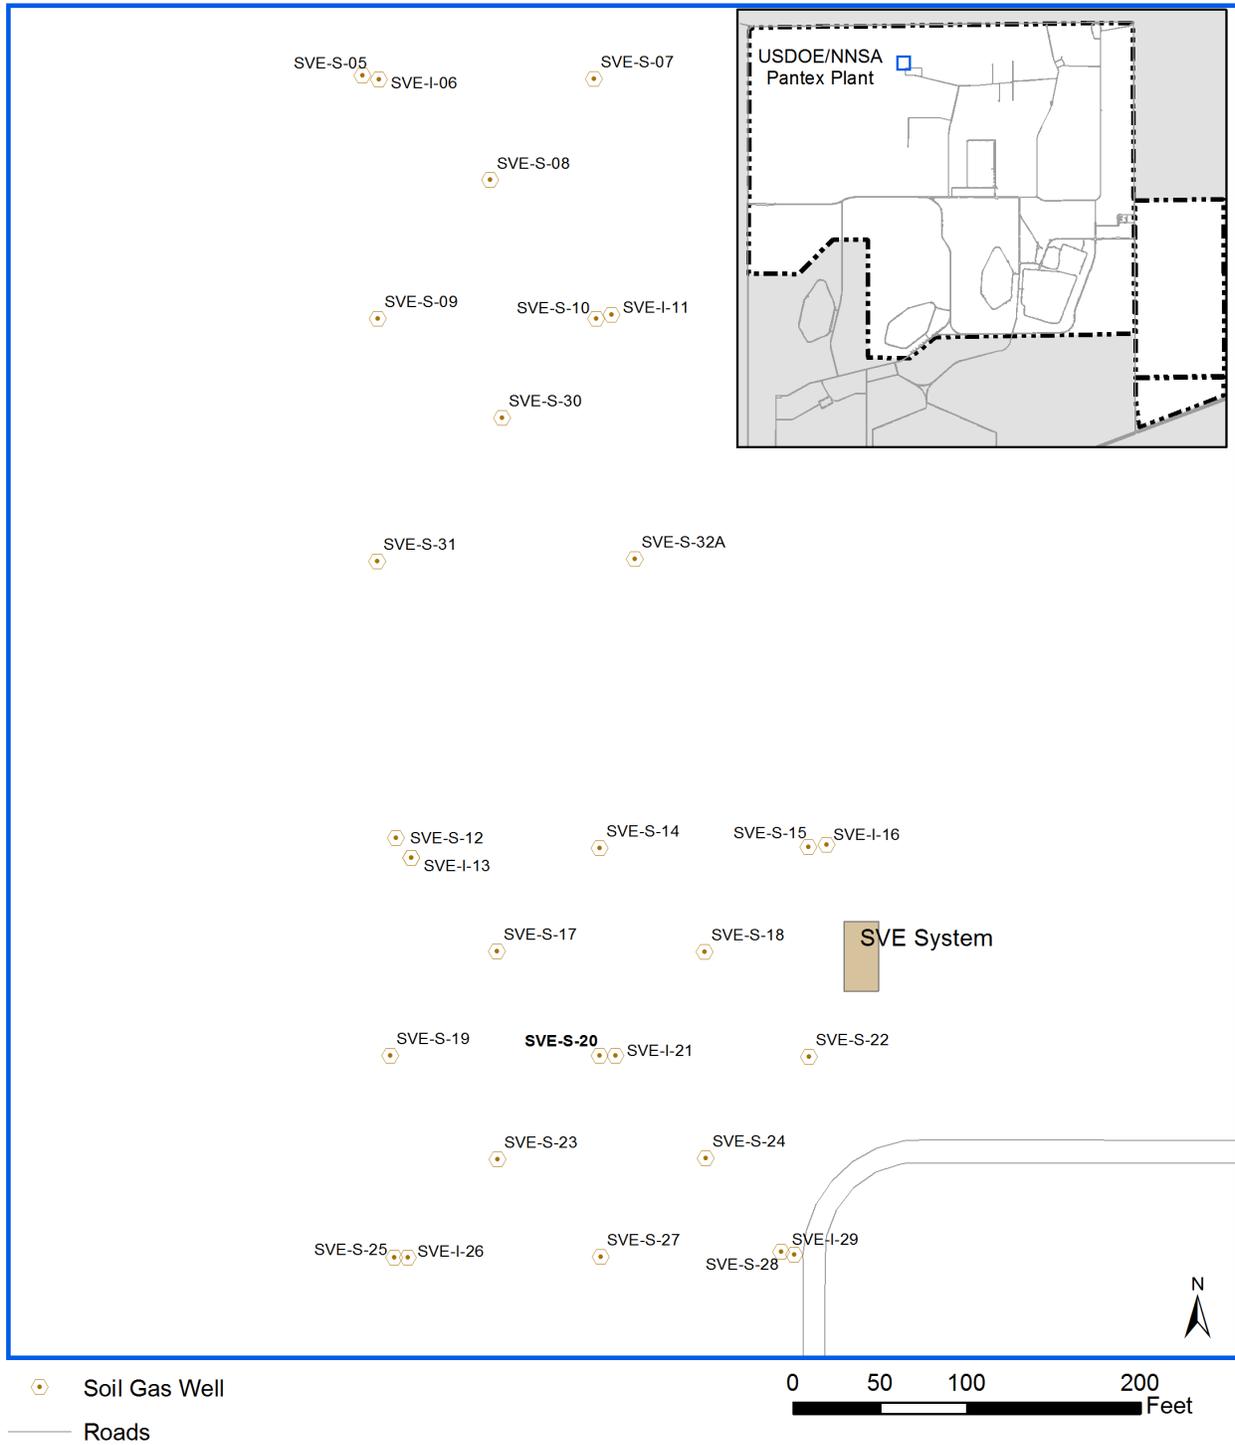
**Figure 1-17. Burning Ground SVE Wells**

This well list represents the final configuration for the full-scale SVE system. SVE pilot test wells that were not appropriate for use in the final system were not included in this list.

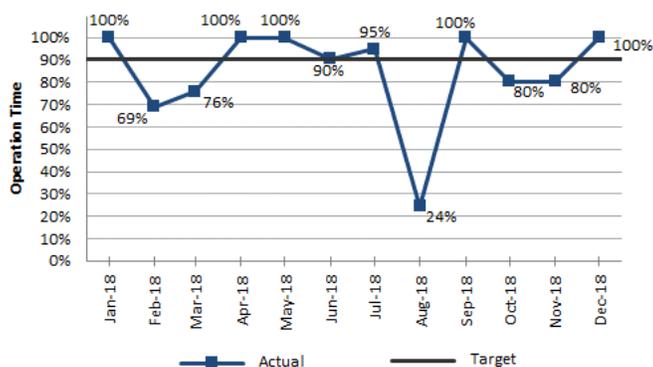
Figure 2-1. P1PTS Operation Time vs Target

The P1PTS operation was near the annual system operational goal by operating 216 days during 2018 with an average annual operational rate of 86%, based on total hours operated versus total possible operation time. The actual percentage monthly system operational time versus target is depicted in Figure 2-1.

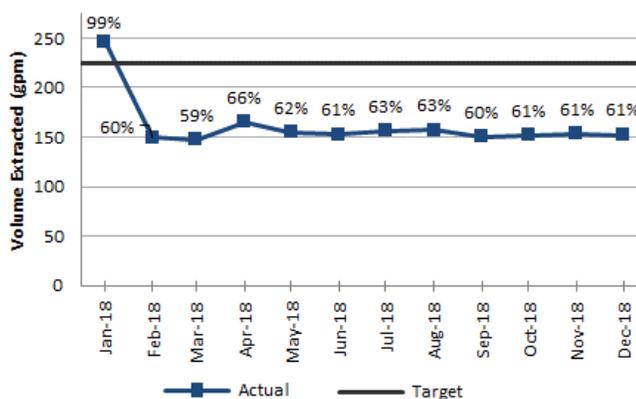
Figure 2-2. P1PTS Average GPM and % Capacity

Figure 2-2 depicts the average gpm extracted from all wells by month, the percentage of design capacity achieved, and goals for the system as a measure of well operation efficiency. While operational throughput of the system was reduced in 2018 to align with minimum flow requirements for the system, the 90% throughput goal is still depicted in the graphs and throughput is evaluated to identify potential issues with well operation.

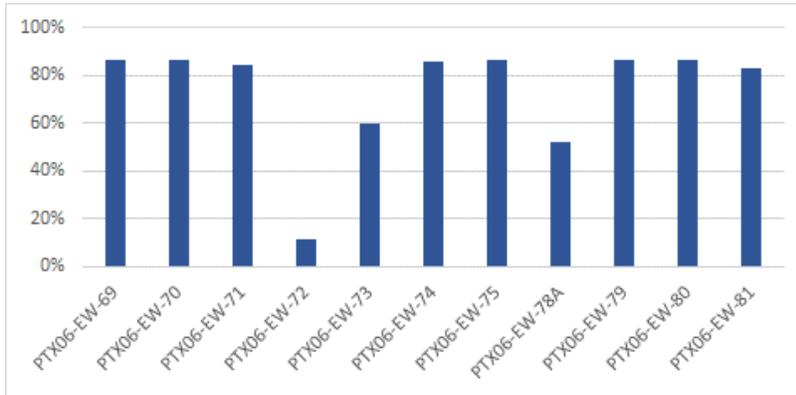
**Figure 2-3. P1PTS Well Operation Time**

Figure 2-3 reflects the operation time by well. The average annual well field operation was about 67%. The well operation was affected by reduced flows due to the irrigation break. Flow is limited by permit to Playa 1, so flows must be reduced at the systems. Several of the wells were shut down intermittently due to the reduced flows in 2018.

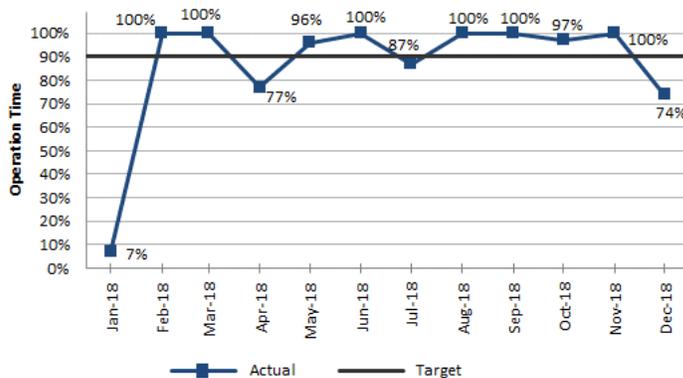
Figure 2-7. SEPTS Operation Time vs Target

possible operation time. The percent operation time (hours/day) versus target is depicted in Figure 2-7. The system operation was affected by shutdown for electrical lines to be installed during January, a scheduled power outage and carbon change in April and communication issues and carbon change in December. Operation continues, but primarily at lower flow rates due to a combination of permit limits on the discharge rate to Playa 1 and the need to minimize injection into the perched aquifer.

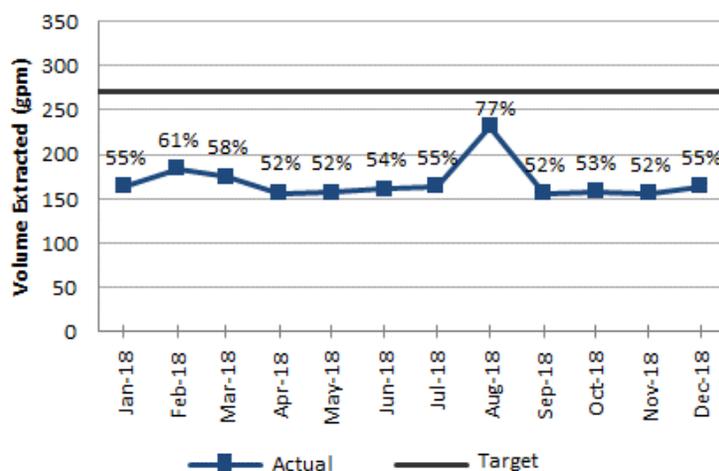
**Figure 2-8. SEPTS Average GPM and % Capacity**

Figure 2-8 depicts the average gpm extracted from all wells by month, the percentage of design capacity achieved, and goals for the system as a measure of well operation efficiency. The operational rate of the system was the prioritized goal after June 2014 unless flow is affected by the WWTF or other issues. Even though the 90% throughput goal was not applicable during 2018, is still depicted in the graphs and well throughput is evaluated to identify potential issues.

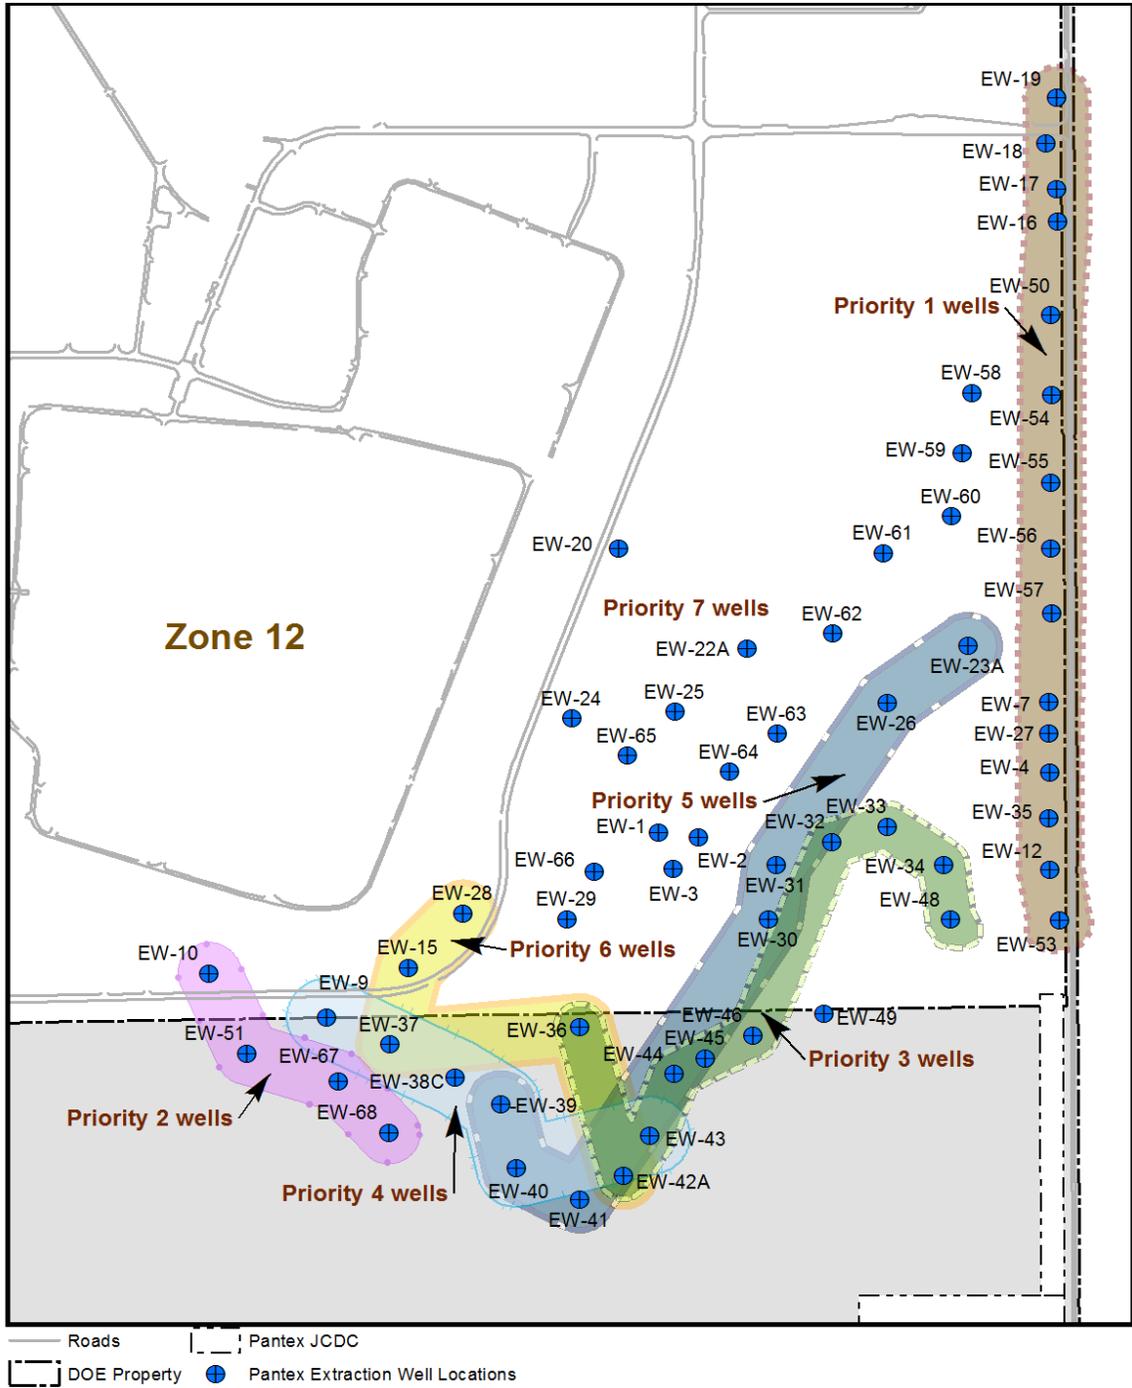
**Figure 2-9. Extraction Well Prioritization**

Although perched groundwater levels are declining, the extractions rates from the well field currently exceed the capacity of the treatment system. Pantex extracts from the well field according to set priorities that best meet long-term objectives. The well extraction priorities for operating wells are depicted in Figure 2-9. Seven priorities were set:

- **Priority 4 Wells:** Wells along the northern edge of the hexavalent chromium plume from the Zone 12 South area.
- **Priority 5 Wells:** Wells close to the highest concentrations of RDX. These wells will continue to capture movement of the RDX plume when the priority 3 wells are not pumping.

- **Priority 6 Wells:** Wells that capture the center of the hexavalent chromium plume from the former cooling tower on the eastern side of Zone 12.
- **Priority 7 Wells:** All other wells in the SEPTS. With the exception of EW-49, these wells will help with reducing saturated thickness in the perched aquifer and removing head that pushes the groundwater horizontally and vertically, but will not be as effective at controlling plume movement. EW-49 is in a low-transmissive zone so is a very low-producing well. For this reason, it was not placed in a high priority for pumping.

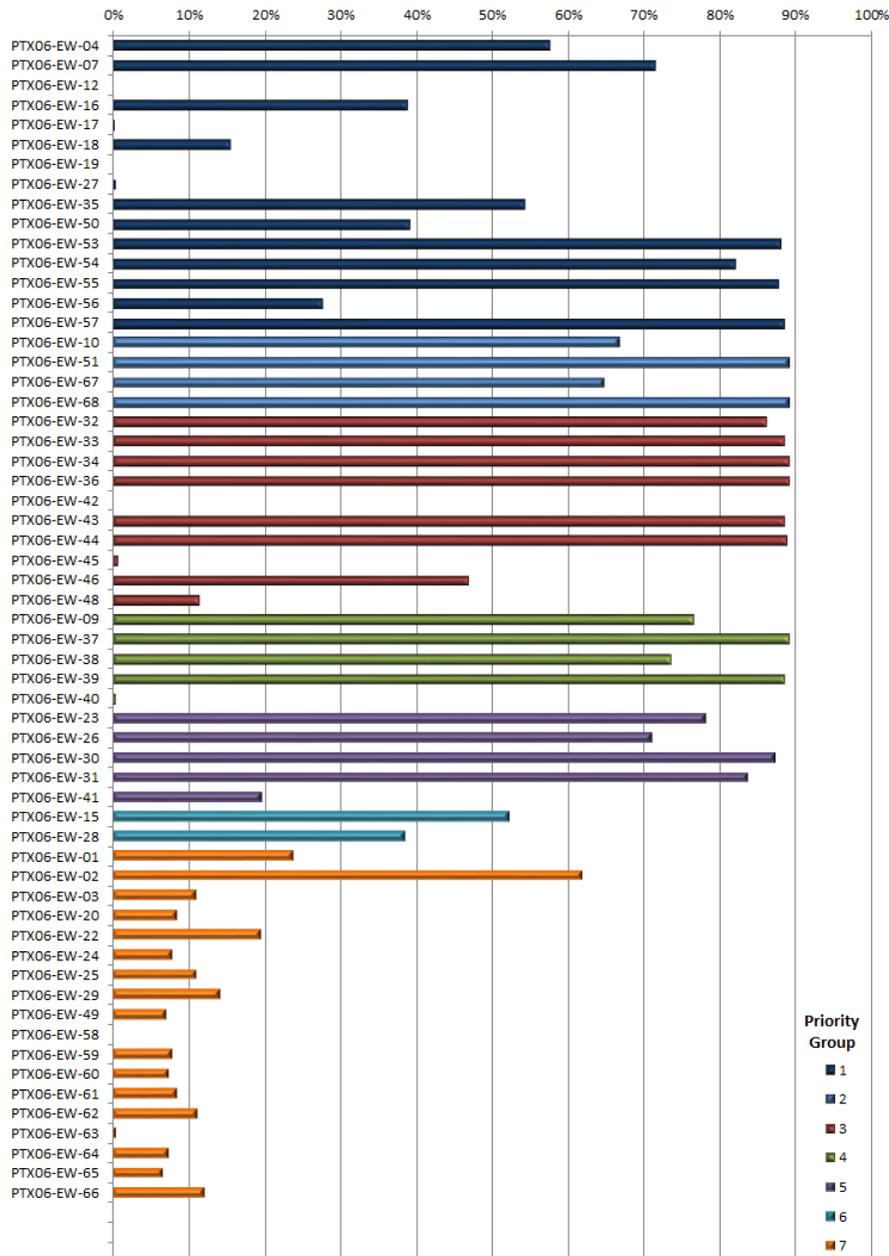
Figure 2-10. 2018 SEPTS Well % Operation

This prioritization was implemented in 2009 after the newly installed extraction wells were placed into operation. Figure 2-10 provides the percentage of days wells were operated in the SEPTS. Priority 1-5 wells are operated at a higher frequency with the exception of a few wells that had repair issues or were locked out due to repair issues with wells on the same line. Priority 6 and 7 extraction wells were operated periodically to ensure that wells remain operational or to make up flow. Some of the high priority wells are in areas that have rapidly declining water levels and/or are in low-yield portions of the formation so

pumps are cycling on and off causing the well to be operated intermittently. This effect is becoming more prominent in many of the wells in thin saturated portions of the perched aquifer as the system continues to remove water from the perched aquifer. Wells along the northern fence line are frequently cycling off due to the limited saturation in that area. PTX06-EW-21 and PTX06-EW-06 have gone dry. The prioritization of the well pumping is expected to change based on results of optimization or be discontinued in the future as the capacity of the pump and treat system will exceed extraction rates.

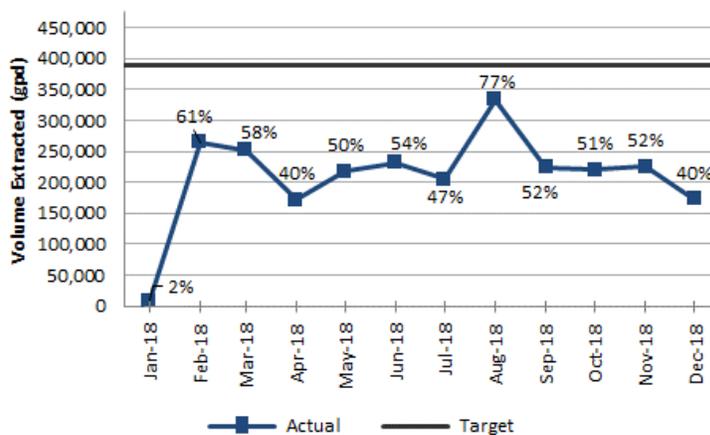
**Figure 2-11. SEPTS Average GPD and % Capacity**

Figure 2-11 reflects the overall system efficiency considering system and well operation. The figure depicts the average daily treatment rate (gpd) by month, target, and percentage of total capacity achieved at the SEPTS. The SEPTS treated an annual average of about 210,630 gpd (about 53% of design capacity) for 2018 based on total possible hours of operation and total inflow from the well field.

The gpd is affected by system operational time, ability to extract water from the wells, and reduced flow to the WWTF and irrigation system. As discussed above, the system was primarily affected by loss of throughput to the WWTF/irrigation system after the break at the irrigation filter bank. Operational time was affected by carbon change-out, electrical line installation, and communication issues.

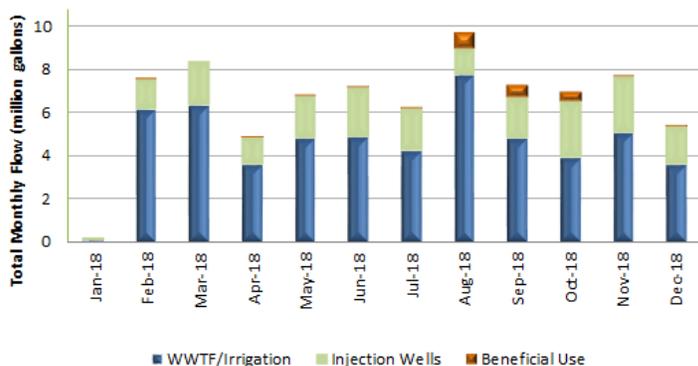
**Figure 2-12. SEPTS Total Flow Volume and Disposition of Effluent**

The system treated over 76 million gallons of extracted water during 2018. The total volume treated by month and the final disposition of the treated water is depicted in Figure 2-12. About 27% of the treated water was injected into the perched aquifer, 2.3% was used beneficially for injection, and

the remaining released to Playa 1 via the WWTF. With the implementation of the revised operational goals, Pantex expects to continue minimizing injection and reducing saturated thickness.

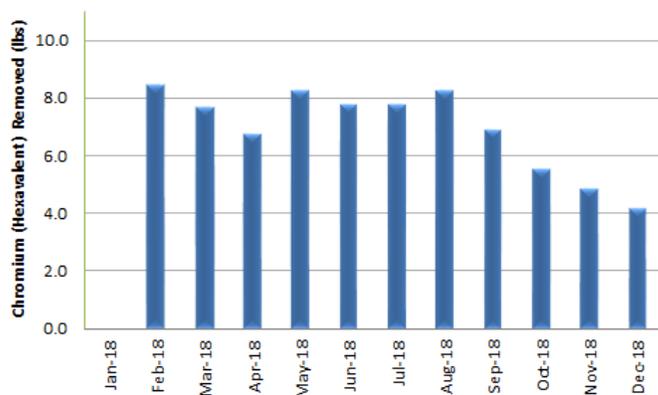
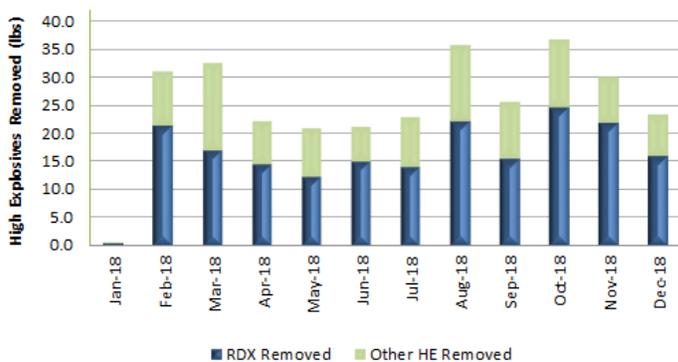
**Figure 2-13. SEPTS Chromium Mass Removed by Month**

**Figure 2-14. SEPTS High Explosive Mass Removed by Month**

The SEPTS primarily removes RDX and hexavalent chromium from the perched groundwater. The system removed about 77 lbs of hexavalent chromium, 195 lbs of RDX, and 107 lbs of all other HEs during 2018. The total mass removed by month is depicted in Figure 2-13 and Figure 2-14. The average removal rate of hexavalent chromium was 1.0 lbs/million gallons (Mgal) of water, and the average removal rate for HEs was 3.9 lbs/Mgal of water. Hexavalent chromium mass removal is declining because concentrations in PTX06-EW-51 and nearby extraction wells continue to decline. This well was located in the heart of the hexavalent chromium plume south of Zone 12 and contributed heavily to the hexavalent chromium influent concentrations at the SEPTS.

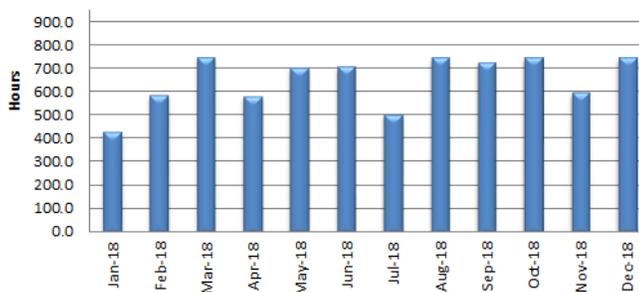
**Figure 2-16. SVE System Operation**

Figure 2-16 depicts the SVE system operation for 2018. The system was consistently operated with shutdowns for maintenance, repairs, extreme temperatures, and power outages. Overall, the system operated about 90% of the year.

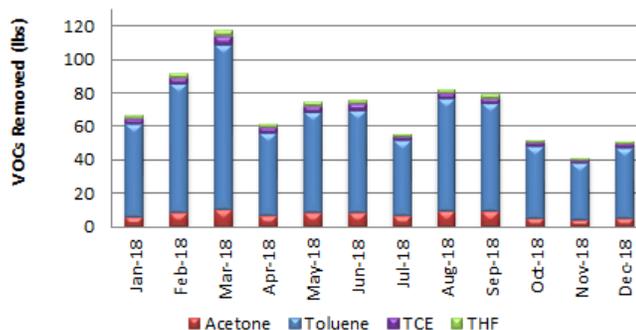
**Figure 2-17. Burning Ground SVE Mass Removal**

Calculated mass removal for 2017 is presented in Figure 2-17. Mass removal was estimated based on concentrations reported from analytical sampling, system operation time, and system flow rates. VOC constituents contributing more than 2% of the total VOC concentration were included in the calculation.

Since modifications were completed at the system in May 2017, the influent flow rate was increased from 32 scfm to about 44 scfm before the end of 2017. The 44 scfm flow rate was maintained consistently in 2018. Flow rates increased by 13% to 24% from 1st quarter 2017 baseline, causing a rise in mass removal as well. However, data collected during 2018 indicate that although flow rate remained steady, mass removal rates declined due to lower influent concentrations.

The system removed about 847 lbs of VOCs during 2018. Since inception, the SVE system has removed over 20,500 lbs of VOCs. Trends of removal rates, concentrations and general effectiveness of the SVE are provided in Section 4.

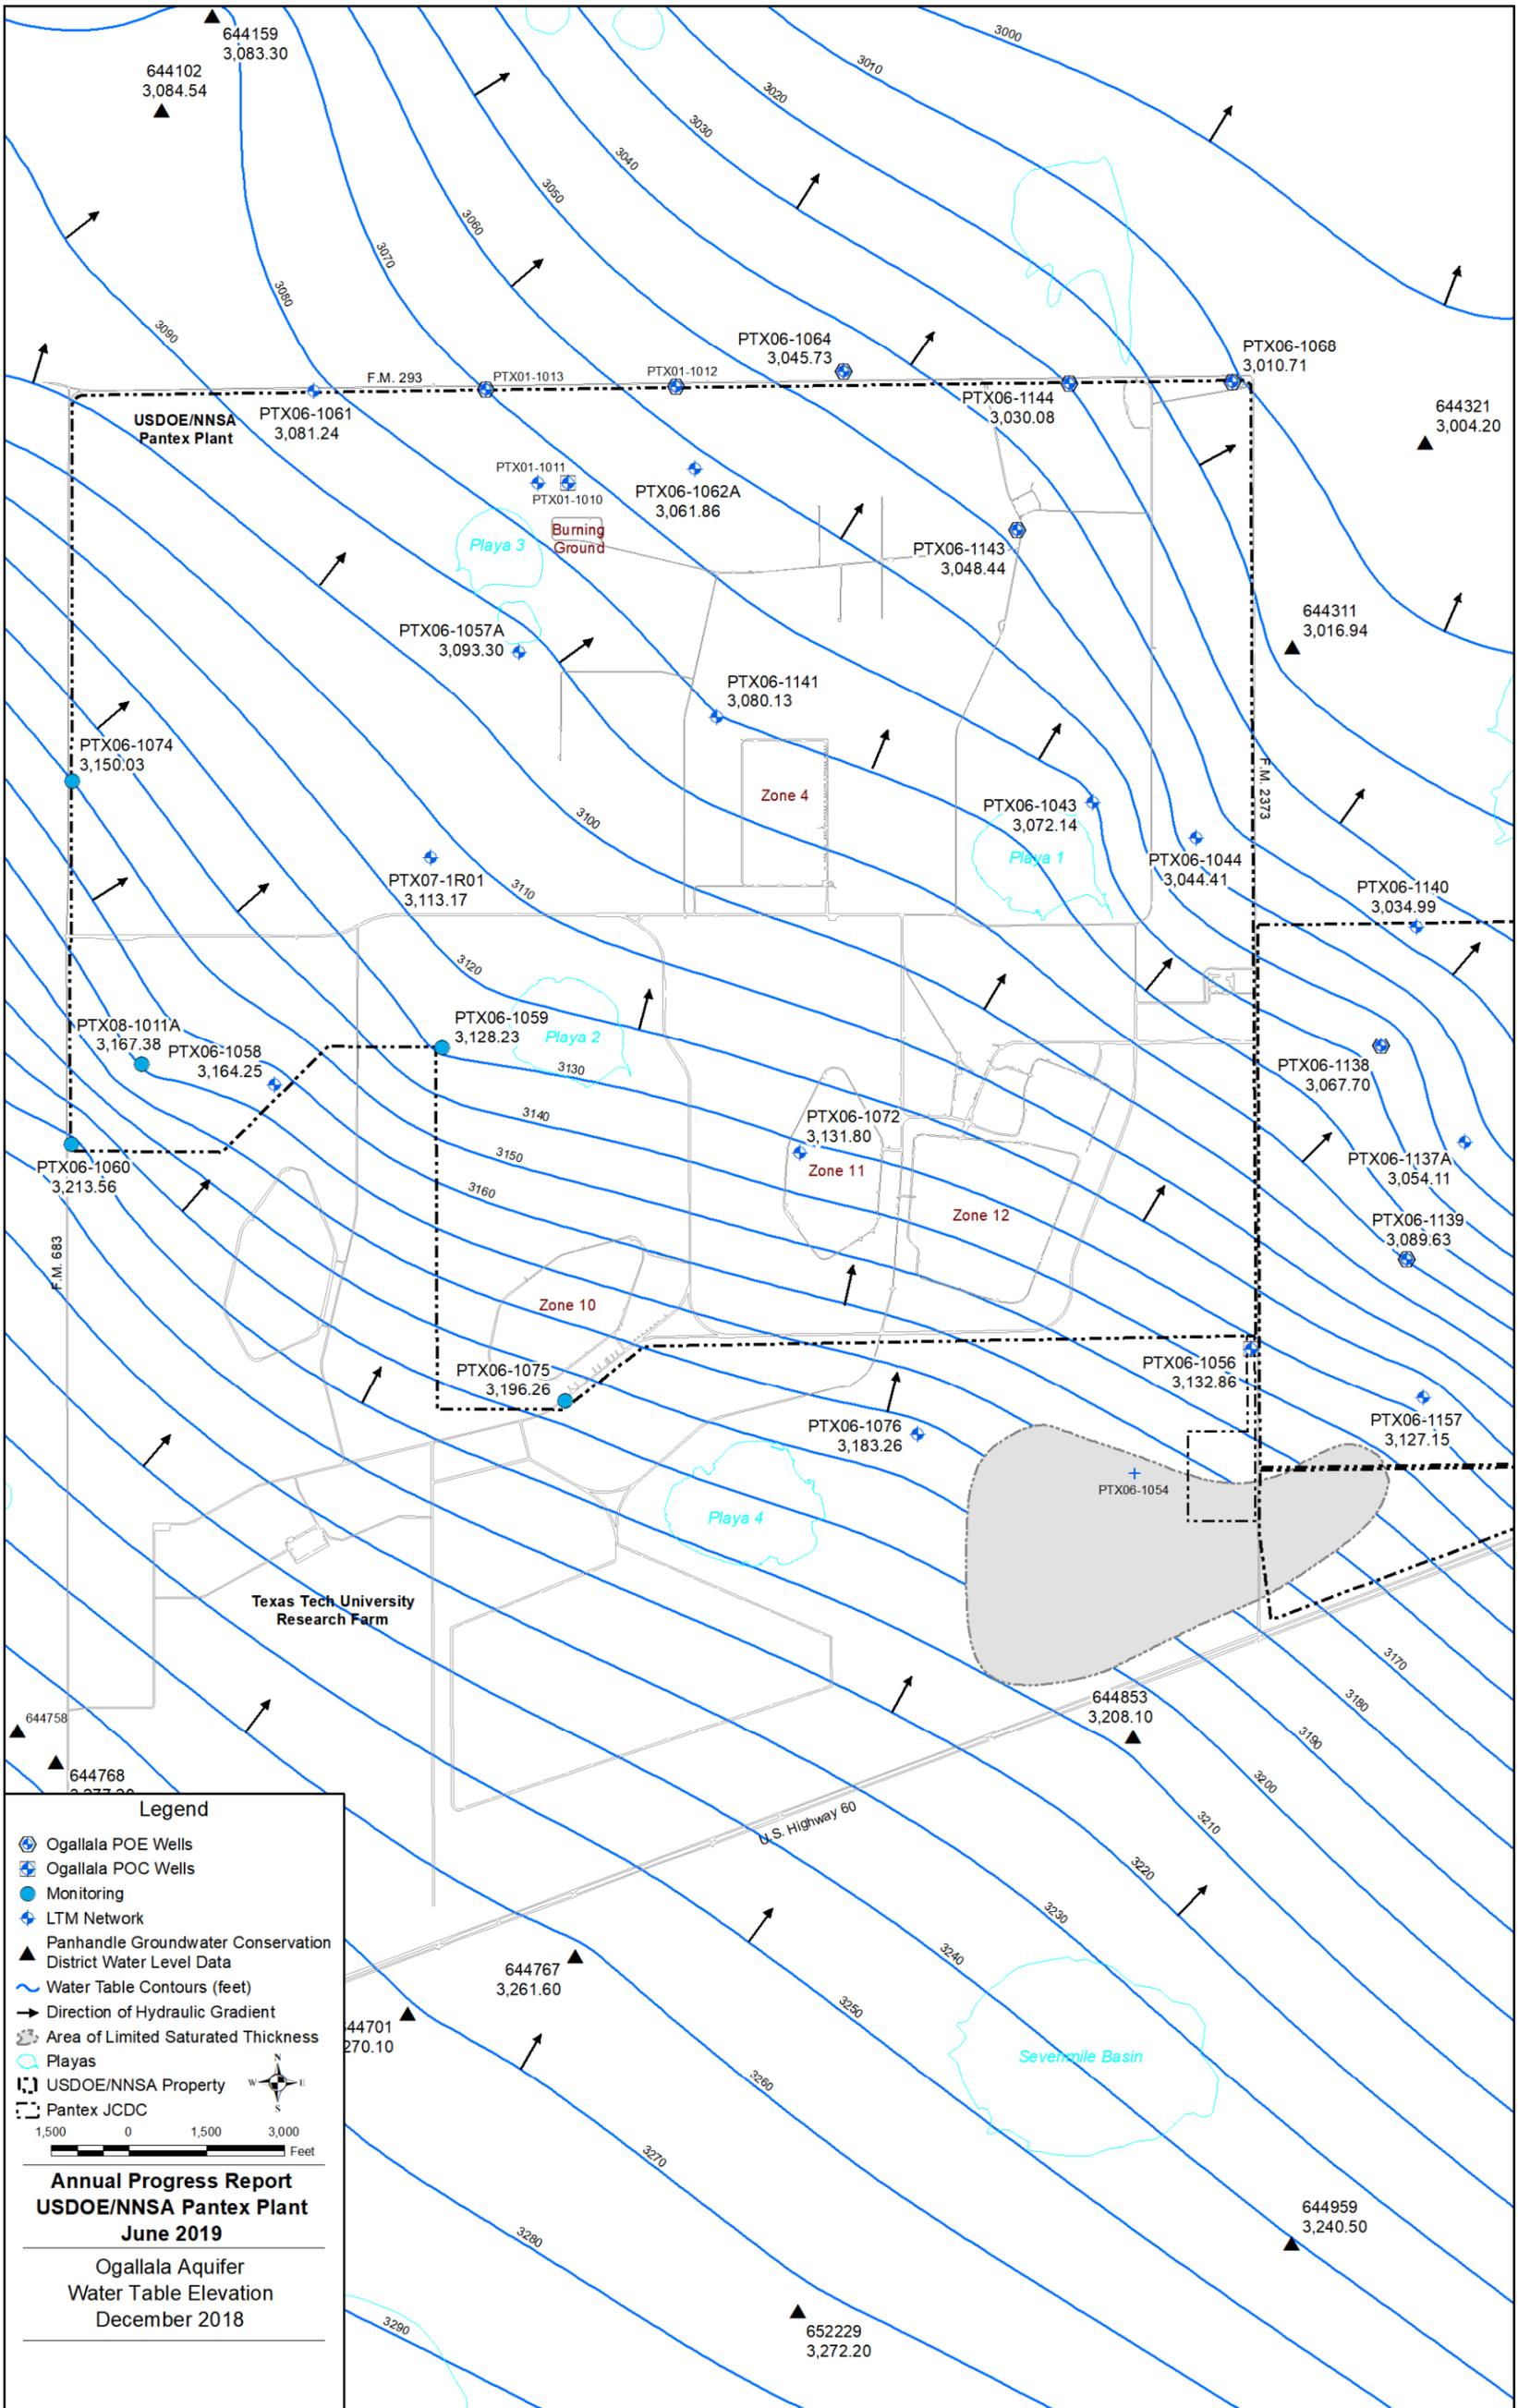
Figure 3-1. Ogallala Aquifer Water Levels

As shown in Figure 3-1, flow in the Ogallala Aquifer underlying Pantex Plant is to the northeast. The northeast hydraulic gradient results from agricultural pumping as well as from the City of Amarillo well field to the north and from the Pantex water supply wells in the northeastern part of the USDOE/NNSA property. The Amarillo well field produces approximately 12.7 million gallons per day from the Ogallala Aquifer, based on 2018 City of Amarillo data. The hydraulic gradient in the Ogallala Aquifer underlying the northern part of Pantex Plant is approximately 0.006 ft/ft.

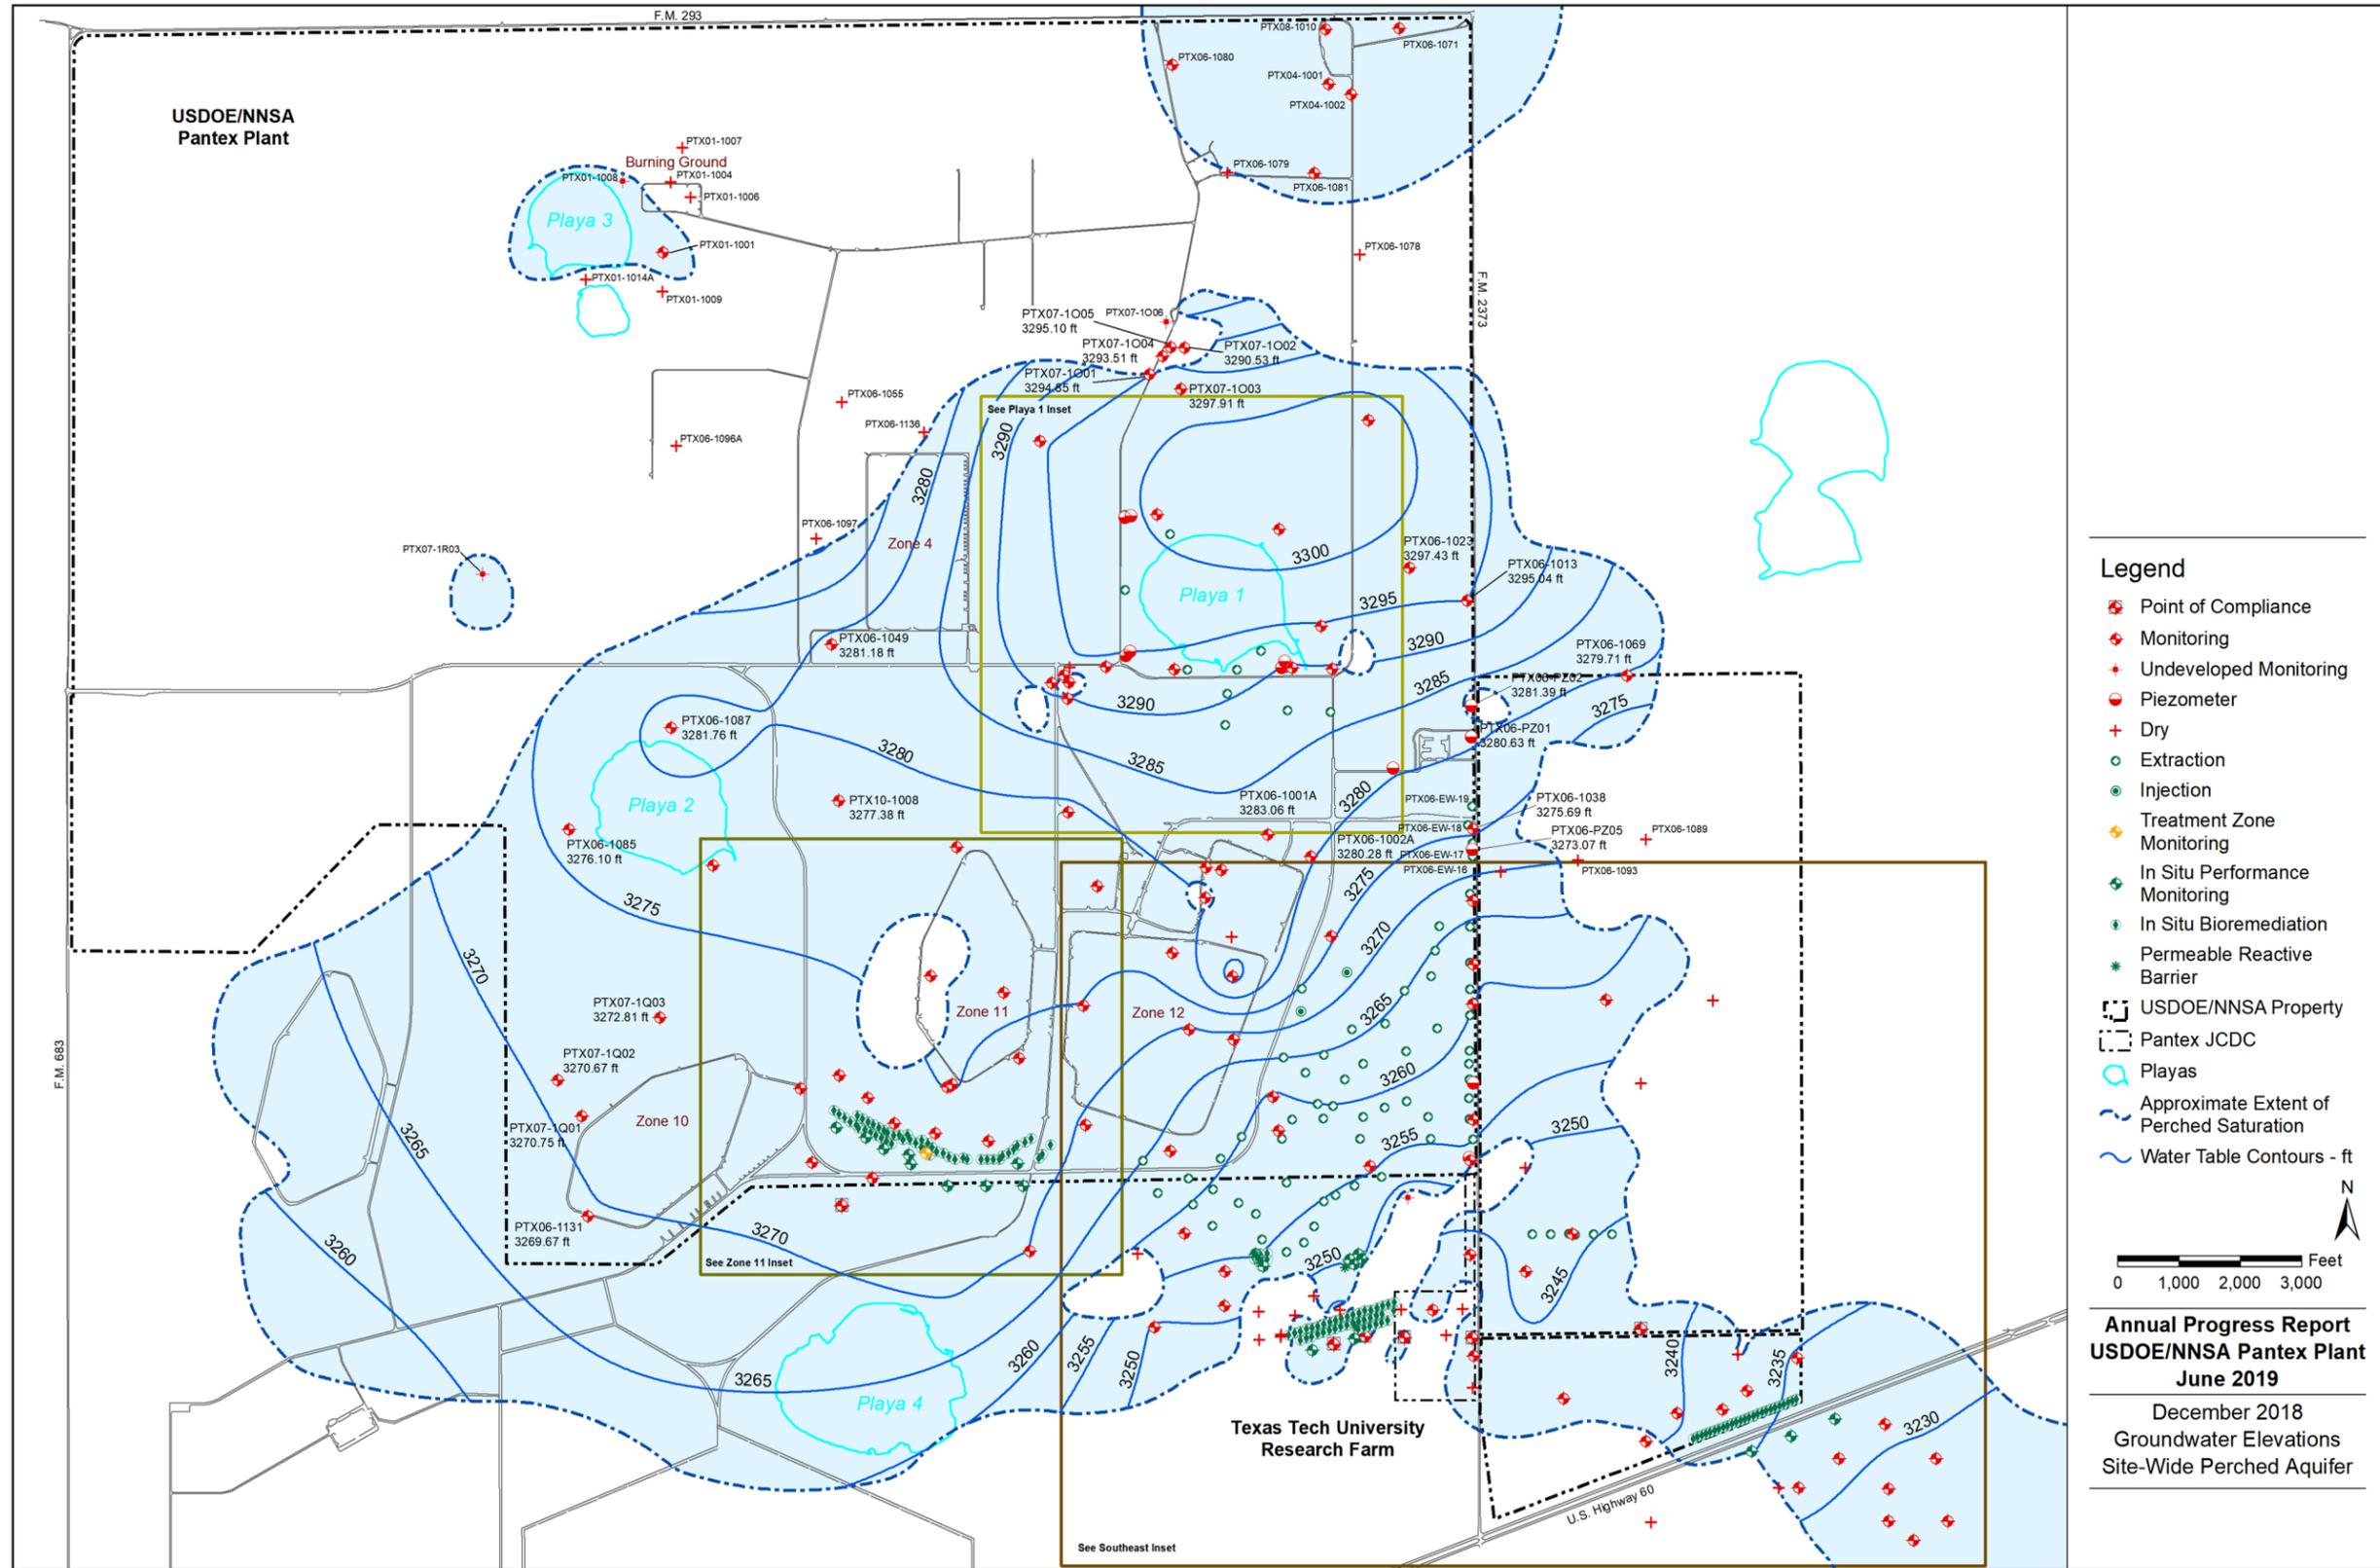
Figure 3-2. Perched Aquifer Water Levels

As shown in Figure 3-2, Figure 3-3 and Figure 3-4, perched groundwater occurs as a number of separate flow systems beneath Pantex Plant. Each of these flow systems is associated with an area of focused recharge, usually a playa lake. The main perched aquifer is associated with natural recharge from Playas 1, 2, and 4, past treated wastewater discharge to Playa 1, and historical wastewater releases to the ditches draining Zones 11 and 12. Small areas of perched groundwater occur in the vicinity of Playa 3, the Old Sewage Treatment Plant (OSTP) area, and Zone 6. Because of the limited extent and saturated thickness of these separate areas, water table contours for these areas are omitted from the perched aquifer contour map. The extents of saturation for the main perched aquifer and perched groundwater beneath the OSTP area show that these two bodies of groundwater are separated by only a short distance. However, observed water levels in both areas indicate that hydraulic interaction between these two areas is limited, even if the extents of saturation overlap. Perched groundwater has also been observed beneath the southern side of Pantex Lake, located about 2.5 miles northeast of the

The horizontal hydraulic gradient of the perched aquifer varies spatially across the Plant. The hydraulic gradient is 0.005 ft/ft near Playa 1, 0.002 ft/ft near Playa 2, 0.004 ft/ft downgradient of Zone 12, and 0.001 ft/ft south of Zone 11.
