# Pantex Plant

# 2018 Annual Progress Report

## Remedial Action Progress

In Support of Hazardous Waste Permit 50284 and  
Pantex Plant Interagency Agreement

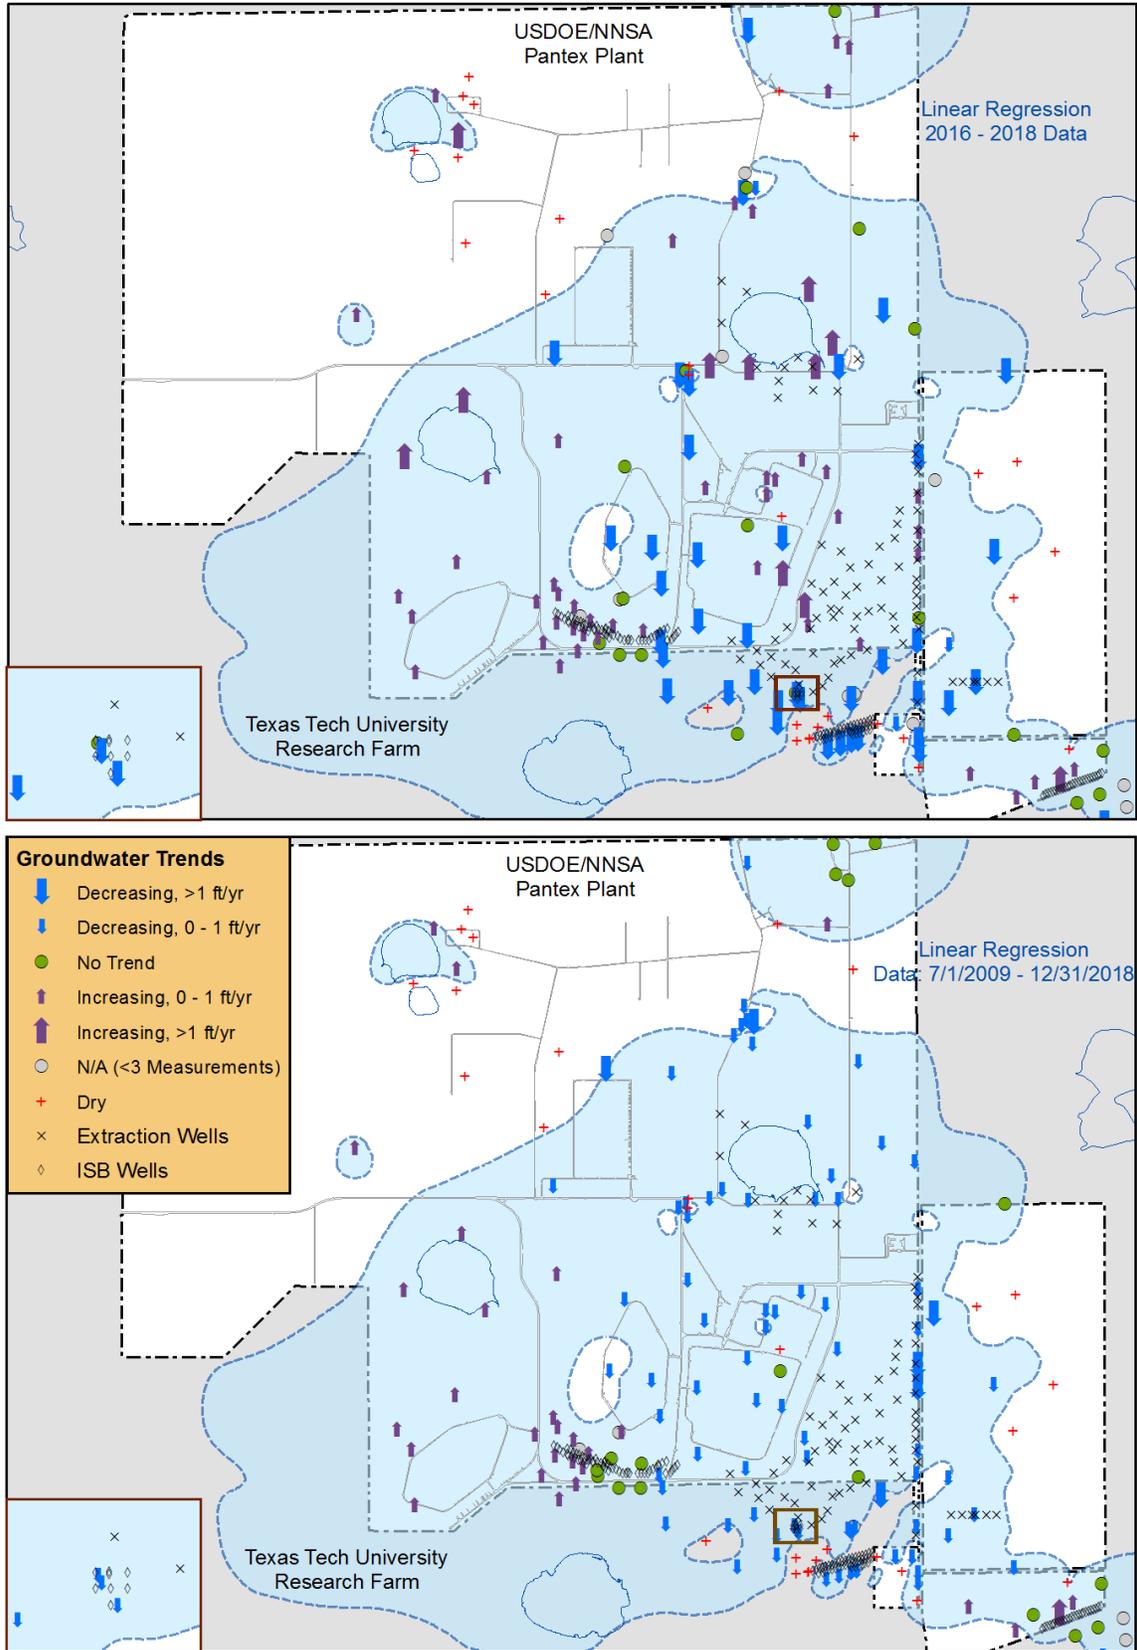
Figure 3-5. Water Level Trends in the Perched Aquifer

MAROS linear regression methodology outlined in the LTM Design Report was used to trend water levels at each well. Trends were calculated for the dataset of water levels collected since the start of remedial actions in 2009, in addition to the most recent two years of data at each well. The recent trends are expected to give a more accurate measurement of the effectiveness of the two pump and treat systems as the P1PTS began operating in late 2008 and the SEPTS began operating near full capacity by April 2009. Figure 3-5 depicts the water level trends in all LTM perched aquifer wells. Well hydrographs are included in Appendix F.

Trending results are showing positive effects of the remedial actions as almost all wells currently recognized to be under the influence of the SEPTS and P1PTS have exhibited decreasing water level trends in recent years. Above normal precipitation during the spring and summer of 2016 and again in the summers of 2017 and 2018 filled the playas, and a resulting increase in water levels was observed in several wells near Playa 1 and some ditches. The apparent recharge through the playa was much greater than the volume extracted by the P1PTS causing short-term increasing trends to be observed in these wells.

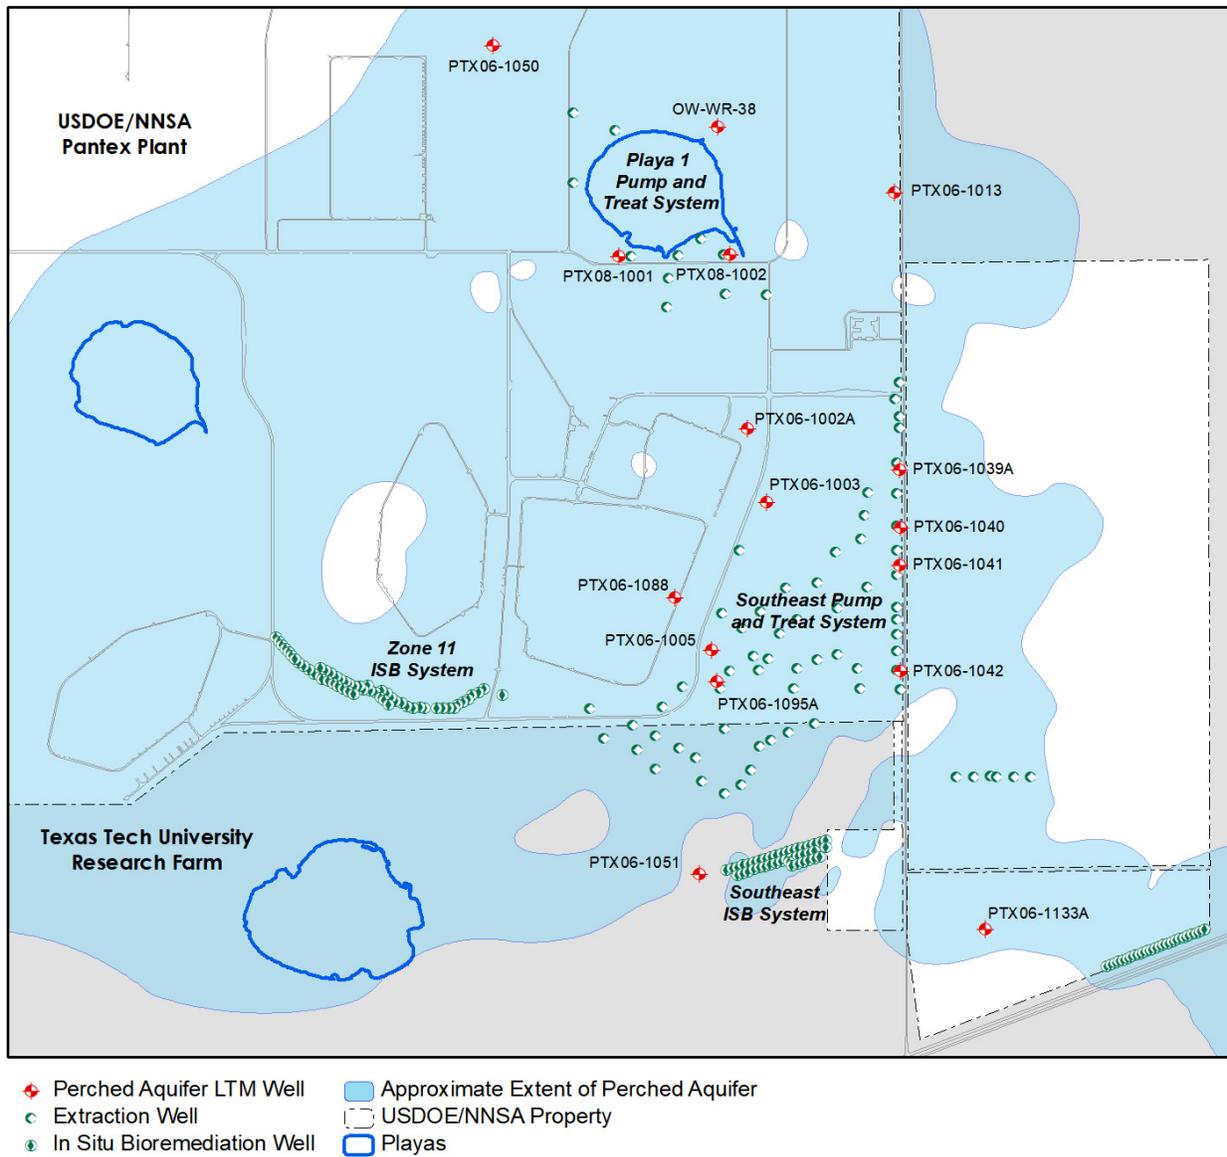
Figure 3-6. Perched Wells with Unexpected Water Level Trends

Overall, calculated groundwater level trends are consistent with expected conditions defined in the LTM Design Report summarized in Appendix E. Of the 48 monitor wells with expected decreasing water level trends, limited water, or dry conditions defined in the *Update to the LTM System Design Report* (Pantex, 2014a) 16 wells (depicted in Figure 3-6) exhibited conditions inconsistent with the current expected conditions or trends.

Water levels in PTX06-1133A increased sharply in 2016 after declining in 2011 and 2012 then holding constant below the bottom of the well screen in 2013 through 2015. Although the recent trend was identified as increasing, inspection of the hydrograph shows that water levels peaked in May 2018 and declined by 0.5-foot in the second half of the year. This well is located near the southern extent of perched groundwater; the sudden appearance of water and subsequent stabilization of water levels may be associated with the above normal precipitation during 2015 and 2016 and increased recharge through a large borrow pit to the south.

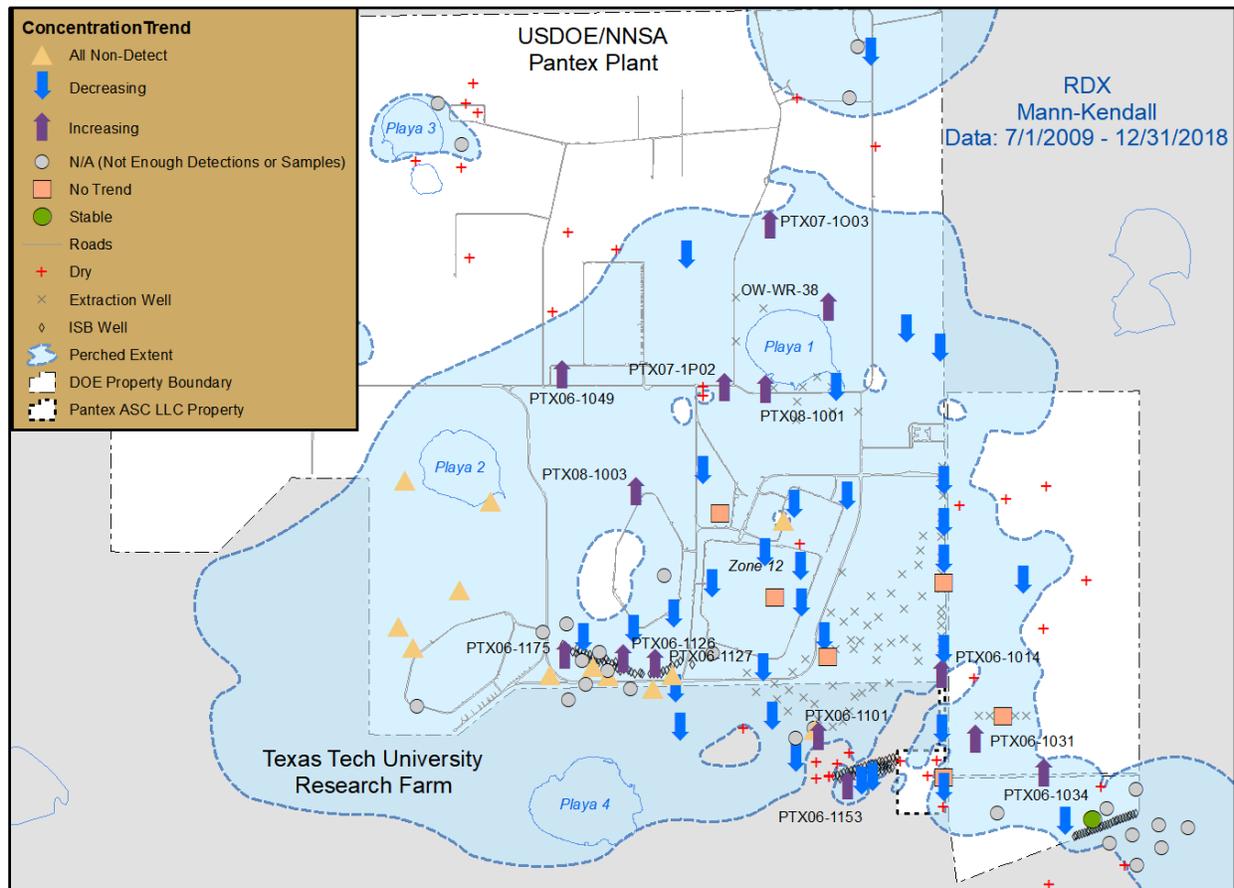
**Figure 3-7. RDX Trends in the Perched Aquifer**

Evaluation of concentration trends for RDX indicates that RDX is decreasing or does not demonstrate a trend at all monitoring points near the ditch along the eastern side of Zone 12. This condition is expected as the source areas are predicted to continue contributing to the perched aquifer for up to 20 years, but at much lower concentrations than in the past (Pantex, 2006). Some wells near Playa 1 are exhibiting increasing trends because of system operations at the P1PTS which have dramatically affected water levels and gradients in this region of perched groundwater. The SEPTS has had some effect on the plume as the majority of COC concentrations are declining or exhibit no trend within the boundaries of the well field. The Southeast ISB has had some effect on wells to the south on TTU property as concentrations in downgradient wells are stable or declining, with the

exception of PTX06-1153. This is a key area for declining concentrations because portions of that area are potentially more sensitive to vertical migration to the deeper drinking water aquifer. The trends are depicted in Figure 3-7.

Overall, 14 monitoring wells exhibited increasing trends in RDX using data since the start of remedial actions, as depicted in Figure 3-7.

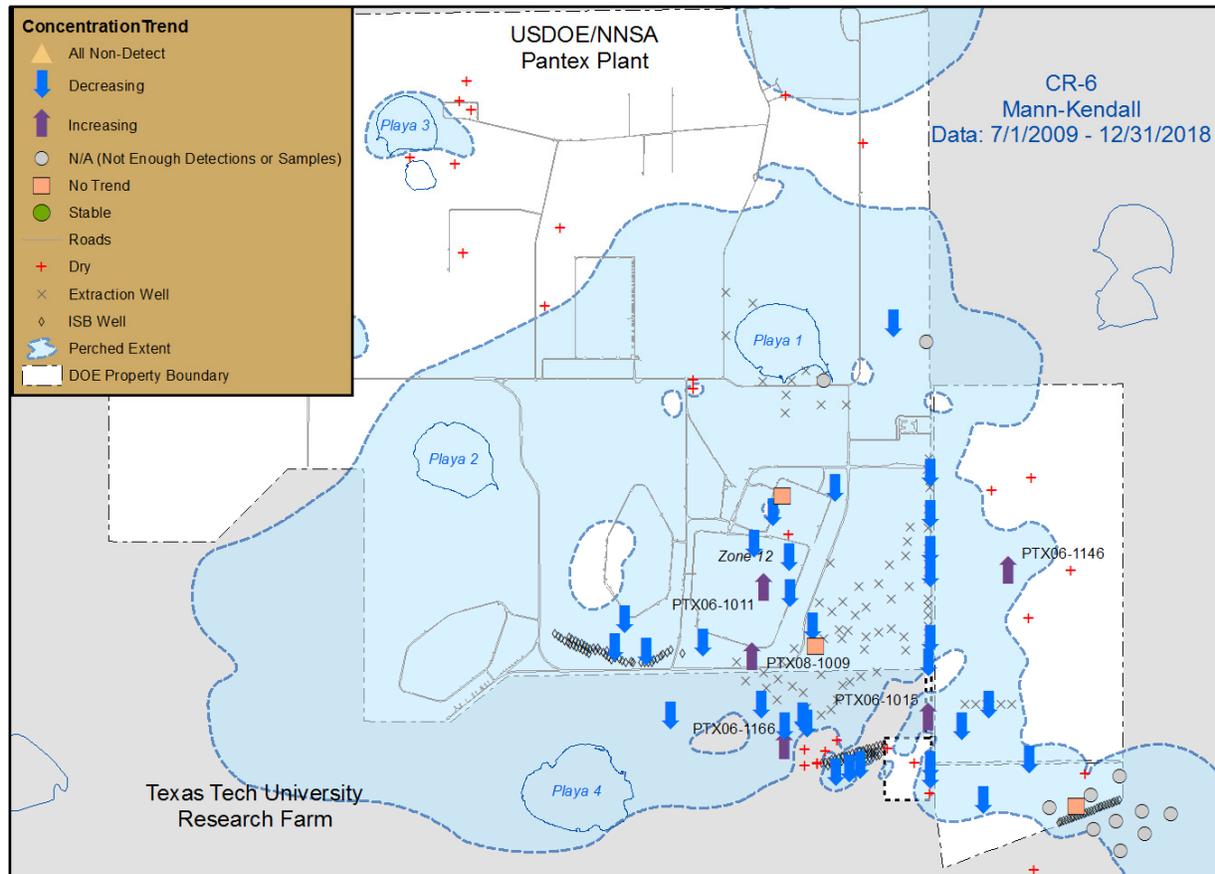
**Figure 3-8. Hexavalent Chromium Trends in the Perched Aquifer**

As depicted in Figure 3-8, five perched aquifer wells are exhibiting increasing trends in hexavalent chromium below the GWPS since remedial actions began:

- An increasing trend was identified for PTX06-1166. This well is located along the southern edge of the hexavalent chromium plume, so the observed increase is related to the movement of the plume to the southeast. A decreasing trend is indicated for the last four samples, and concentrations remain below the GWPS.

- An apparent increasing trend was identified for PTX08-1009; however, a decreasing trend was identified for the last four samples and concentrations remain below the GWPS. This well is located along the northern edge of the hexavalent chromium plume and historically exhibited very high concentrations. The recent detections may indicate general plume movement to the southeast and the influence of the SEPTS well field.

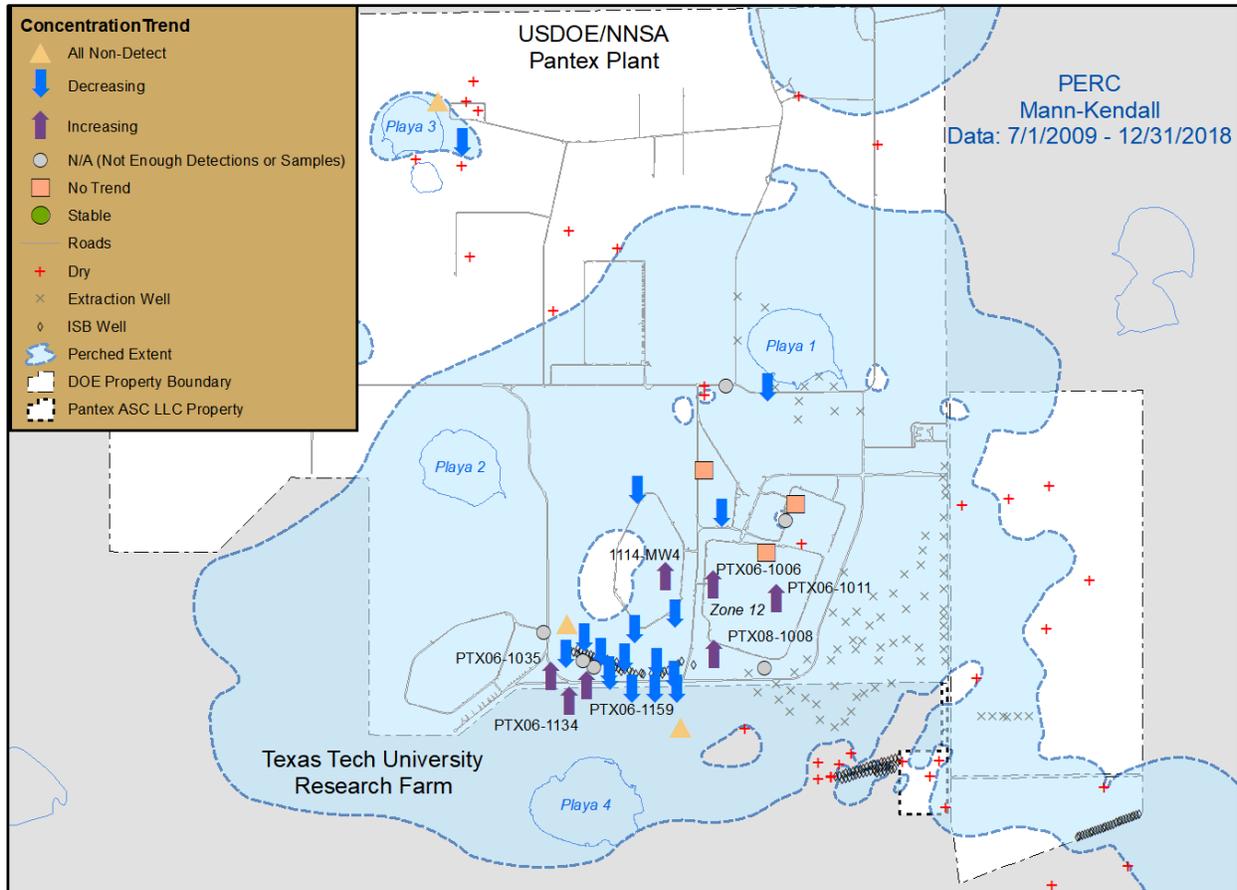
**Figure 3-9. Perchlorate Trends in the Perched Aquifer**

As depicted in Figure 3-9, seven monitoring wells are exhibiting increasing trends in perchlorate concentration:

could be caused by changes in gradients and plume movement from the SWMU 5-13A ditch. Another possible cause of these shifting trends could be caused by historic injection and the resulting return to unaffected perchlorate concentrations after injection ceased. As discussed in several prior Annual Progress Reports, historic injection at SEPTS injection well PTX06-INJ-02 (1996–2006) affected COC concentrations and trends in wells installed east of PTX06-1006.

- An apparent increasing trend was identified for PTX06-1011. However, all samples have been below the PQL or non-detect, and the apparent trend is caused by using one-half the sample detection limit in the trend analysis.
- PTX06-1035, PTX06-1134, and PTX06-1159, which are located southwest of the Zone 11 ISB system, are demonstrating increasing trends in perchlorate concentrations likely due to general plume movement downgradient. While these wells are located downgradient of the current Zone 11 ISB system, treated water is not expected to reach these wells for many years.
- Perchlorate increased in PTX08-1008 into 2017, but a decreasing trend is indicated for the last four samples. The variation in perchlorate in this well may be due to general plume movement to the southeast in this area, which may also be influenced by SEPTS operations.

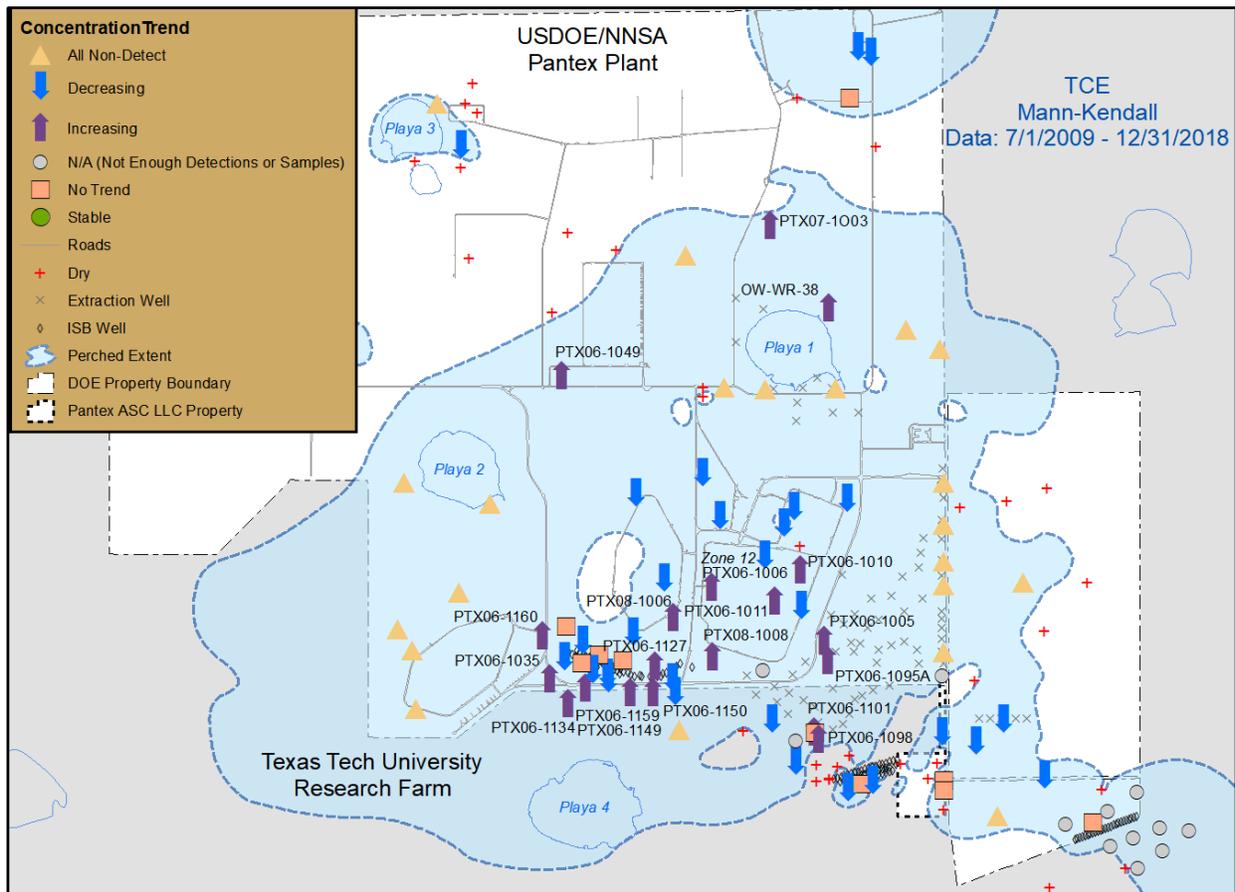
**Figure 3-10. TCE Trends in the Perched Aquifer**

As depicted in Figure 3-10, 19 monitoring wells are exhibiting increasing trends in TCE concentration since the start of remedial actions:

- An apparent increasing trend was identified for OW-WR-38 located northeast of Playa 1. Detections have been sporadic since 2009, and all sample results have been below the sample PQLs. The identified increasing trend is the result of low-level detections and use of one-half the detection limit in the trending and does not indicate actual increasing concentrations in this area.
- The apparent increasing TCE trend in PTX06-1005 is likely caused by the return of unaffected conditions in this area following the cessation of injection of treated water at SEPTS injection well PTX06-INJ-12A, which is located approximately 200-feet to the east. Almost 70 million gallons of treated water were injected into the perched aquifer at PTX06-INJ-12A from the time it was installed in 2008 through

- PTX06-1149 and PTX06-1150 are downgradient of the original part of the Zone 11 ISB. Detections of TCE at PTX06-1149 remain below the PQL. TCE concentrations at PTX06-1050 were increasing until 2016, but have remained stable near the GWPS in recent analyses. Because the concentrations detected at these wells are at or below the GWPS, these data indicate expected conditions are being met in this area.

- PTX06-1095A is within the influence of the SEPTS well field, but is also located less than 50 feet downgradient of the PRB pilot study wells PTX06-PRB01A and PTX06-PRB02. Since 2014, detections have been highly variable. The increasing trend is likely due to the PRB losing treatment effectiveness and concentrations returning to baseline conditions. A decreasing trend was exhibited by the last four samples.

- TCE was detected below the PQL in 2018 at PTX08-1008, located southwest of Zone 12, for the first time since 2011. The identified increasing trend is the result of

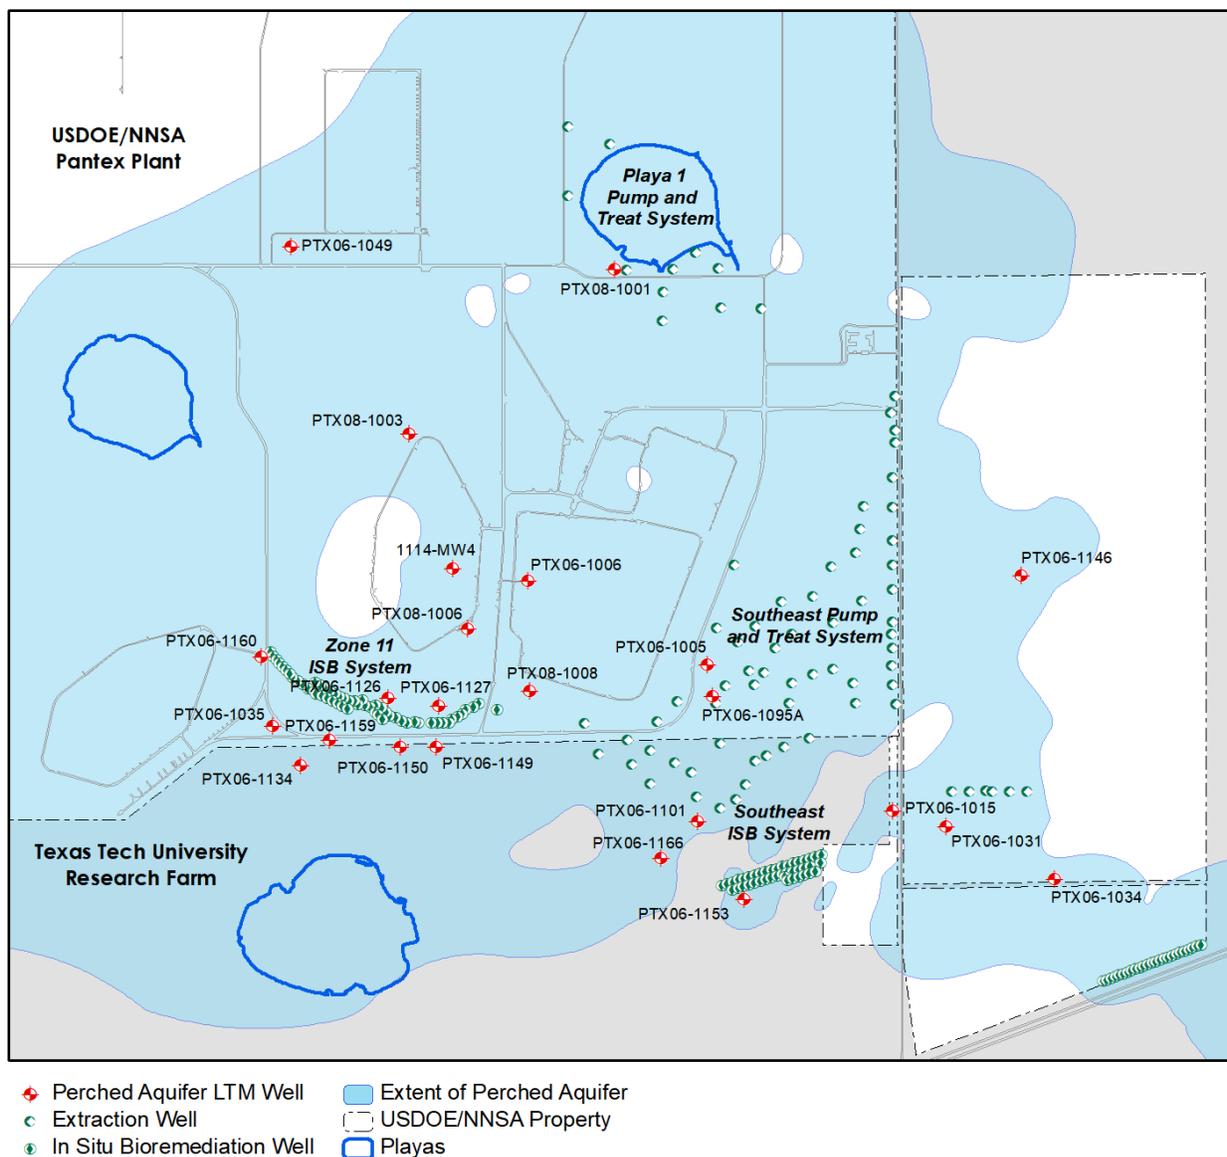
**Figure 3-11. Perched Wells with Unexpected COC Trends**

The following 24 monitoring wells (depicted in Figure 3-11), 1114-MW4, PTX06-1005, PTX06-1006, PTX06-1015, PTX06-1031, PTX06-1034, PTX06-1035, PTX06-1049, PTX06-1095A, PTX06-1101, PTX06-1126, PTX06-1127, PTX06-1134, PTX06-1146, PTX06-1149, PTX06-1150, PTX06-1153, PTX06-1159, PTX06-1160, PTX06-1166, PTX08-1001, PTX08-1003, PTX08-1006, and PTX08-1008, exhibited trends that were not consistent with the expected conditions and were previously discussed in Section 3.1.4. Additional detail on all LTM wells is located in Table E-1 in Appendix E.

Of the 103 monitor wells with expected COC concentration conditions defined in the LTM Design Report, 31 wells did not exhibit trends (since the start of remedial actions) consistent with the expected conditions. Seven wells (OW-WR-38, PTX06-1010, PTX06-1014, PTX06-1011, PTX07-1003, PTX07-1P02, and PTX08-1009) had expected conditions of long-term stable or decreasing trends in concentration, but indicated increasing trends since the start of remedial actions. However, their long-term trends were decreasing or stable, so the expected conditions are met and the trends in these wells are not discussed further. Currently, the smaller size of the comparative dataset (covering approximately 8 ½ years since remedial actions began) limits its effectiveness to represent long-term trends. It is expected that, as remedial actions continue to operate and the dataset continues to grow,

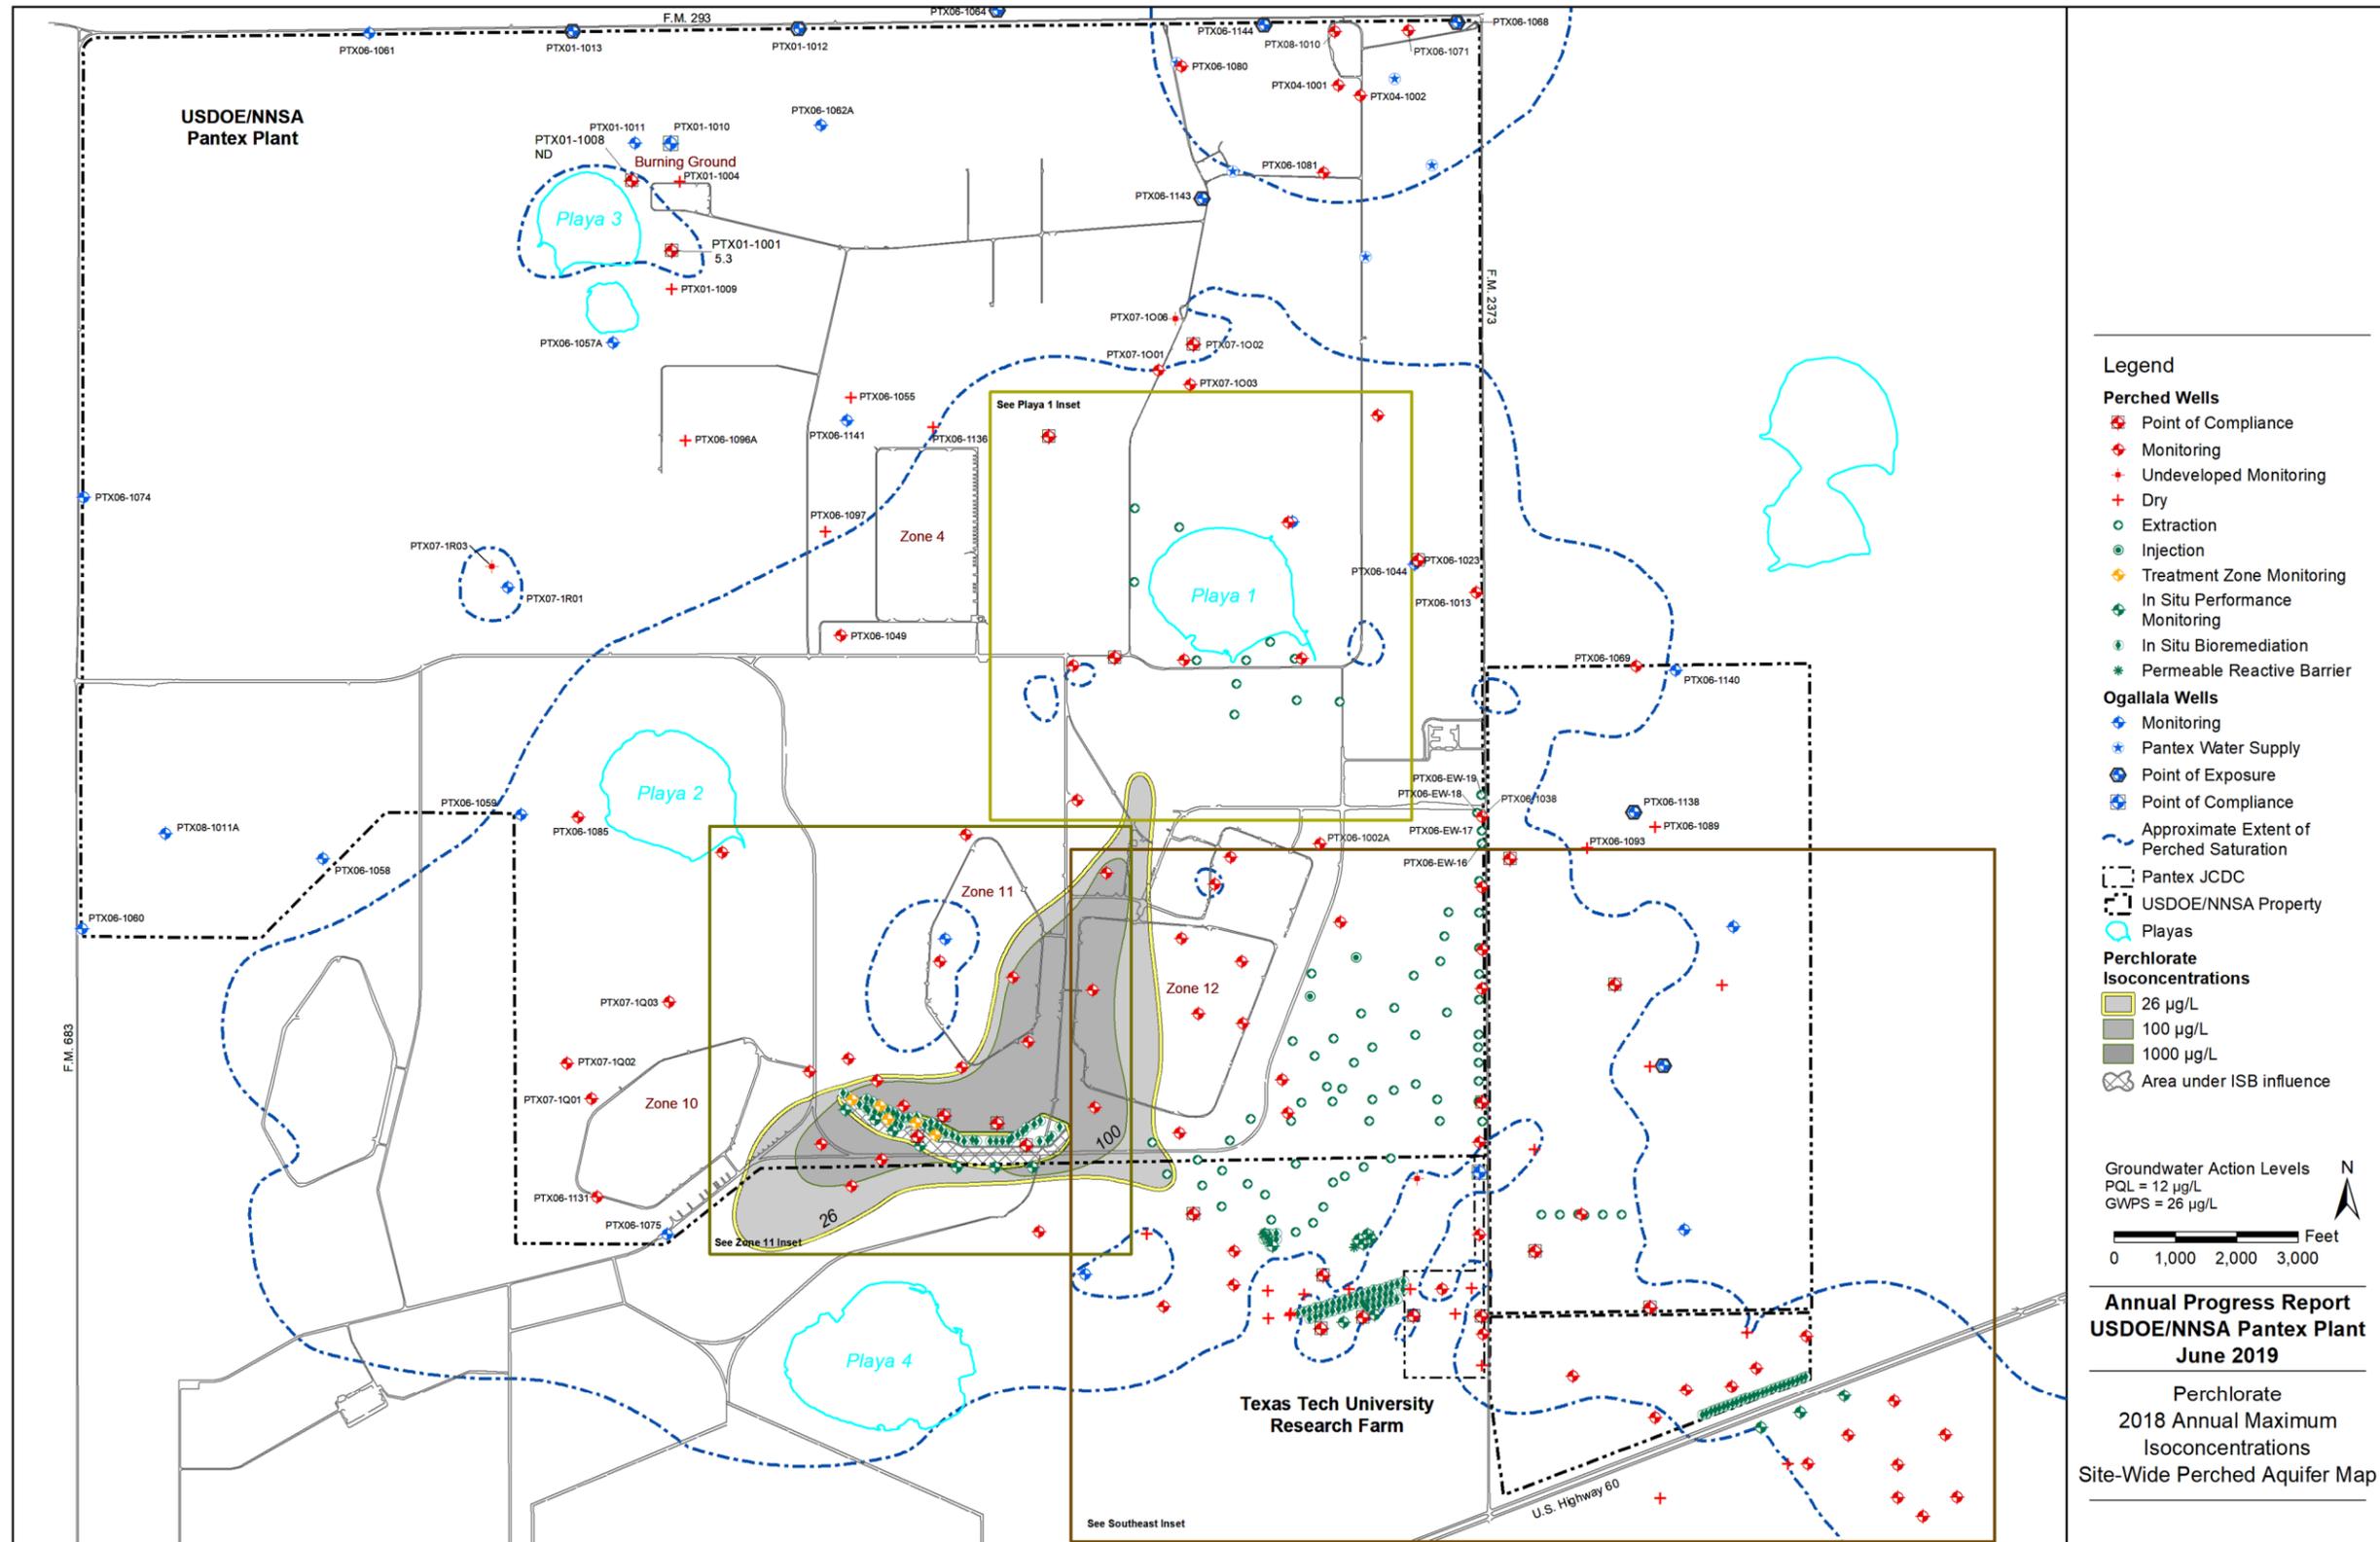
Figure 3-21. Perchlorate Isoconcentration Map

Perchlorate  
 2018 Annual Maximum  
 Isoconcentrations  
 Site-Wide Perched Aquifer Map

A single plume of perchlorate occurs in the perched aquifer underlying Zone 11 and the western portion of Zone 12. This plume extends northeast toward Playa 1 and southwest beneath TTU property as shown in Figure 3-21, Figure 3-22, and Figure 3-23. This plume is associated with the historical release of perchlorate from processes in Zone 11 to unlined ditches that carried the untreated water to the playa.

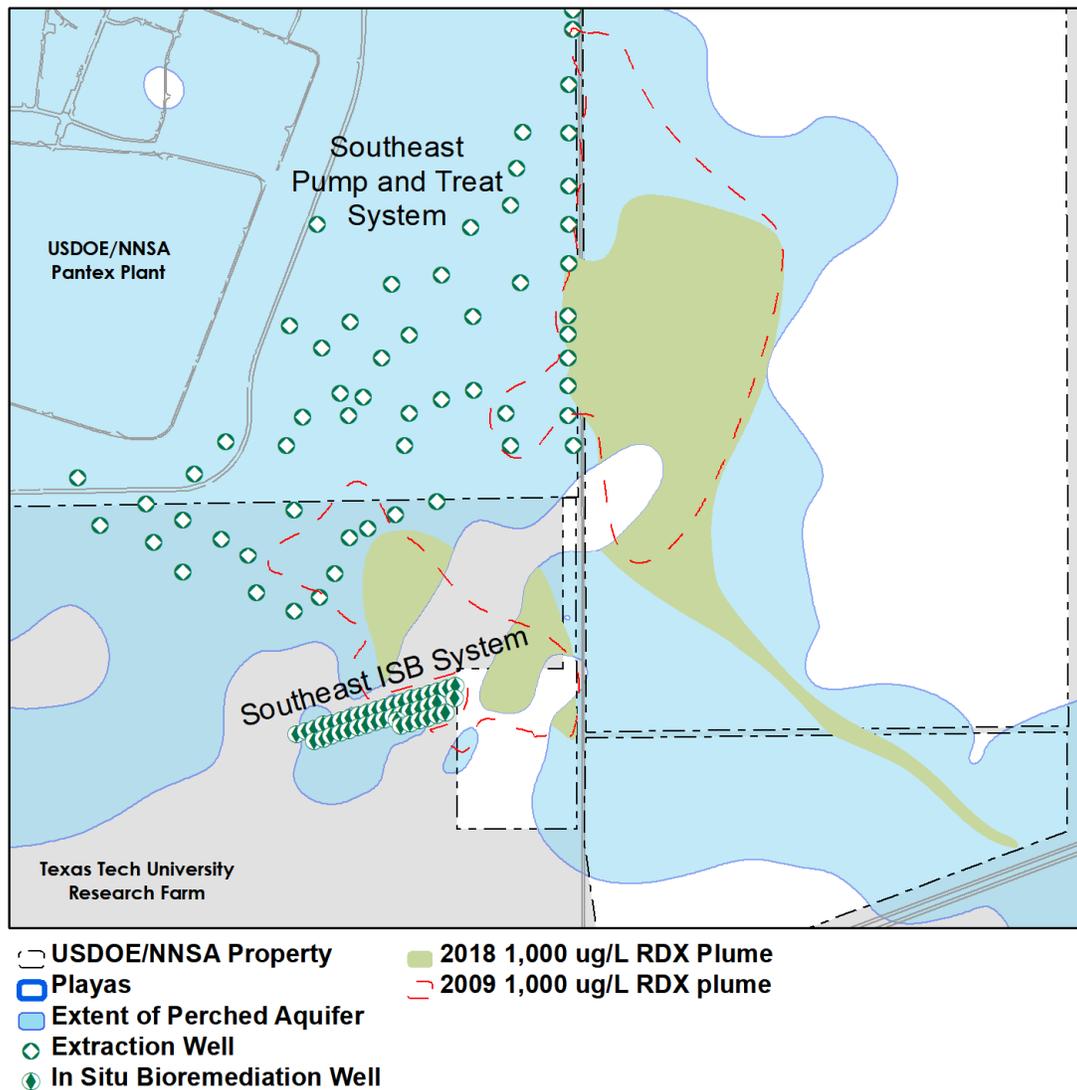
Figure 3-27. RDX Plume Movement, 2009-2018

In order to attempt to evaluate HE plume movement from 2009–2018, the RDX plume was chosen due to its size and distribution near the remedial actions. Considering the size and complexity of the RDX plume and the fact the plume is defined by the perched aquifer extent in many areas, the 1000 ug/L contours were included in the evaluation. These two contours represent the “hearts” of the two original plume sources (Playa 1 and Zone 12 ditches) that have since commingled in the southeast portion of the perched aquifer and are under the effects of the remedial actions. As depicted in Figure 3-27, the 1,000 ug/L plume outlines have slightly shifted in the SEPTS well field and shifted to the southern and eastern edge of the perched aquifer extent. This is likely due to a combination of SEPTS operations and general plume movement in areas that are not under the SEPTS influence. For 2018, the RDX contour has extended into the far southeastern lobe of perched

groundwater. This shift is the result of increases in RDX to above 1,000 ug/L at PTX06-1034, PTX06-1147, and PTX06-ISB124 coupled with recent additional investigation of the perched groundwater in this area. Movement of the plume in this area appears to be associated with faster groundwater flow paths along channel-type features in the top of the FGZ. Pantex determined the downgradient extent of the plume in early 2019 with the installation of 6 new wells to the southeast and has already completed a line of injection wells as part of an extension to of the Southeast ISB remedy to intercept this plume as it migrates to the southeast.

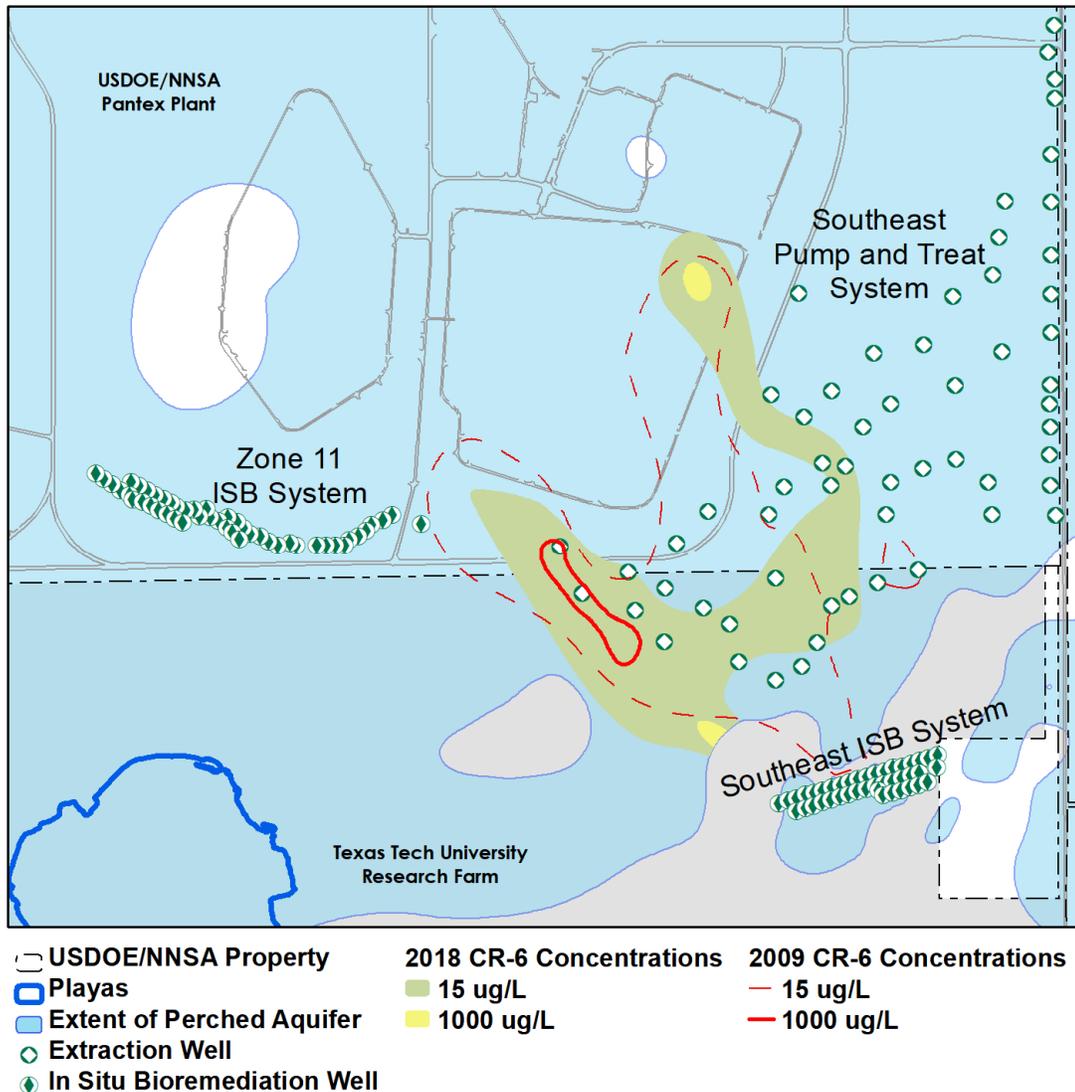
**Figure 3-28. Hexavalent Chromium Plume Movement, 2009-2018**

When compared with the 2009 hexavalent chromium maps (Figure 3-28), the shapes are similar, with the following exceptions:

- The northern lobe of the plume has apparently shifted to the east, likely due to a combination of SEPTS extraction well pumping and reduction of injection in the area.
- The southern portion of the plume has apparently shifted southwest because of downgradient movement of chromium beyond the influence of the SEPTS.

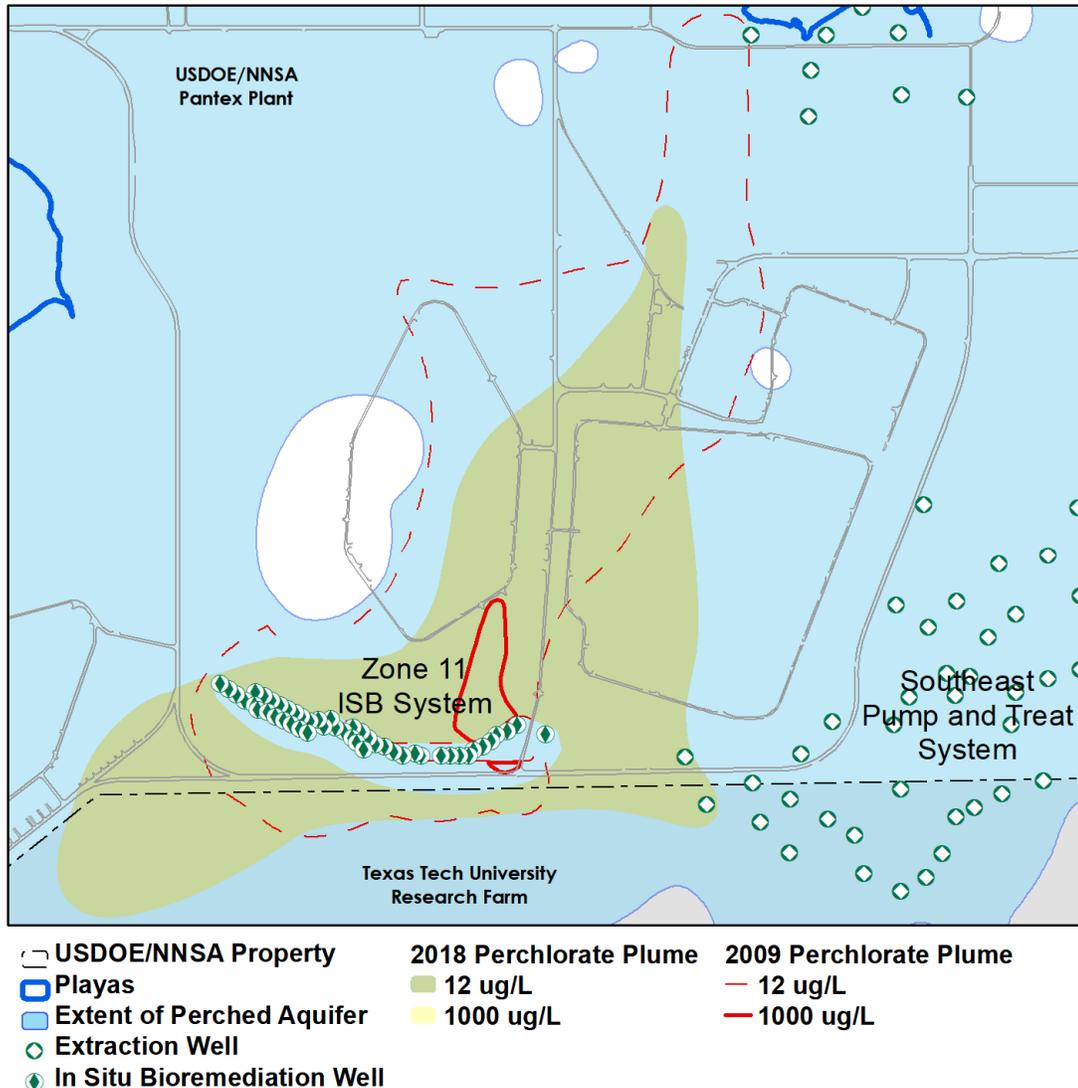
**Figure 3-29. Perchlorate Plume Movement, 2009-2018**

As depicted in Figure 3-29, the perchlorate plume shape is similar to the 2009 plume map, with the following notable exceptions.

- The northern lobe of the plume has contracted due to the decreasing concentrations in wells that define the boundaries in the area. However, these concentrations and resulting plume shapes have been quite variable since remedial actions began in 2009.
- The southern lobe of the plume has shifted to the south and west, likely due to advection and dispersion, as well as data collected from newly installed monitor wells.
- The southeastern boundary of the plume has shifted east because of the increase of perchlorate in PTX08-1008 first observed in 2008 and in the two westernmost SEPTS extraction wells.

The hydraulic gradient in the area between the southern parts of Zones 11 and 12 has shifted more eastward because of the influence of the SEPTS and the decline in perched water levels. This shift in the hydraulic gradient has allowed perchlorate to migrate east and southeast with perchlorate moving into the SEPTS well field. This portion of the perchlorate plume is being actively remediated by SEPTS at this time. The ion exchange resin used in SEPTS for treatment of chromium can also treat perchlorate at lower concentrations. Pantex has plans to upgrade SEPTS with perchlorate resin vessels to treat the higher concentrations that are expected in the future. In addition, Pantex is planning to install two new extraction wells on the southwest side of the existing well field and convert PTX06-1183 to extraction. These three new extraction wells will improve capture of perchlorate migrating to the southeast. The new wells will be installed in 2019, with design and construction of the SEPTS treatment modifications and installation of infrastructure planned for late 2020.

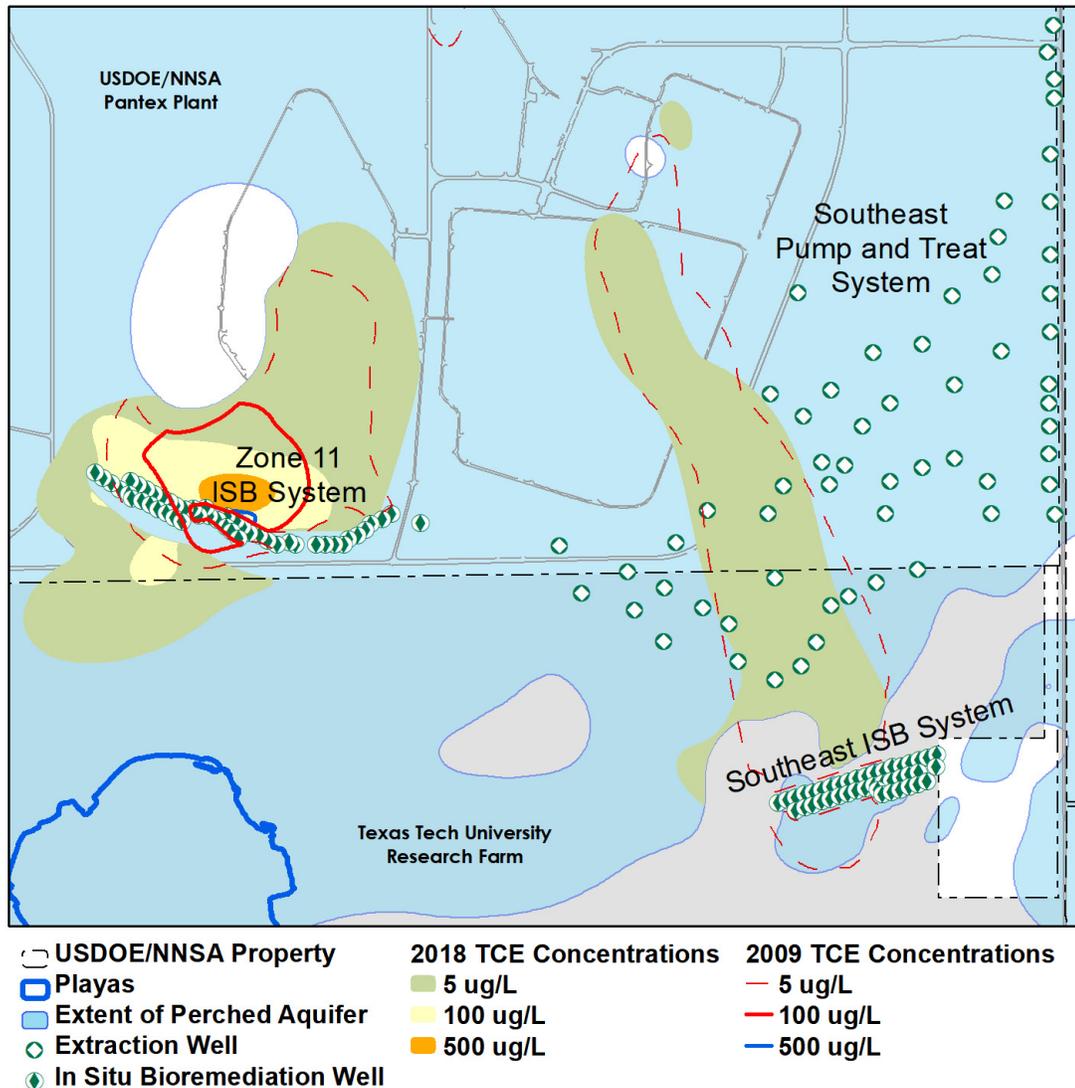
Figure 3-30. TCE Plume Movement, 2009-2018

As depicted in Figure 3-30, the 2009 and 2018 TCE plume shapes are similar, with the following notable exceptions.

- The plume originating from Zone 12 has contracted near the Zone 12 source areas. However, the southern edge of the plume has shifted to the west due to data collected at monitoring well PTX06-1166 and decreasing TCE concentrations in Southeast ISB ISPM wells.
- The plume originating from Zone 11 has shifted to the south and west due to general gradient in the area and recently installed wells to the west. The TCE plume beneath Zone 11 has also expanded to the east as a result of the shifting flow gradients in perched groundwater.

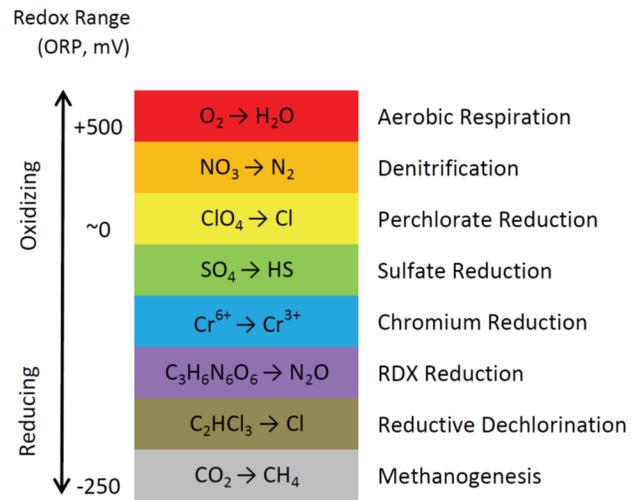
**Figure 3-32. Typical Geochemical Redox Ranges**

Geochemical conditions can be evaluated to determine if adequate reducing conditions exist to achieve reduction. Figure 3-32 presents the redox ranges for reduction of various COCs. TCE and perchlorate are the primary COCs in the Zone 11 area, while HEs (primarily RDX) and hexavalent chromium are the primary COCs in the southeast area. Perchlorate degradation does not require as strongly reduced conditions as RDX or TCE. To document the effectiveness of COC removal, downgradient wells are monitored for specific target indicators chosen for each ISB system. Target indicators include COCs that are the most widespread and that have the potential to affect human health if the water were to be used for residential purposes, even though perched groundwater use is controlled to prevent any potential for exposure. In addition, breakdown products are monitored to determine if complete degradation is occurring. Specific indicators are discussed separately for each system below.

(DO, nitrate, and sulfate) concentrations will decline after injection. As shown in Figure 3-32, strongly reducing conditions must be achieved for reductive dechlorination of TCE to occur. The redox potential should decline from baseline and be below  $-50$  mV for the reduction of TCE and near 0 mV for the reduction of perchlorate. Concentrations of total organic carbon should increase after injection, but decline over time as the amendment is consumed.
