# Pantex Plant

# 2018 Annual Progress Report

## Remedial Action Progress

In Support of Hazardous Waste Permit 50284 and  
Pantex Plant Interagency Agreement

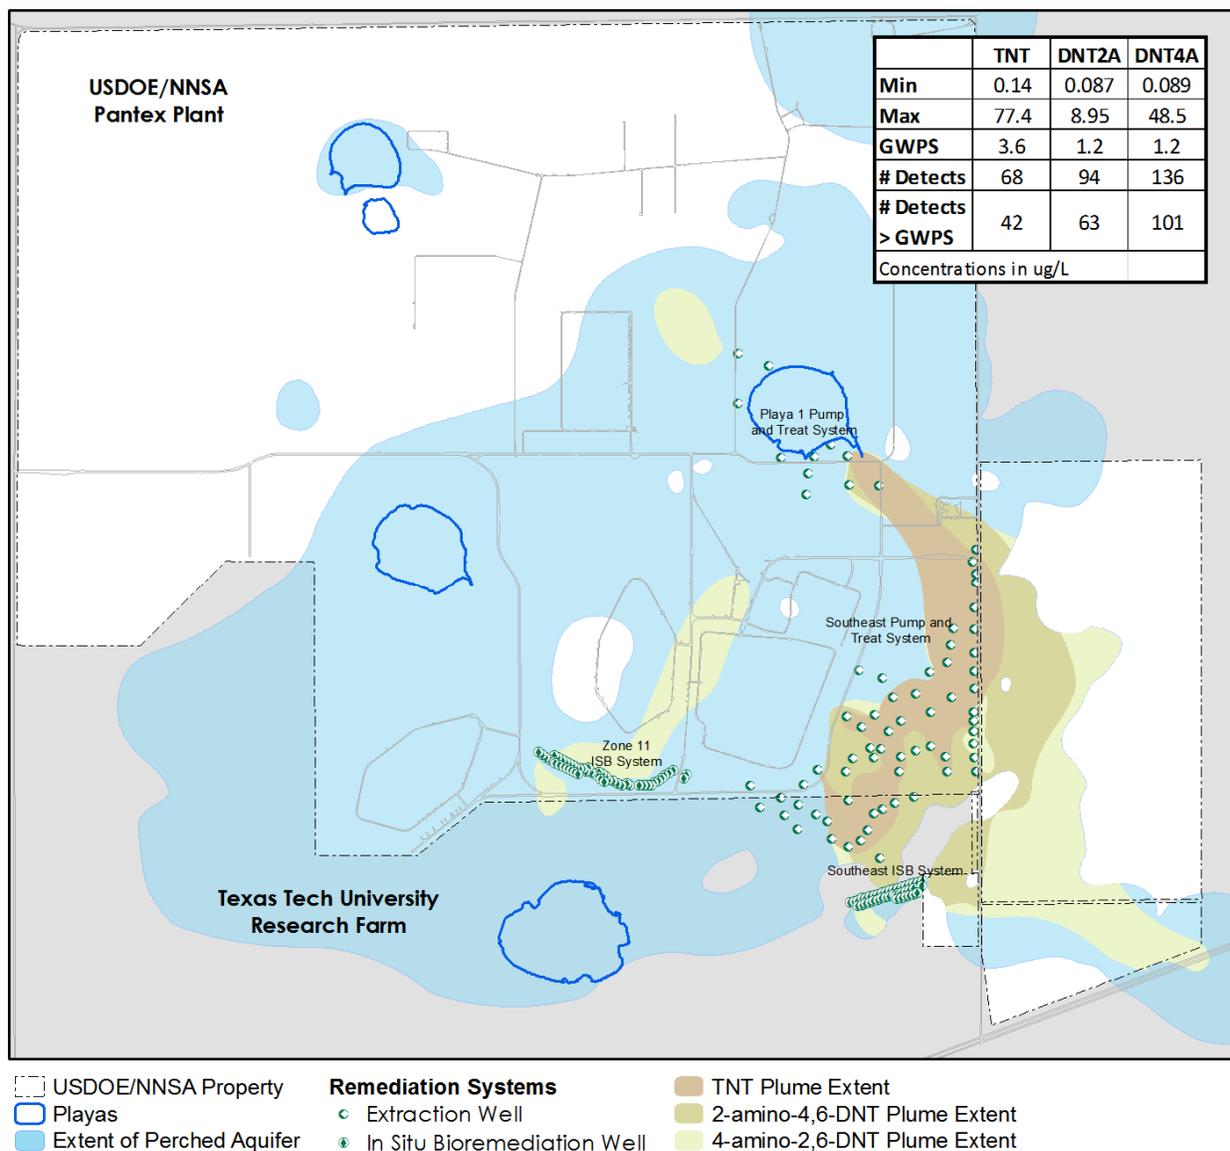
Figure 3-33. TNT and Degradation Product Plumes

Based on monitoring results for TNT and its breakdown products (2-amino-4,6-DNT and 4-amino-2,6-DNT), TNT has naturally attenuated over time (see Figure 3-33). TNT has

been manufactured at Pantex since the 1950s, yet is only present in the central portion of the overall southeastern plume - within the SEPTS well field and near Playa 1. Its first breakdown product, 2-amino-4,6-DNT, occurs near the TNT plume and extends slightly beyond. The final monitored breakdown product, 4-amino-2,6-DNT, extends out to the edges of the perched aquifer saturation at low concentrations. Only TNT breakdown products are present in perched groundwater beneath Zone 11 and north of Playa 1. Concentrations of the breakdown products are still above GWPS, but most wells with detections are recently showing a decreasing or stable trend. A table of natural concentration ranges for wells outside the influence of the ISB systems is included in Figure 3-33.

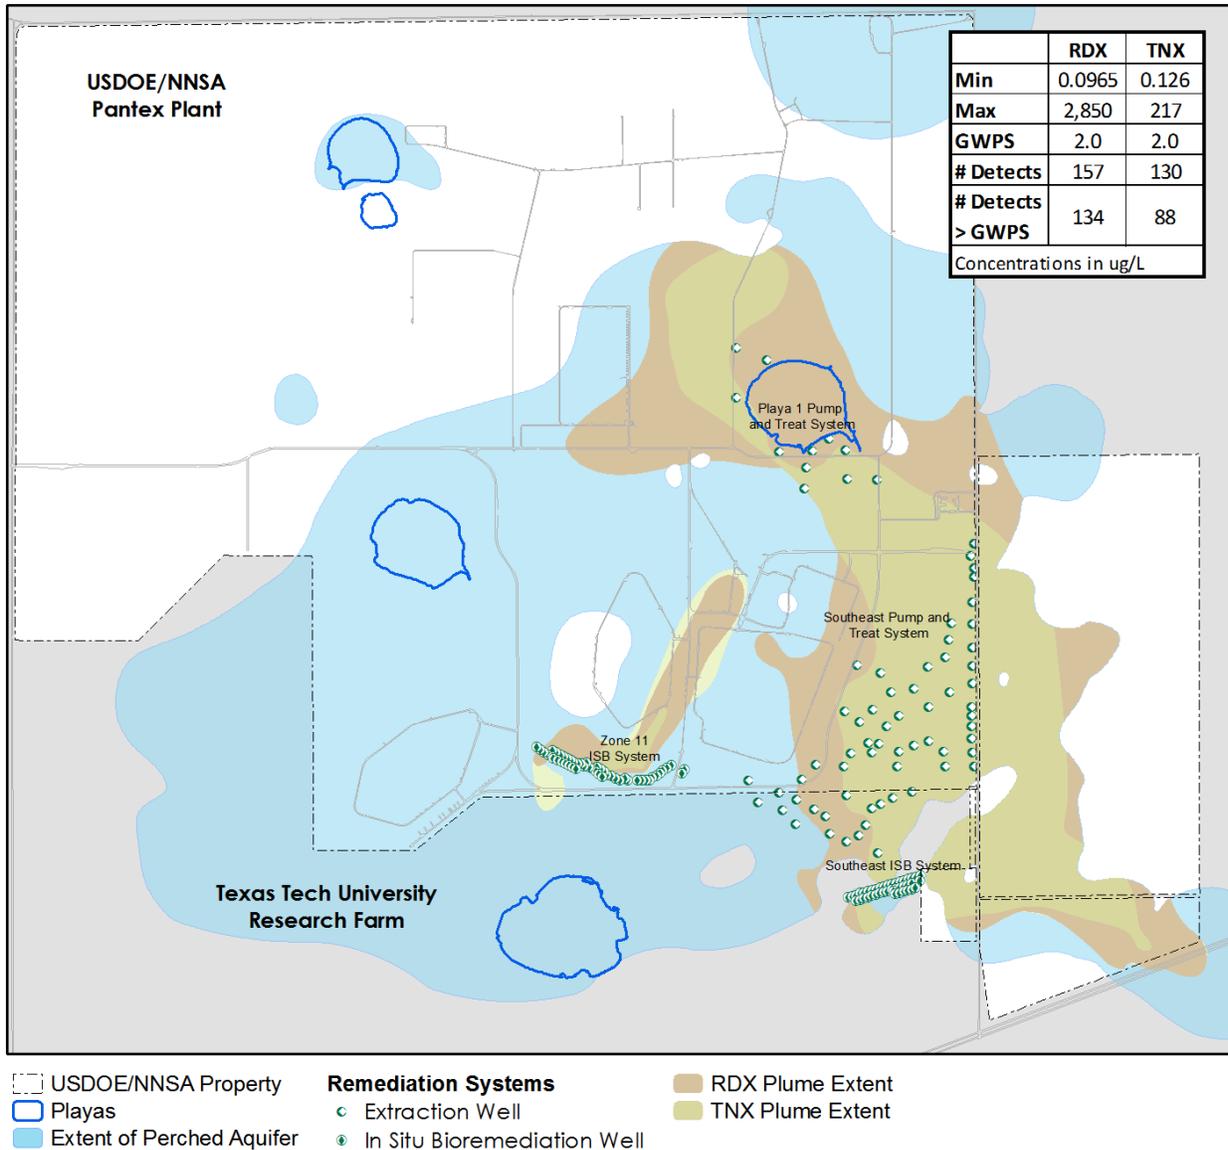
**Figure 3-34. RDX and Degradation Product Plumes**

Perched aquifer sampling results for RDX and breakdown products (MNX, DNX, and TNX) indicate that the breakdown products are present throughout most of the RDX plume, with TNX being the most widespread. TNX, the final degradation product, is a better indicator of degradation because the other intermediate products (MNX, DNX) degrade rapidly and do not accumulate in the environment (SERDP, 2004). If complete biodegradation of RDX is occurring, RDX and all breakdown products would be expected to decrease over time. Figure 3-34 depicts the overall RDX and TNX plume. A table of concentration ranges for wells outside the influence of the ISB systems is included in the figure.

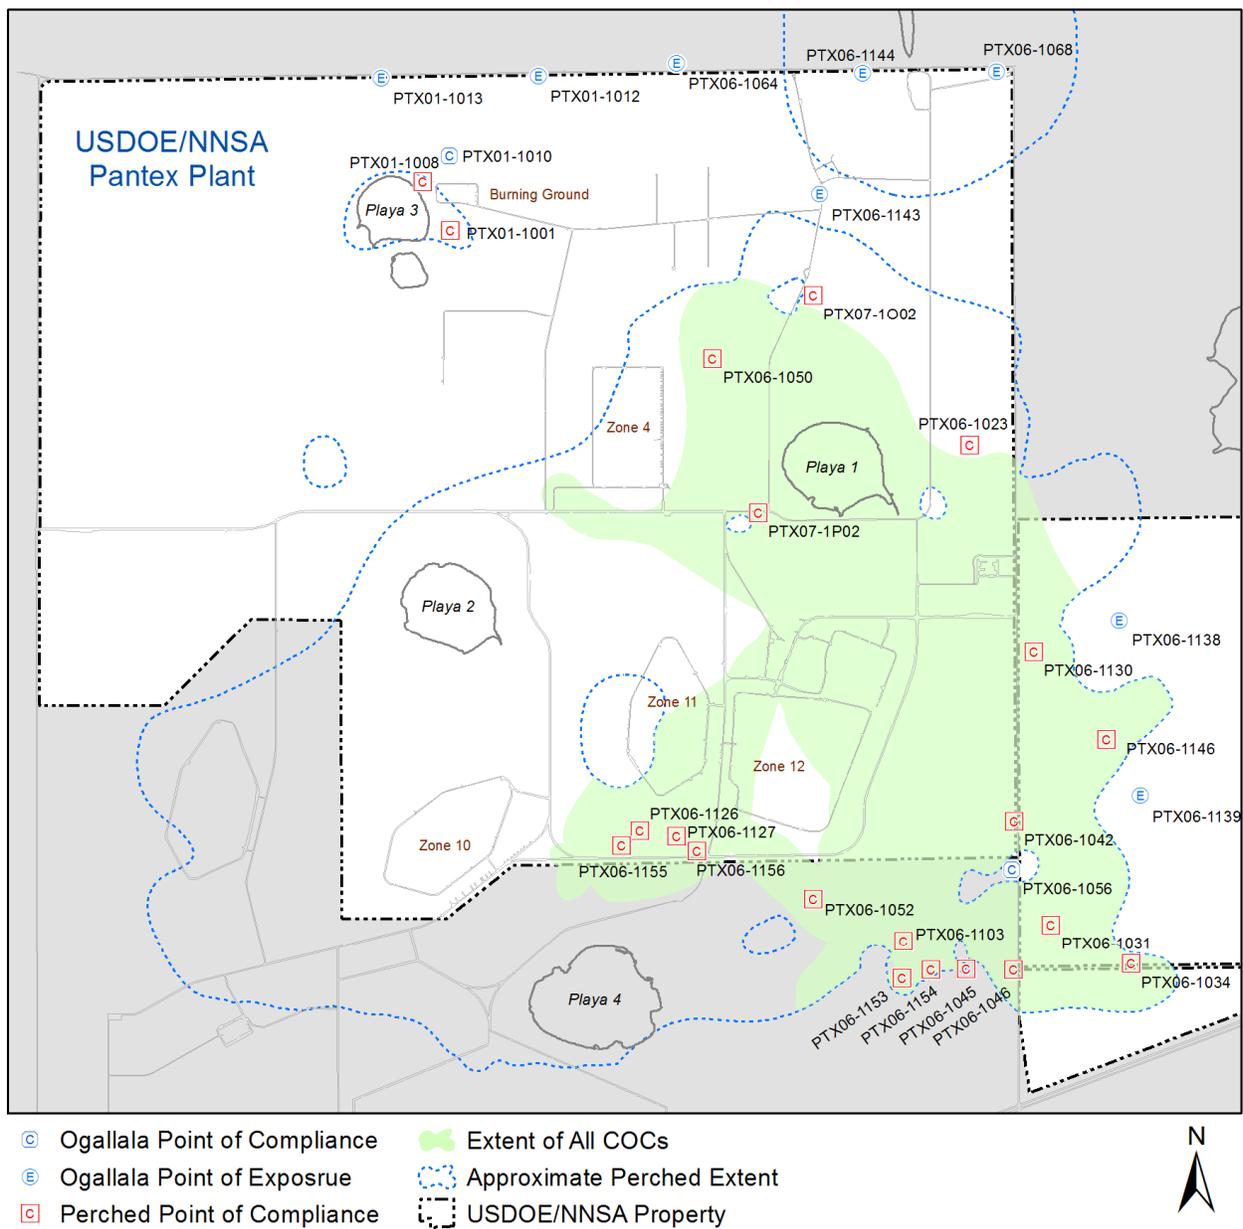
**Figure 3-36. POC and POE Wells**

The remediation program must continue until the POC and POE wells are compliant with the GWPS. The POC/POE wells approved in HW-50284 are depicted in Figure 3-36. All but two POC wells are in the perched aquifer. All POE wells are in the Ogallala Aquifer and are not expected to exhibit detections of organic COCs or detections above background values for inorganic COCs.

All POC/POE wells were evaluated against the established GWPS. Evaluation of the data indicates that only three perched aquifer POC well had concentrations below GWPS. This is an expected condition at these wells because the full remedial actions were started in 2009. The Ogallala Aquifer wells were evaluated in the uncertainty management/early detection section to determine if any COCs were detected above background or PQL. All well data, along with comparison to the laboratory PQL, background, and GWPS are provided in Appendix D.

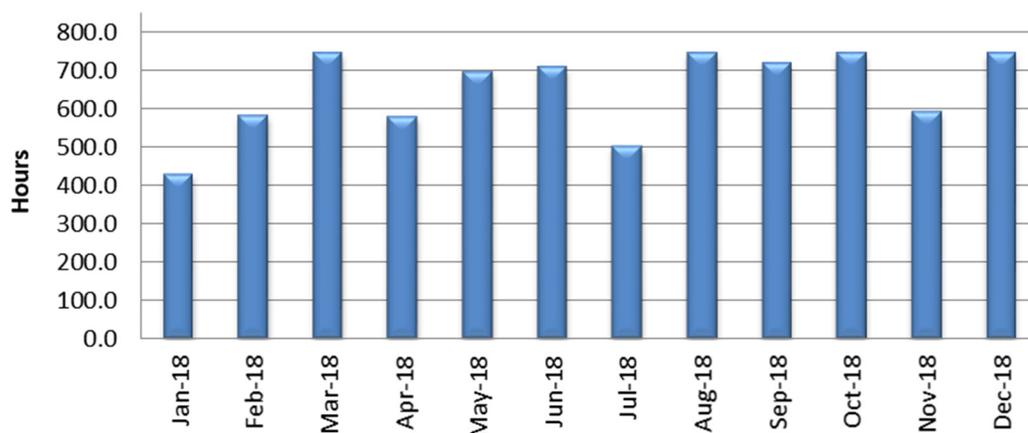
**Figure 4-1. SVE System Operational Hours**

The Burning Ground SVE system operated variably during 2018 with about 7,782 hours of operation during the year, or 89 percent operational. Figure 4-1 shows that the system operational hours varied from a low of 57 percent (428 hours) in January to a maximum of 100 percent (744 hours) in March, August, October, and December. The system was down for a power outage, maintenance, and repairs.

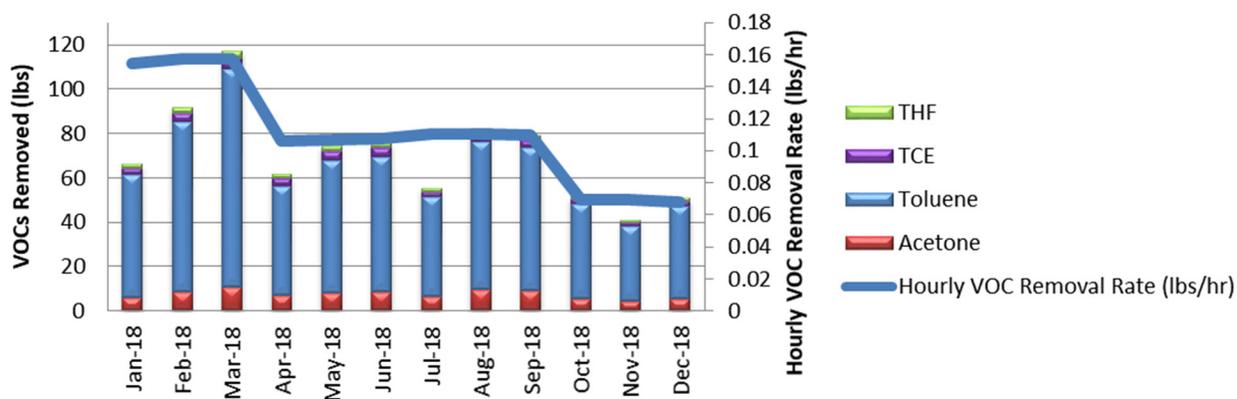
Based on the analytical and system operation, the system removed approximately 847 lbs of VOCs during 2018. Comparison of PID data collected at the system effluent port to data from the influent port suggests that the overall system destruction efficiency was greater than 99 percent on average in 2018. Figure 4-2 shows the estimated mass removed each month for the four highest VOC compounds. Hourly VOC removal rates increased through the first quarter of 2018 with the increased flow likely resulting from the system modification in 2017. However, hourly removal rates declined later in the year.

Figure 4-2. SVE System VOC Removal

Influent (prior to the oxidizer) and effluent (at the scrubber stack) PID readings are collected at the SVE system on a weekly basis to ensure compliance with the permit-by-rule. Pantex also collects monthly influent gas samples that are sent to a laboratory for analysis. The analytical samples are used to estimate the mass removal for the SVE system. In 2018, a total of 12 samples were collected for laboratory analysis from January through December.

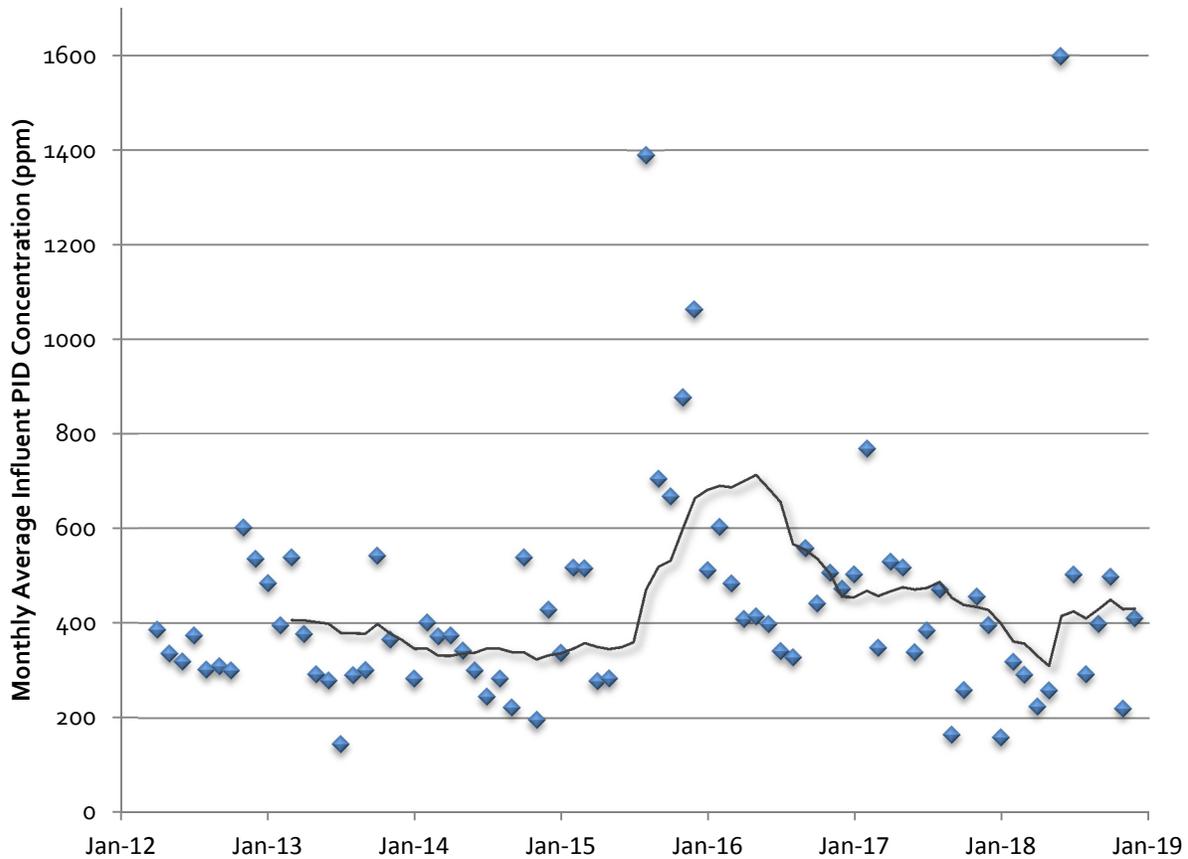
The average monthly PID measurements collected at the system influent, summarized in Figure 4-33, show some variability, but a 12-month moving average for the dataset, represented by the trend line on the graph, indicates influent PID have generally been in the range of 350 to 450 ppm. Average influent PID measurements in 2018 were slightly lower than in 2017, with the exception of two very high readings in June 2018. Because of these two June high PID readings the system was taken offline to purge fresh air through the CatOx. The analytical data for the month of June show that the concentration of the three of the highest VOCs decreased in June, which suggests that the high PID readings are not representative of the VOC content of the influent in June. The average influent concentration for 2018 was 342 ppm (without the two anomalously high PID readings in June) compared to the 2017 June through December average which was about 350 ppm. Decreases in influent PID readings are expected as operations continue.

**Figure 4-3. Influent Average PID VOC Concentrations vs. Time**
