Managed and Operated by
Consolidated Nuclear Security, LLC

**Long-Term Environmental
Stewardship Public Presentation**

2020

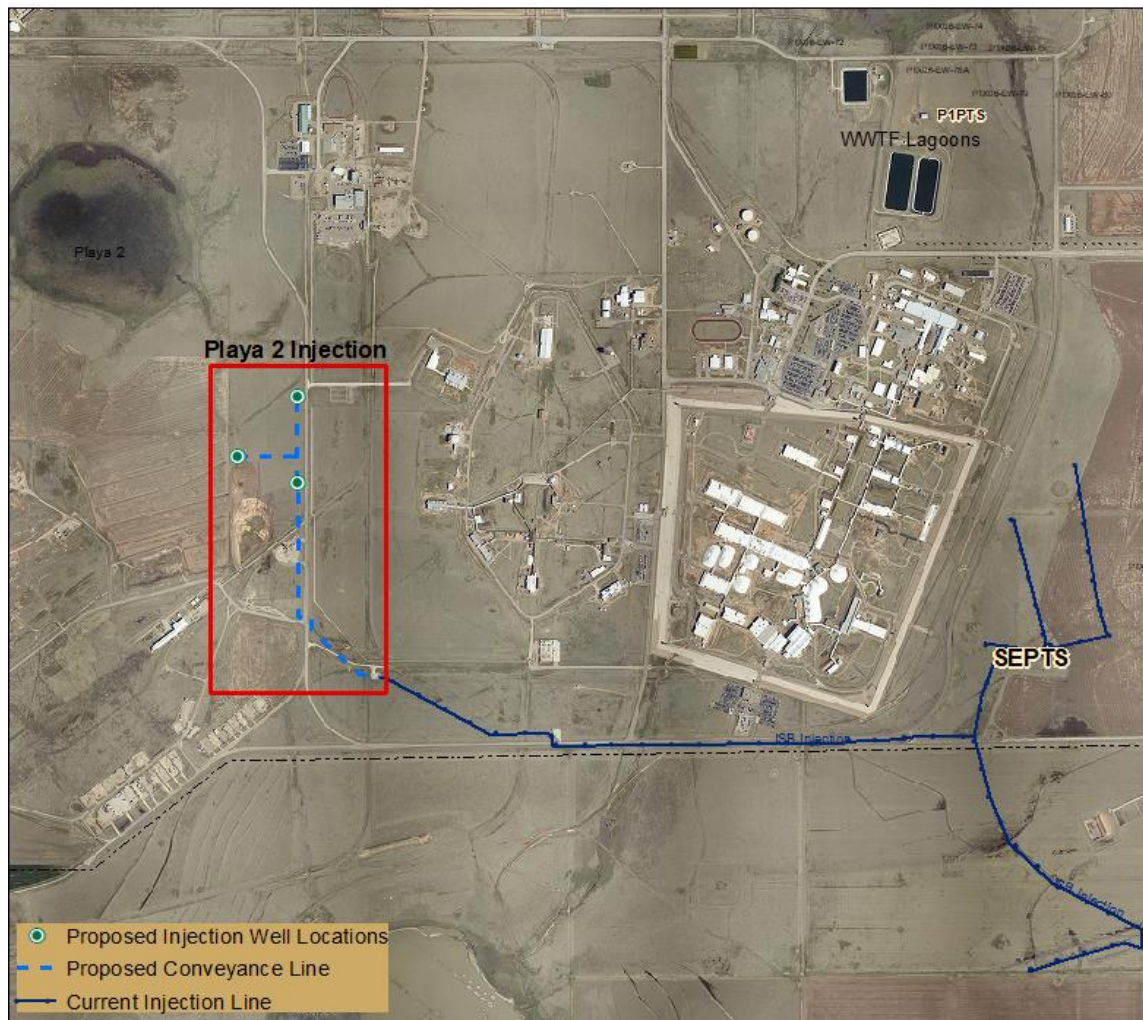
SEPTS Expansion: Playa 2 Injection

Milestones:

- Completed design in Dec 2019
- Began construction in Feb 2020
- Completing construction in Nov 2020

System Components:

- 3 injection wells, 150 gpm, subsurface conveyance line and booster pump
- SCADA system to communicate with SEPTS

- Repair on current irrigation system complete by late 2020
- New Pivot Irrigation east of FM 2373 – (design phase initiated)
- Inject in perched groundwater near Playa 2 (next slide)
- New Perchlorate Vessel at SEPTS to treat perchlorate plume

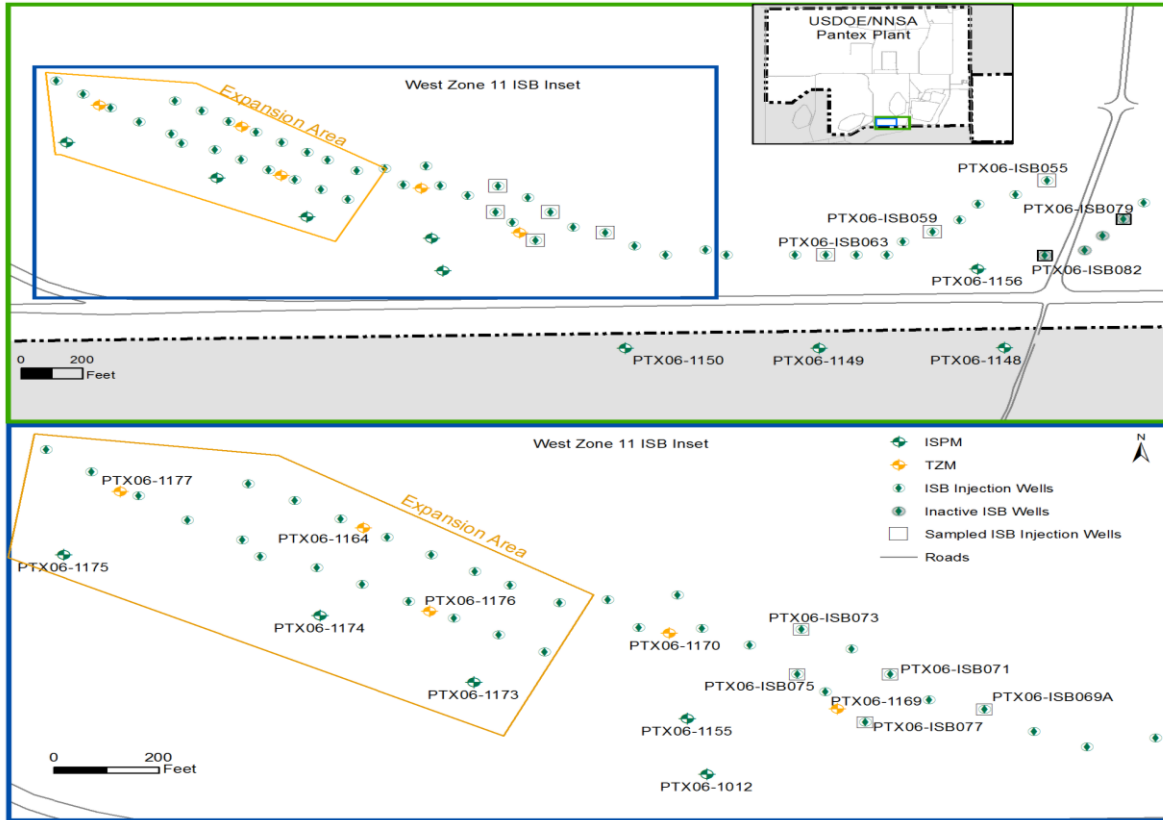
Zone 11 ISB

July 2019 - June 2020

- Perchlorate and TCE reduced near or below groundwater protection standards (GWPS) at most wells
- Installation of new wells northwest of system

Current/Upcoming Related Projects:

- Currently injecting system and planned for yearly injections
- Installation of new wells south and southeast of system to address migrating plume

System Information:

- Main contaminants – TCE and perchlorate
- Installed on March 2009
 - Originally consisting of 23 wells
 - Additional 9 wells installed in Sept 2009 to treat east ClO_4^- plume and west TCE plume
- 2019 Configuration
 - 52 active and inactive injection wells,
 - 5 treatment zone monitoring wells
 - 9 downgradient performance monitoring wells
 - Saturated thickness of area approximately 15-20 ft
 - Originally injected Newman Zone soybean oil as amendment but as of 2018 we have been injecting molasses for better distribution

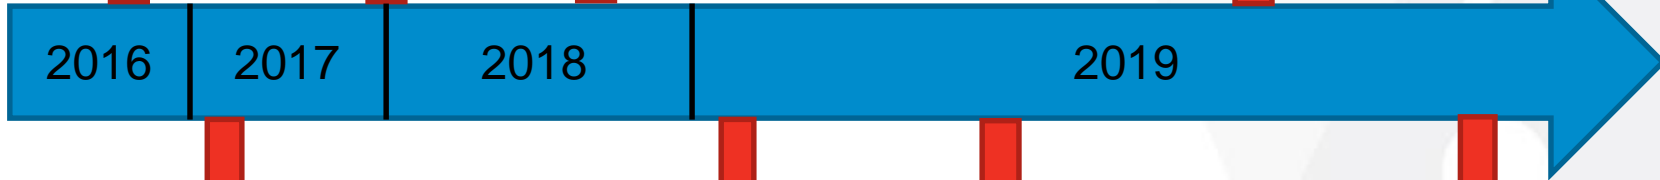
Past Events Addressing Southeast Plume

2016:

**Observation of
Southeast
Moving Plume**

**2017/2018:
Plume
Extending
Further SE**

**2018: Installed 25 injection
wells to remediate/cutoff
plume (SE-Ext ISB)**

**2019: 2nd Injection into
SE-Ext ISB**

**Installation of New
Offsite System Begins**

**2019: 1st Injection
into SE-Ext ISB**

**2019: Addition of monitoring
wells on neighbors property
to define extent**

**2017: Pump and treat wells are
added east of FM 2373 to
SEPTS system to reduce
impact of water movement to
SE**

**2019: Optimization/modeling
of new system to right-size
the remedy is completed and
remedy is selected**

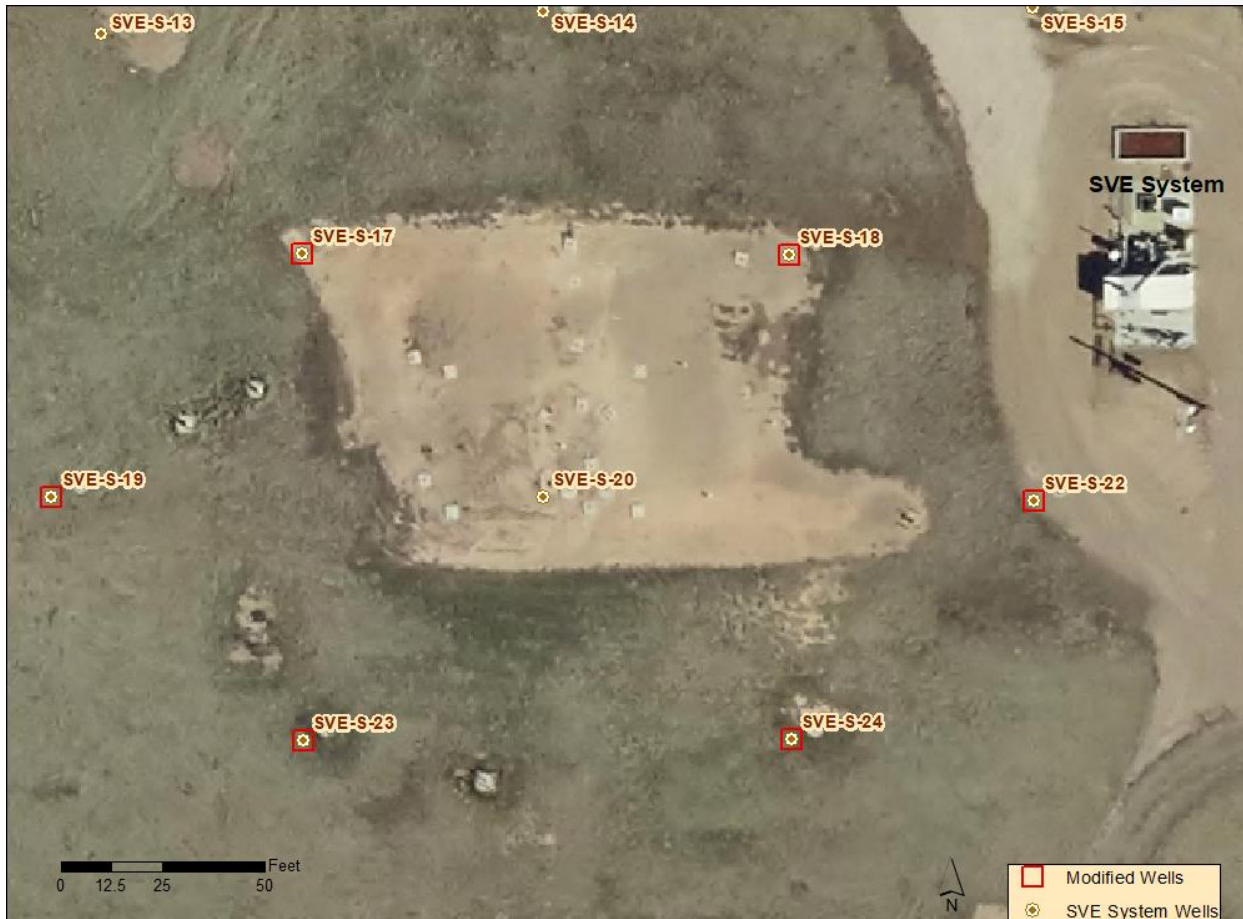
Soil Vapor Extraction System

Installed in February 2002

- Remedial goal to reduce the mass of Volatile Organic Compounds (VOCs) – highest historical concentration ~ 1845 ppmv; highest current concentration ~ 100 ppmv

System Information:

- Large-scale catalytic oxidation originally
- System transitioned to:
 - Activated carbon drums
 - Smaller blower motor for extraction
- Later replaced by more cost efficient small scale CatOx system (current system)
- Modified in May 2017 to increase air flow

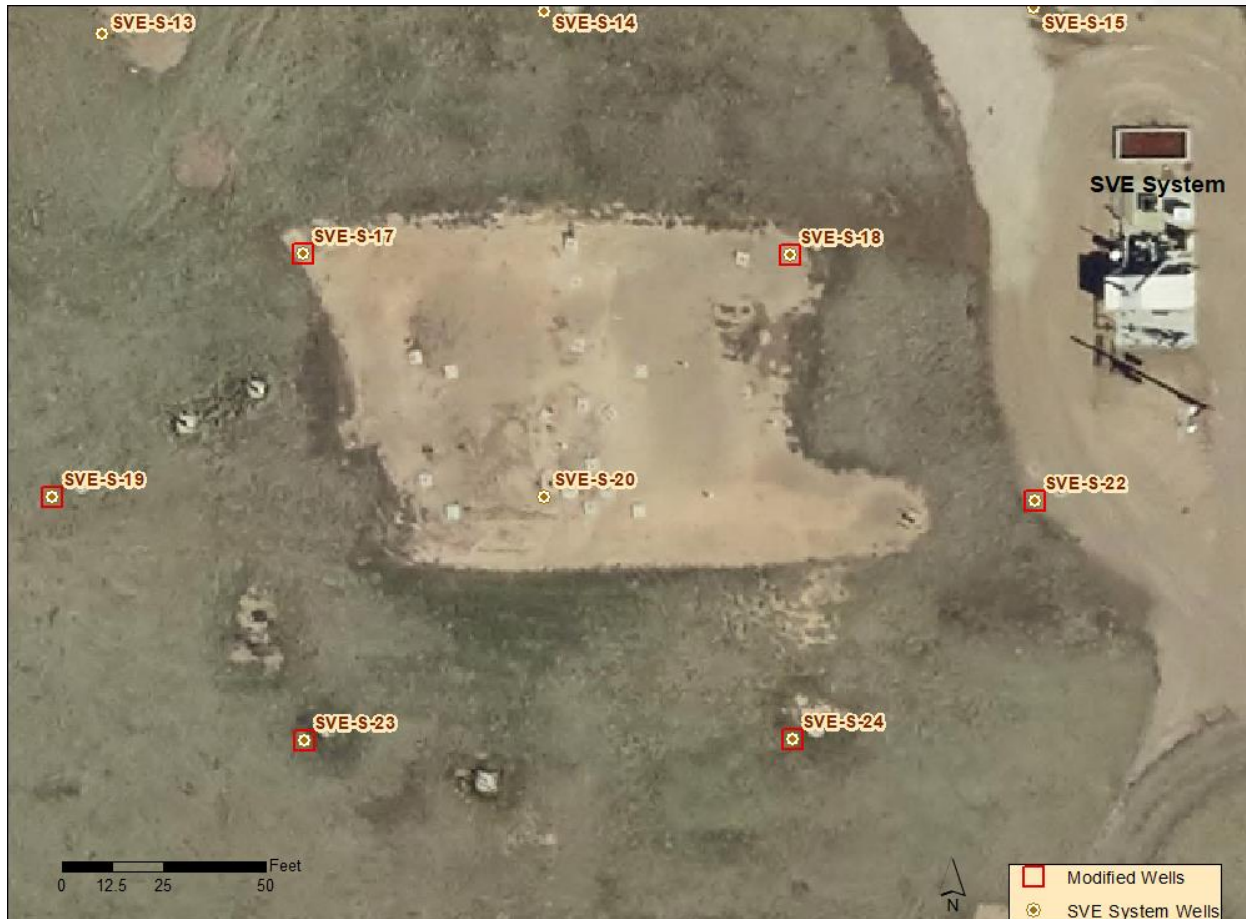
Soil Vapor Extraction System

Accomplishments: (July 2019 – June 2020)

- Removed 214 lbs of volatile organic compounds

Total VOCs removed since startup:
21,035 lbs
