## **Environmental Projects: Public Meeting**

**November 7, 2024**

# Current Pantex Remedial Action Systems

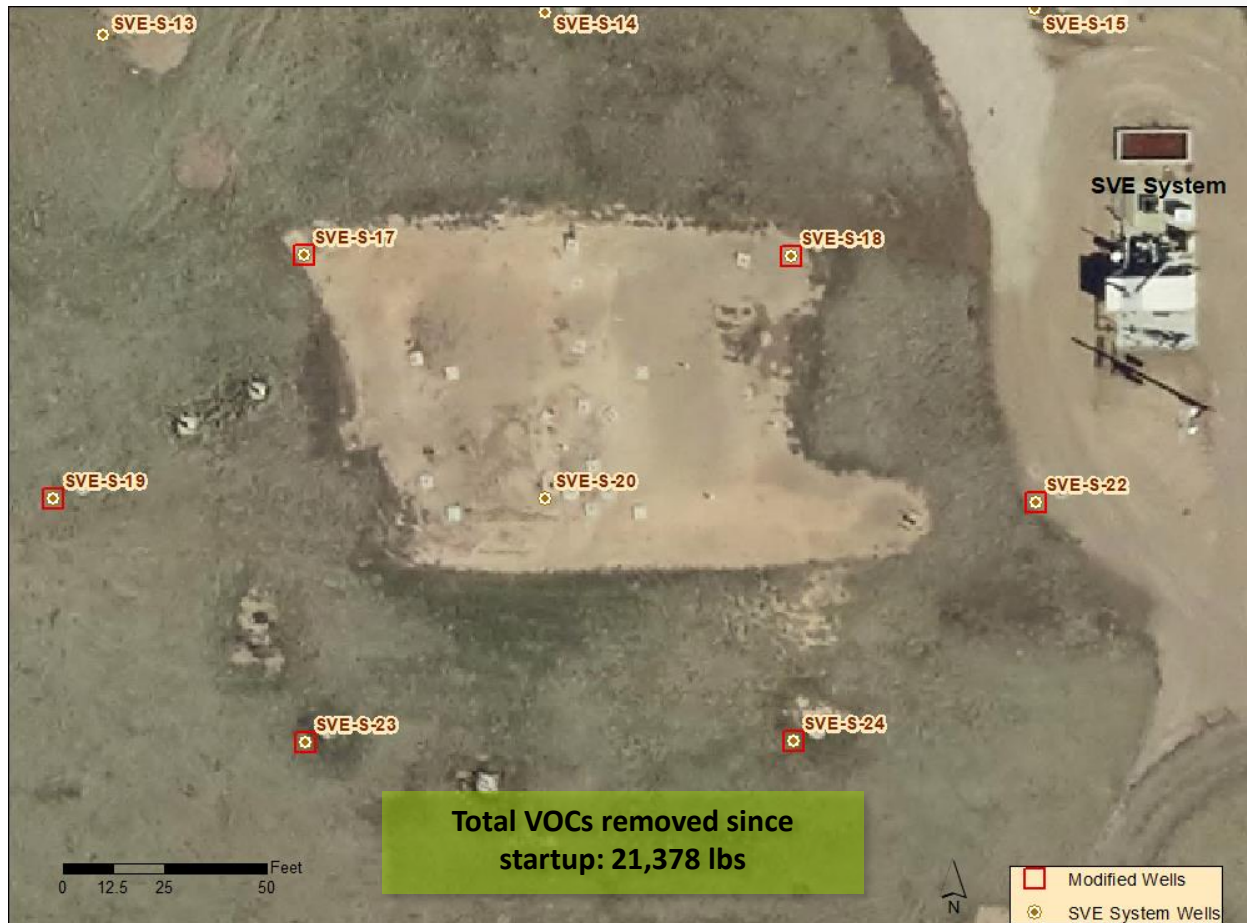
# Soil Vapor Extraction System

Installed in February 2002

- Remedial goal to reduce the mass of Volatile Organic Compounds (VOCs) – highest historical Toluene concentration ~ 1845 ppmv; highest current concentration ~ 59 ppmv

## Operations:

- Pulsed system in 2020 - 2023
- Closure report provided to EPA and TCEQ in August 2023 and approved in December 2023

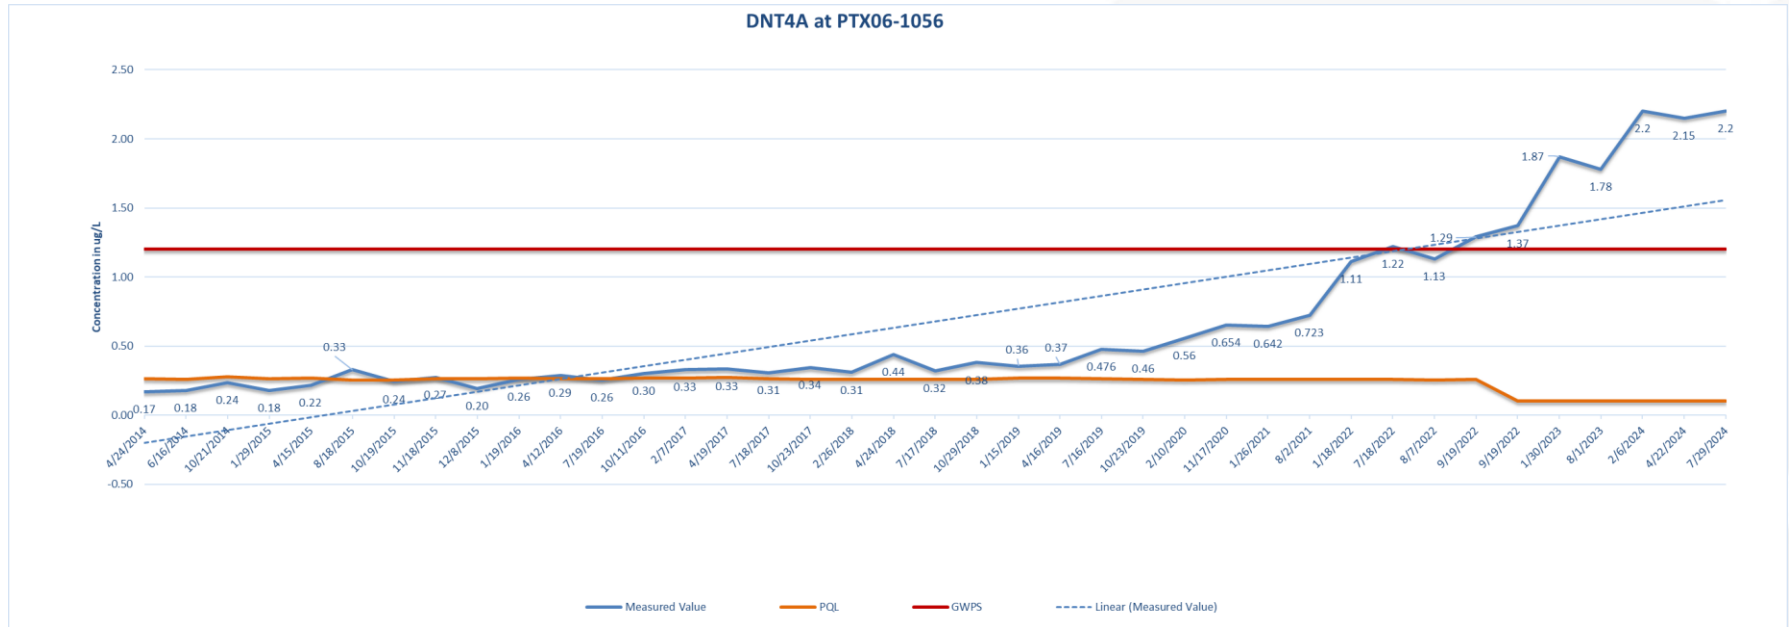
# Ogallala Detections (PTX06-1056)

- **PTX06-1056 (DNT4A)**

- First detected in April 2014 at 0.17 ppb, below the practical quantitation limit (PQL) of 0.262 ppb. Slow increasing trend throughout the years.
- In response to the detections of HEs, Pantex installed three new Ogallala monitoring wells in 2023 to investigate nature and extent of the contamination.
- New wells were installed in areas identified in earlier plume modeling for being at risk of vertical contaminant migration from the perched to the Ogallala Aquifer or within the Ogallala flow path.
