# PANTEX QUARTERLY PROGRESS REPORT

## Remedial Action Progress

### 1st Quarter 2020

In support of Hazardous Waste Permit #50284 and  
Pantex Plant Interagency Agreement  
June 2020

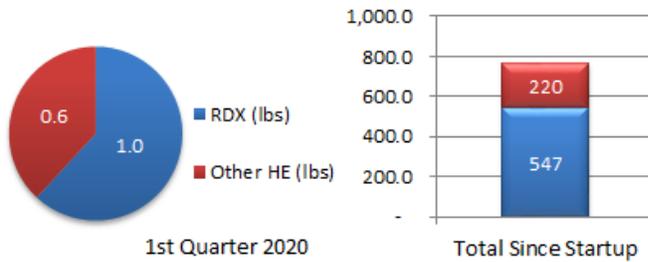
Figure 1. P1PTS Mass Removal

P1PTS primarily treats RDX and SEPTS primarily treats RDX and hexavalent chromium [Cr(VI)]. Figures 1 and 2 provide mass removal information for RDX and other high explosives (HEs) and Cr(VI) for the 1st Quarter, as well as totals since system startup. Concentrations near Playa 1 are much lower due to declining source concentrations therefore, mass removal is much lower at P1PTS. The primary goal of P1PTS is water removal to decrease saturated thickness and remove the head pressure that pushes groundwater out horizontally, with mass removal as a secondary goal. Overall, the systems have removed over 15,200 lbs of HE and chromium contaminants from perched groundwater since operations began.

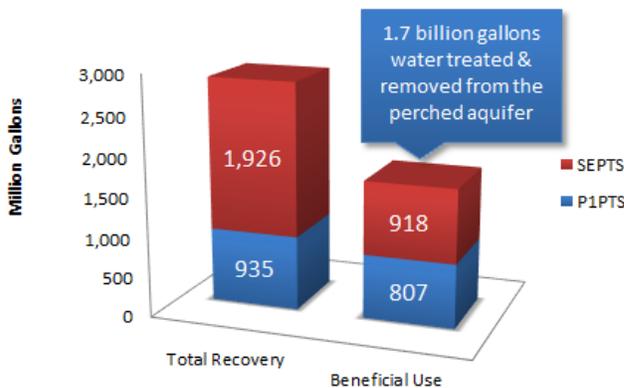
Figure 3. System Recovery and Use

water has been used beneficially since 2005, with a total of over 1.7 billion gallons of treated water beneficially used since startup of the irrigation system. The recovery and beneficial use totals are presented in Figure 3. Currently the systems are releasing water to the WWTF and then to Playa 1 or to injection wells, so most of the treated water is not currently beneficially used. Evaluation of effluent data from both systems indicates that all COCs were treated to levels below the groundwater protection standard (GWPS).

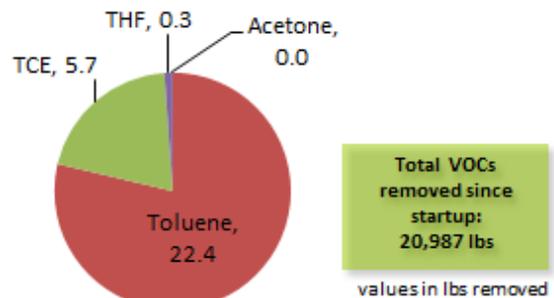
Figure 4. SVE Mass Removal

The system removed ~ 28 lbs of VOCs during the 1st quarter but has removed about 21,000 lbs of VOCs since startup. Based on PID data collected at the system effluent port, system destruction efficiency was at least 92%. The system operated at a higher flow due to the modifications to the system, with the flow increased from 32 standard cubic feet per minute (scfm) in early 2017 to the current level of 44 scfm. The hourly VOC removal rates increased with the increased flow until 4th Quarter 2018. The removal rate declined during 2018, but began to improve over the first 2 quarters of 2019. In the 3<sup>rd</sup> and 4th quarter of 2019, removal rates decreased and continue to remain low in the 1st quarter 2020. As concentrations continue to drop below 100 ppmv, Pantex is actively working on detailed plan to pulse the system to determine current recovery efforts of the system. A more detailed discussion is included in the 2019 Annual Report (submission June 2020).

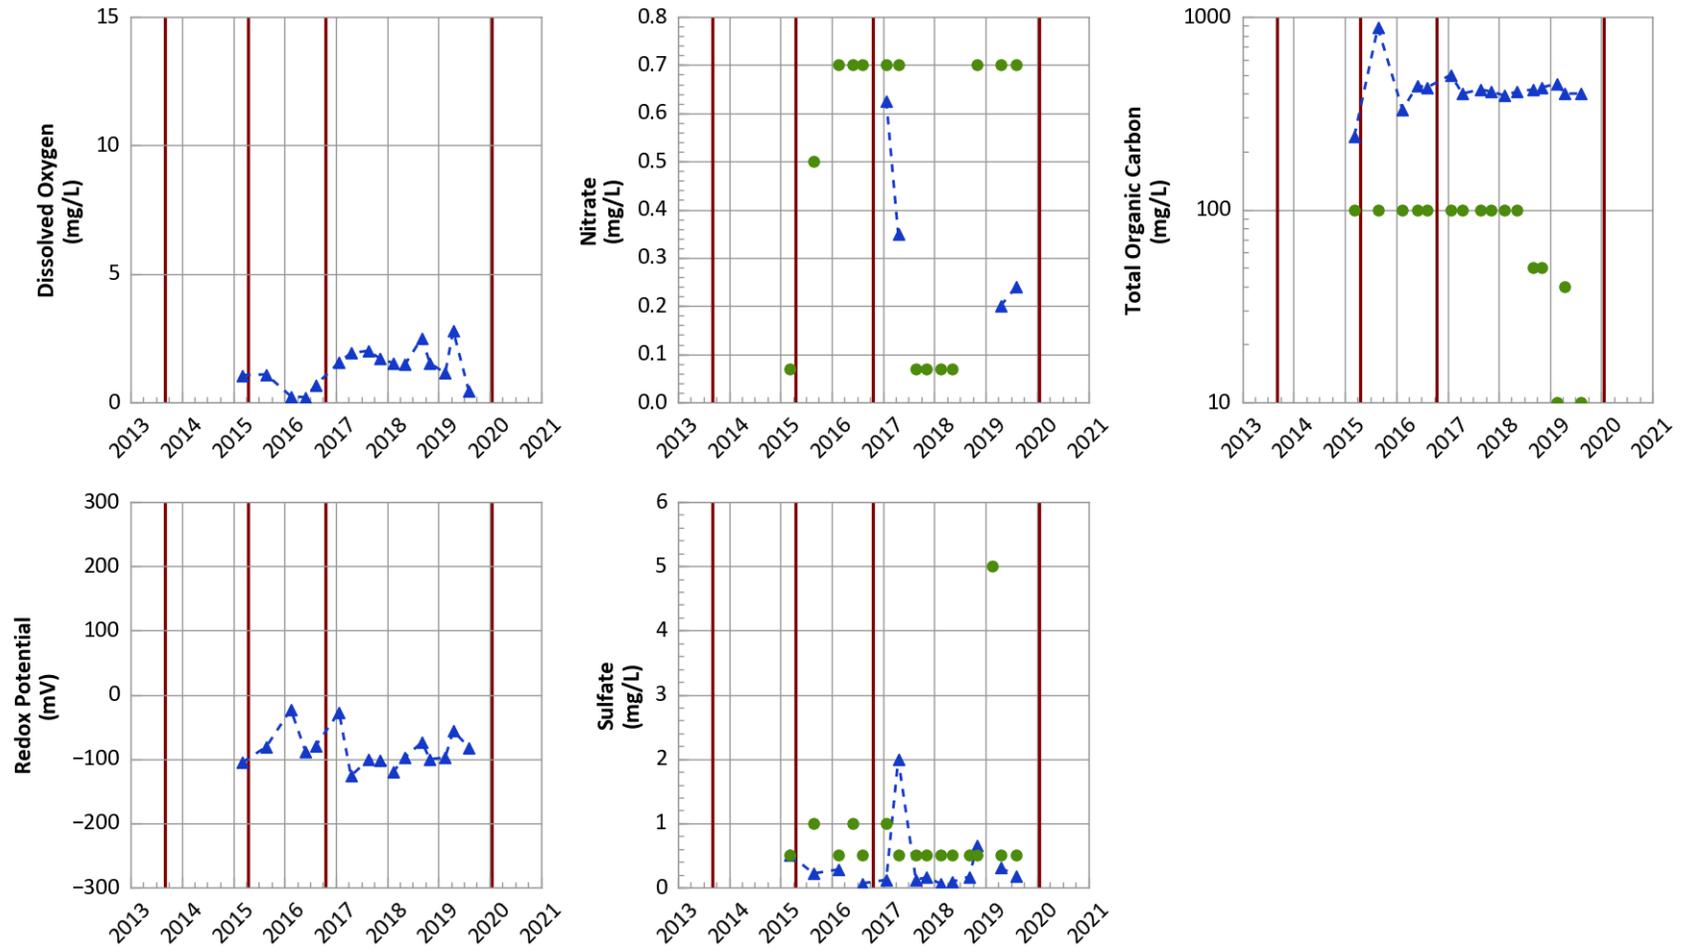
PTX06-ISB030B Treatment Zone Performance Indicators  
USDOE/NNSA Pantex Plant

Dissolved Oxygen: 5-10 mg/L  
 Redox Potential: > 100 mV  
 Nitrate: > 1 mg/L  
 Sulfate: > 10 mg/L  
 Total Organic Carbon: < 5 mg/L  
 Total Volatile Fatty Acids: Not Detected

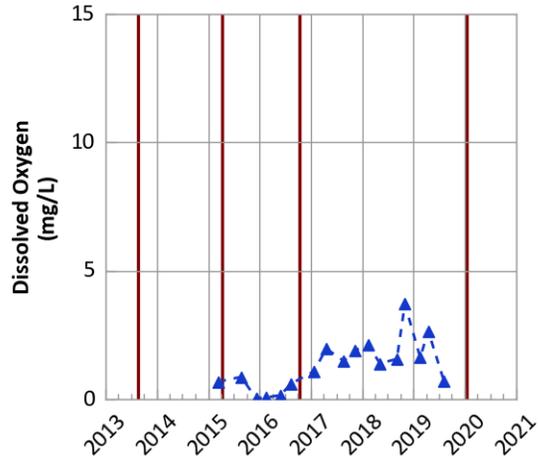
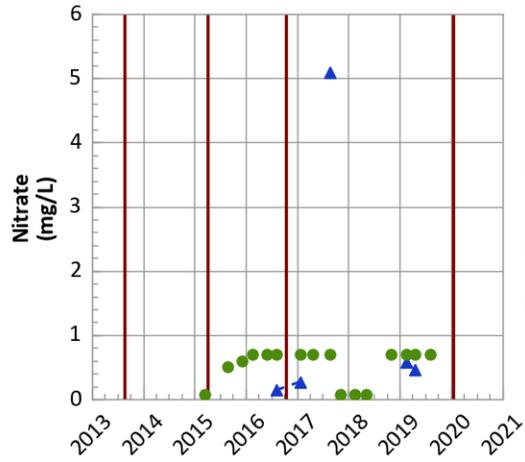
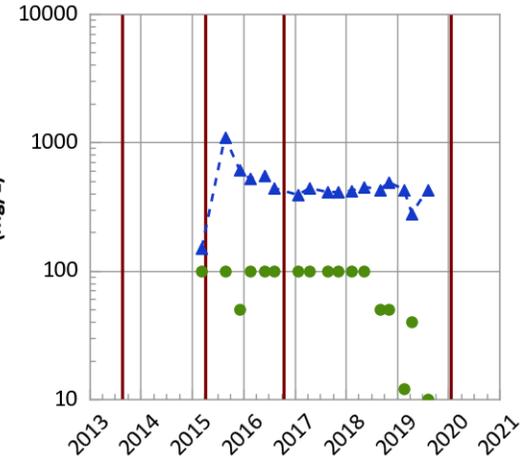
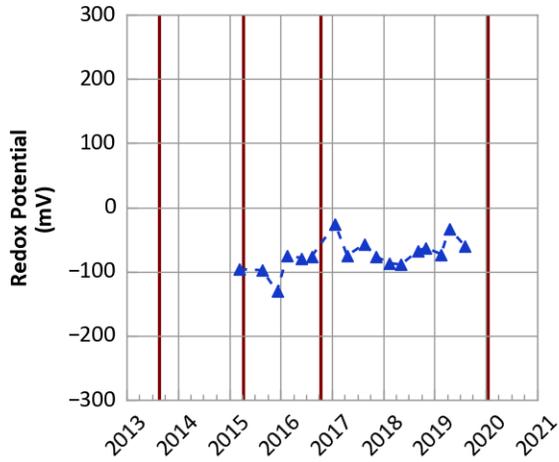
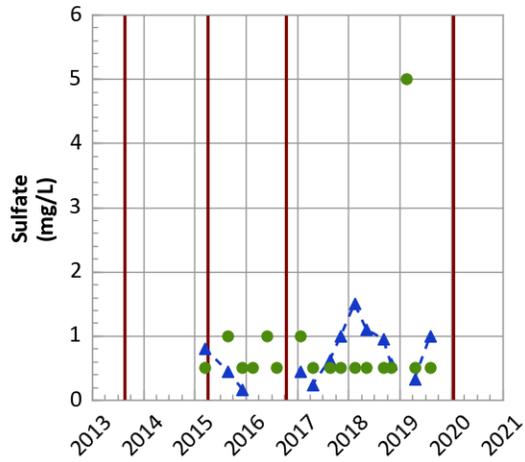
**PTX06-ISB038 Treatment Zone Performance Indicators  
USDOE/NNSA Pantex Plant**

- Dissolved Oxygen: 5-10 mg/L
- Redox Potential: > 100 mV
- Nitrate: > 1 mg/L
- Sulfate: > 10 mg/L
- Total Organic Carbon: < 5 mg/L
- Total Volatile Fatty Acids: Not Detected

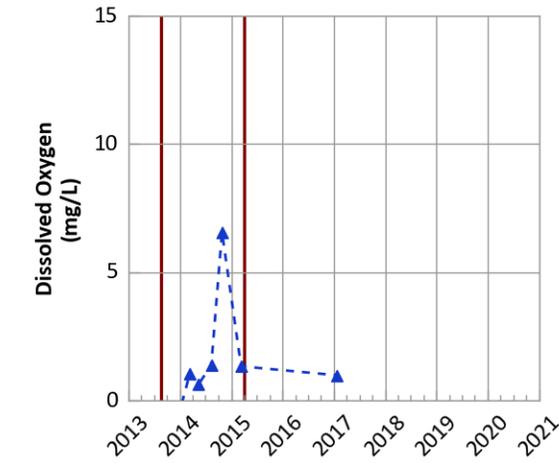
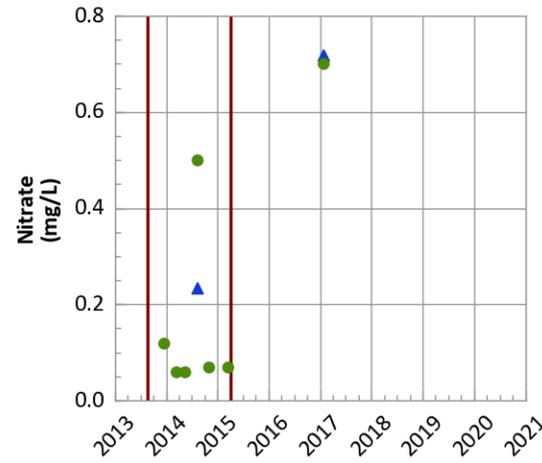
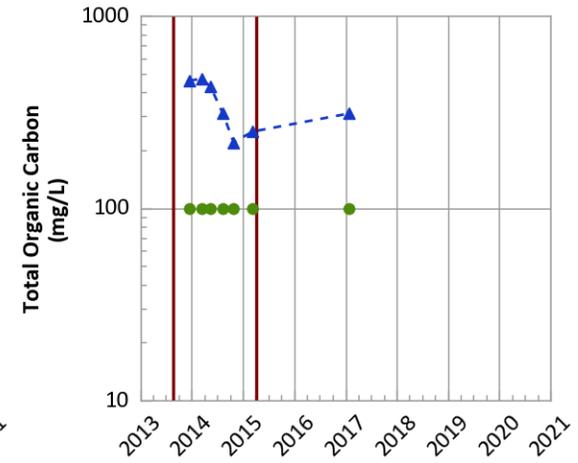
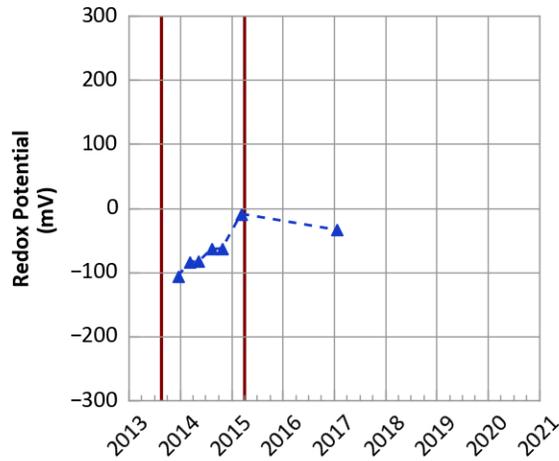
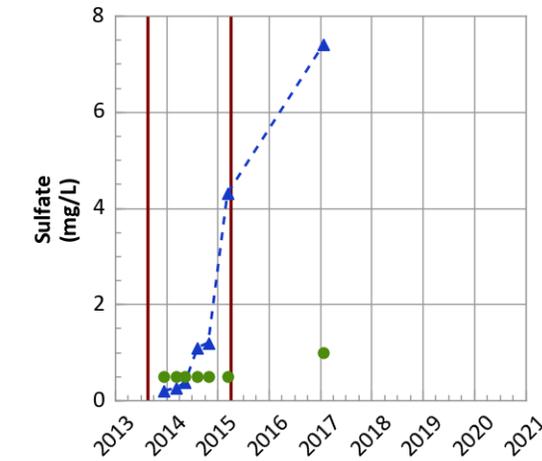
PTX06-ISB042 Treatment Zone Performance Indicators  
USDOE/NNSA Pantex Plant

Dissolved Oxygen: 5-10 mg/L  
 Redox Potential: > 100 mV  
 Nitrate: > 1 mg/L  
 Sulfate: > 10 mg/L  
 Total Organic Carbon: < 5 mg/L  
 Total Volatile Fatty Acids: Not Detected

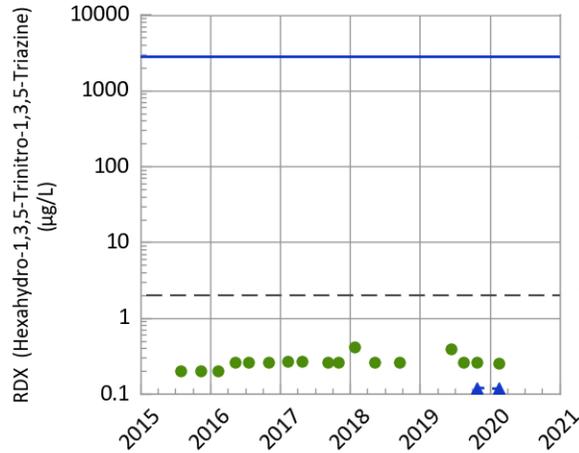
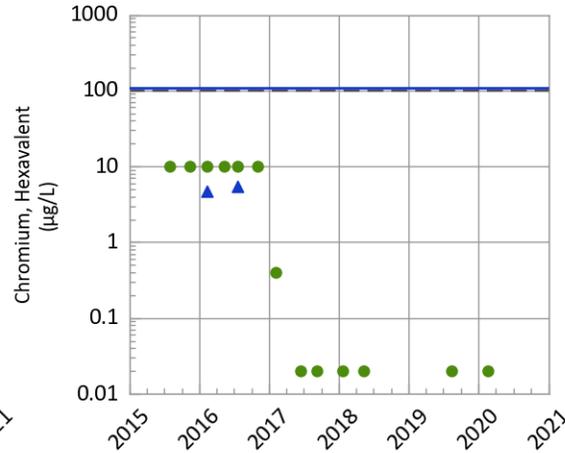
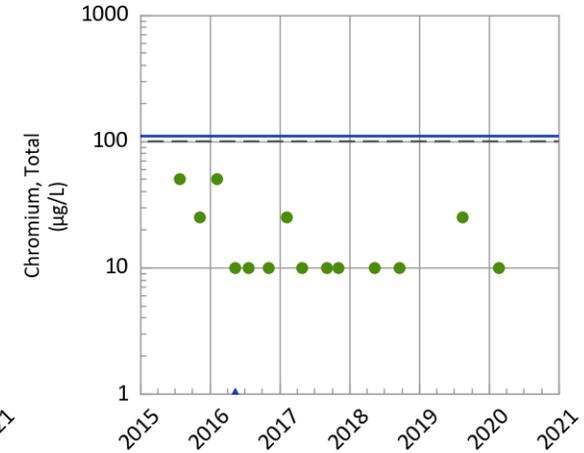
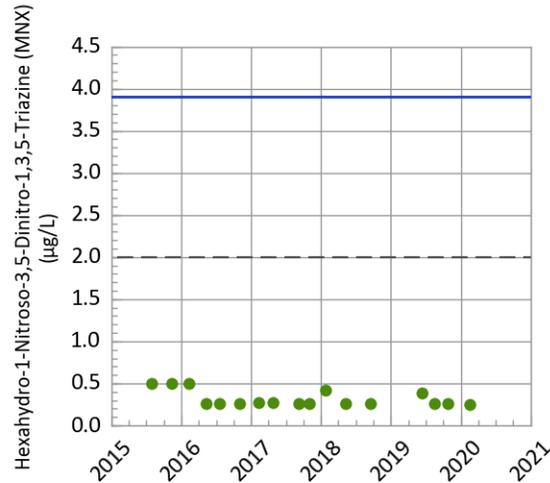
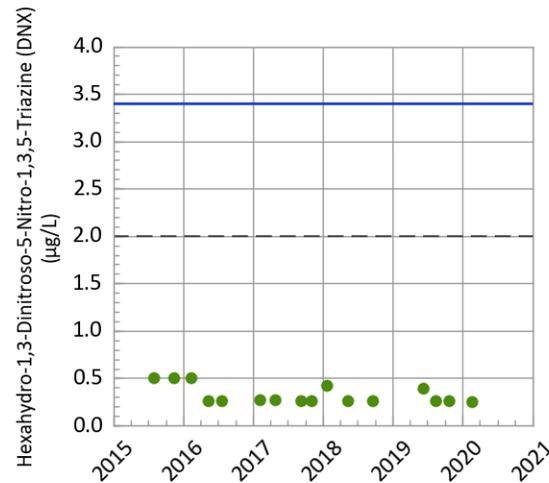
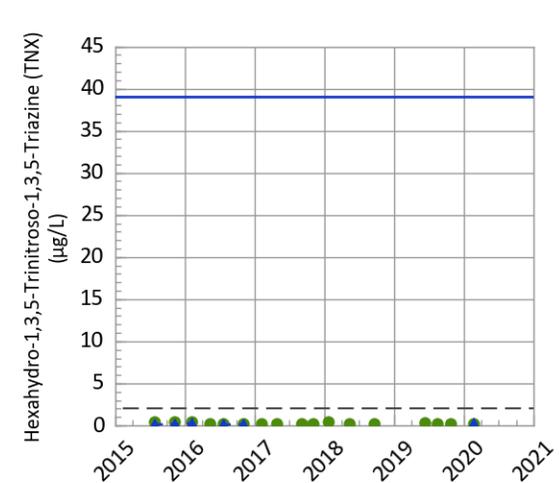
**PTX06-1037 Downgradient Performance Indicators  
Southeast In Situ Bioremediation System  
USDOE/NNSA Pantex Plant**

COC	Concentration (µg/L)	GWPS (µg/L)
RDX	0.12	2.0
MNX	Non-Detect	2.0
CR-6	Non-Detect	100.0
DNX	Non-Detect	2.0
CR	Non-Detect	100.0
TNX	0.19	2.0

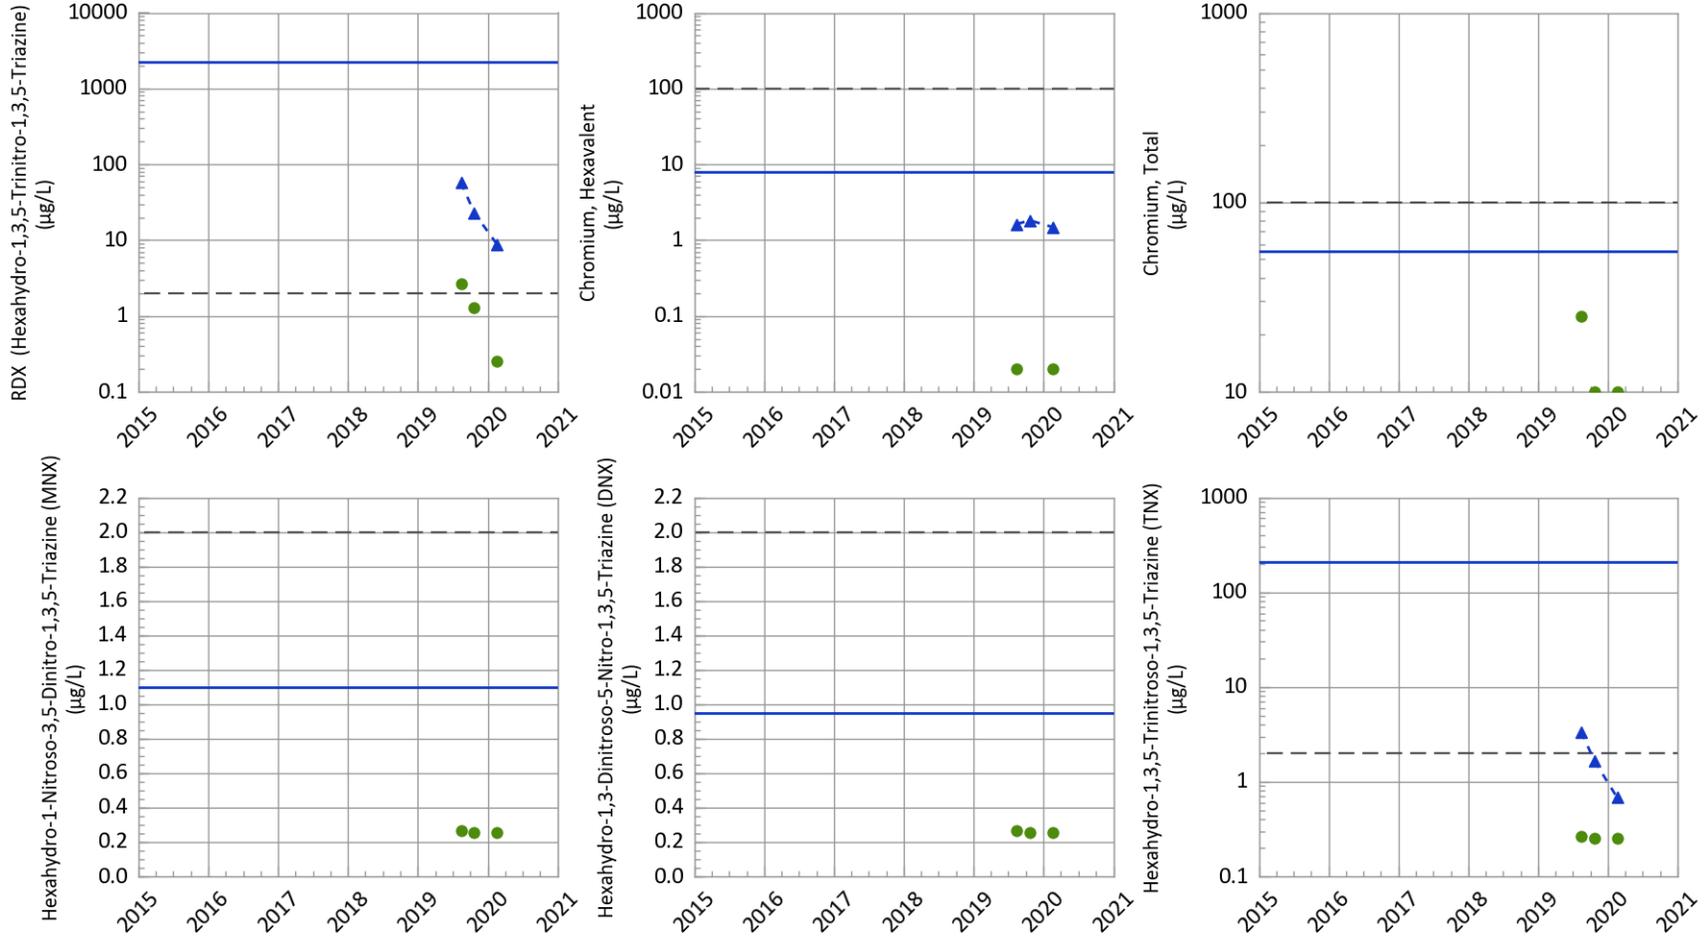
**PTX06-1045 Downgradient Performance Indicators  
Southeast In Situ Bioremediation System  
USDOE/NNSA Pantex Plant**

Most Recent Measured COC Concentrations (Feb 18, 2020)

COC	Concentration ( $\mu\text{g/L}$ )	GWPS ( $\mu\text{g/L}$ )
RDX	8.86	2.0
MNX	Non-Detect	2.0
CR-6	1.48	100.0
DNX	Non-Detect	2.0
CR	Non-Detect	100.0
TNX	0.68	2.0

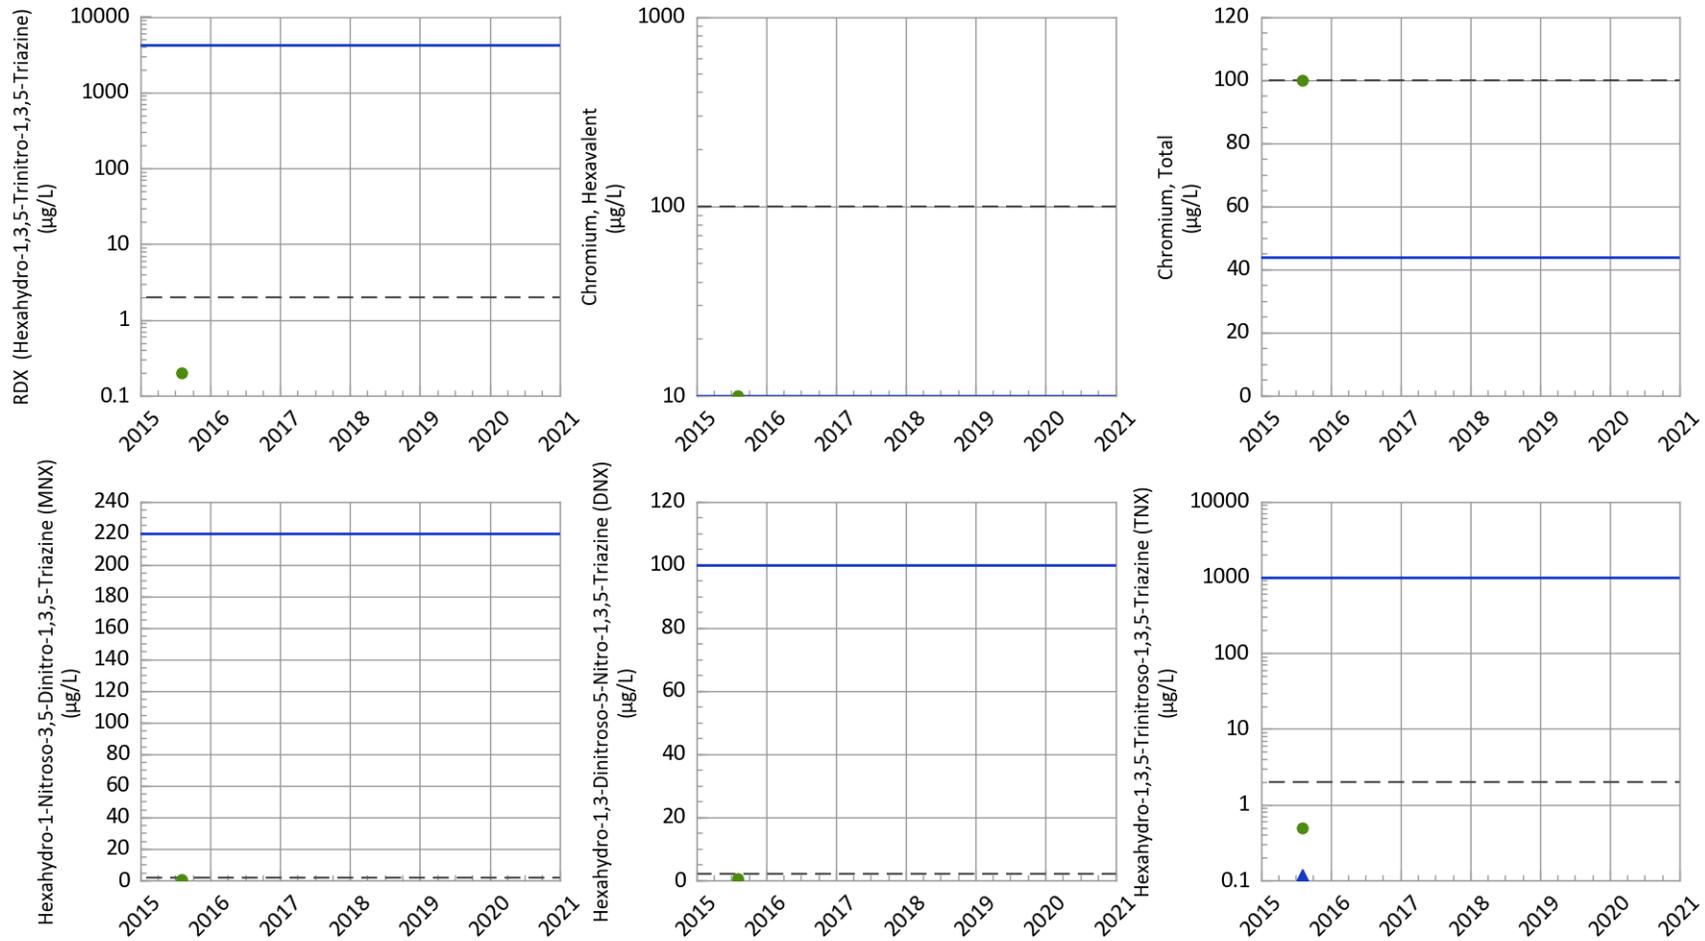
**PTX06-1123 Downgradient Performance Indicators  
Southeast In Situ Bioremediation System  
USDOE/NNSA Pantex Plant**

<sup>2</sup> Pantex formerly sampled four downgradient wells at this system. However, one of the wells (PTX06-1123) continues to demonstrate low water conditions and can no longer be sampled. This well had demonstrated complete treatment of HEs and Cr(VI) from October 2012 to August 2015. PTX06-1037 was sampled for limited analytes this quarter due to low water levels. PTX06-1045, PTX06-1153 and PTX06-1154 were all sampled this quarter.

Most Recent Measured COC Concentrations (Aug 05, 2015)

COC	Concentration ( $\mu\text{g/L}$ )	GWPS ( $\mu\text{g/L}$ )
RDX	Non-Detect	2.0
MNX	Non-Detect	2.0
CR-6	Non-Detect	100.0
DNX	Non-Detect	2.0
CR	Non-Detect	100.0
TNX	0.12	2.0

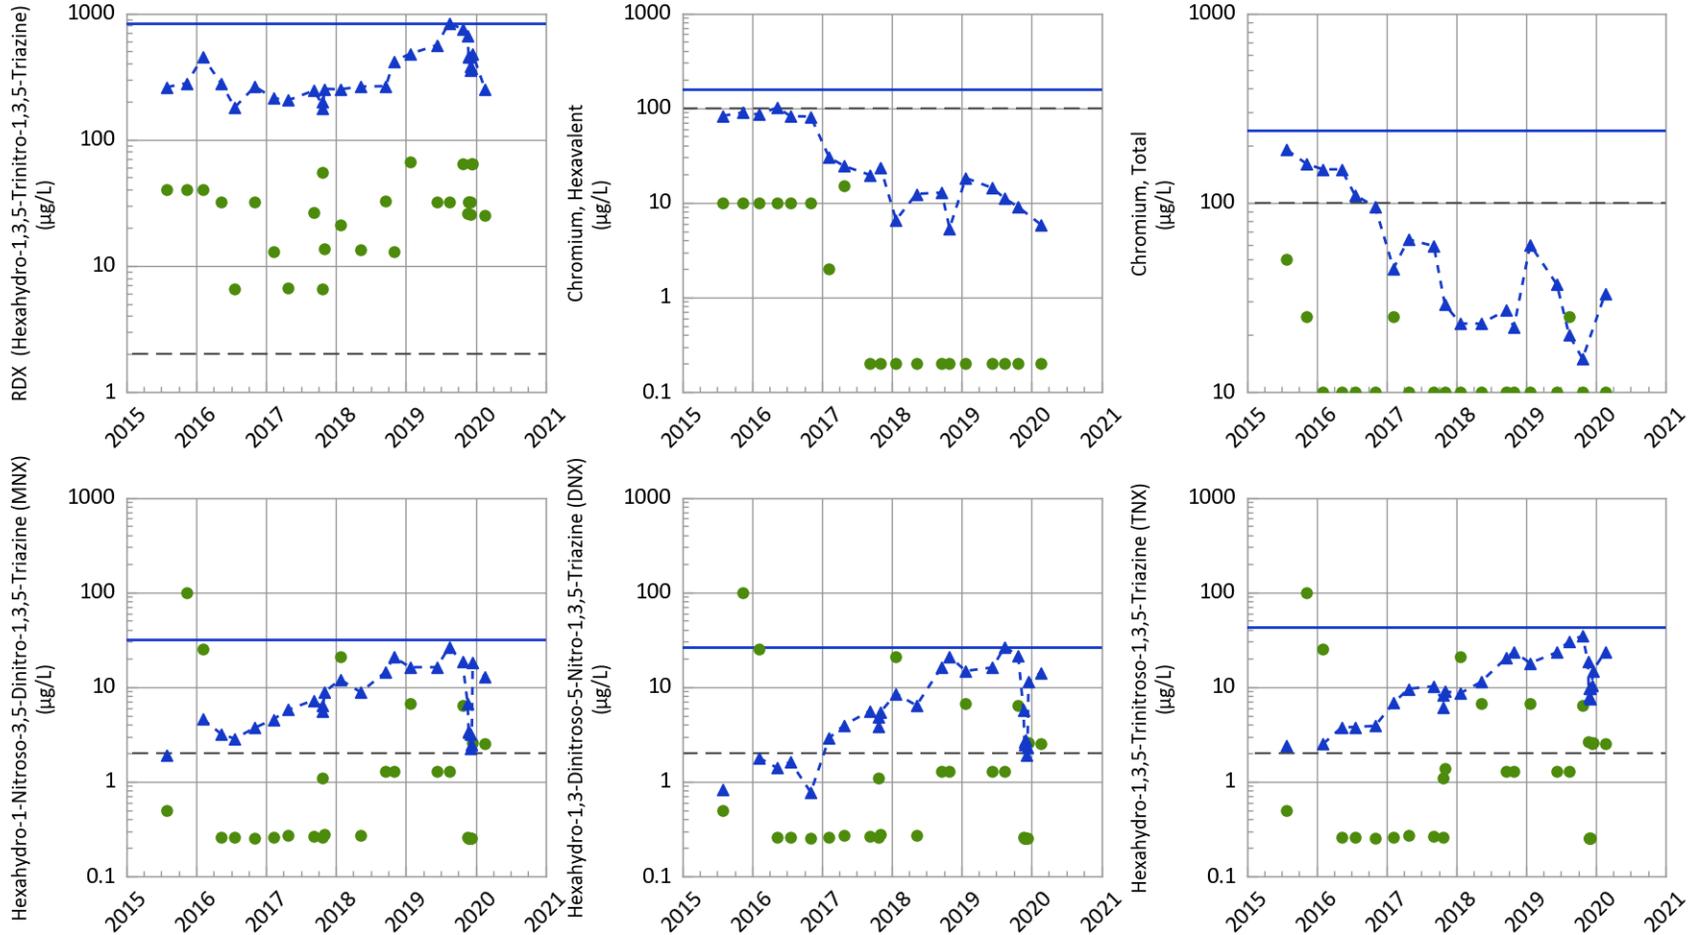
**PTX06-1153 Downgradient Performance Indicators  
Southeast In Situ Bioremediation System  
USDOE/NNSA Pantex Plant**

<sup>3</sup> PTX06-1153 is currently demonstrating partial treatment. Therefore, the degradation products of RDX are now observed above the GWPS.

Four downgradient wells were sampled during the 1st quarter. One of the closest downgradient monitoring wells for the Southeast ISB, PTX06-1154, demonstrates reduction of RDX, RDX degradation products, and Cr(VI), with all COCs below GWPS. PTX06-1123 had demonstrated COC concentrations below the GWPS until August 2015 when water levels dropped and the well could no longer be sampled. PTX06-1037 also demonstrated treatment from October 2011 through September 2018. Limited sampling has occurred at this well since November 2017 due to declining water levels. The last HE sample collected at PTX06-1037 indicates that the primary COCs continue to be treated to non-detect. PTX06-1153 continues to exhibit RDX concentrations above the GWPS, but Cr(VI) concentrations remain below the GWPS. During the 1st Quarter, this well continued to demonstrate signs of partial treatment. Breakdown products of RDX were detected at concentrations above the GWPS (ranging from 0.4 to 25.4 µg/L). In an effort to affect treatment at the well, Pantex extracted water from the well at ~ 1.25 gpm over 2 weeks in the 4th quarter of 2019, though it is unknown at this time how this will affect treatment long term. Pantex will continue to monitor PTX06-1153 for contaminant concentrations and water levels over time to see if treated water extends to the well. It is expected that injection with molasses will improve treatment conditions and affect PTX06-1153 in the future.

Most Recent Measured COC Concentrations (Feb 18, 2020)

COC	Concentration (µg/L)	GWPS (µg/L)
RDX	252.0	2.0
MNX	12.8	2.0
CR-6	5.89	100.0
DNX	14.2	2.0
CR	33.0	100.0
TNX	23.5	2.0

COC concentrations meet the GWPS at the Southeast ISB at three downgradient wells. One downgradient well (PTX06-1153) for the Southeast ISB is not responding to treatment as well as the others. Pantex injected molasses during the recent injection event to attempt better distribution of the amendment and will monitor the results over time to determine if the injection will impact the water moving into that area. Monitoring will continue at PTX06-1153 as described in the SAP. Further recommendations will be made based on evaluation of data over time.

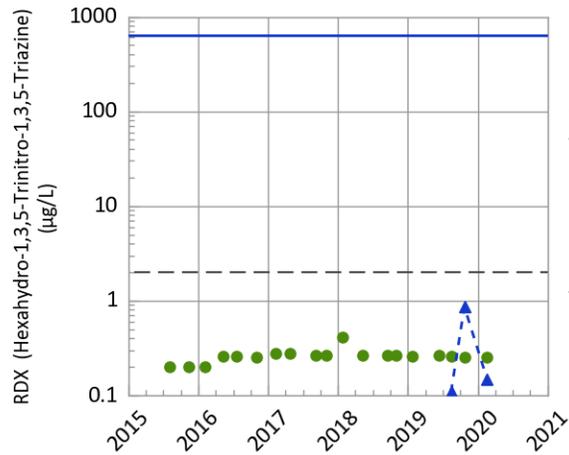
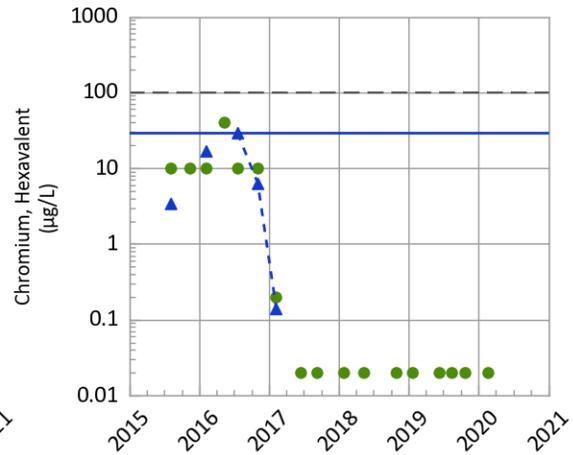
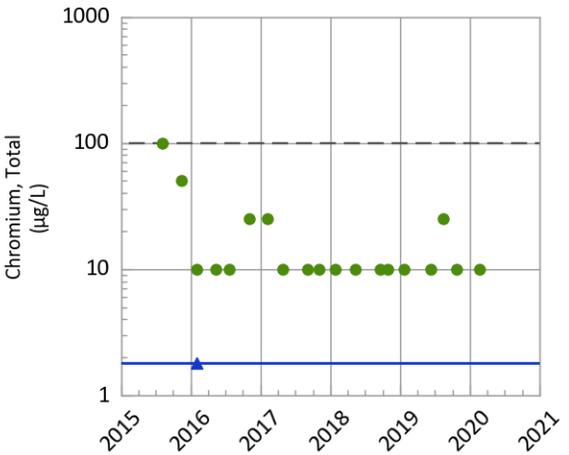
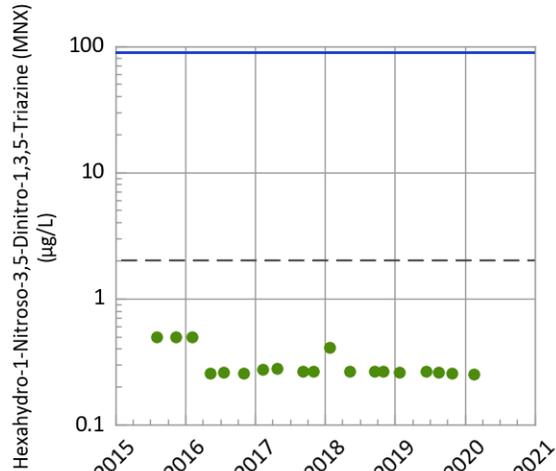
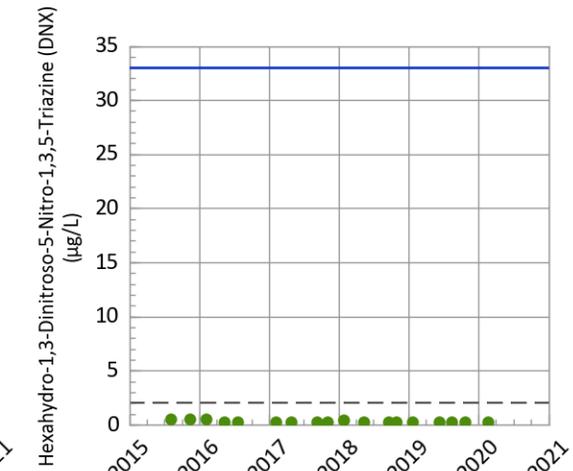
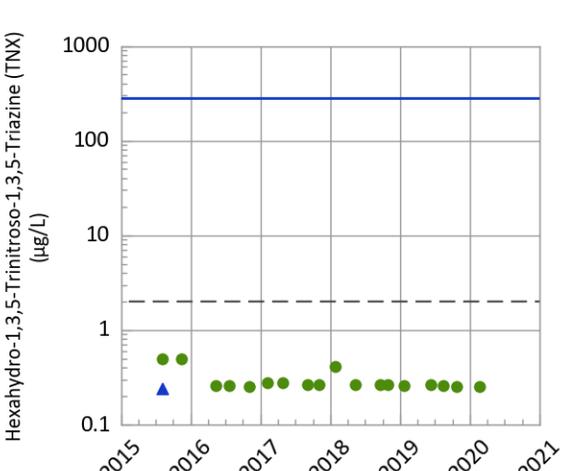
**PTX06-1154 Downgradient Performance Indicators  
Southeast In Situ Bioremediation System  
USDOE/NNSA Pantex Plant**

COC	Concentration (µg/L)	GWPS (µg/L)
RDX	0.15	2.0
MNX	Non-Detect	2.0
CR-6	Non-Detect	100.0
DNX	Non-Detect	2.0
CR	Non-Detect	100.0
TNX	Non-Detect	2.0

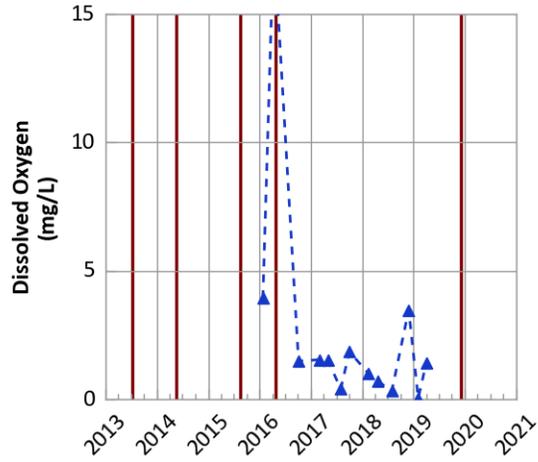
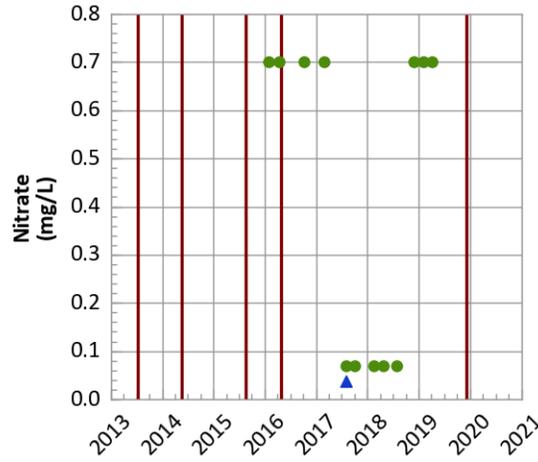
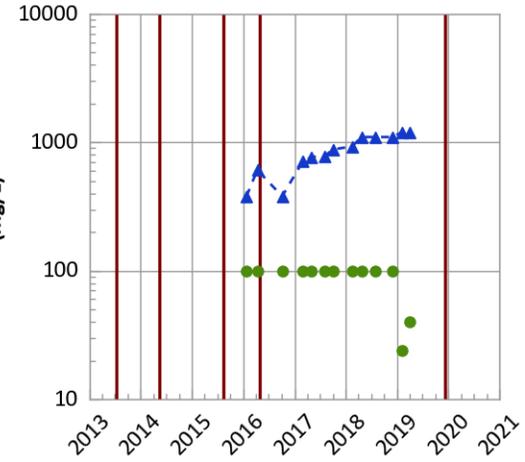
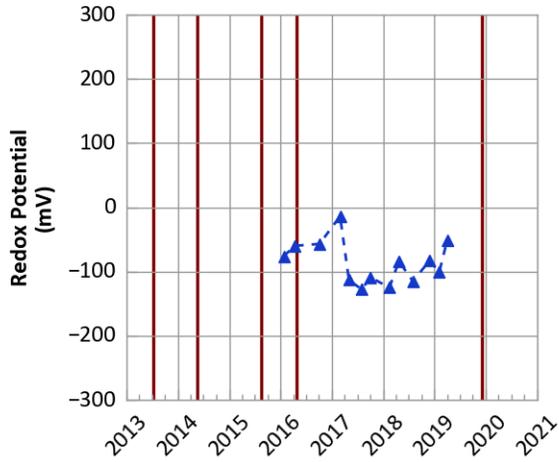
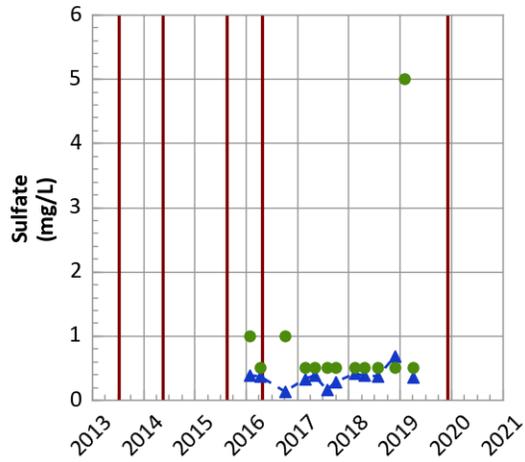
**PTX06-ISB055 Treatment Zone Performance Indicators  
USDOE/NNSA Pantex Plant**

**Typical Baseline Concentrations in Perched Groundwater**

- Dissolved Oxygen: 5-10 mg/L
- Redox Potential: > 100 mV
- Nitrate: > 1 mg/L
- Sulfate: > 10 mg/L
- Total Organic Carbon: < 5 mg/L
- Total Volatile Fatty Acids: Not Detected

Evaluation of data in the treatment zone indicates mild to strong reducing conditions (ORP ranging from -153 to -46 and sulfate from 0.85 to 28  $\mu\text{g}/\text{L}$ ) across the Zone 11 ISB. Monitored conditions inside the treatment zone indicate that sulfate was reduced in three of six wells and negative ORP in six of six wells, indicating deeper reducing conditions in those areas. Conditions improved at most of the non-injected wells in the expansion area, following the molasses/EVO injection in 2018. TCE continues to be reduced to cis-1,2-dichloroethene (DCE), with TCE concentrations below GWPS in two monitored wells inside of the treatment zone and cis-1,2-DCE present at concentrations below the GWPS in four of the six monitored wells. The presence of TCE and cis-1,2-DCE continues to indicate partial treatment in the non-injected treatment zone wells, as concentrations tend to be higher in the non-injected wells. When greater amounts of TCE and cis-1,2-DCE are being degraded, ethene and vinyl chloride are expected to be detected. Vinyl chloride was detected in four wells inside the treatment zone and ethene was detected in two wells. The low vinyl chloride results, coupled with the minimal detection of ethene, indicates that a portion of the TCE is being completely degraded in some areas of the treatment zone. When TCE concentrations inside the treatment zone are low ( $< 300\mu\text{g}/\text{L}$ ), these low degradation rates may be enough to treat TCE and its breakdown products to GWPS, as indicated by downgradient monitoring well data. Upgradient data still indicate TCE concentrations periodically fluctuating above 300  $\mu\text{g}/\text{L}$ , with a concentration of 1500  $\mu\text{g}/\text{L}$  indicated at an upgradient monitoring well in late 2018.

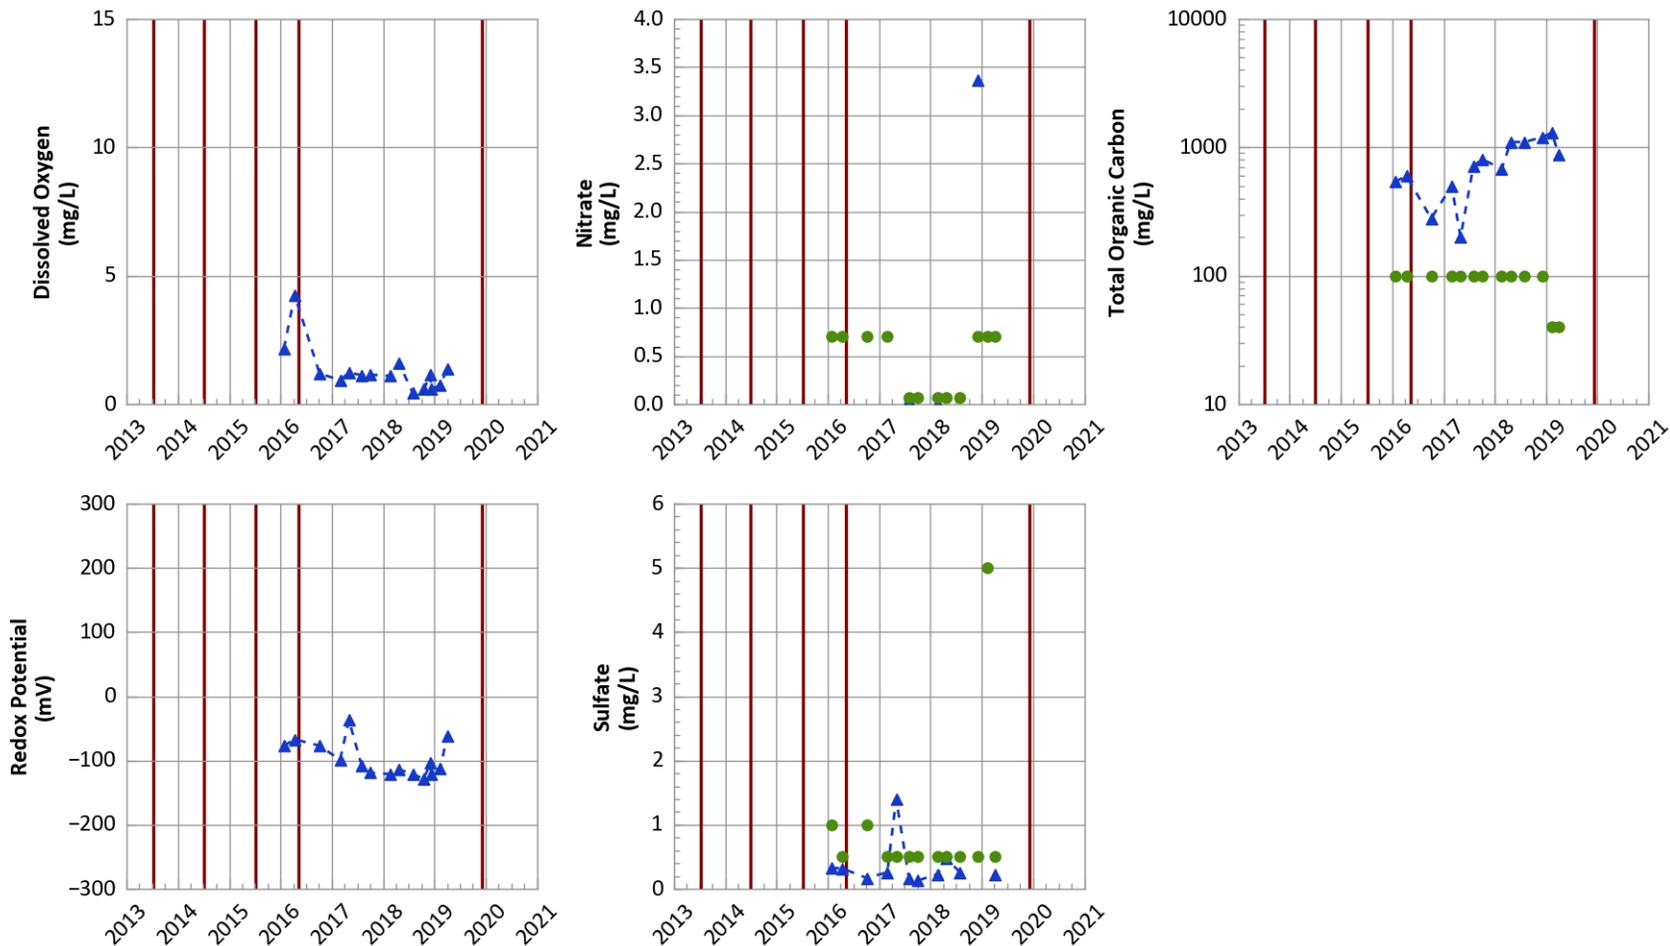
**PTX06-ISB059 Treatment Zone Performance Indicators  
USDOE/NNSA Pantex Plant**

**Typical Baseline Concentrations in Perched Groundwater**

Dissolved Oxygen: 5-10 mg/L  
 Redox Potential: > 100 mV  
 Nitrate: > 1 mg/L  
 Sulfate: > 10 mg/L  
 Total Organic Carbon: < 5 mg/L  
 Total Volatile Fatty Acids: Not Detected

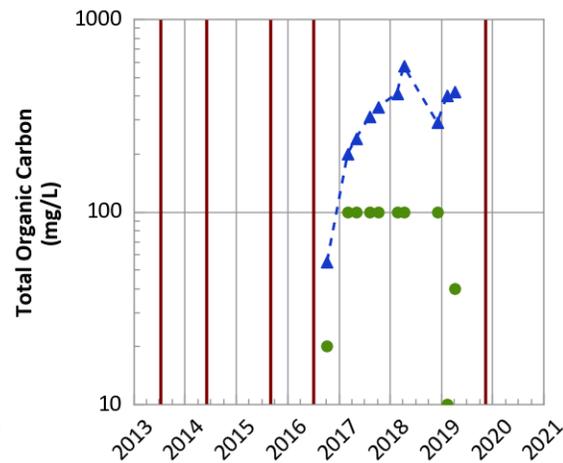
PTX06-ISB071 Treatment Zone Performance Indicators  
USDOE/NNSA Pantex Plant

Typical Baseline Concentrations in Perched Groundwater

- Dissolved Oxygen: 5-10 mg/L
- Redox Potential: > 100 mV
- Nitrate: > 1 mg/L
- Sulfate: > 10 mg/L
- Total Organic Carbon: < 5 mg/L
- Total Volatile Fatty Acids: Not Detected

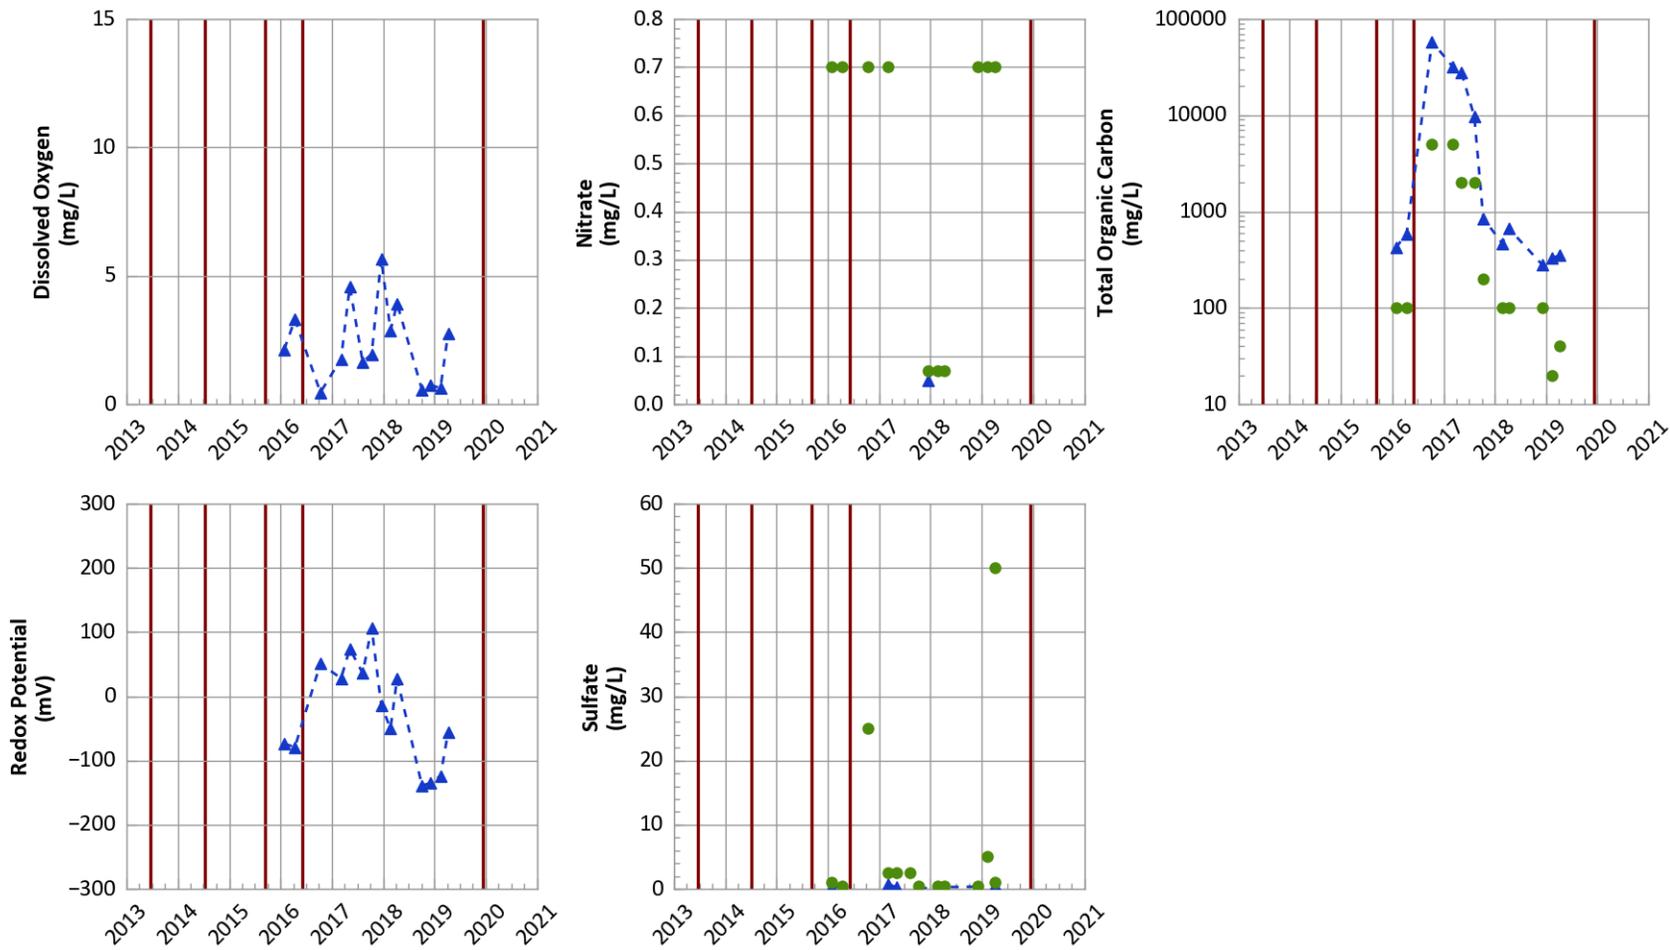
PTX06-ISB073 Treatment Zone Performance Indicators  
USDOE/NNSA Pantex Plant

Typical Baseline Concentrations in Perched Groundwater

Dissolved Oxygen: 5-10 mg/L  
 Redox Potential: > 100 mV  
 Nitrate: > 1 mg/L  
 Sulfate: > 10 mg/L  
 Total Organic Carbon: < 5 mg/L  
 Total Volatile Fatty Acids: Not Detected

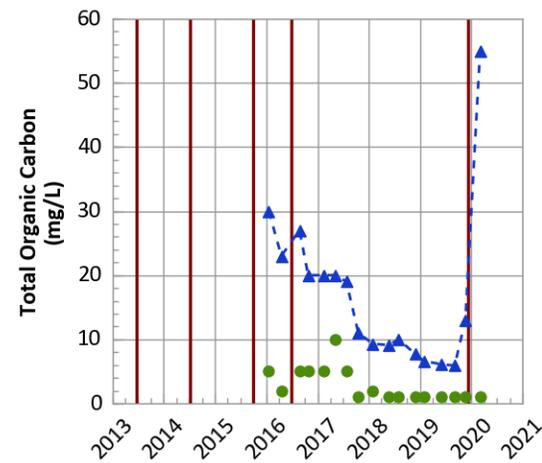
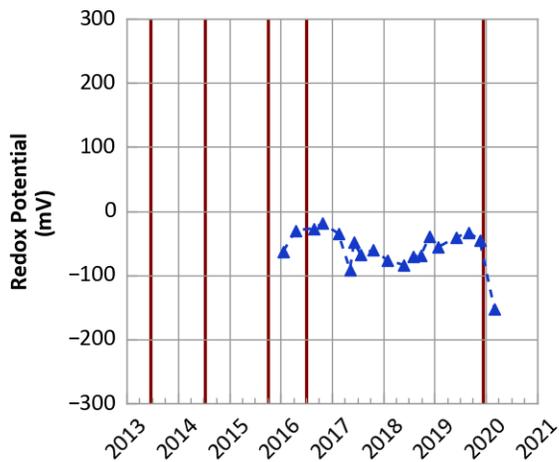
PTX06-ISB075 Treatment Zone Performance Indicators  
USDOE/NNSA Pantex Plant

Typical Baseline Concentrations in Perched Groundwater

- Dissolved Oxygen: 5-10 mg/L
- Redox Potential: > 100 mV
- Nitrate: > 1 mg/L
- Sulfate: > 10 mg/L
- Total Organic Carbon: < 5 mg/L
- Total Volatile Fatty Acids: Not Detected

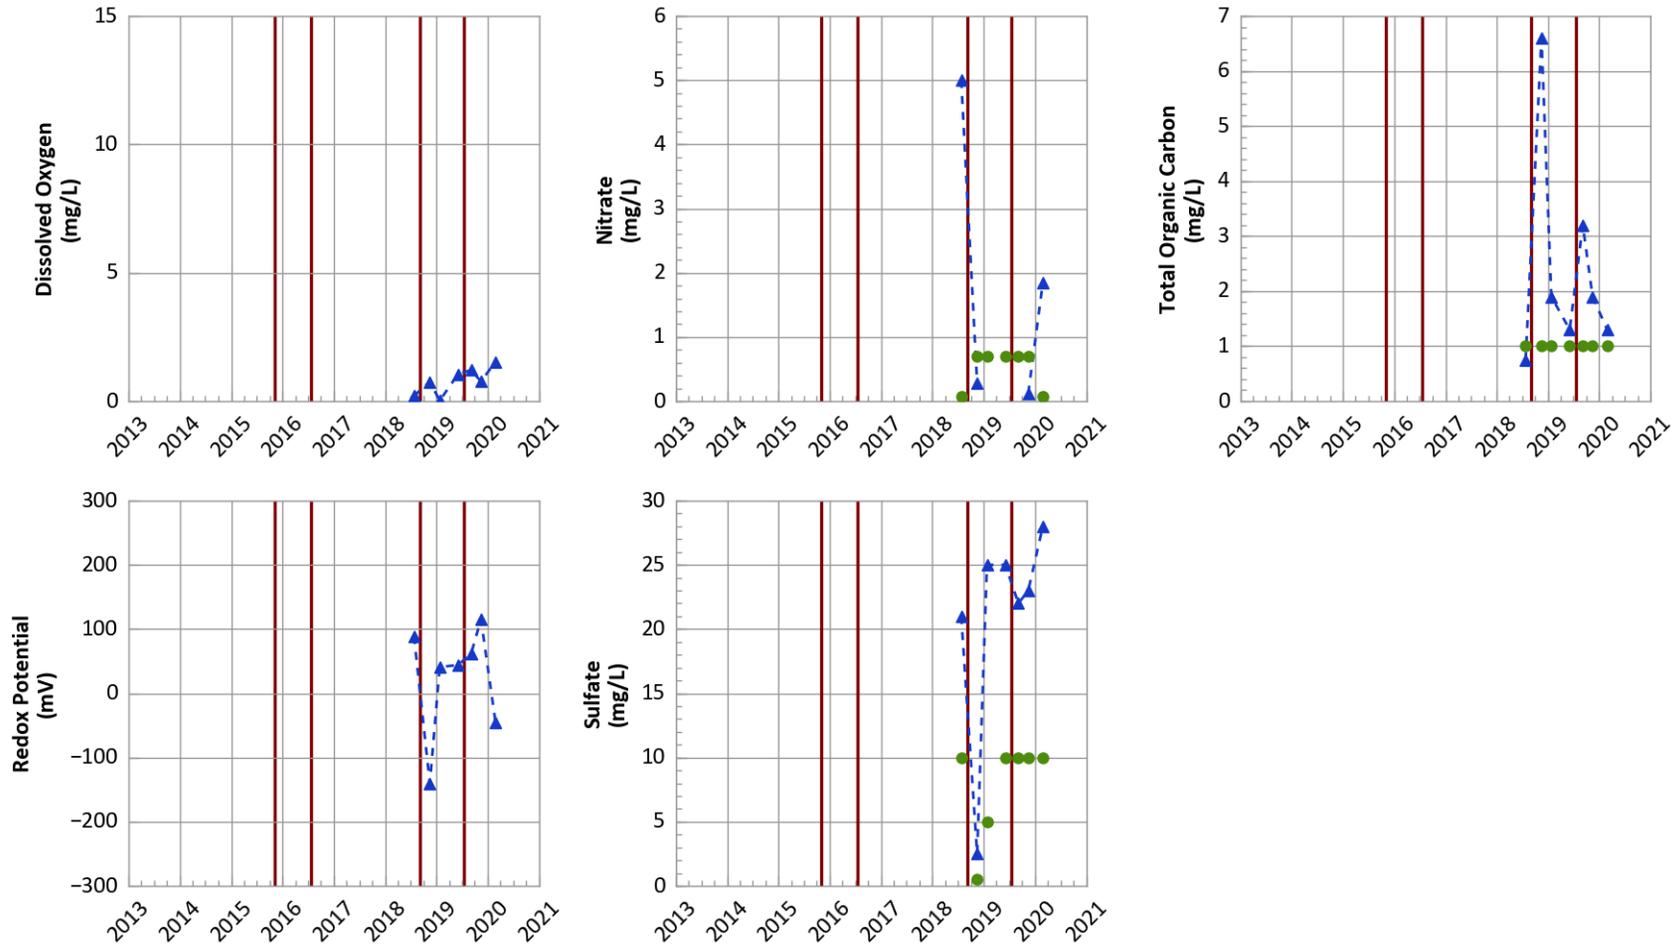
**PTX06-1164 Treatment Zone Performance Indicators  
USDOE/NNSA Pantex Plant**

**Typical Baseline Concentrations in Perched Groundwater**

Dissolved Oxygen: 5-10 mg/L  
 Redox Potential: > 100 mV  
 Nitrate: > 1 mg/L  
 Sulfate: > 10 mg/L  
 Total Organic Carbon: < 5 mg/L  
 Total Volatile Fatty Acids: Not Detected
