# PANTEX QUARTERLY PROGRESS REPORT

## Remedial Action Progress

### 1st Quarter 2020

In support of Hazardous Waste Permit #50284 and  
Pantex Plant Interagency Agreement  
June 2020

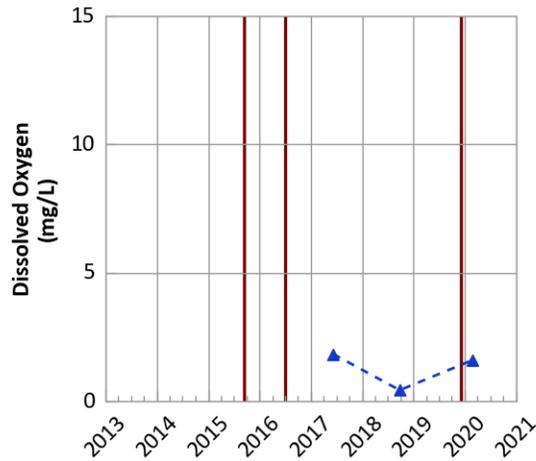
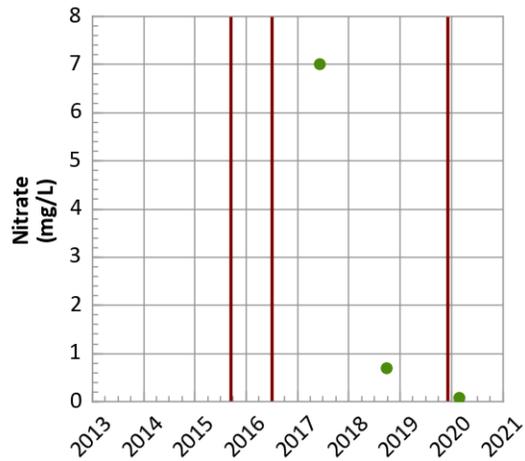
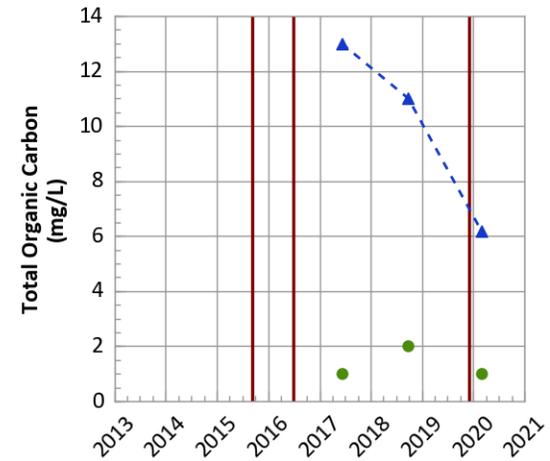
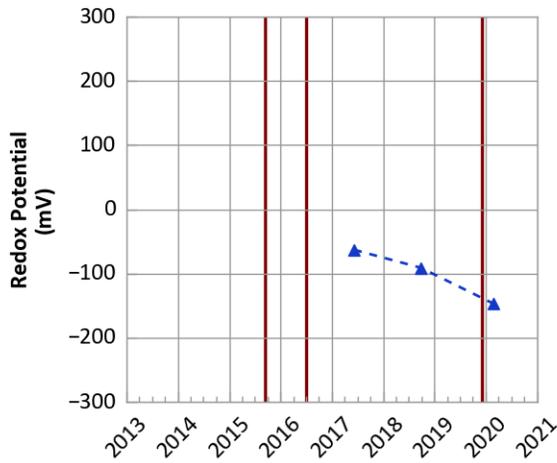
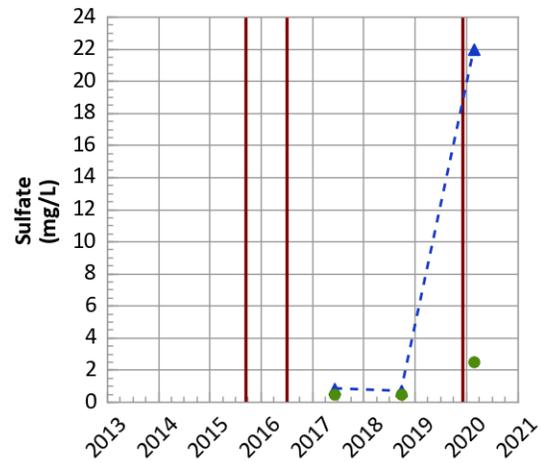
PTX06-1169 Treatment Zone Performance Indicators  
USDOE/NNSA Pantex Plant

Typical Baseline Concentrations in Perched Groundwater

- Dissolved Oxygen: 5-10 mg/L
- Redox Potential: > 100 mV
- Nitrate: > 1 mg/L
- Sulfate: > 10 mg/L
- Total Organic Carbon: < 5 mg/L
- Total Volatile Fatty Acids: Not Detected

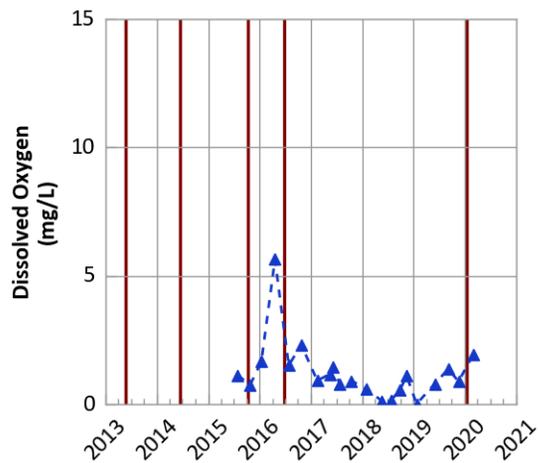
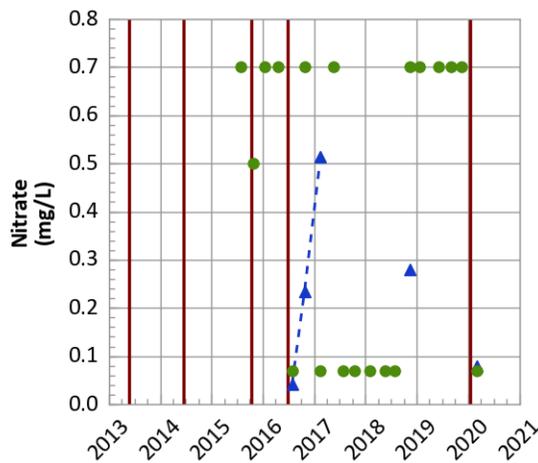
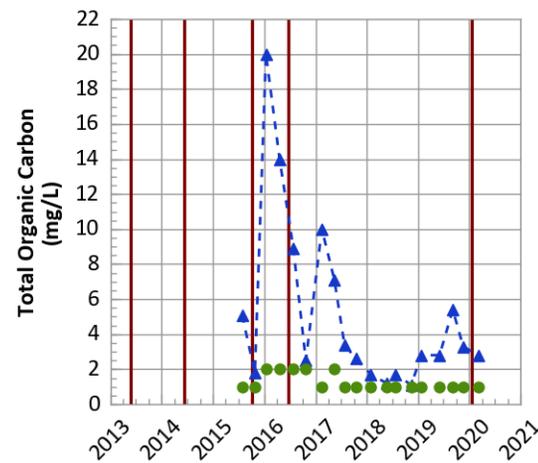
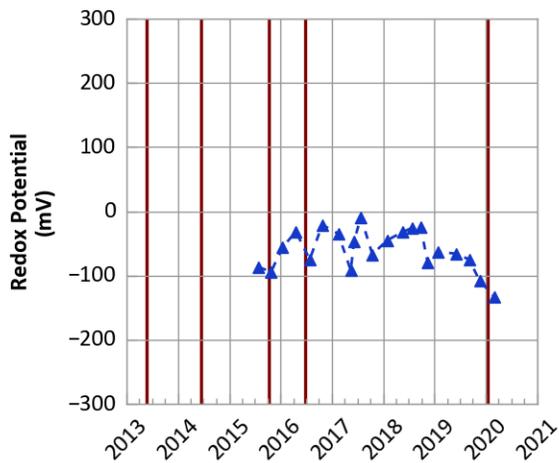
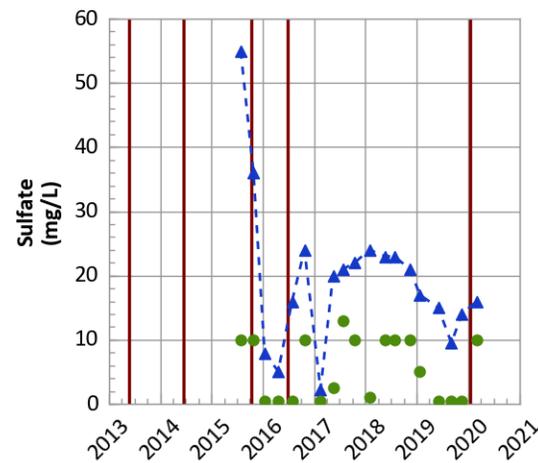
**PTX06-1170 Treatment Zone Performance Indicators  
USDOE/NNSA Pantex Plant**

**Typical Baseline Concentrations in Perched Groundwater**

- Dissolved Oxygen: 5-10 mg/L
- Redox Potential: > 100 mV
- Nitrate: > 1 mg/L
- Sulfate: > 10 mg/L
- Total Organic Carbon: < 5 mg/L
- Total Volatile Fatty Acids: Not Detected

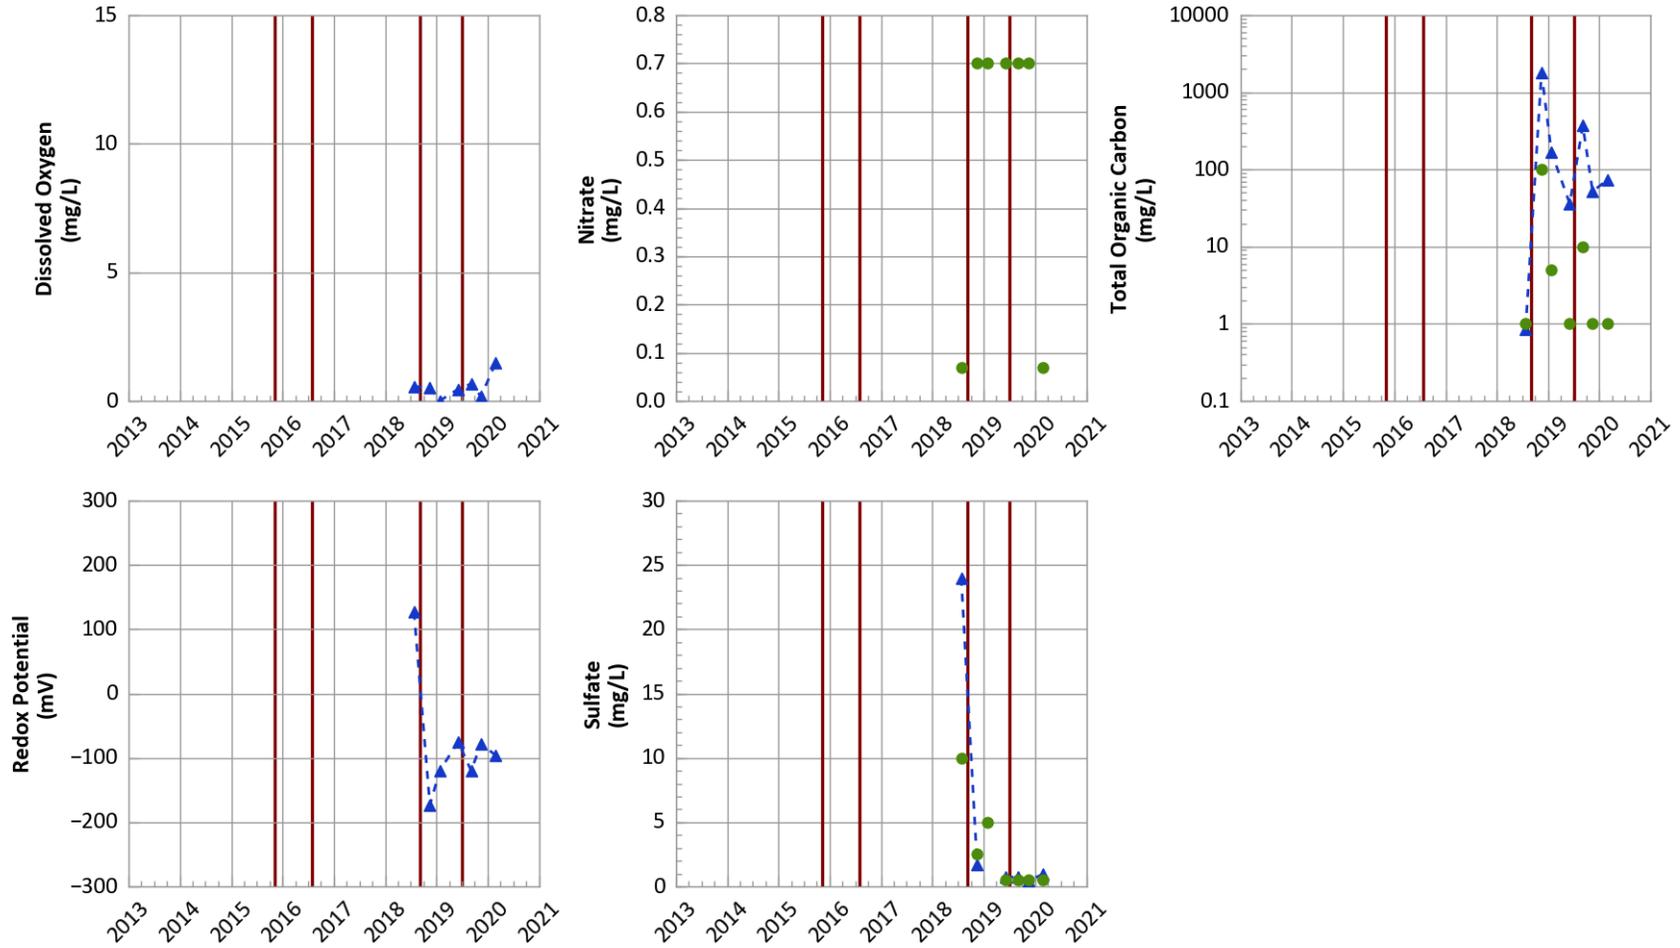
**PTX06-1177 Treatment Zone Performance Indicators  
USDOE/NNSA Pantex Plant**

**Typical Baseline Concentrations in Perched Groundwater**

Dissolved Oxygen: 5-10 mg/L  
 Redox Potential: > 100 mV  
 Nitrate: > 1 mg/L  
 Sulfate: > 10 mg/L  
 Total Organic Carbon: < 5 mg/L  
 Total Volatile Fatty Acids: Not Detected

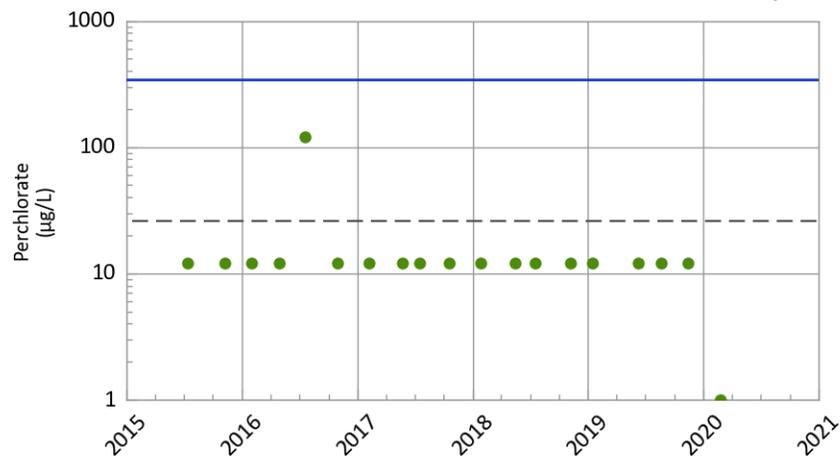
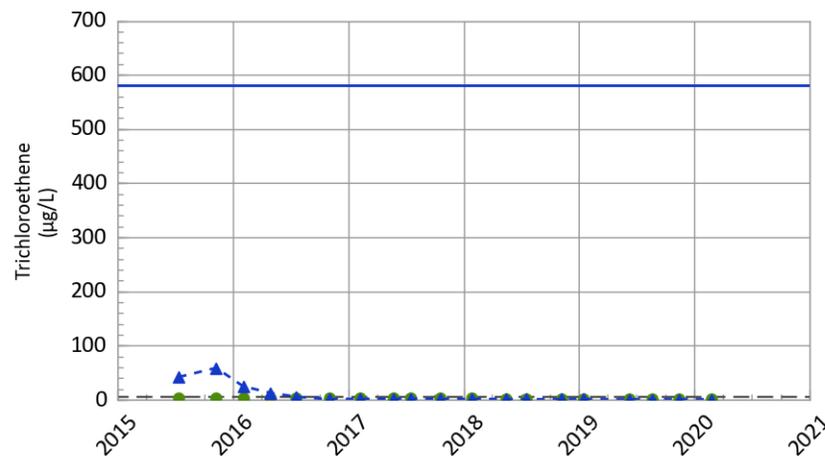
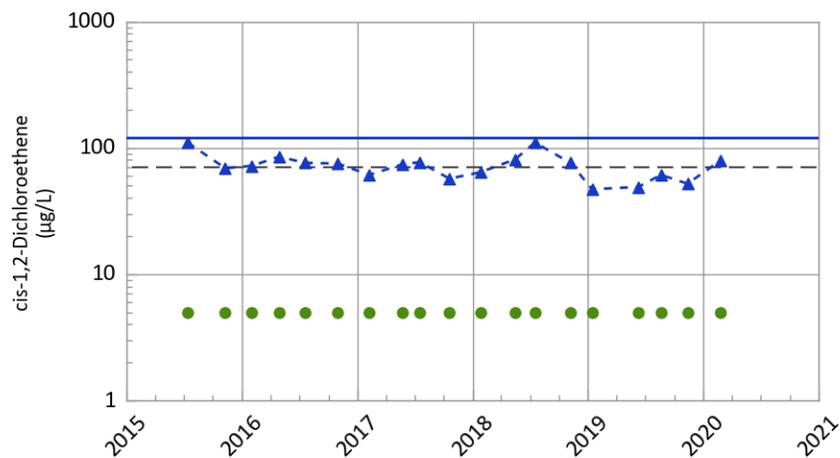
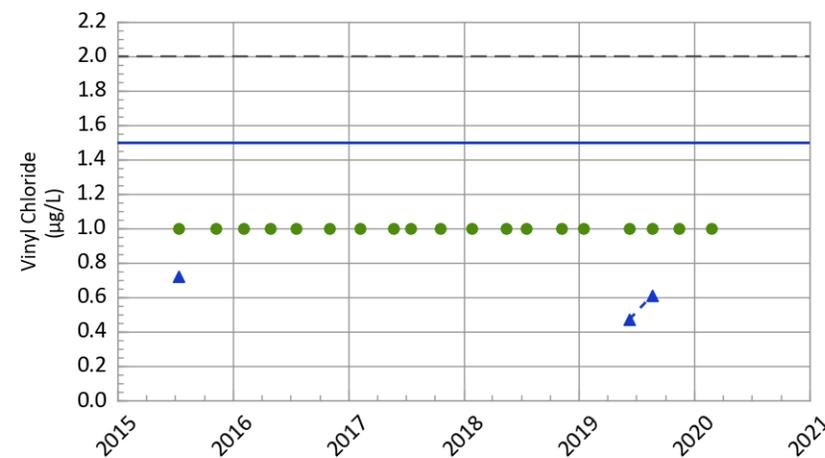
**PTX06-1012 Downgradient Performance Indicators  
Zone 11 In Situ Bioremediation System  
USDOE/NNSA Pantex Plant**

**Most Recent Measured COC Concentrations (Aug 20, 2019)**

COC	Concentration (µg/L)	GWPS (µg/L)
PERC	Non-Detect	26.0
DCE12C	79.0	70.0
TCE	0.86	5.0
VC	Non-Detect	2.0

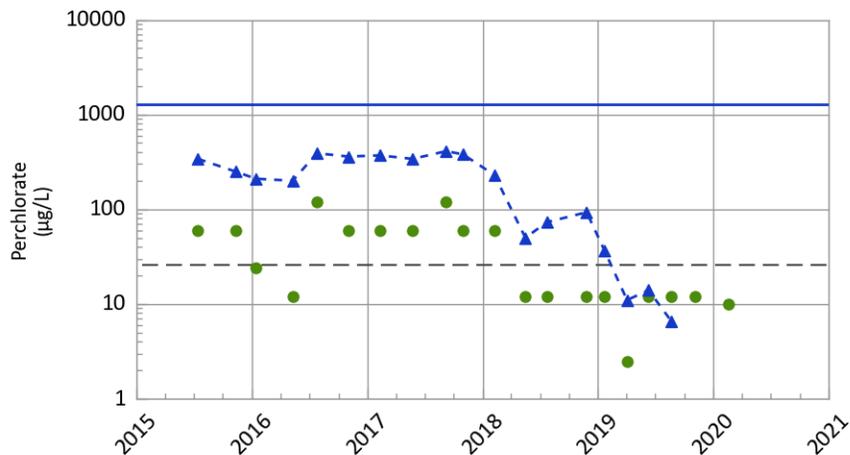
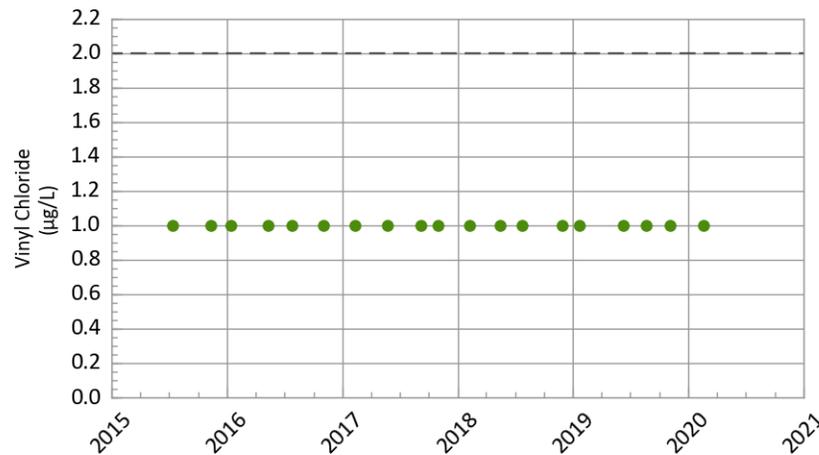
**PTX06-1148 Downgradient Performance Indicators  
Zone 11 In Situ Bioremediation System  
USDOE/NNSA Pantex Plant**

Most Recent Measured COC Concentrations (Feb 19, 2020)

COC	Concentration (µg/L)	GWPS (µg/L)
PERC	Non-Detect	26.0
DCE12C	0.72	70.0
TCE	4.7	5.0
VC	Non-Detect	2.0

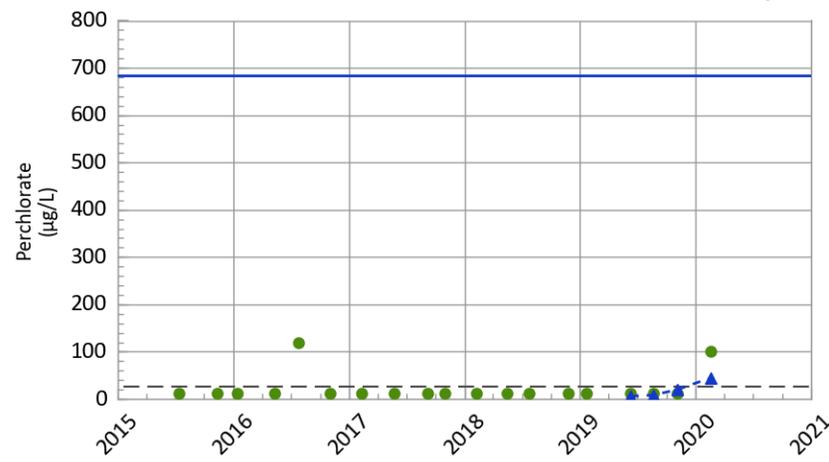
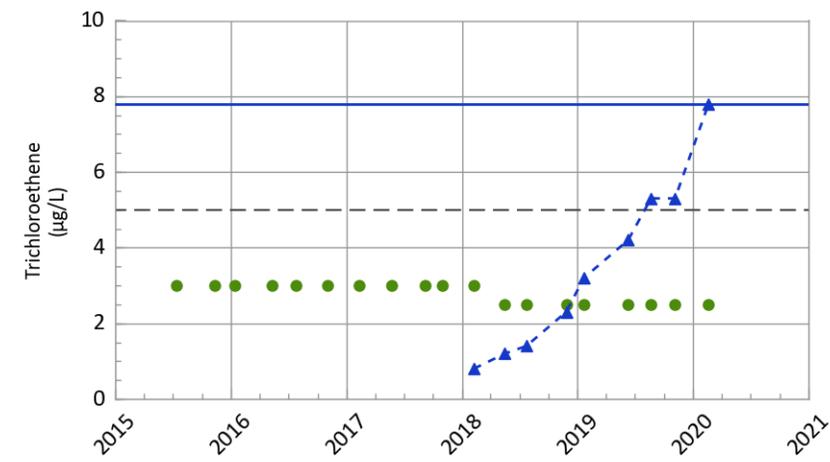
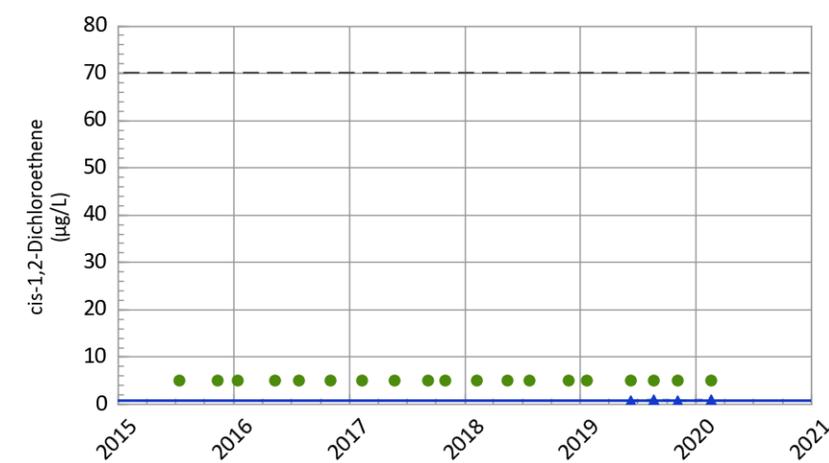
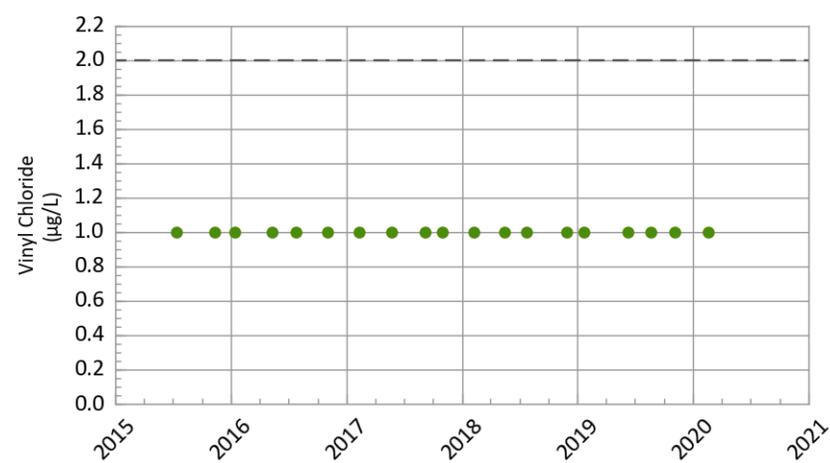
**PTX06-1149 Downgradient Performance Indicators  
Zone 11 In Situ Bioremediation System  
USDOE/NNSA Pantex Plant**

Most Recent Measured COC Concentrations (Feb 19, 2020)

COC	Concentration (µg/L)	GWPS (µg/L)
PERC	45.0	26.0
DCE12C	0.82	70.0
TCE	7.8	5.0
VC	Non-Detect	2.0

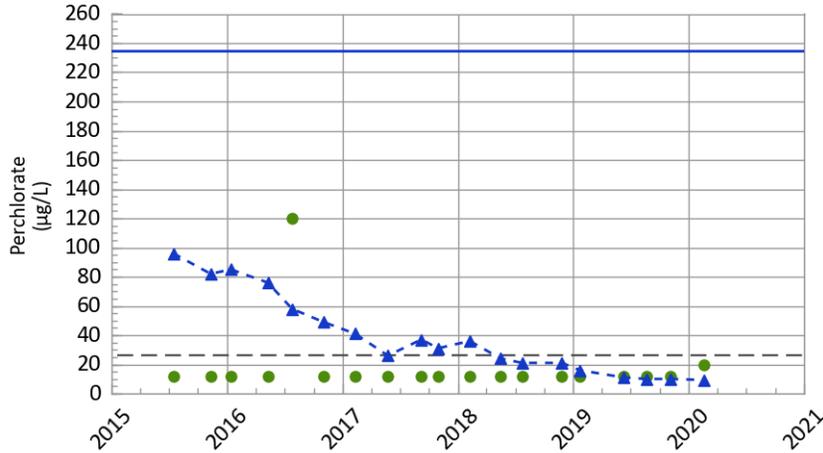
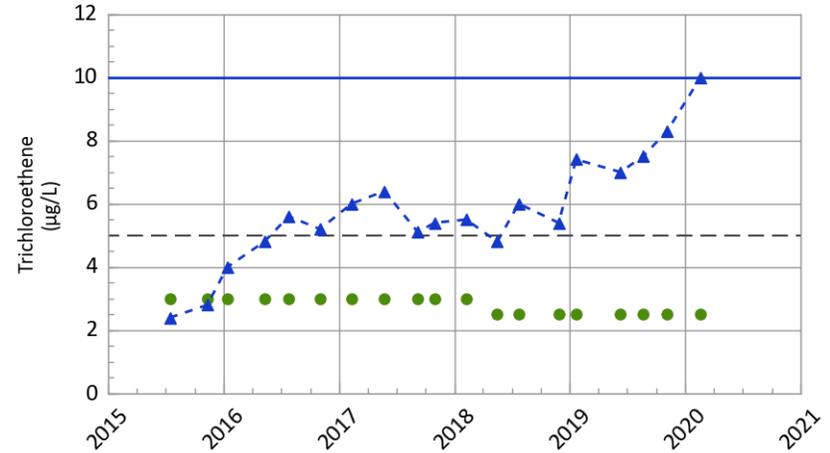
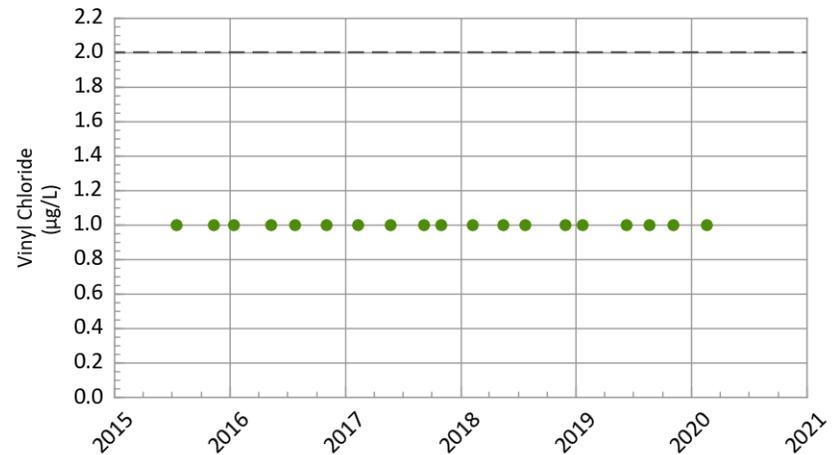
**PTX06-1150 Downgradient Performance Indicators  
Zone 11 In Situ Bioremediation System  
USDOE/NNSA Pantex Plant**

Most Recent Measured COC Concentrations (Feb 19, 2020)

COC	Concentration (µg/L)	GWPS (µg/L)
PERC	9.3	26.0
DCE12C	0.42	70.0
TCE	10.0	5.0
VC	Non-Detect	2.0

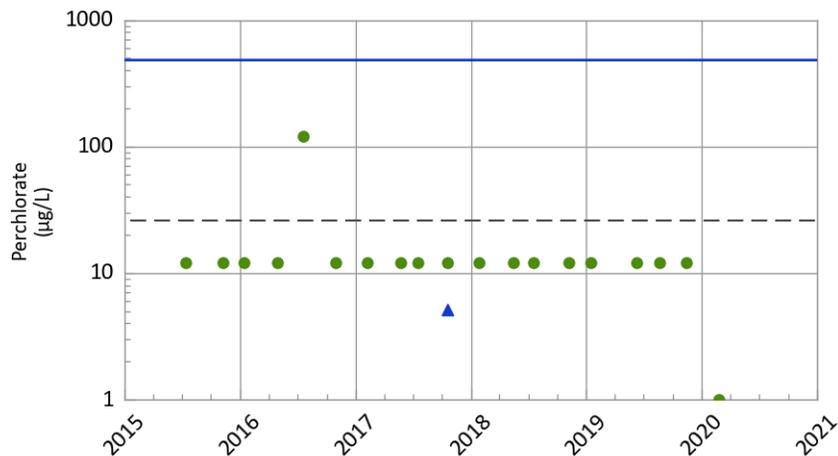
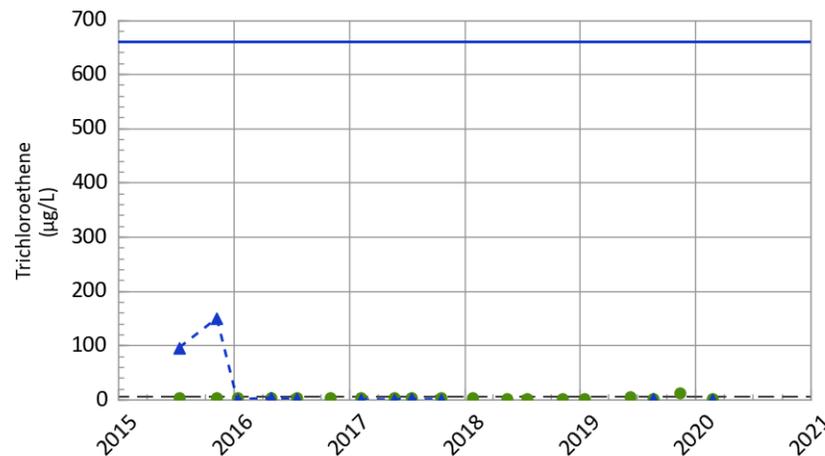
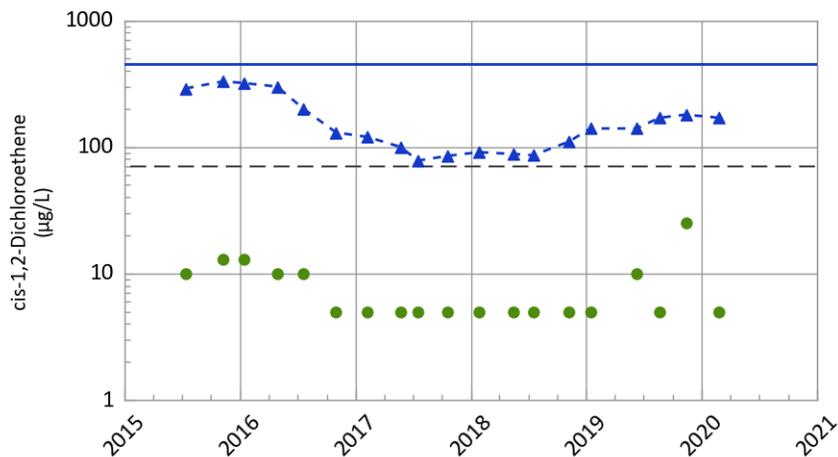
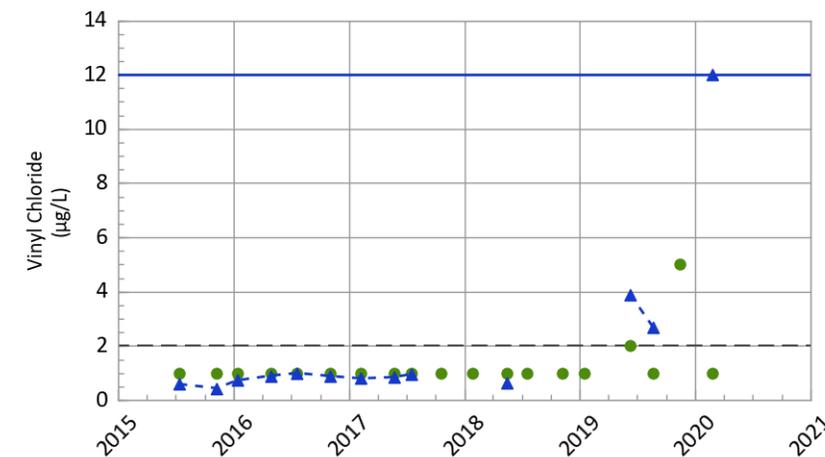
**PTX06-1155 Downgradient Performance Indicators  
Zone 11 In Situ Bioremediation System  
USDOE/NNSA Pantex Plant**

Most Recent Measured COC Concentrations (Feb 24, 2020)

COC	Concentration (µg/L)	GWPS (µg/L)
PERC	Non-Detect	26.0
DCE12C	170.0	70.0
TCE	0.59	5.0
VC	12.0	2.0

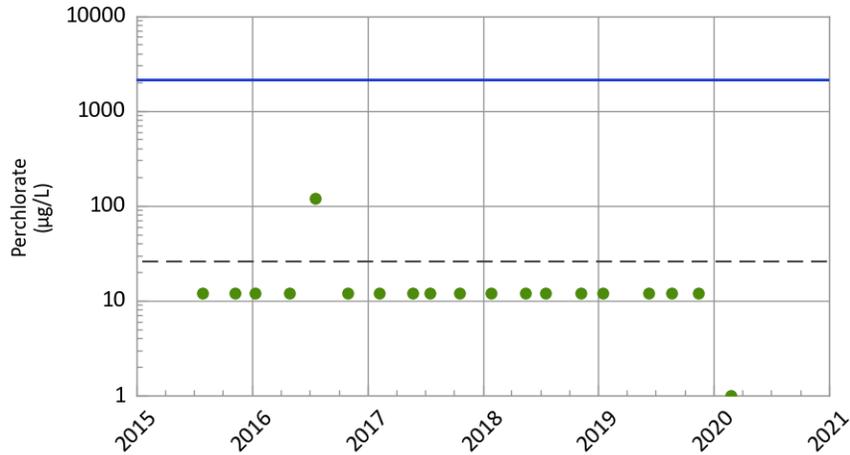
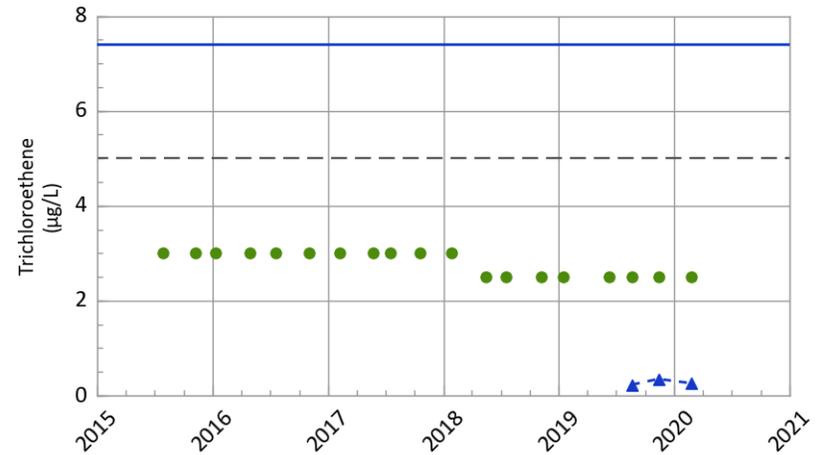
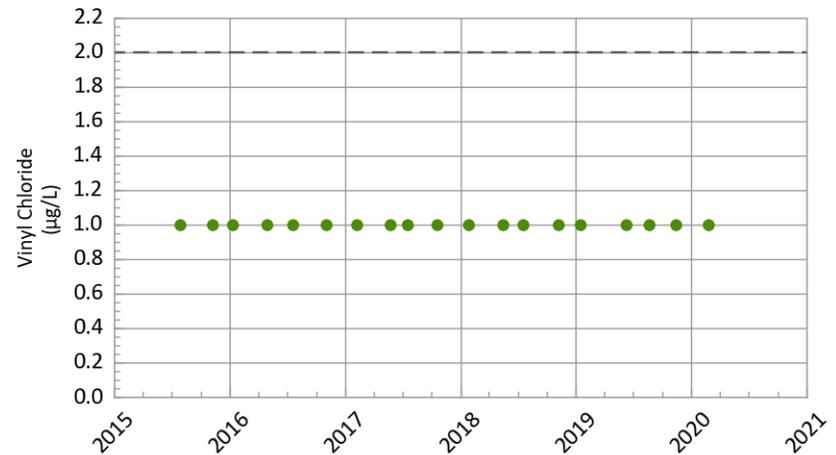
**PTX06-1156 Downgradient Performance Indicators  
Zone 11 In Situ Bioremediation System  
USDOE/NNSA Pantex Plant**

Most Recent Measured COC Concentrations (Feb 24, 2020)

COC	Concentration (µg/L)	GWPS (µg/L)
PERC	Non-Detect	26.0
DCE12C	1.8	70.0
TCE	0.26	5.0
VC	Non-Detect	2.0

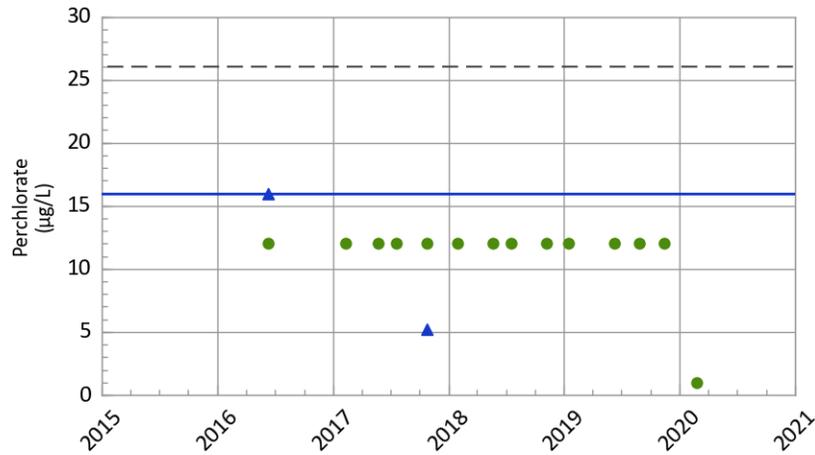
**PTX06-1173 Downgradient Performance Indicators  
Zone 11 In Situ Bioremediation System  
USDOE/NNSA Pantex Plant**

Most Recent Measured COC Concentrations (Nov 13, 2019)

COC	Concentration (µg/L)	GWPS (µg/L)
PERC	Non-Detect	26.0
DCE12C	120.0	70.0
TCE	140.0	5.0
VC	Non-Detect	2.0

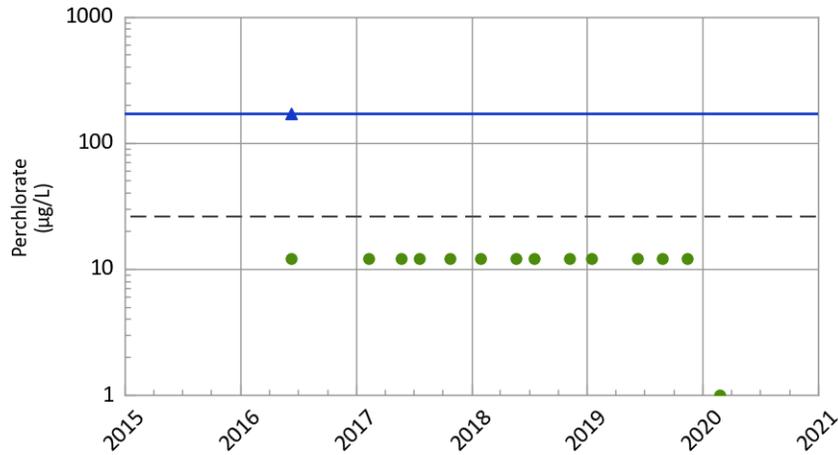
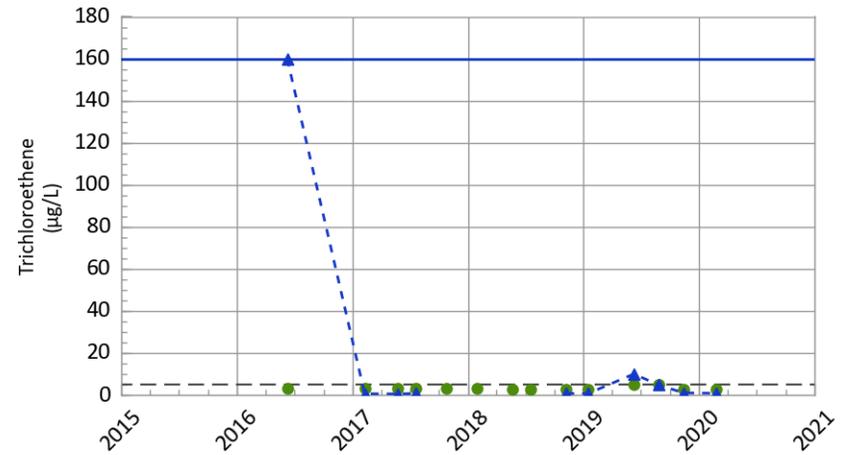
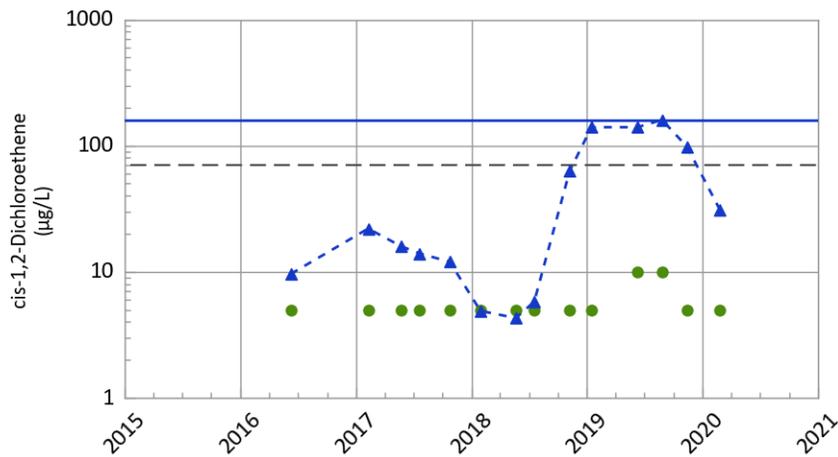
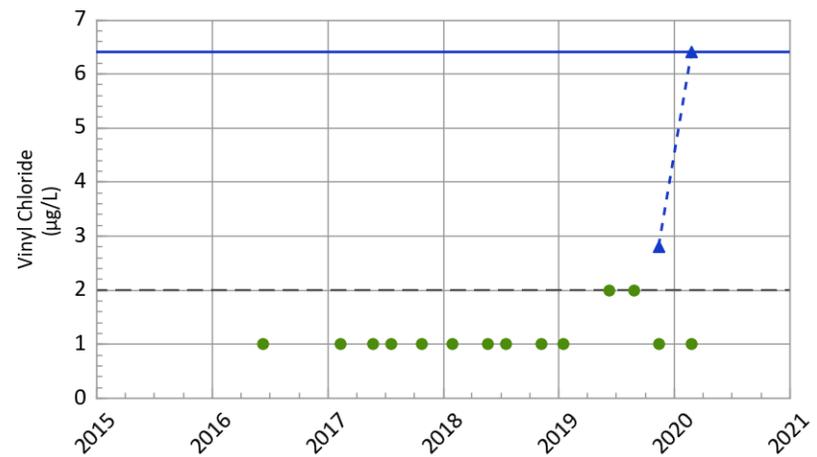
**PTX06-1174 Downgradient Performance Indicators  
Zone 11 In Situ Bioremediation System  
USDOE/NNSA Pantex Plant**

Most Recent Measured COC Concentrations (Feb 25, 2020)

COC	Concentration (µg/L)	GWPS (µg/L)
PERC	Non-Detect	26.0
DCE12C	31.0	70.0
TCE	0.83	5.0
VC	6.4	2.0

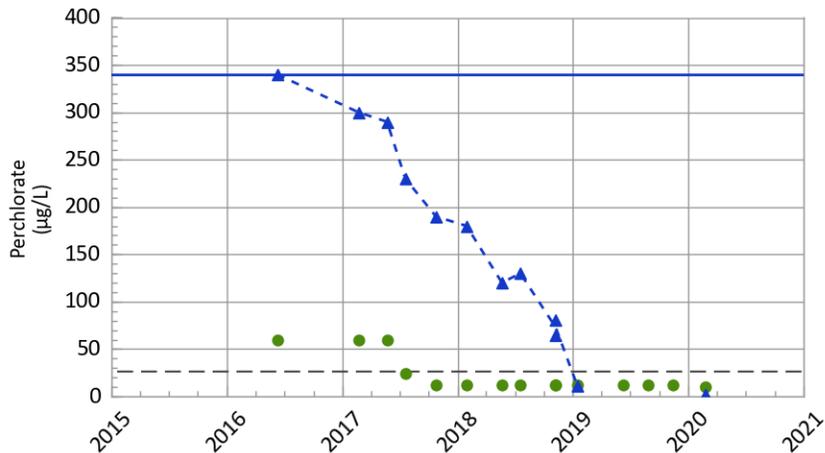
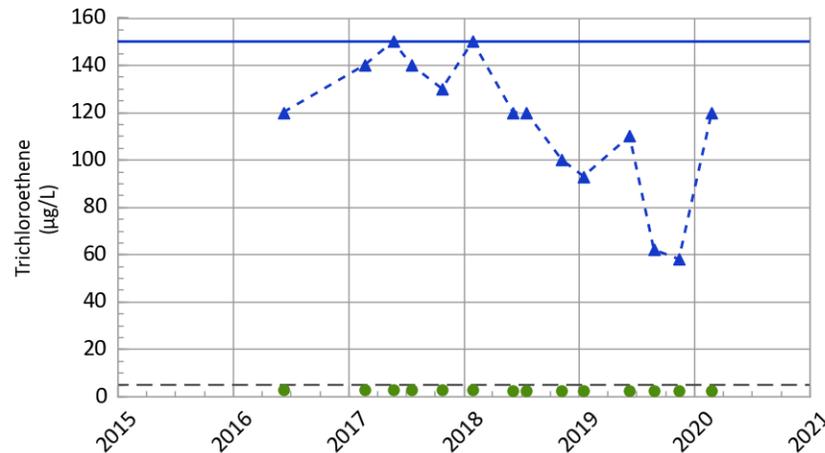
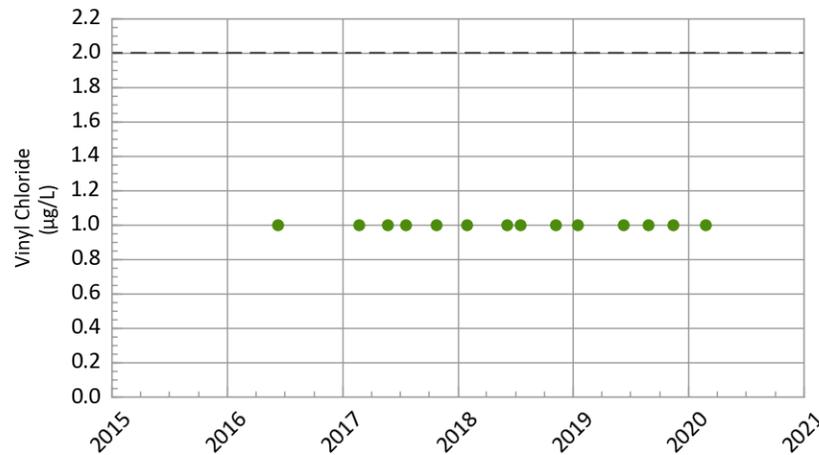
**PTX06-1175 Downgradient Performance Indicators  
Zone 11 In Situ Bioremediation System  
USDOE/NNSA Pantex Plant**

Most Recent Measured COC Concentrations (Feb 25, 2020)

COC	Concentration (µg/L)	GWPS (µg/L)
PERC	2.4	26.0
DCE12C	9.2	70.0
TCE	120.0	5.0
VC	Non-Detect	2.0

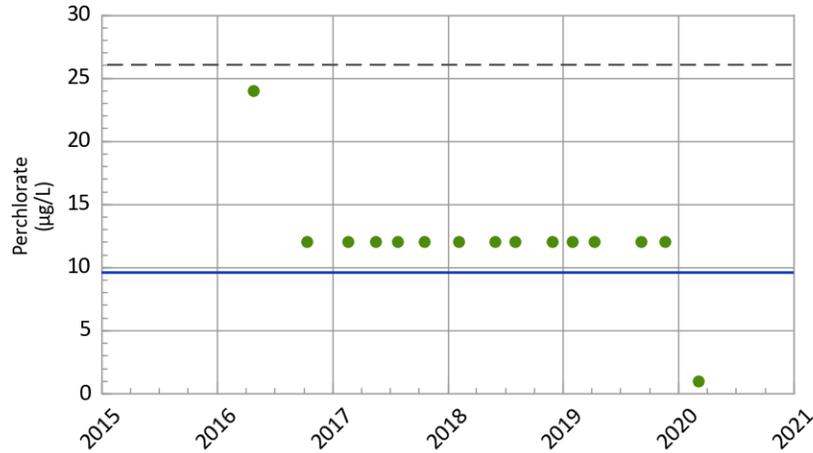
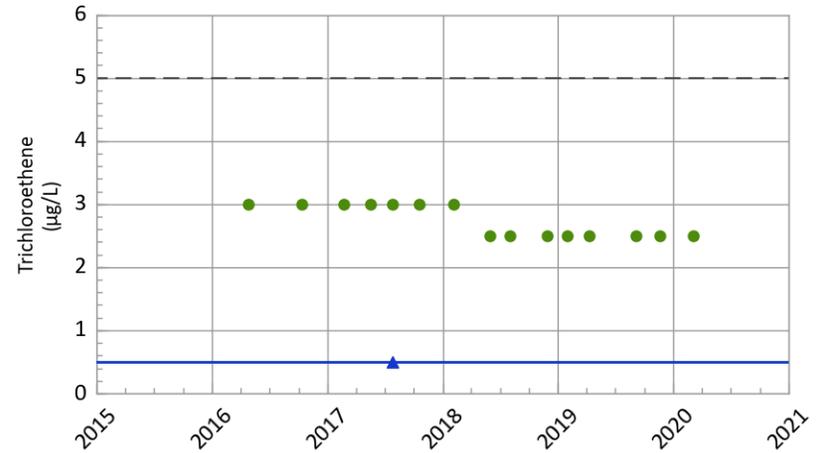
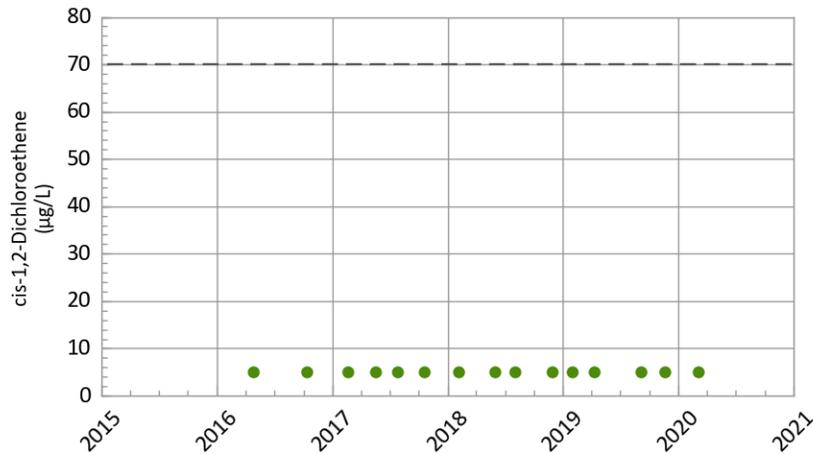
**PTX06-ISB079 Downgradient Performance Indicators  
Zone 11 In Situ Bioremediation System  
USDOE/NNSA Pantex Plant**

Most Recent Measured COC Concentrations (Mar 04, 2020)

COC	Concentration (µg/L)	GWPS (µg/L)
PERC	Non-Detect	26.0
DCE12C	Non-Detect	70.0
TCE	Non-Detect	5.0
VC	Non-Detect	2.0

PTX06-ISB079 and PTX06-ISB082 are now monitored to evaluate perchlorate conditions on the eastern side of the ISB, in the second row of injection wells. Pantex will no longer inject into the second row of wells, and will evaluate these wells to ensure that treatment continues on the perchlorate side of the ISB. TCE and its degradation products were not detected in PTX06-ISB079 and PTX06-ISB082. Past results for upgradient well PTX06-1127 indicate that TCE is continuing to increase on the eastern side of the ISB, so treatment of the TCE will also be evaluated to determine if changes in the system operation will be required. Currently, perchlorate and the low concentrations of TCE that occur on the eastern side are treated below GWPS or to non-detect.

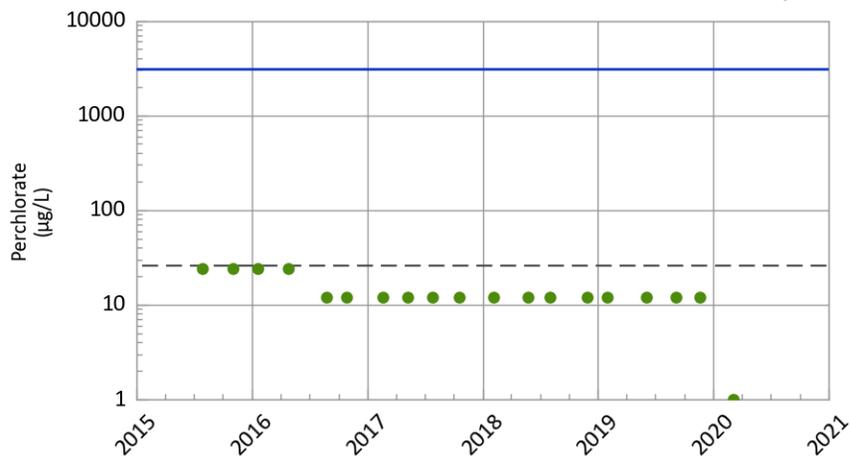
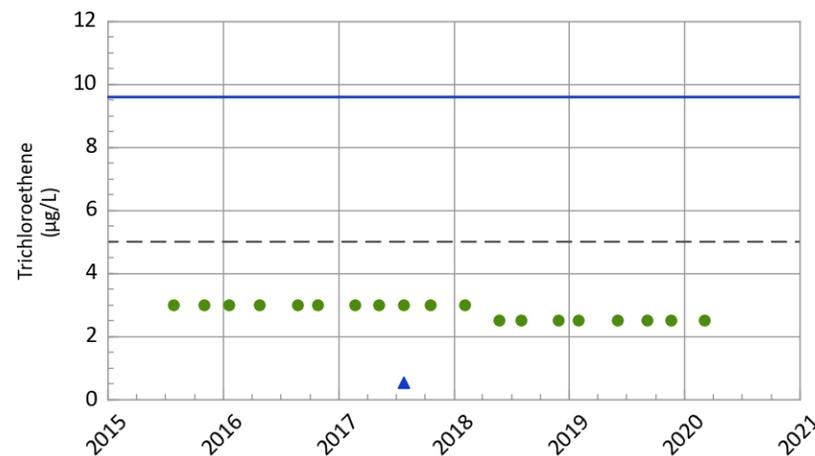
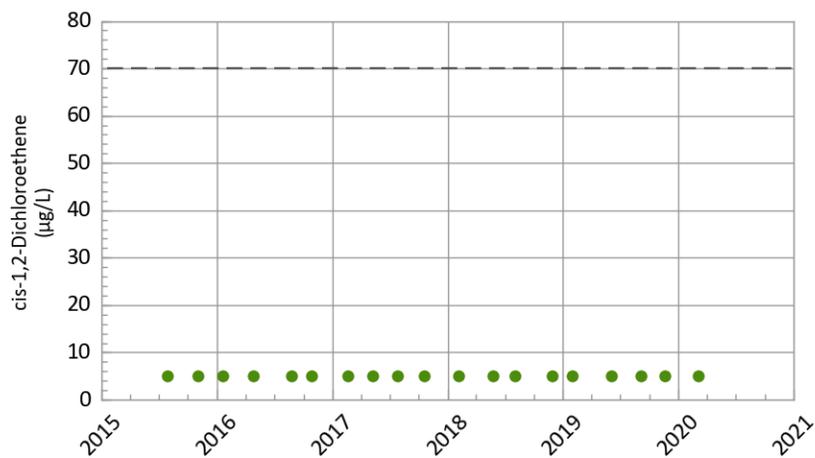
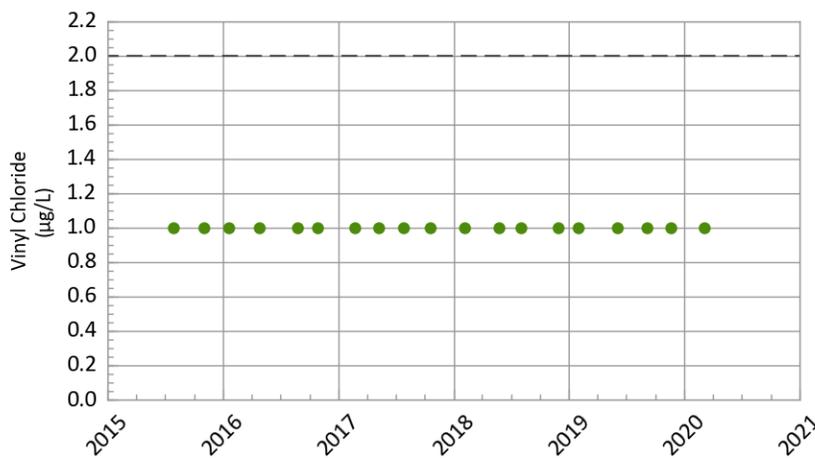
**PTX06-ISB082 Downgradient Performance Indicators  
Zone 11 In Situ Bioremediation System  
USDOE/NNSA Pantex Plant**

Most Recent Measured COC Concentrations (Mar 04, 2020)

COC	Concentration (µg/L)	GWPS (µg/L)
PERC	Non-Detect	26.0
DCE12C	Non-Detect	70.0
TCE	Non-Detect	5.0
VC	Non-Detect	2.0

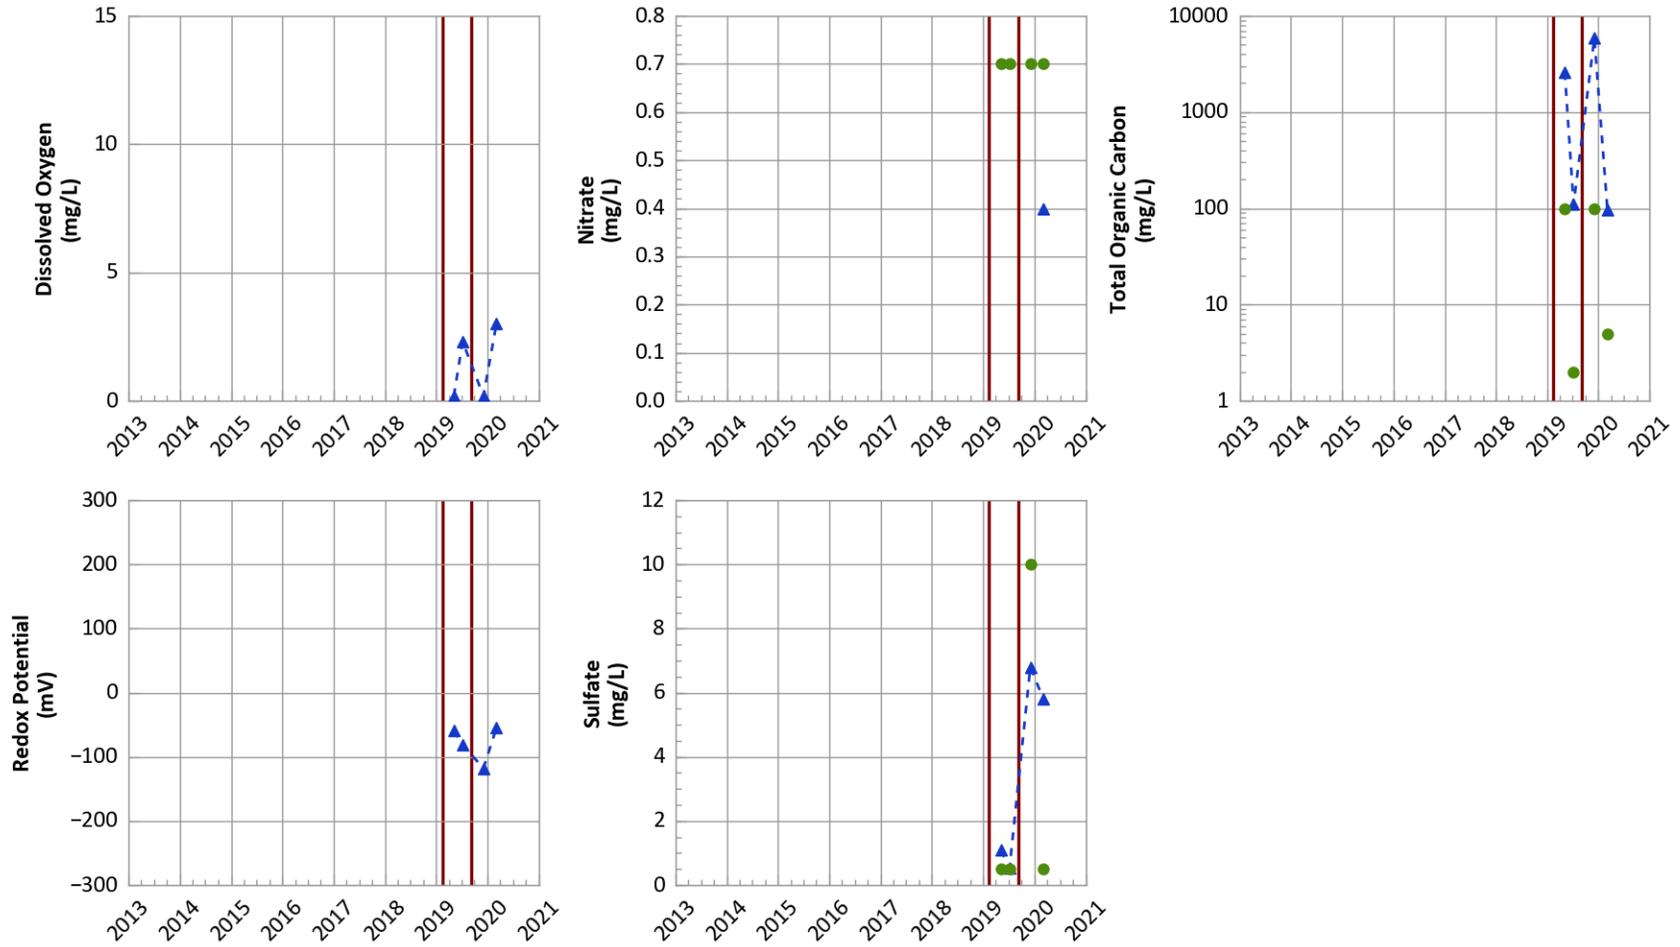
PTX06-ISB302 Treatment Zone Performance Indicators  
USDOE/NNSA Pantex Plant

Typical Baseline Concentrations in Perched Groundwater

Dissolved Oxygen: 5-10 mg/L  
 Redox Potential: > 100 mV  
 Nitrate: > 1 mg/L  
 Sulfate: > 10 mg/L  
 Total Organic Carbon: < 5 mg/L  
 Total Volatile Fatty Acids: Not Detected

The first post-injection treatment zone data were collected in 2nd Quarter 2019. Five wells were sampled during the 1st quarter 2020. Treatment zone data indicates that mild to deep reducing conditions are present for treatment of HEs. ORP was between -127 mV and -55 mV, nitrate was reduced in most wells, and sulfate was reduced to values from 1.6 to 9.3 µg/L. Soluble metals (arsenic and manganese) increased, indicating that reducing conditions are establishing. Total organic carbon results indicate that a sufficient food source is available to continue to establish reducing conditions at two wells, indicating it may be appropriate to inject every 9 months. Sampling results from the ISB wells indicate HEs are not detected. Downgradient wells did not demonstrate treatment during this quarter, but are expected to demonstrate treatment within 1 -2 years after the first injection.

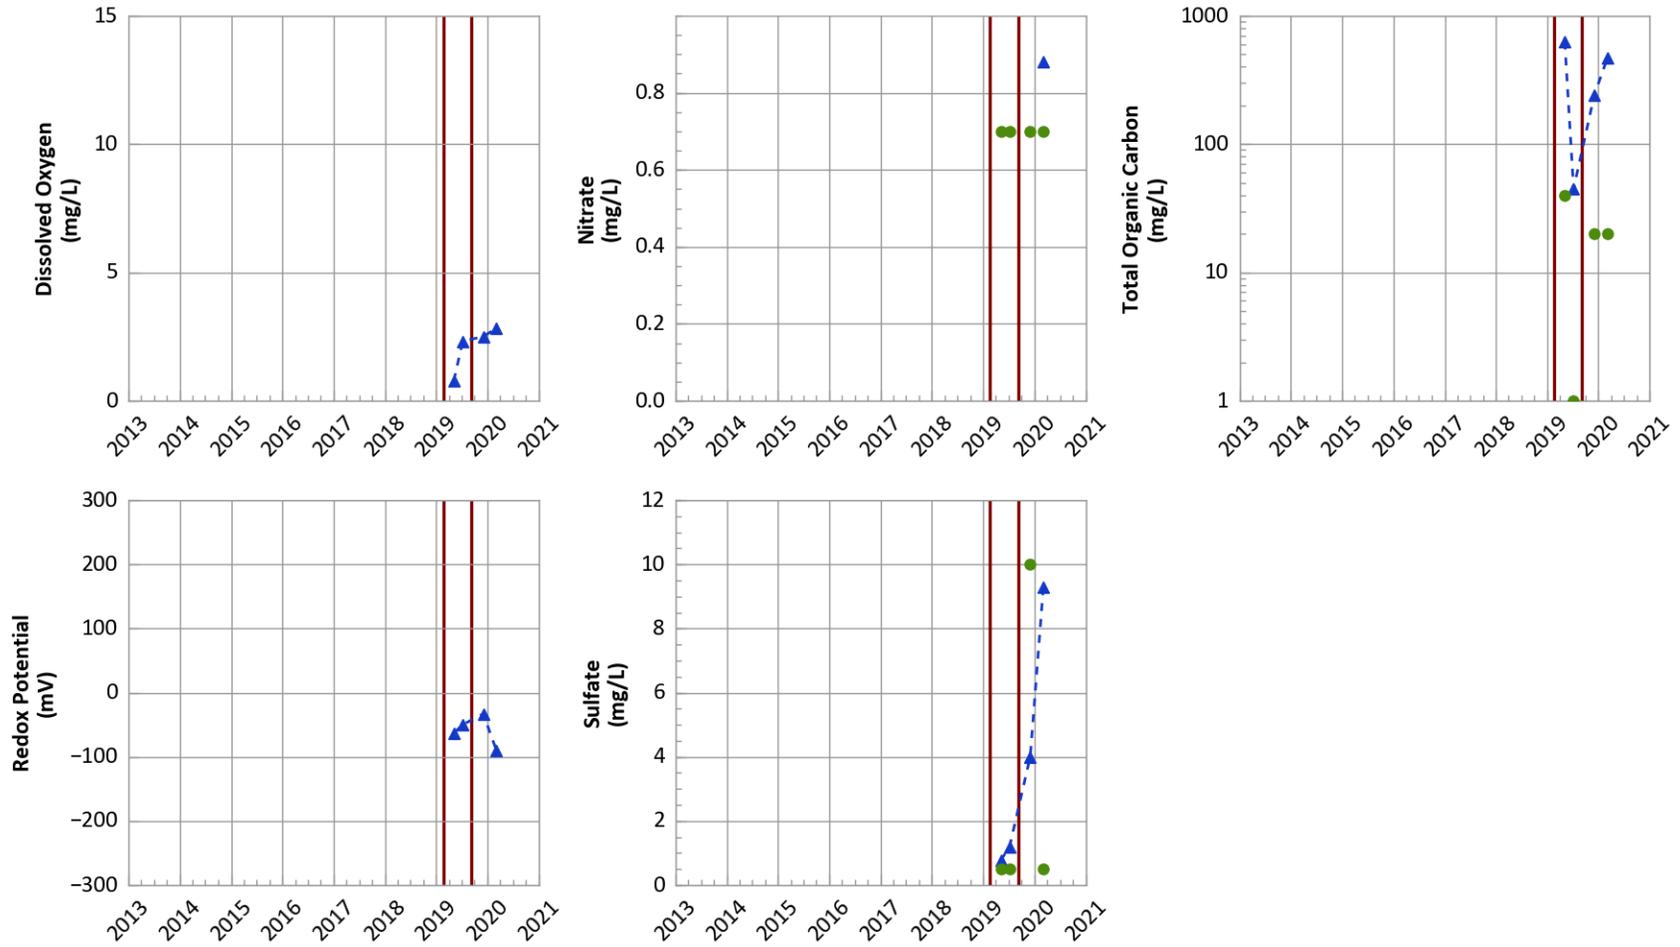
PTX06-ISB307 Treatment Zone Performance Indicators  
USDOE/NNSA Pantex Plant

Typical Baseline Concentrations in Perched Groundwater

Dissolved Oxygen: 5-10 mg/L  
 Redox Potential: > 100 mV  
 Nitrate: > 1 mg/L  
 Sulfate: > 10 mg/L  
 Total Organic Carbon: < 5 mg/L  
 Total Volatile Fatty Acids: Not Detected
