# PANTEX QUARTERLY PROGRESS REPORT

## Remedial Action Progress

### 1st Quarter 2020

In support of Hazardous Waste Permit #50284 and  
Pantex Plant Interagency Agreement  
June 2020

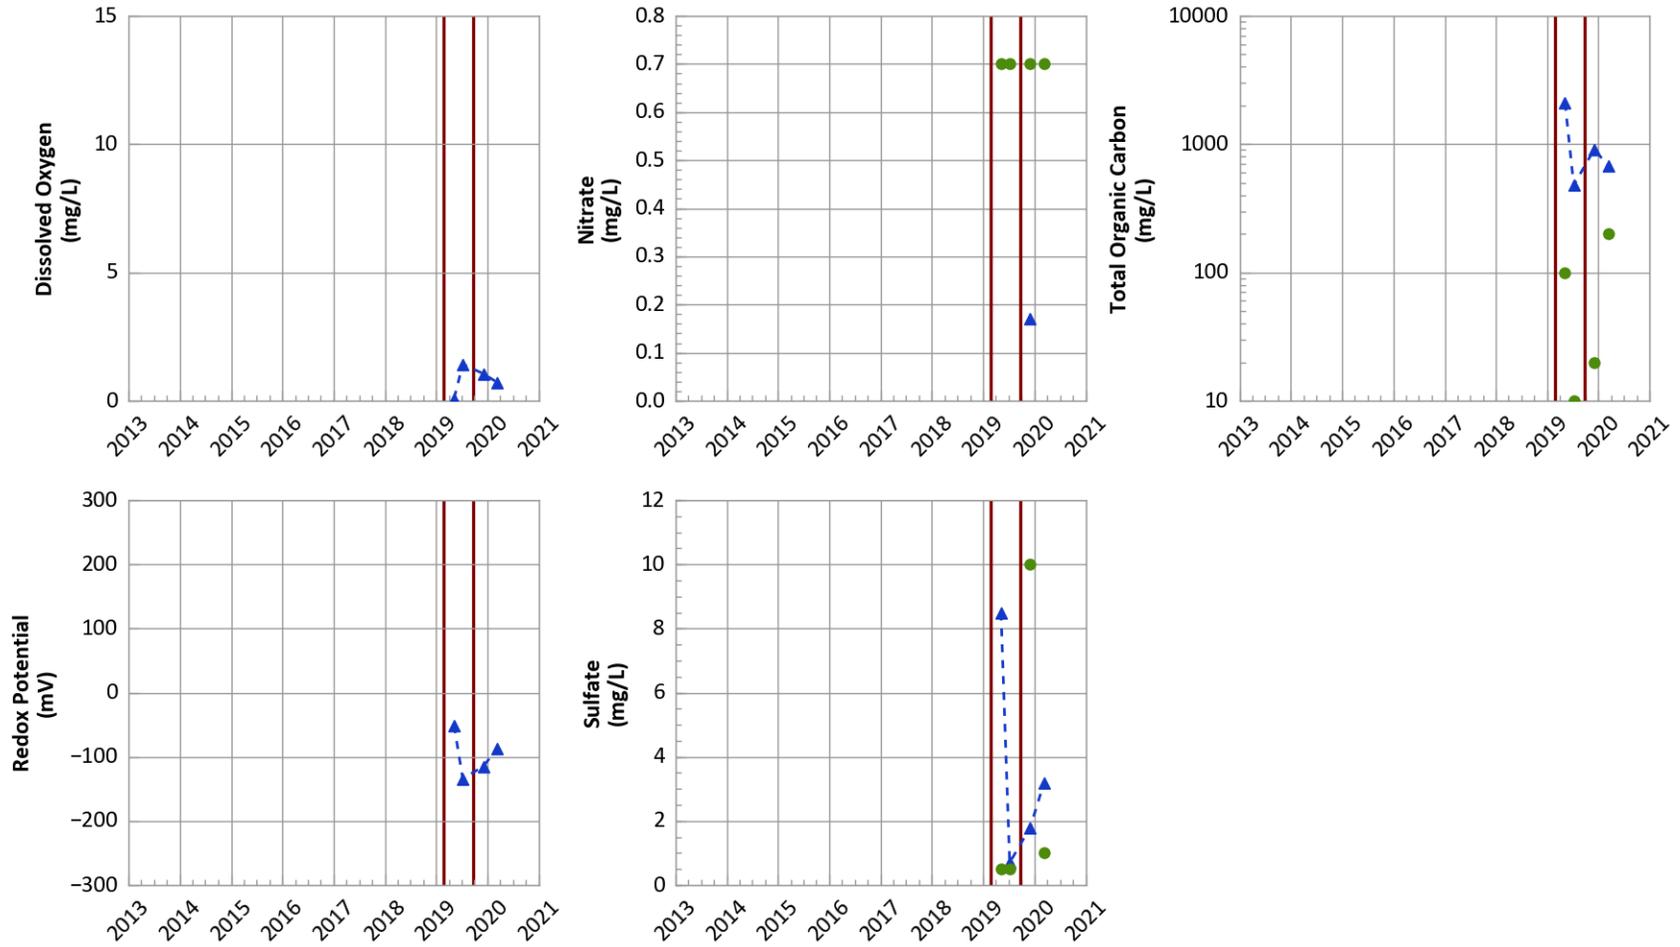
PTX06-ISB317 Treatment Zone Performance Indicators  
USDOE/NNSA Pantex Plant

Typical Baseline Concentrations in Perched Groundwater

- Dissolved Oxygen: 5-10 mg/L
- Redox Potential: > 100 mV
- Nitrate: > 1 mg/L
- Sulfate: > 10 mg/L
- Total Organic Carbon: < 5 mg/L
- Total Volatile Fatty Acids: Not Detected

The first post-injection treatment zone data were collected in 2nd Quarter 2019. Five wells were sampled during the 1st quarter 2020. Treatment zone data indicates that mild to deep reducing conditions are present for treatment of HEs. ORP was between -127 mV and -55 mV, nitrate was reduced in most wells, and sulfate was reduced to values from 1.6 to 9.3 µg/L. Soluble metals (arsenic and manganese) increased, indicating that reducing conditions are establishing. Total organic carbon results indicate that a sufficient food source is available to continue to establish reducing conditions at two wells, indicating it may be appropriate to inject every 9 months. Sampling results from the ISB wells indicate HEs are not detected. Downgradient wells did not demonstrate treatment during this quarter, but are expected to demonstrate treatment within 1 -2 years after the first injection.

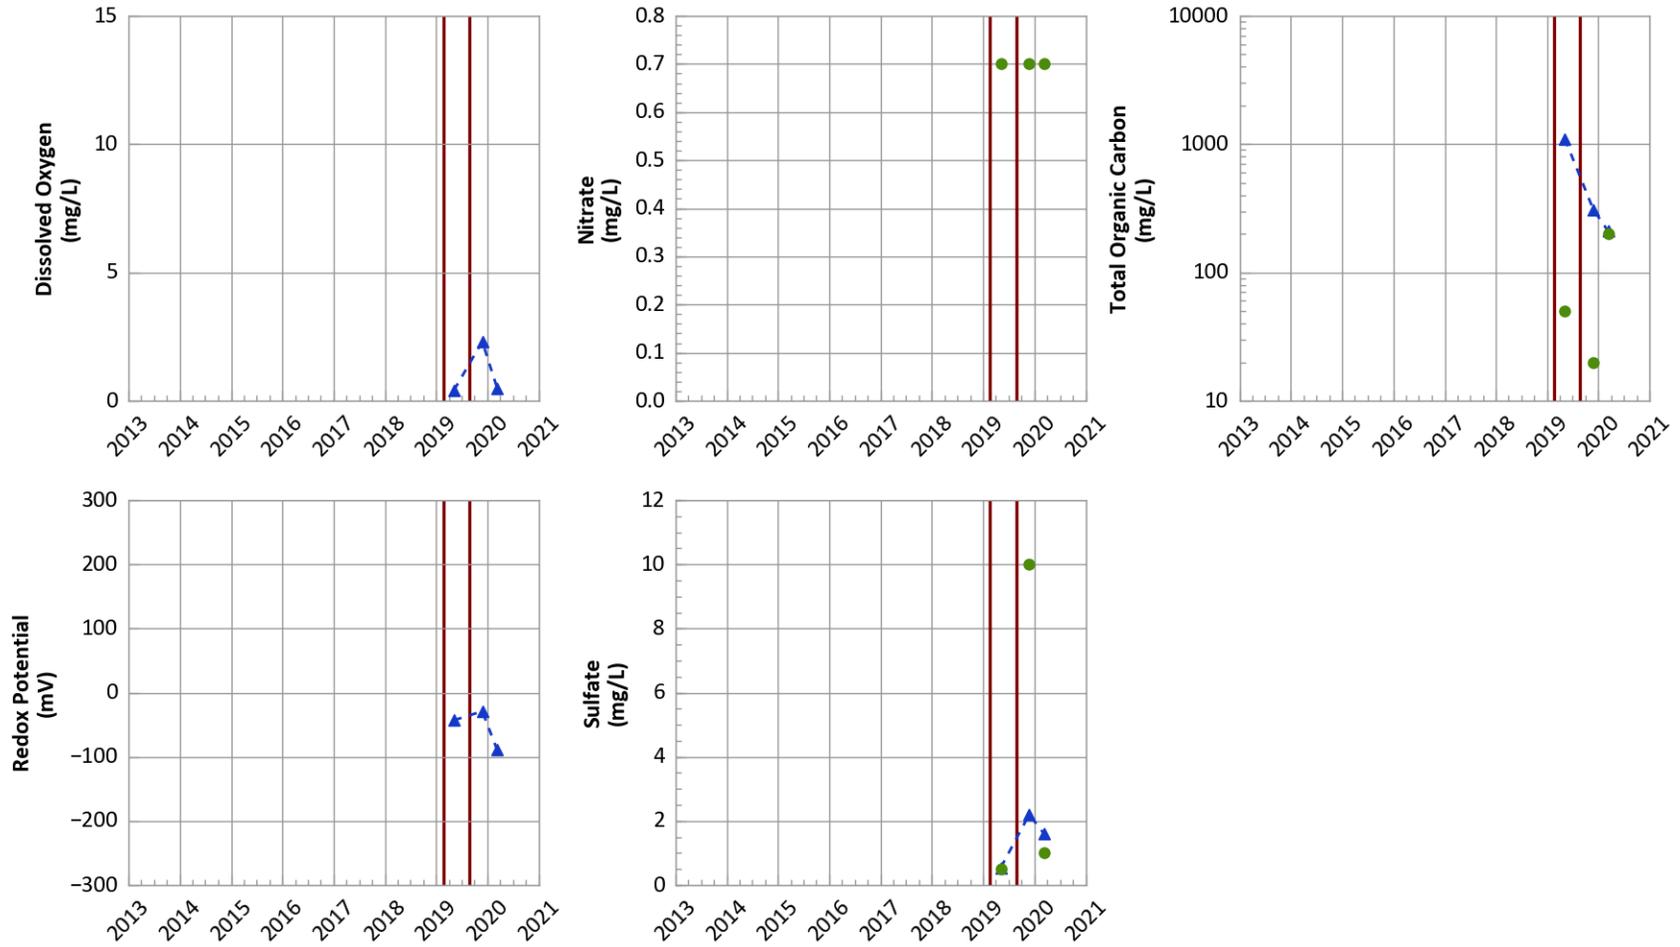
**PTX06-ISB321 Treatment Zone Performance Indicators  
USDOE/NNSA Pantex Plant**

**Typical Baseline Concentrations in Perched Groundwater**

Dissolved Oxygen: 5-10 mg/L  
 Redox Potential: > 100 mV  
 Nitrate: > 1 mg/L  
 Sulfate: > 10 mg/L  
 Total Organic Carbon: < 5 mg/L  
 Total Volatile Fatty Acids: Not Detected

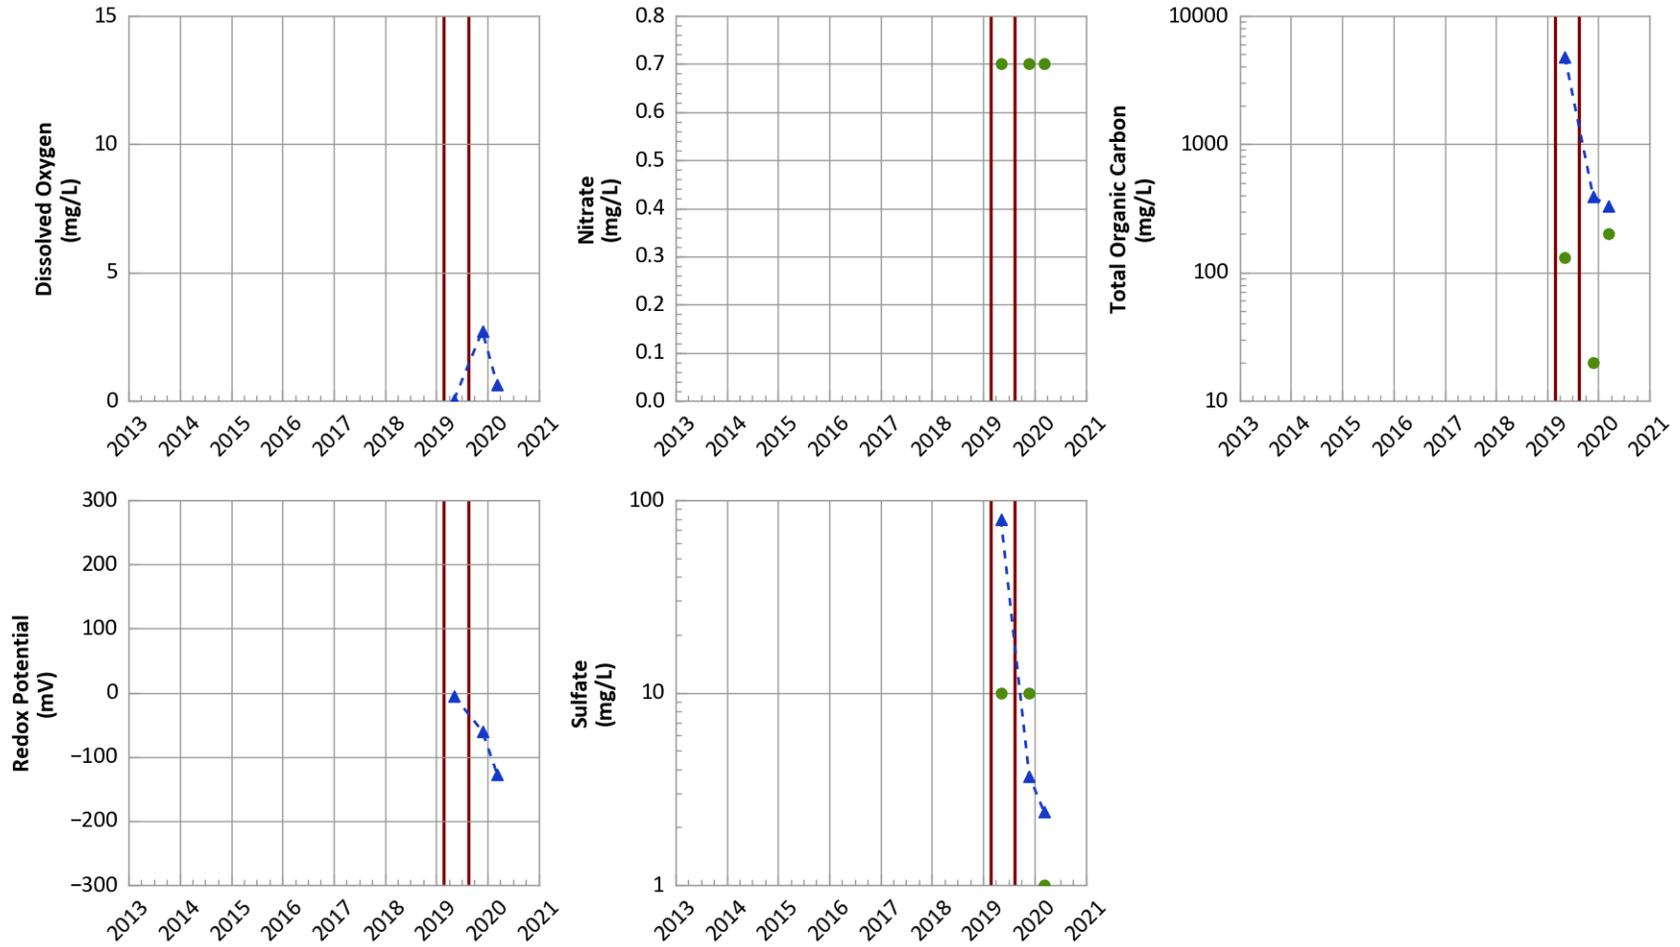
PTX06-ISB325 Treatment Zone Performance Indicators  
USDOE/NNSA Pantex Plant

Typical Baseline Concentrations in Perched Groundwater

- Dissolved Oxygen: 5-10 mg/L
- Redox Potential: > 100 mV
- Nitrate: > 1 mg/L
- Sulfate: > 10 mg/L
- Total Organic Carbon: < 5 mg/L
- Total Volatile Fatty Acids: Not Detected

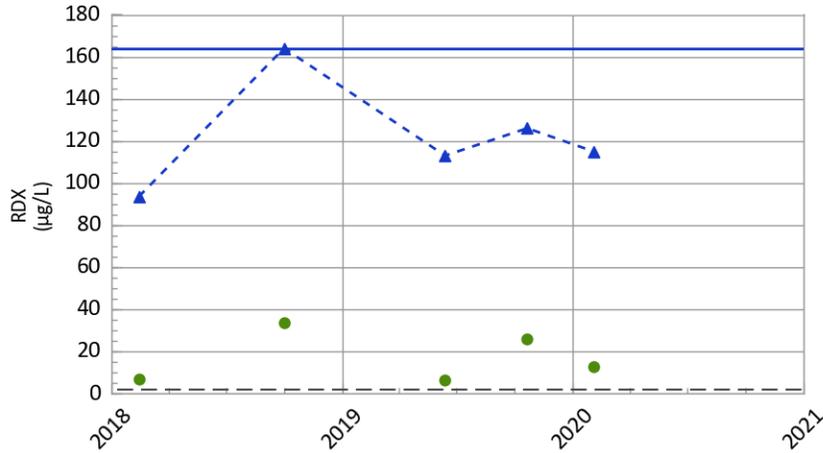
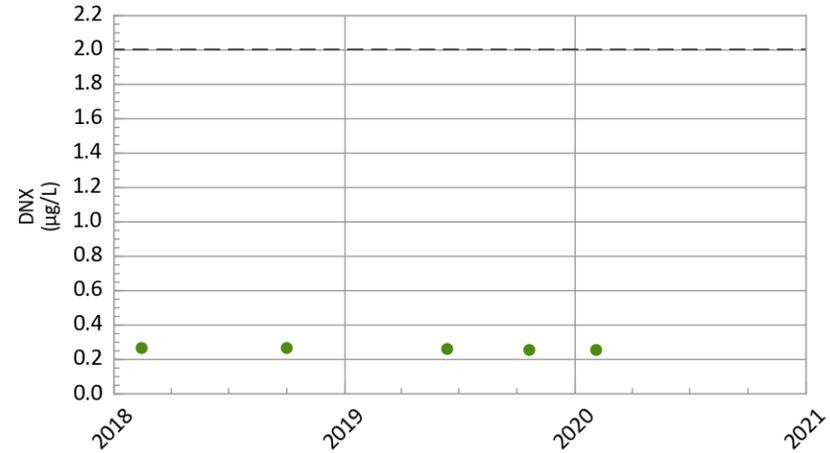
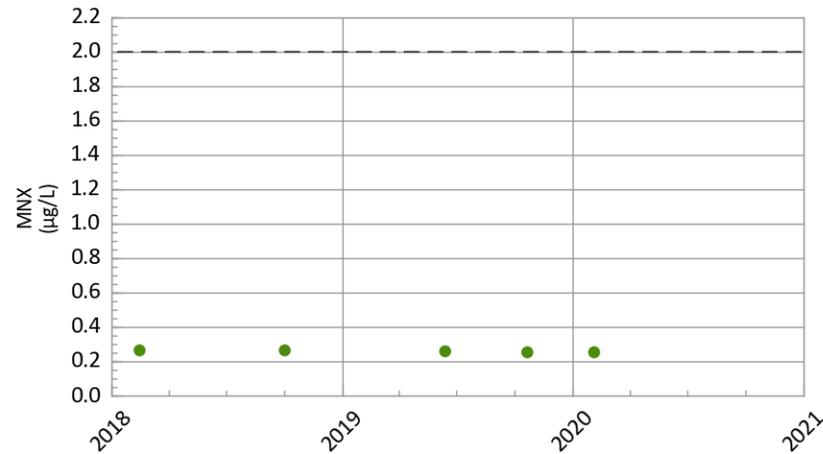
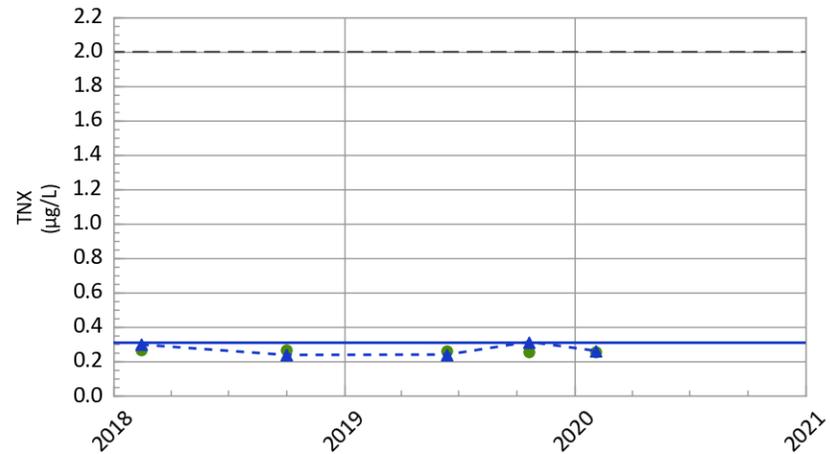
**PTX06-1191 Downgradient Performance Indicators  
Southeast Ext In Situ Bioremediation System  
USDOE/NNSA Pantex Plant**

Most Recent Measured COC Concentrations (Feb 03, 2020)

COC	Concentration (µg/L)	GWPS (µg/L)
RDX	115.0	2.0
MNX	Non-Detect	2.0
DNX	Non-Detect	2.0
TNX	0.261	2.0

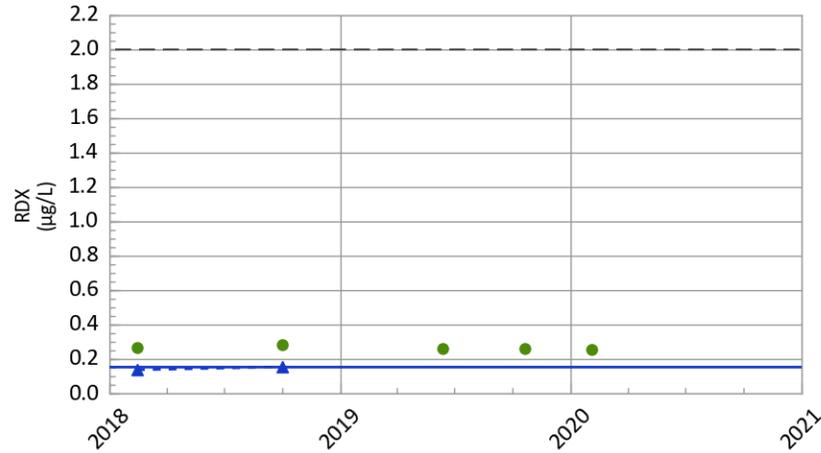
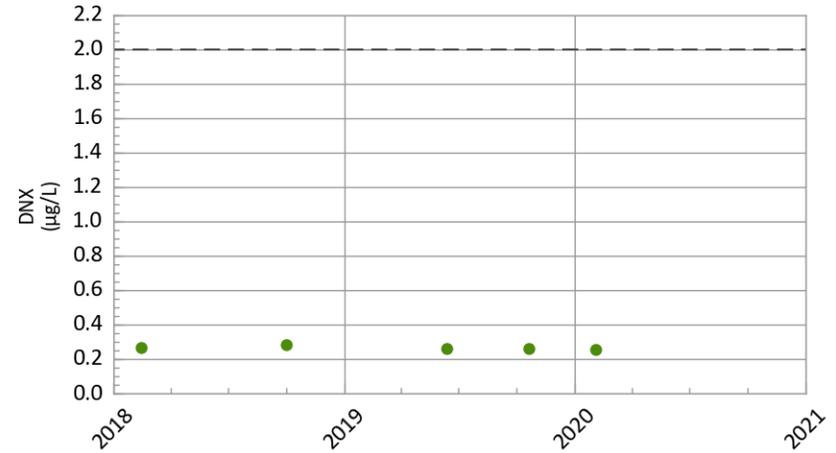
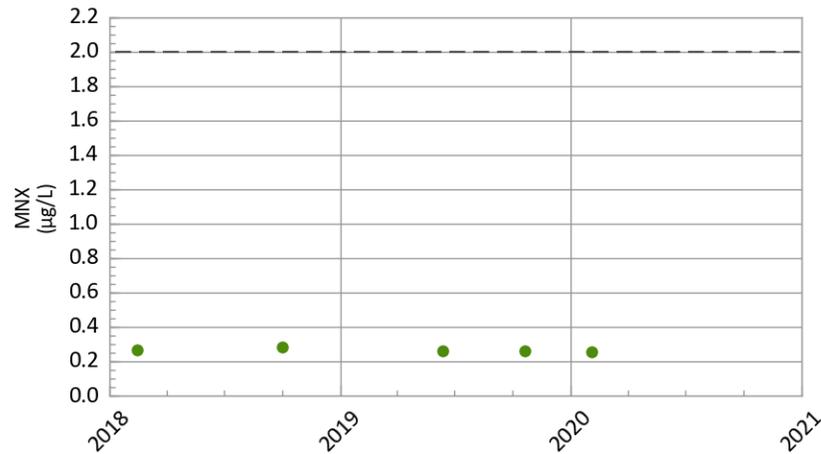
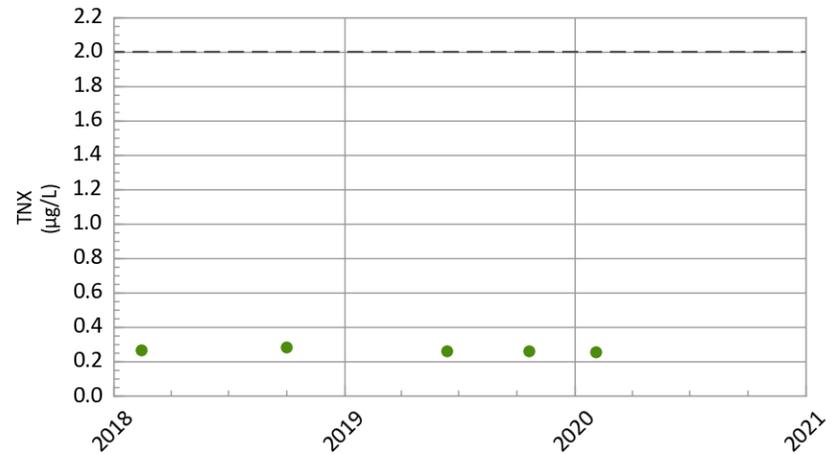
**PTX06-1194 Downgradient Performance Indicators  
Southeast Ext In Situ Bioremediation System  
USDOE/NNSA Pantex Plant**

Most Recent Measured COC Concentrations (Feb 03, 2020)

COC	Concentration (µg/L)	GWPS (µg/L)
RDX	Non-Detect	2.0
MNX	Non-Detect	2.0
DNX	Non-Detect	2.0
TNX	Non-Detect	2.0

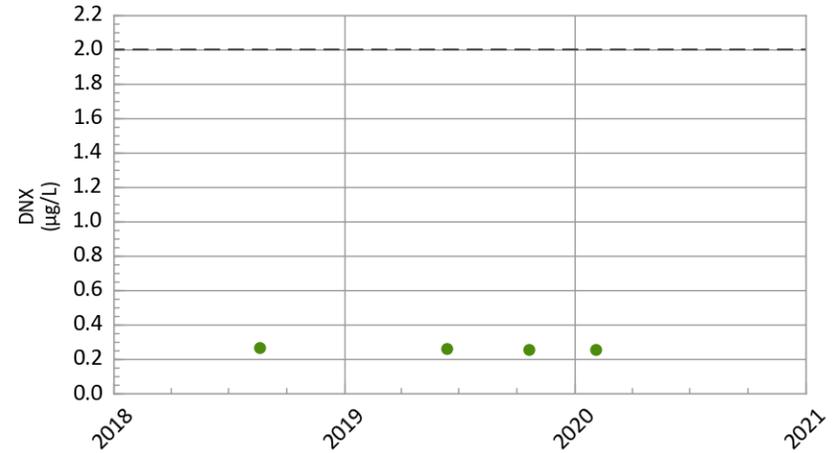
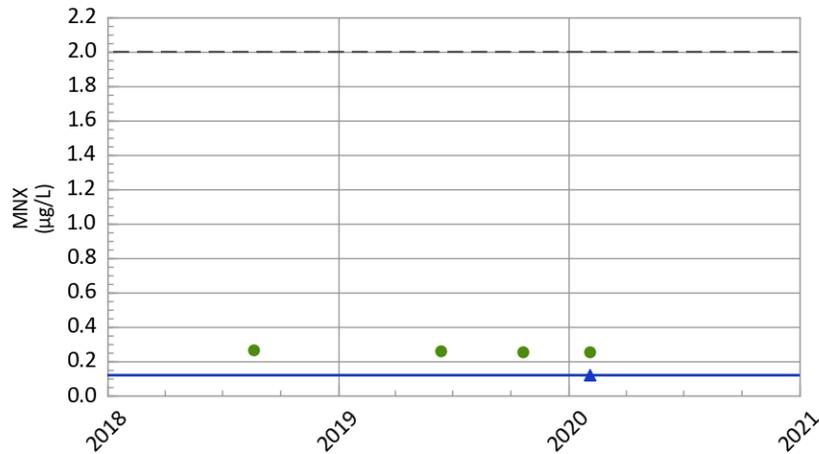
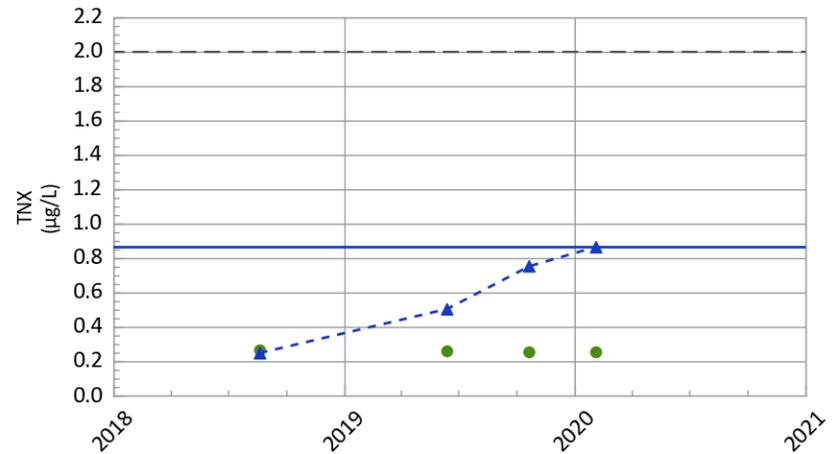
**PTX06-1196 Downgradient Performance Indicators  
Southeast Ext In Situ Bioremediation System  
USDOE/NNSA Pantex Plant**

Most Recent Measured COC Concentrations (Feb 03, 2020)

COC	Concentration (µg/L)	GWPS (µg/L)
RDX	24.4	2.0
MNX	0.121	2.0
DNX	Non-Detect	2.0
TNX	0.864	2.0
