PANTEX QUARTERLY PROGRESS REPORT

Remedial Action Progress

3rd Quarter 2019

**Quarterly Progress Report
3rd Quarter 2019
in Support of Hazardous Waste Permit #50284
and Pantex Plant Interagency Agreement
for the Pantex Plant, Amarillo, Texas
December 2019**

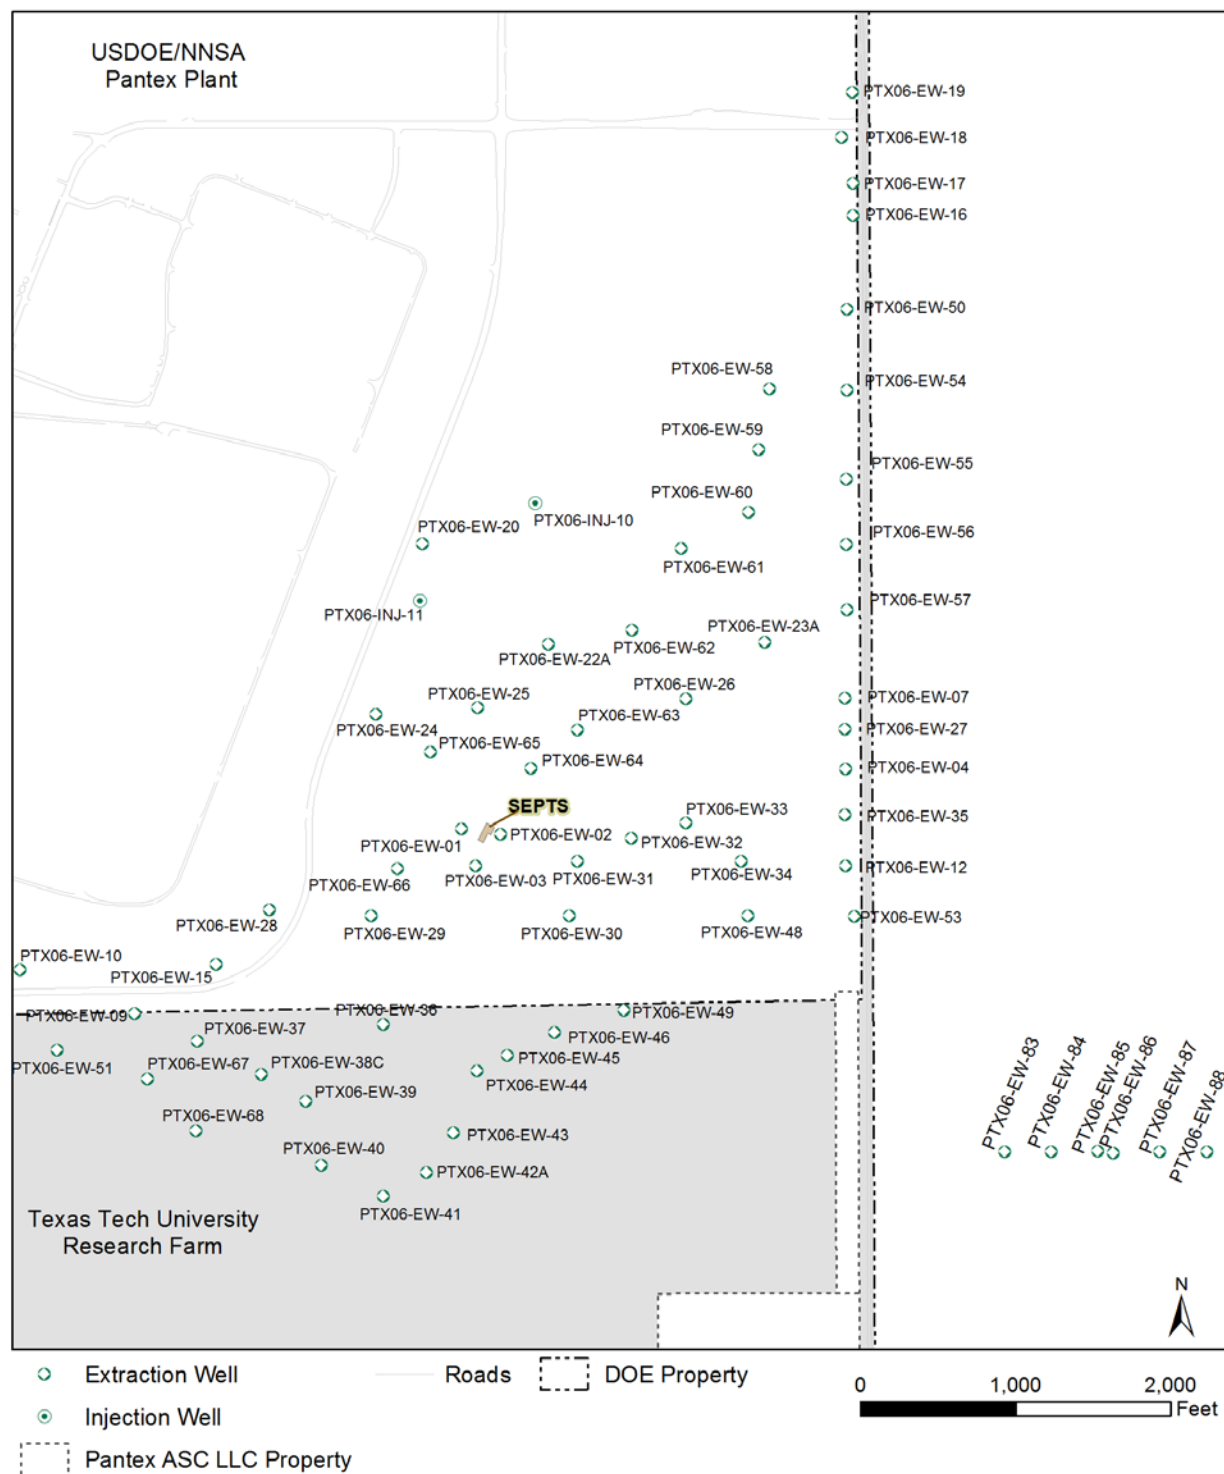
Southeast Pump and Treat System Wells
