PANTEX QUARTERLY PROGRESS REPORT

Remedial Action Progress

3rd Quarter 2020

In support of Hazardous Waste Permit #50284 and
Pantex Plant Interagency Agreement
December 2020

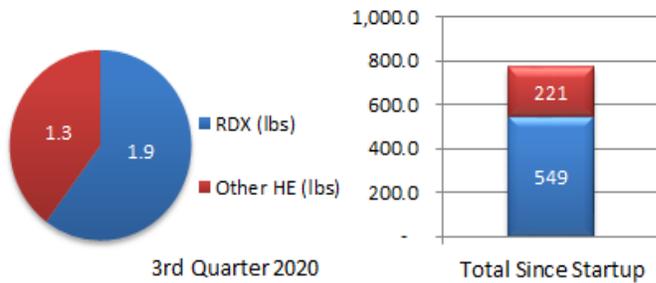
Figure 1. P1PTS Mass Removal

P1PTS primarily treats RDX (hexahydro-1,3,5-trinitro-1,3,5-triazine) and SEPTS primarily treats and hexavalent chromium [Cr(VI)]. Figures 1 and 2 provide mass removal information for RDX and other high explosives (HEs) and Cr(VI) for the 3rd Quarter, as well as totals since system startup. Concentrations near Playa 1 are much lower due to declining source concentrations therefore, mass removal is much lower at P1PTS. Overall, the systems have removed over 15,400 pounds (lbs) of HE and chromium contaminants from perched groundwater since operations began.

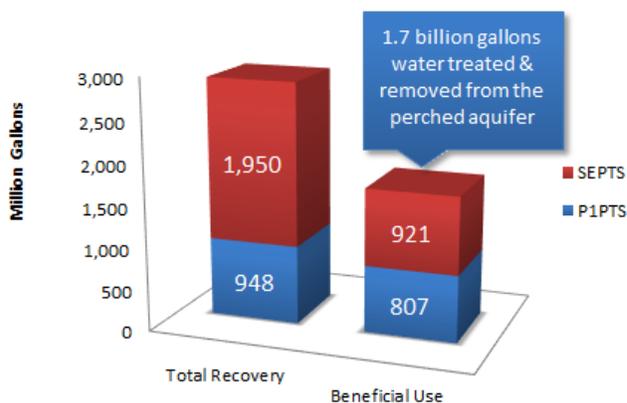
Figure 3. System Recovery and Use

Due to decreased capability to fully operate SEPTS, P1PTS was operated during July and August while well repairs were underway at SEPTS. Both systems treated about 32.3 million gallons (Mgal) during 3rd quarter. About 95% of the treated water was either released to Playa 1 or injected into perched injection wells, with the remainder used for ISB injection.

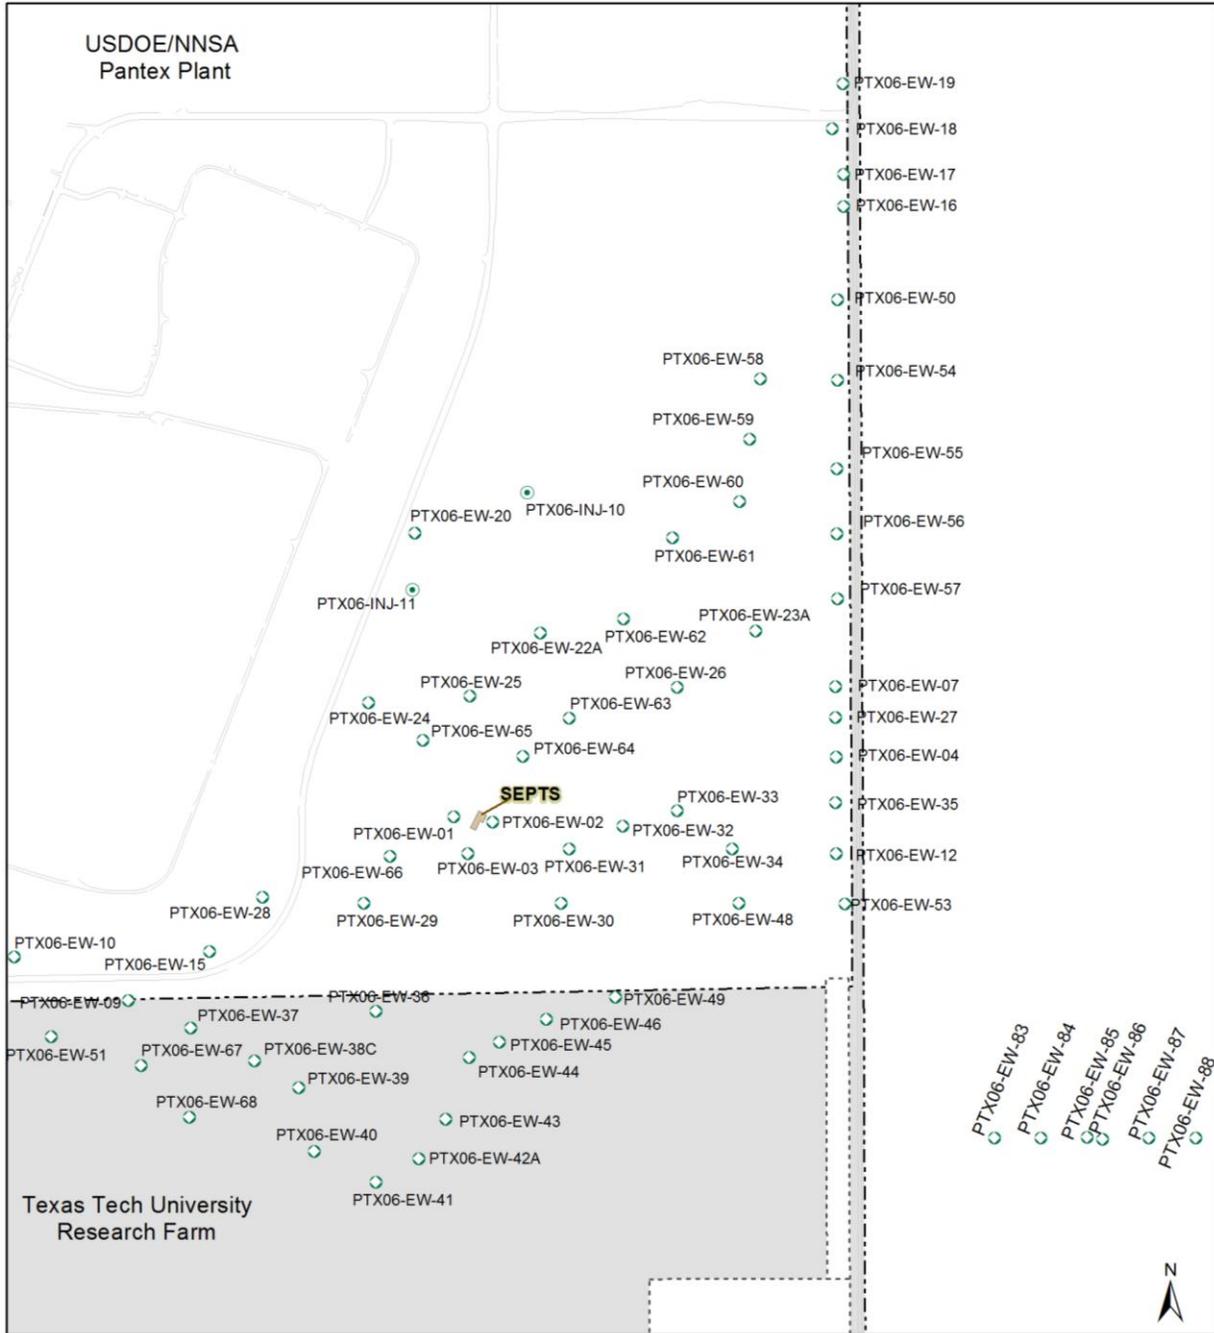
Southeast Pump and Treat System Wells

- Extraction Well
 - Injection Well
 - Roads
 - - - DOE Property
 - ⋯ Pantex ASC LLC Property
- 0 1,000 2,000 Feet

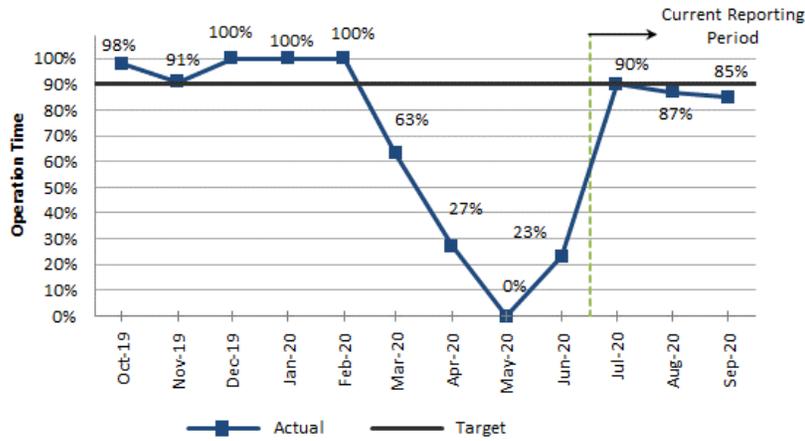
SEPTS Operation Time vs Target

The SEPTS wellfield had wells that were not operational during 3rd quarter due to electrical and equipment issues. Pantex has issued a contract to address the problems with the SEPTS wells. All wells are expected to be operational by end of 2020. Graphs of monthly operation and throughput are included in Appendix B.

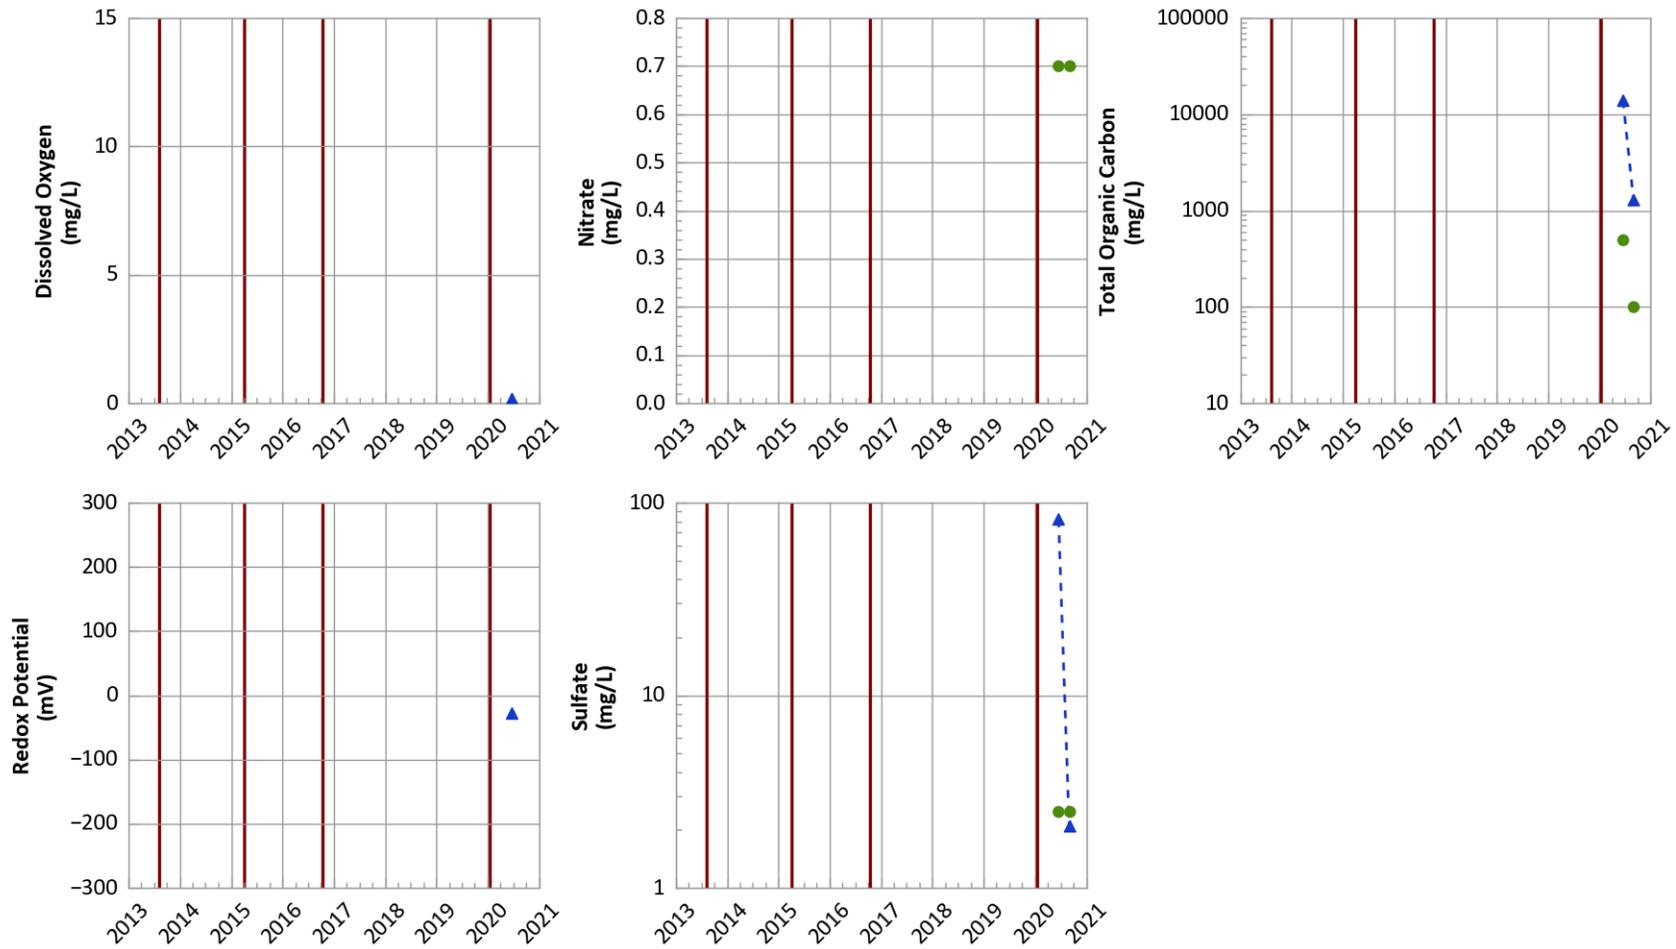
**PTX06-ISB021 Treatment Zone Performance Indicators
USDOE/NNSA Pantex Plant**

Typical Baseline Concentrations in Perched Groundwater

Dissolved Oxygen: 5-10 mg/L
 Redox Potential: > 100 mV
 Nitrate: > 1 mg/L
 Sulfate: > 10 mg/L
 Total Organic Carbon: < 5 mg/L
 Total Volatile Fatty Acids: Not Detected

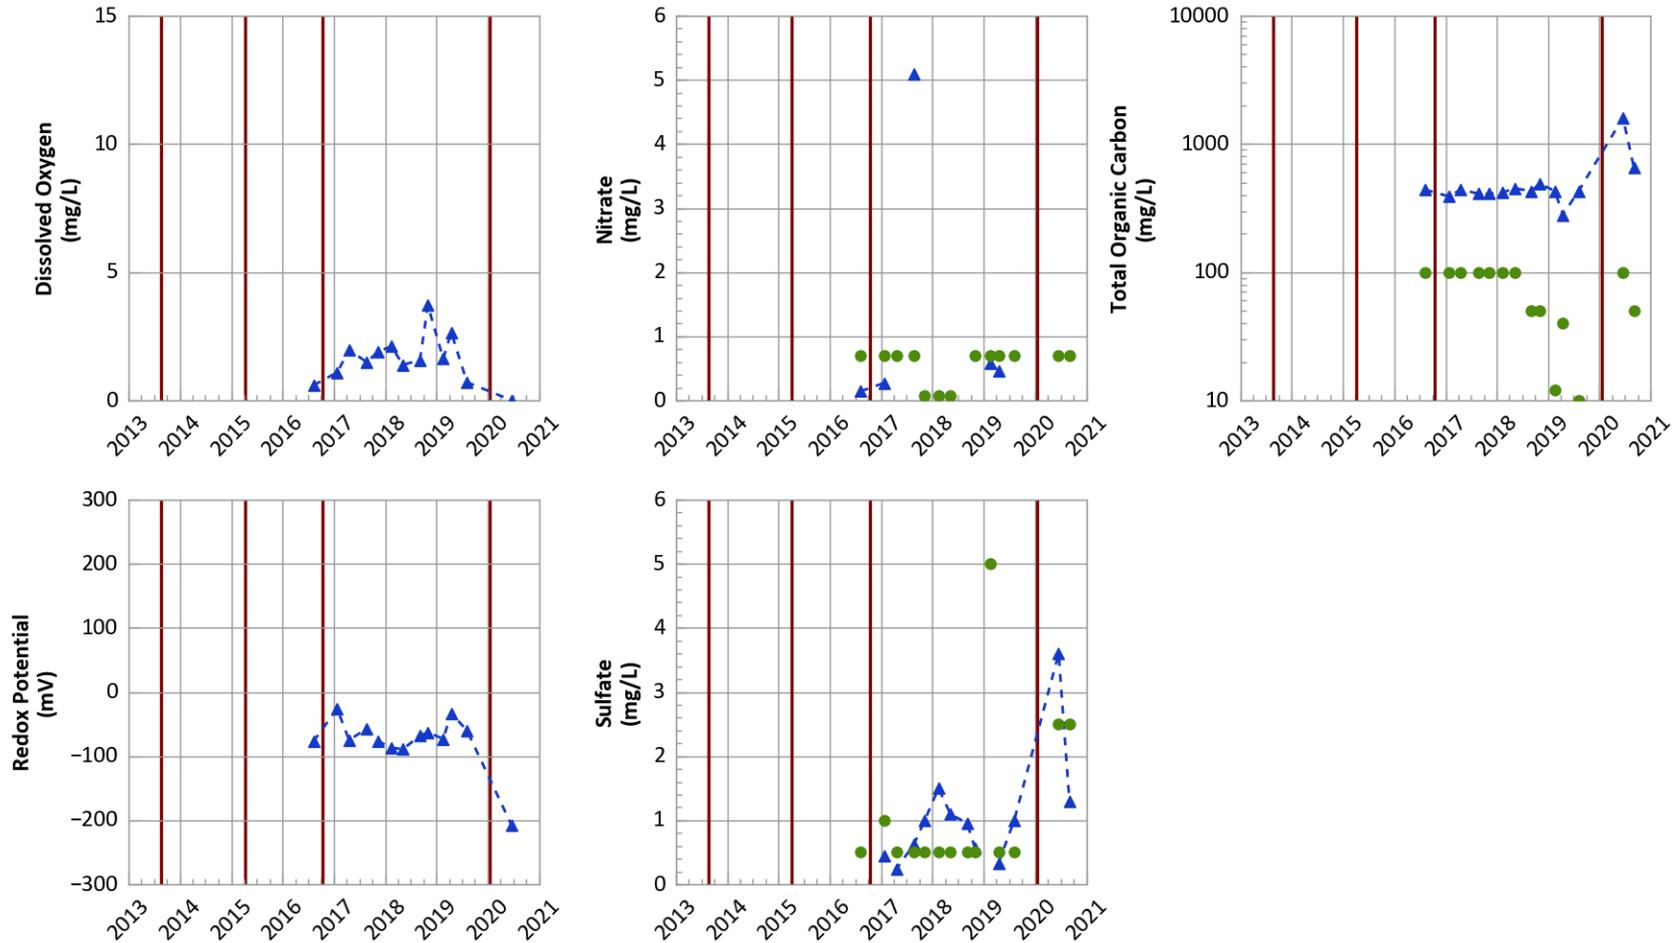
PTX06-ISB038 Treatment Zone Performance Indicators
USDOE/NNSA Pantex Plant

Typical Baseline Concentrations in Perched Groundwater

Dissolved Oxygen: 5-10 mg/L
 Redox Potential: > 100 mV
 Nitrate: > 1 mg/L
 Sulfate: > 10 mg/L
 Total Organic Carbon: < 5 mg/L
 Total Volatile Fatty Acids: Not Detected

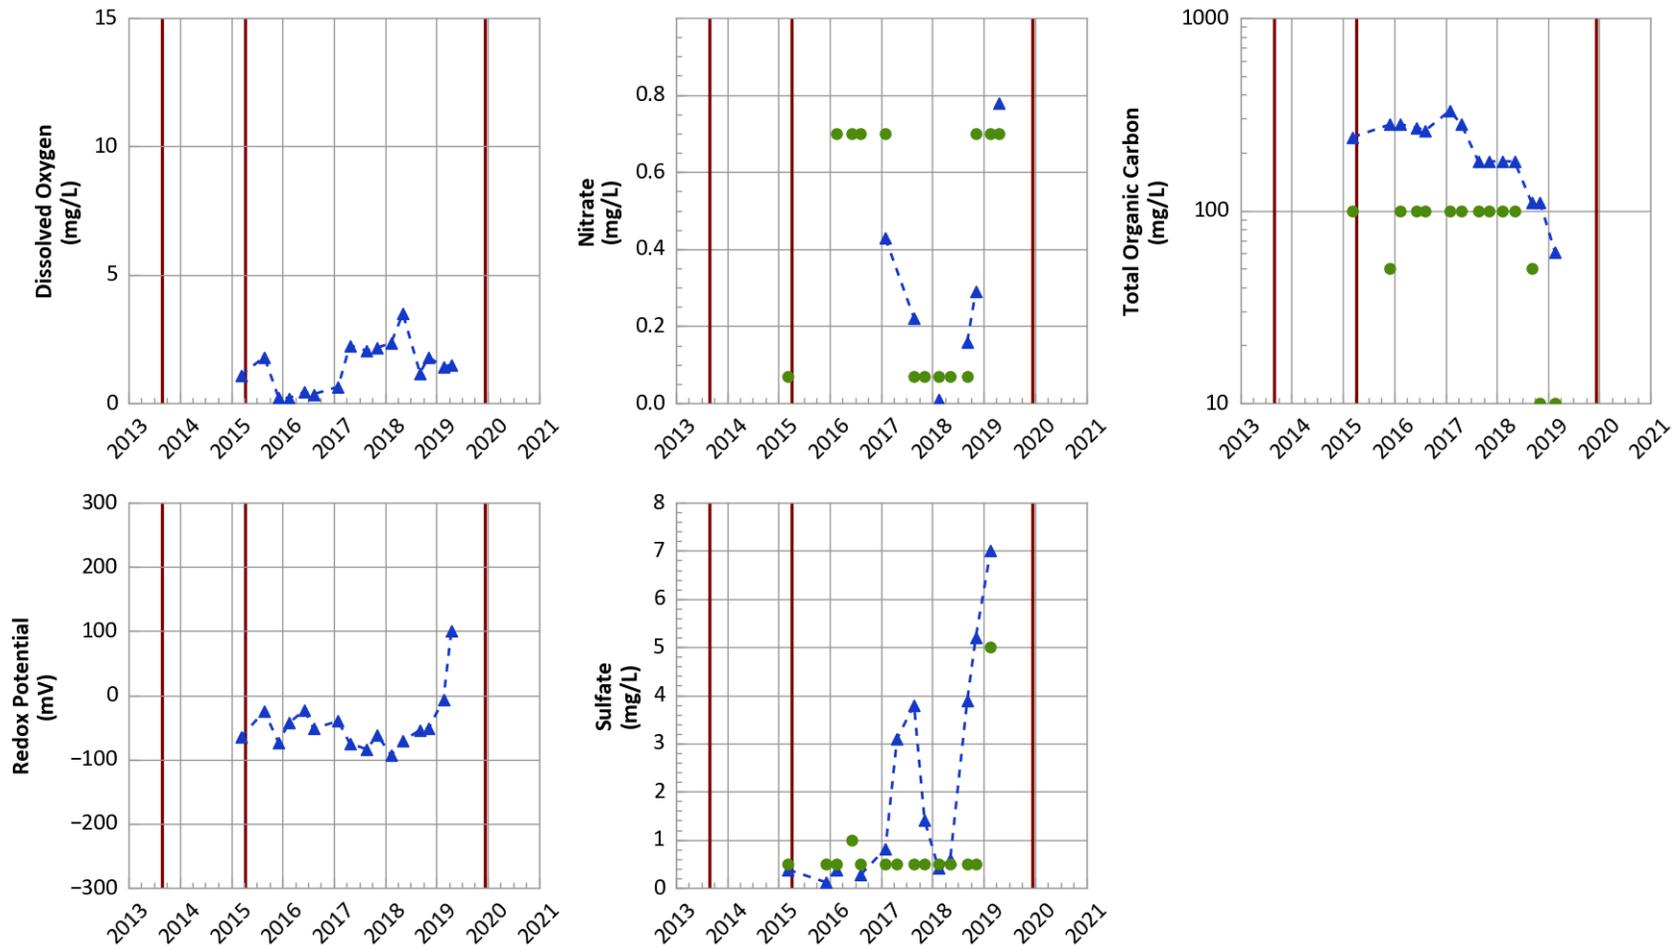
PTX06-ISB048 Treatment Zone Performance Indicators
USDOE/NNSA Pantex Plant

Typical Baseline Concentrations in Perched Groundwater

- Dissolved Oxygen: 5-10 mg/L
- Redox Potential: > 100 mV
- Nitrate: > 1 mg/L
- Sulfate: > 10 mg/L
- Total Organic Carbon: < 5 mg/L
- Total Volatile Fatty Acids: Not Detected

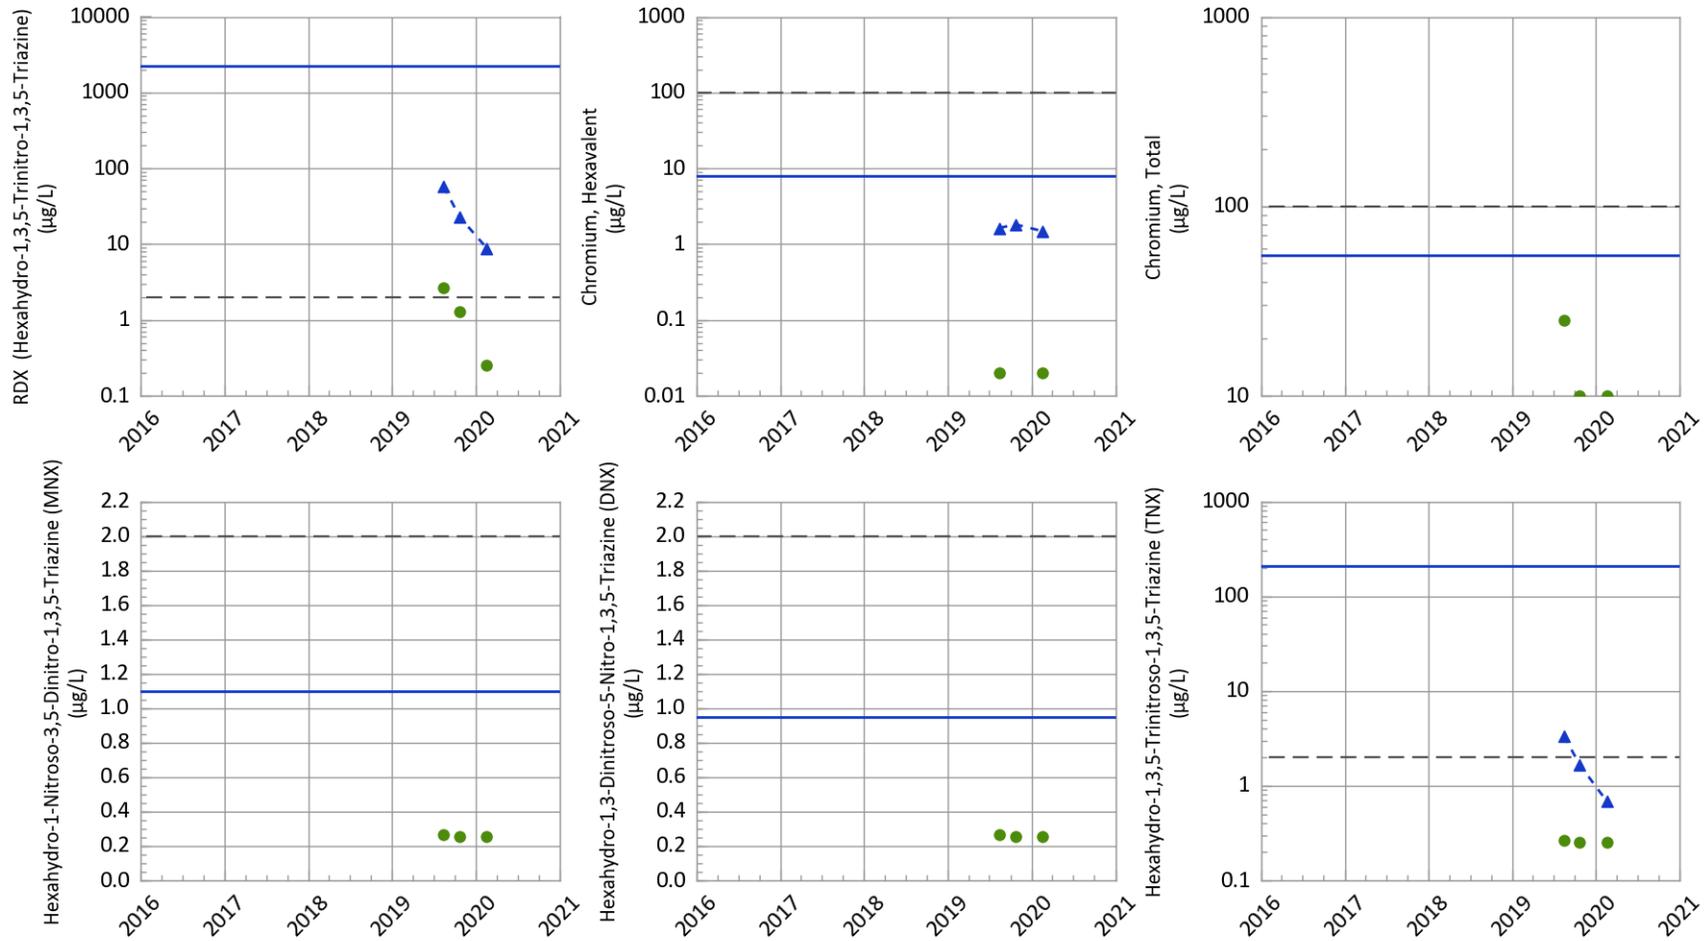
**PTX06-1045 Downgradient Performance Indicators
Southeast In Situ Bioremediation System
USDOE/NNSA Pantex Plant**

Most Recent Measured COC Concentrations (Feb 18, 2020)

COC	Concentration (µg/L)	GWPS (µg/L)
RDX	8.86	2.0
MNX	Non-Detect	2.0
CR-6	1.48	100.0
DNX	Non-Detect	2.0
CR	Non-Detect	100.0
TNX	0.68	2.0

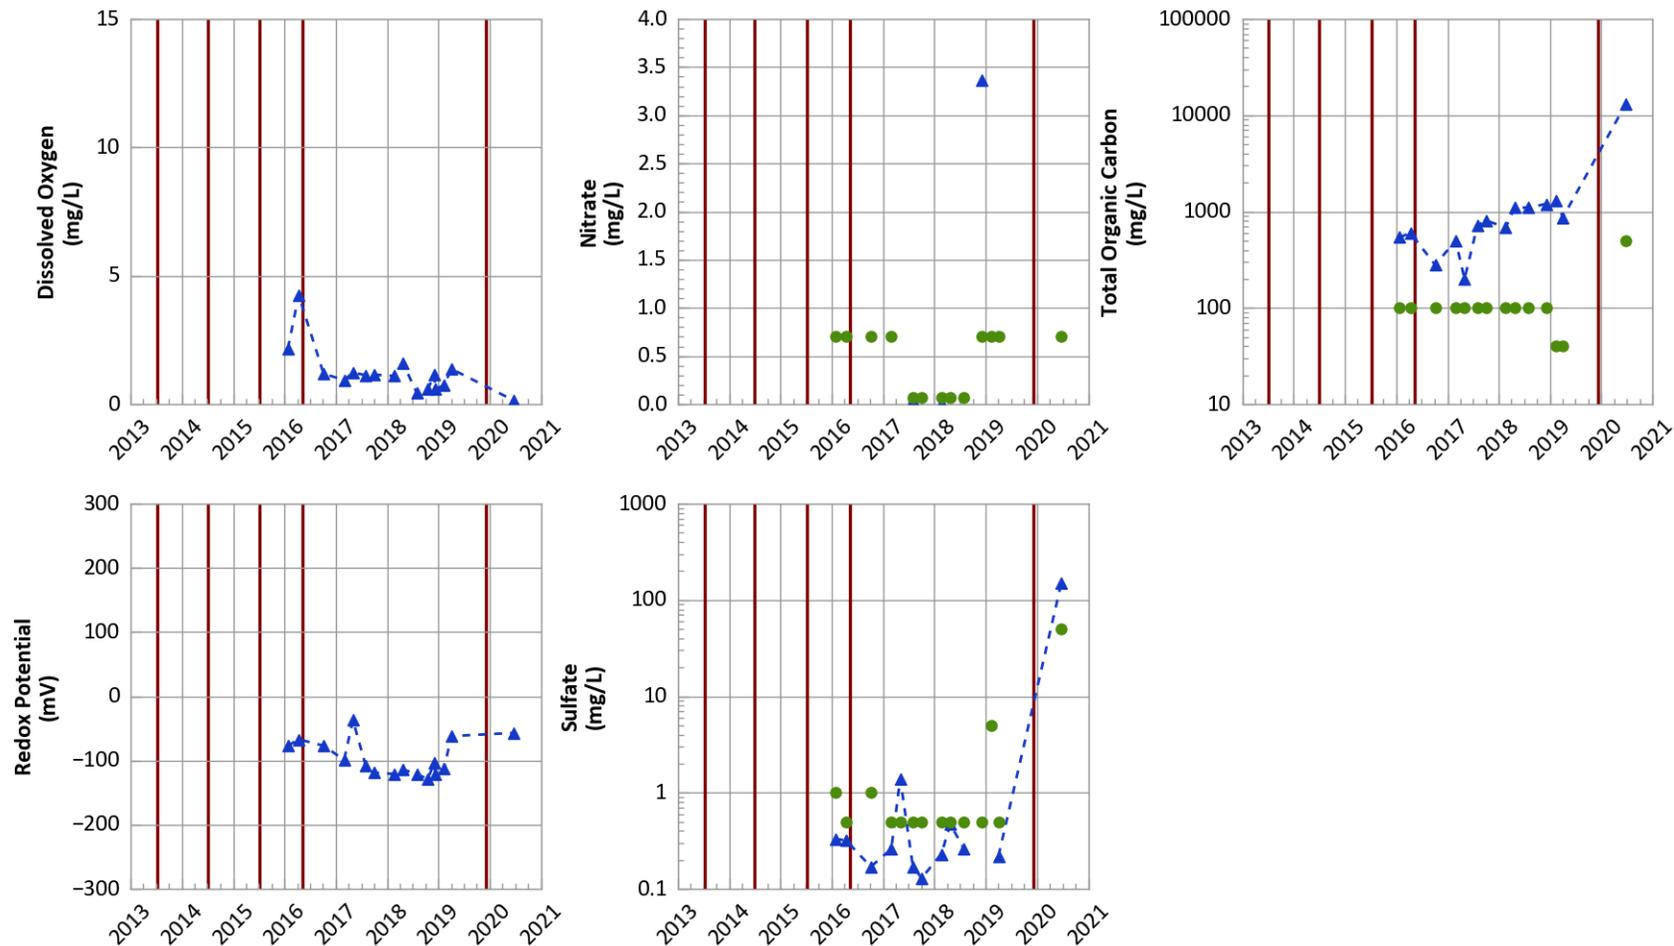
**PTX06-ISB059 Treatment Zone Performance Indicators
USDOE/NNSA Pantex Plant**

Typical Baseline Concentrations in Perched Groundwater

Dissolved Oxygen: 5-10 mg/L
 Redox Potential: > 100 mV
 Nitrate: > 1 mg/L
 Sulfate: > 10 mg/L
 Total Organic Carbon: < 5 mg/L
 Total Volatile Fatty Acids: Not Detected

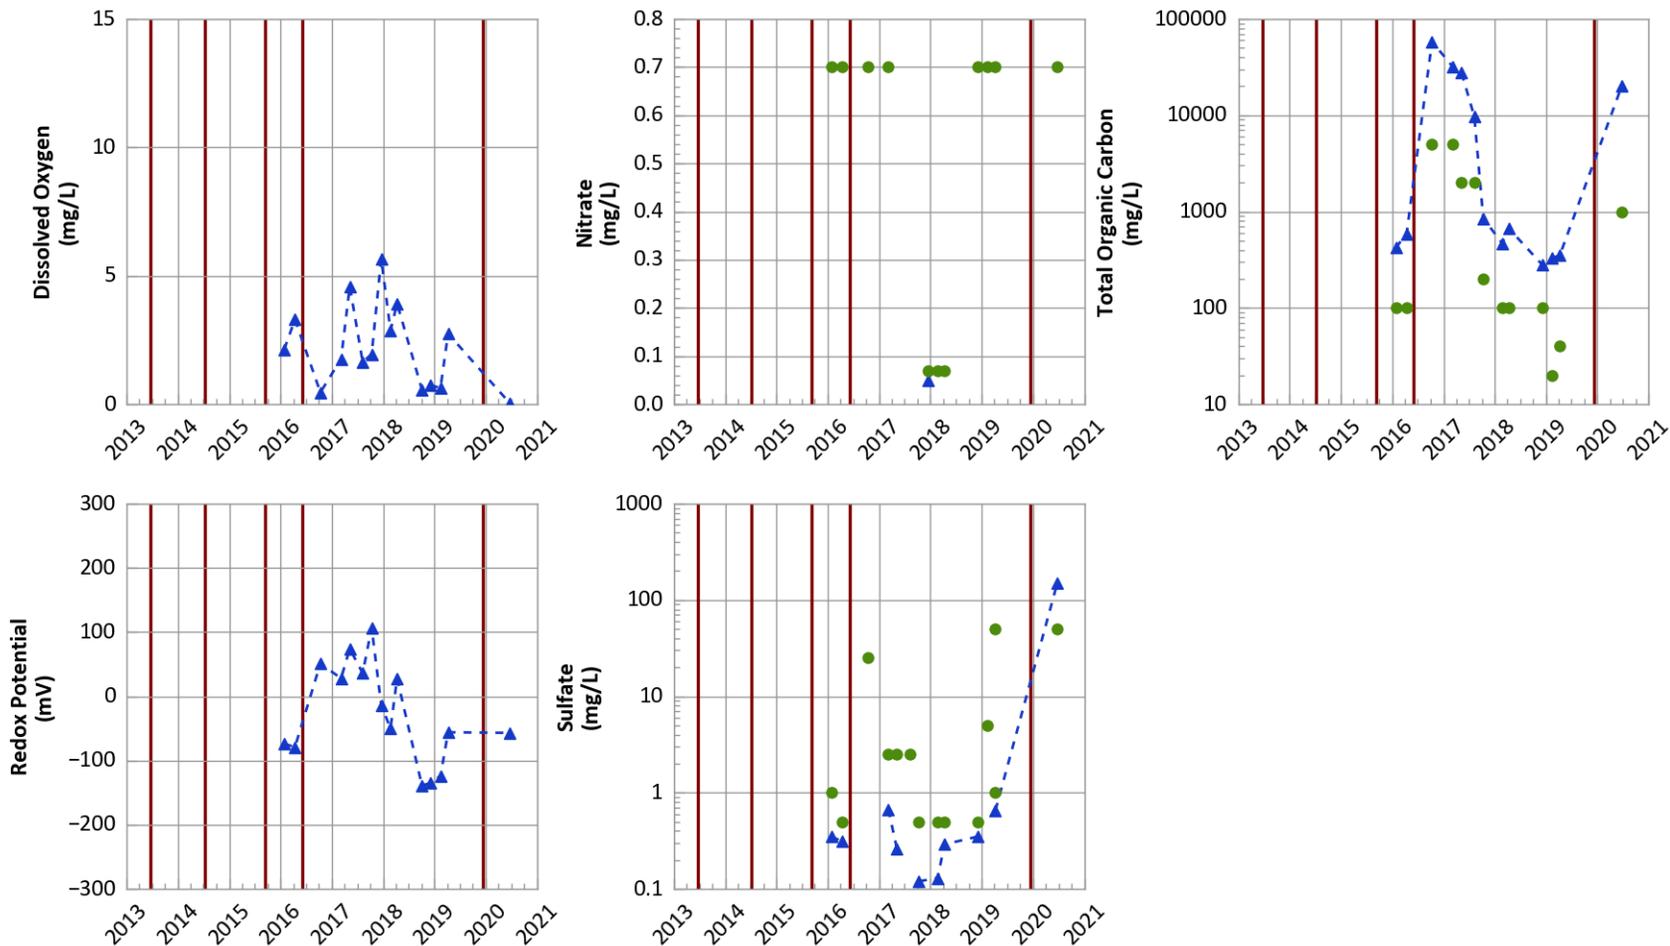
PTX06-ISB073 Treatment Zone Performance Indicators
USDOE/NNSA Pantex Plant

Typical Baseline Concentrations in Perched Groundwater

Dissolved Oxygen: 5-10 mg/L
 Redox Potential: > 100 mV
 Nitrate: > 1 mg/L
 Sulfate: > 10 mg/L
 Total Organic Carbon: < 5 mg/L
 Total Volatile Fatty Acids: Not Detected

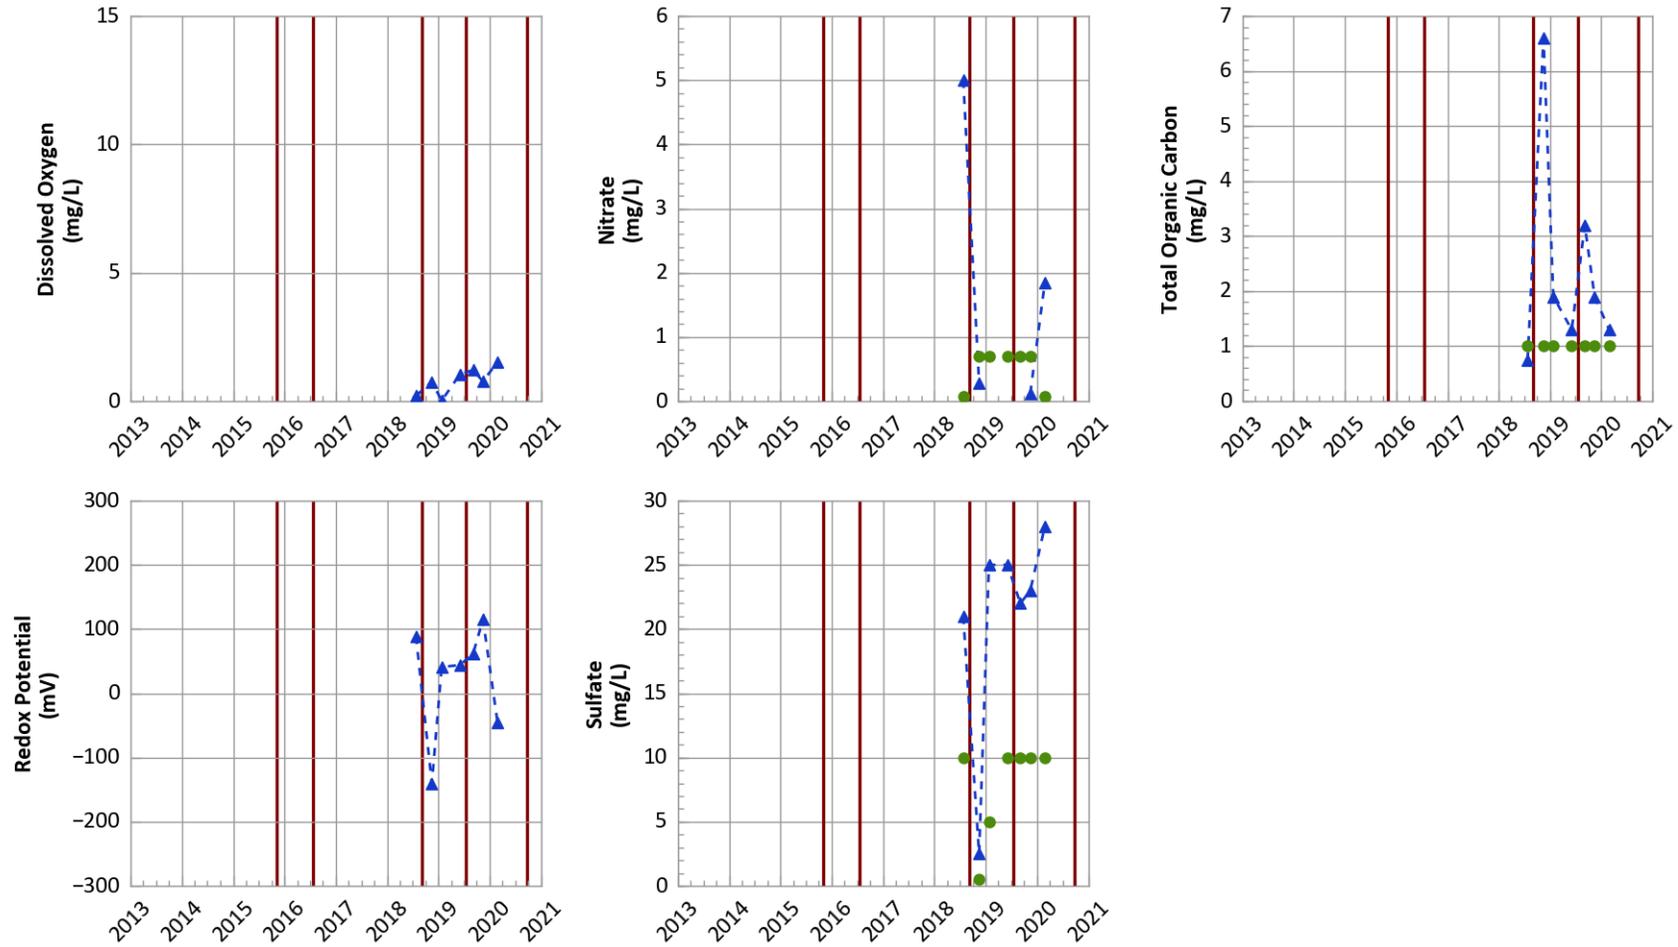
**PTX06-1164 Treatment Zone Performance Indicators
USDOE/NNSA Pantex Plant**

Typical Baseline Concentrations in Perched Groundwater

Dissolved Oxygen: 5-10 mg/L
 Redox Potential: > 100 mV
 Nitrate: > 1 mg/L
 Sulfate: > 10 mg/L
 Total Organic Carbon: < 5 mg/L
 Total Volatile Fatty Acids: Not Detected

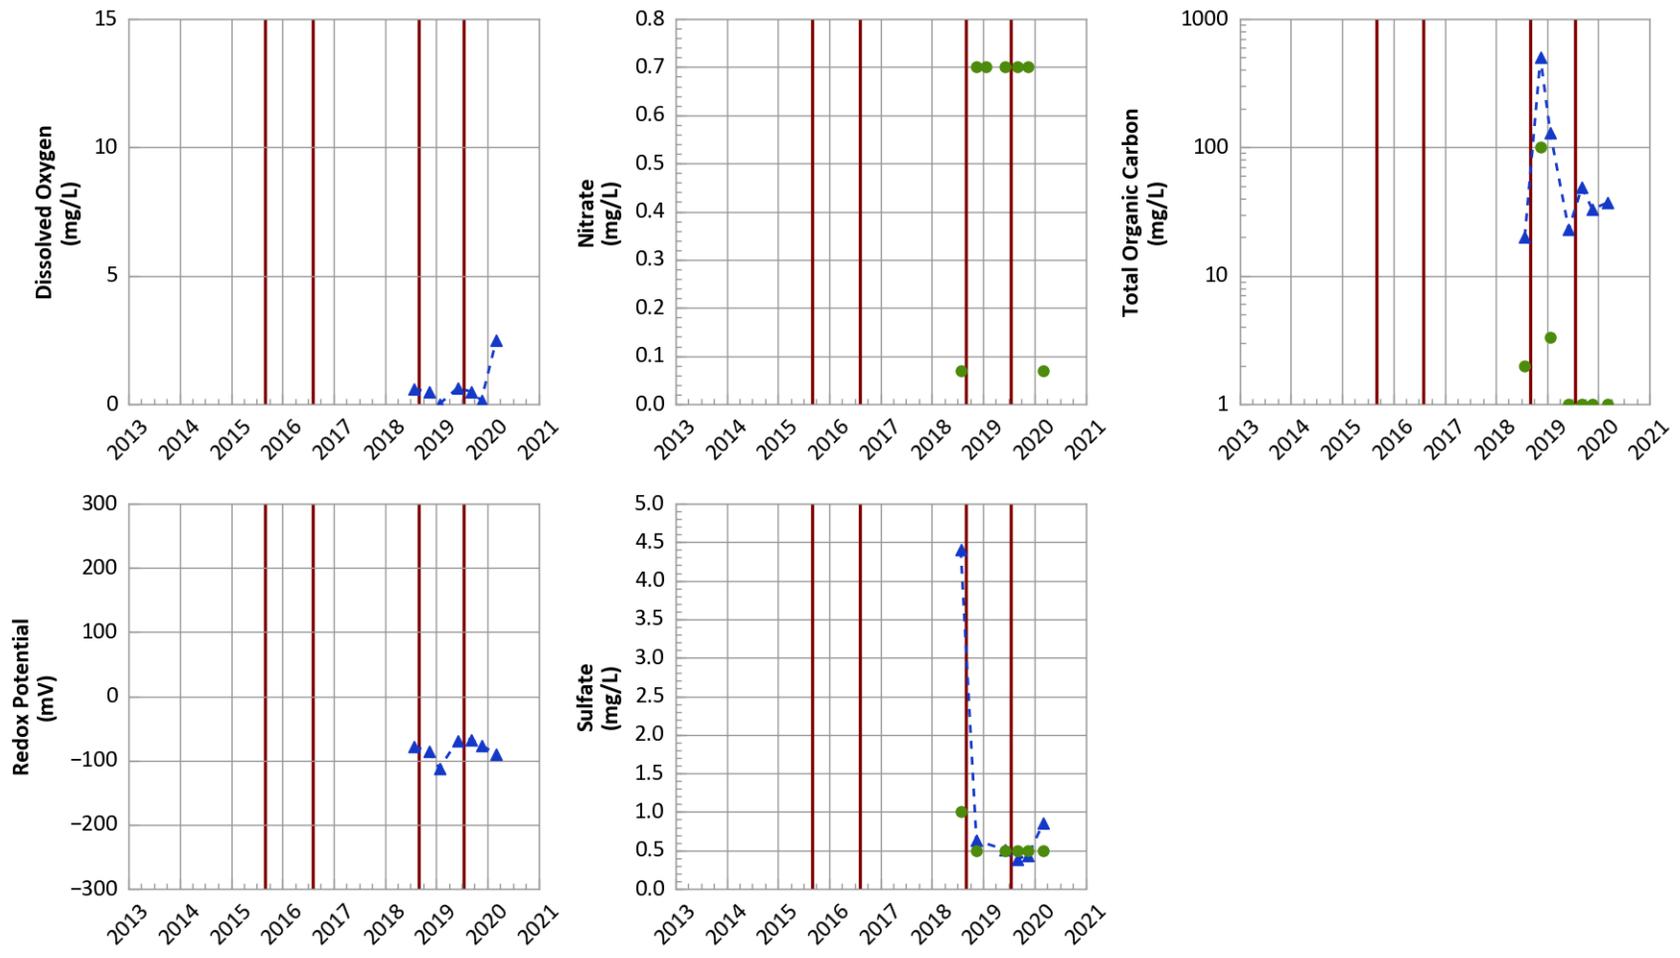
**PTX06-1176 Treatment Zone Performance Indicators
USDOE/NNSA Pantex Plant**

Typical Baseline Concentrations in Perched Groundwater

Dissolved Oxygen: 5-10 mg/L
 Redox Potential: > 100 mV
 Nitrate: > 1 mg/L
 Sulfate: > 10 mg/L
 Total Organic Carbon: < 5 mg/L
 Total Volatile Fatty Acids: Not Detected

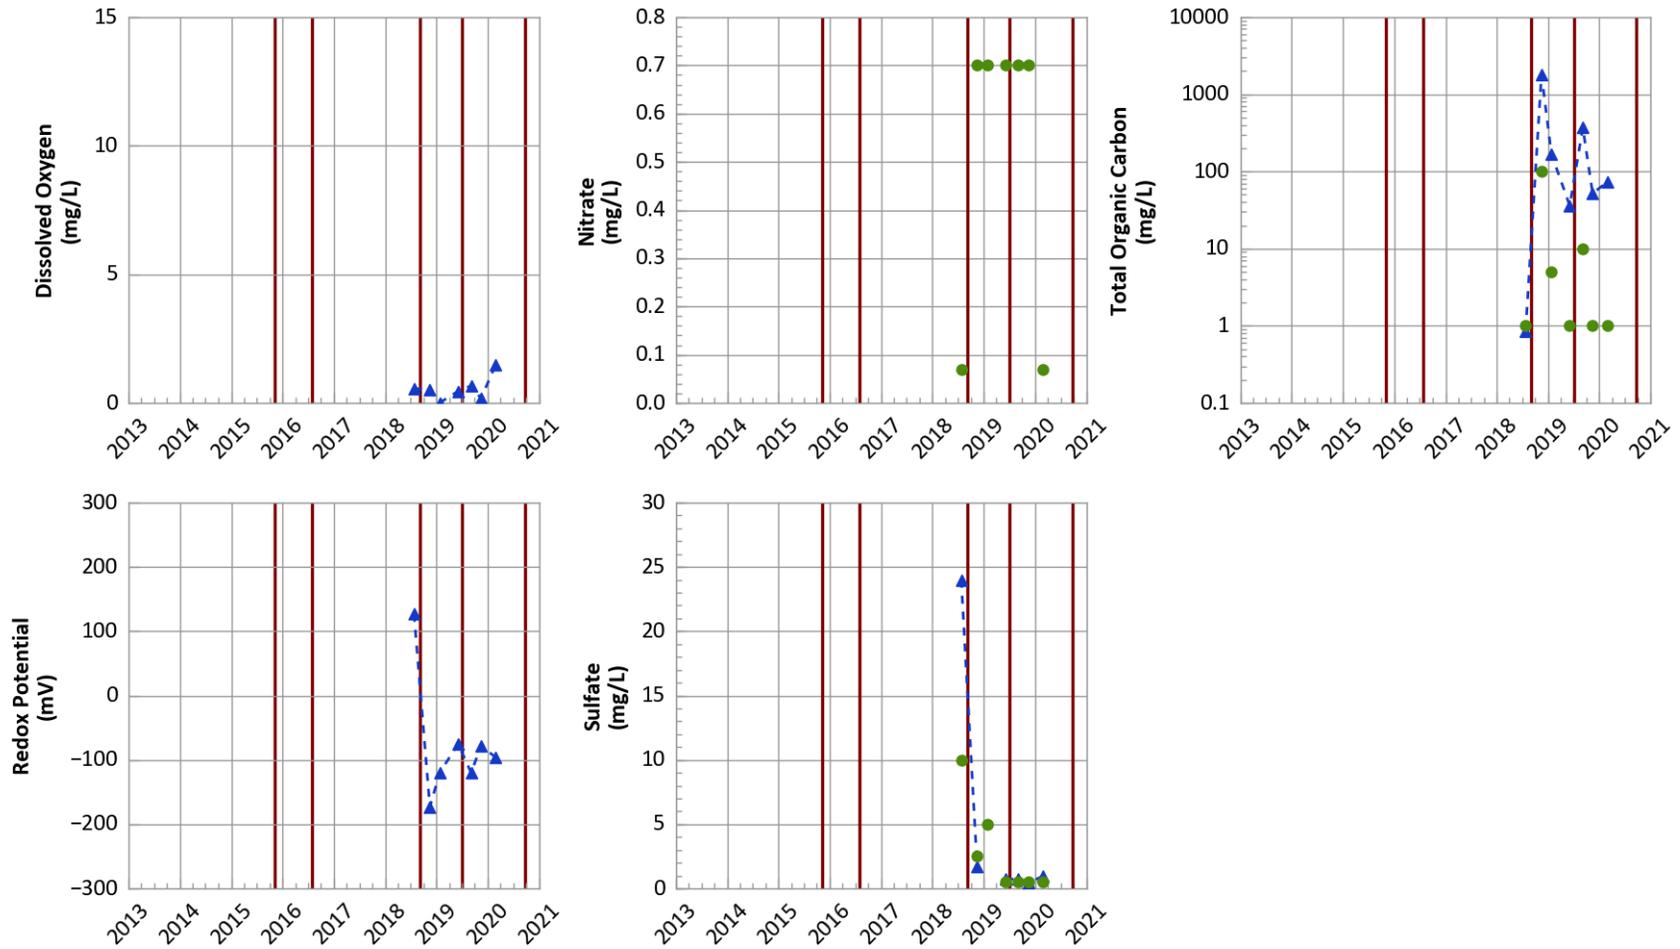
**PTX06-1177 Treatment Zone Performance Indicators
USDOE/NNSA Pantex Plant**

Typical Baseline Concentrations in Perched Groundwater

Dissolved Oxygen: 5-10 mg/L
 Redox Potential: > 100 mV
 Nitrate: > 1 mg/L
 Sulfate: > 10 mg/L
 Total Organic Carbon: < 5 mg/L
 Total Volatile Fatty Acids: Not Detected

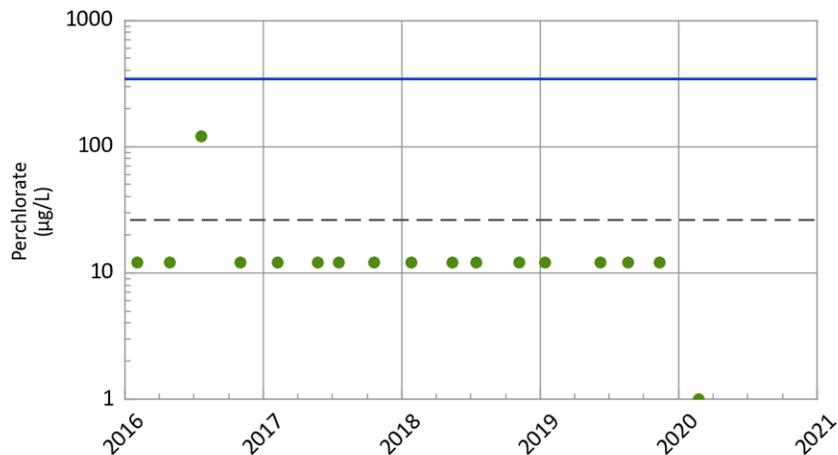
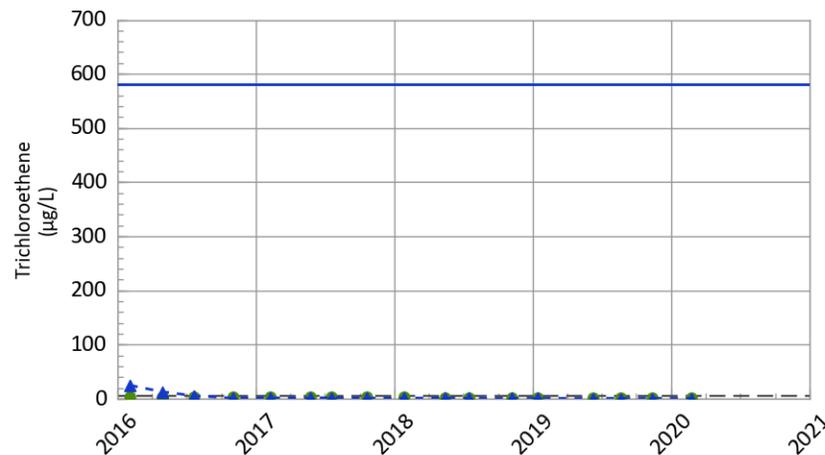
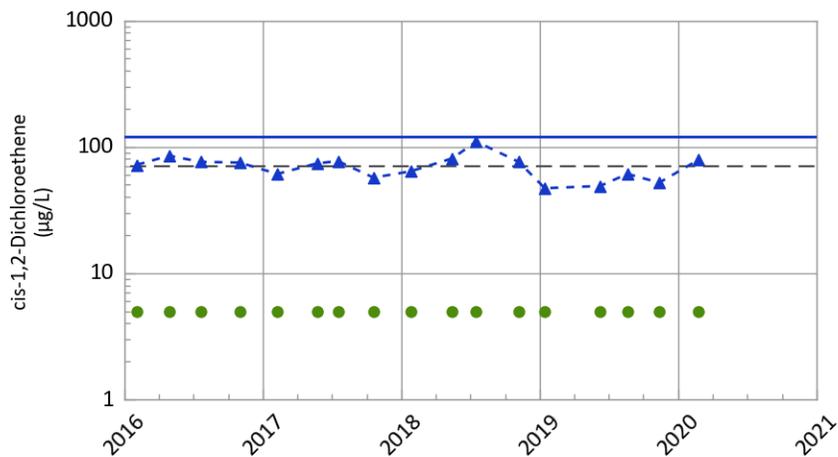
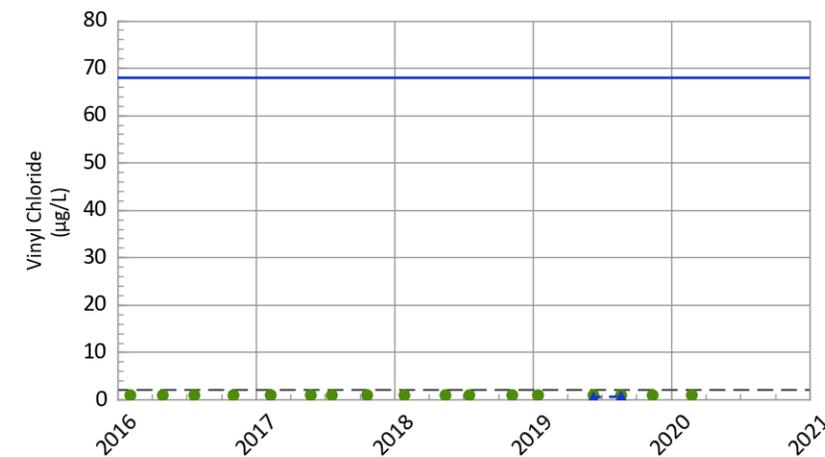
**PTX06-1012 Downgradient Performance Indicators
Zone 11 In Situ Bioremediation System
USDOE/NNSA Pantex Plant**

Most Recent Measured COC Concentrations (Aug 20, 2019)

COC	Concentration (µg/L)	GWPS (µg/L)
PERC	Non-Detect	26.0
DCE12C	79.0	70.0
TCE	0.86	5.0
VC	Non-Detect	2.0

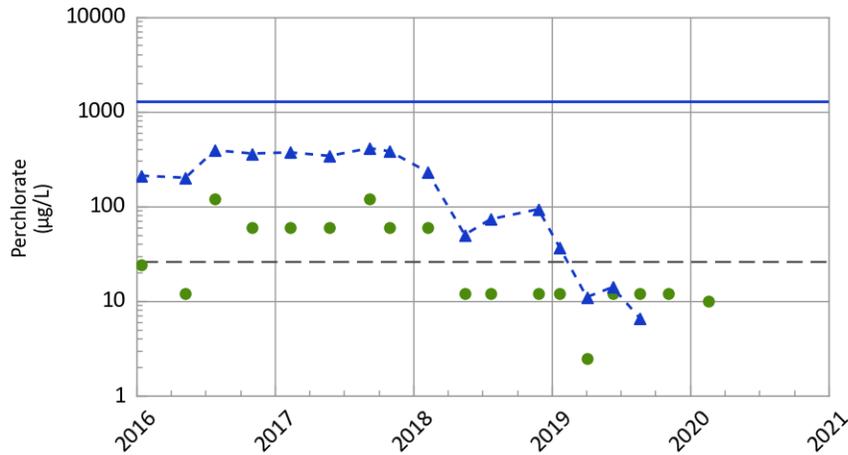
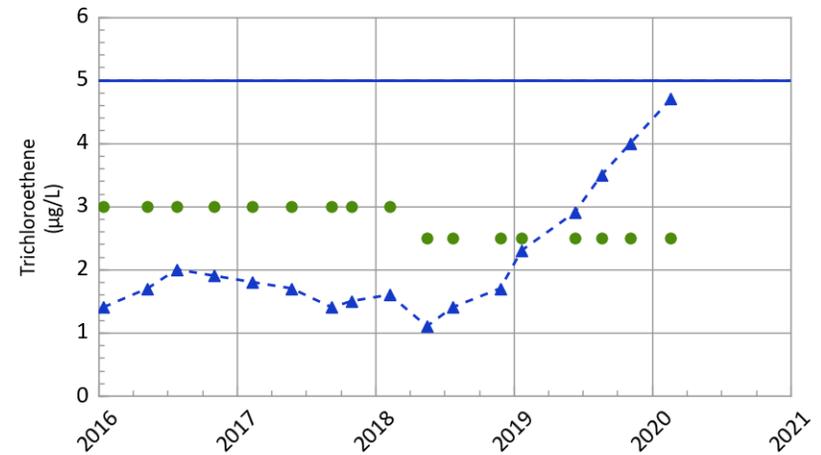
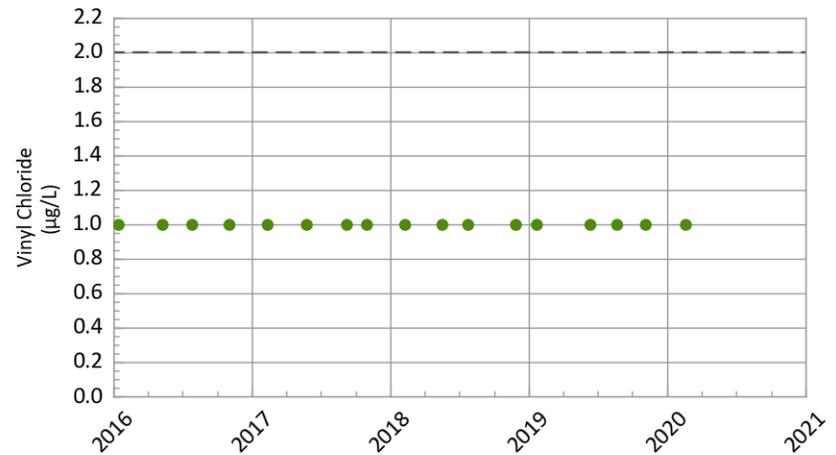
**PTX06-1148 Downgradient Performance Indicators
Zone 11 In Situ Bioremediation System
USDOE/NNSA Pantex Plant**

Most Recent Measured COC Concentrations (Feb 19, 2020)

COC	Concentration (µg/L)	GWPS (µg/L)
PERC	Non-Detect	26.0
DCE12C	0.72	70.0
TCE	4.7	5.0
VC	Non-Detect	2.0

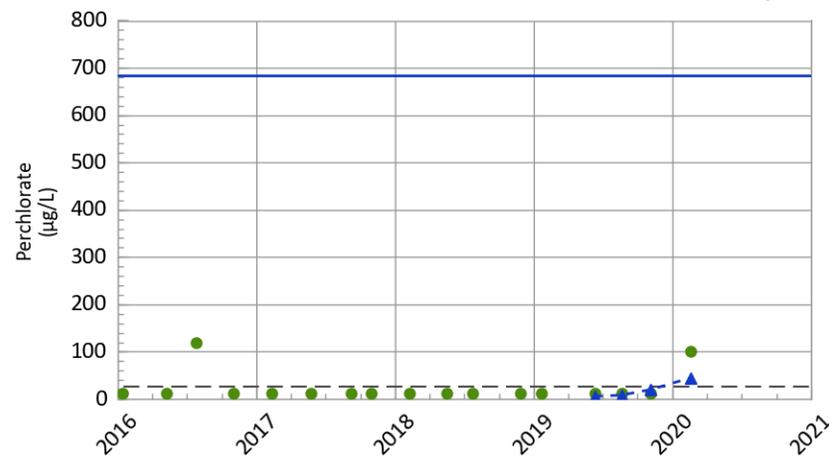
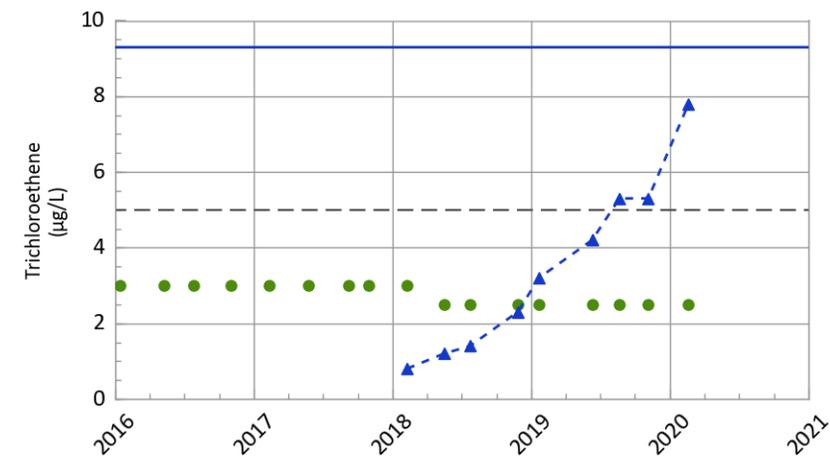
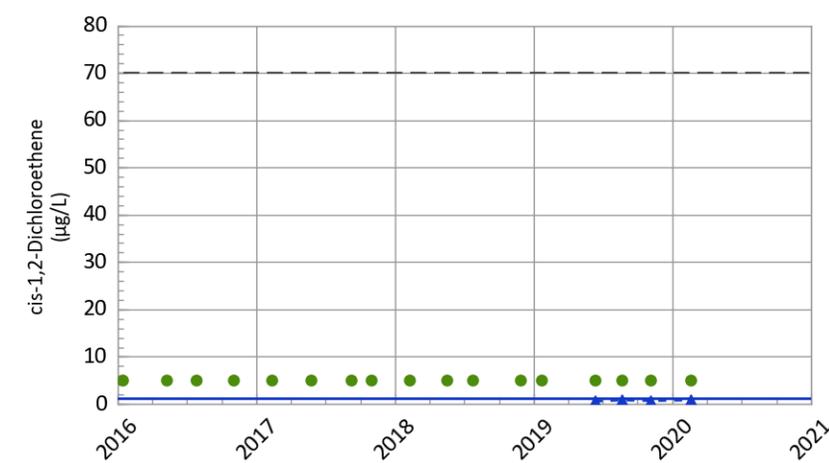
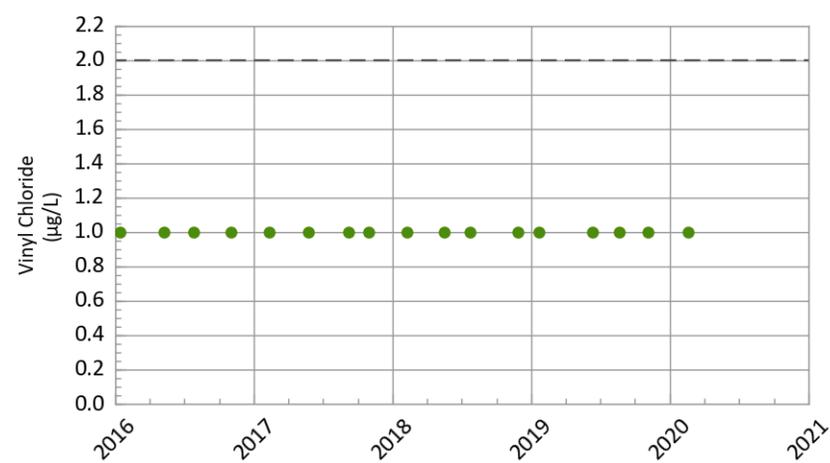
**PTX06-1149 Downgradient Performance Indicators
Zone 11 In Situ Bioremediation System
USDOE/NNSA Pantex Plant**

Most Recent Measured COC Concentrations (Feb 19, 2020)

COC	Concentration (µg/L)	GWPS (µg/L)
PERC	45.0	26.0
DCE12C	0.82	70.0
TCE	7.8	5.0
VC	Non-Detect	2.0

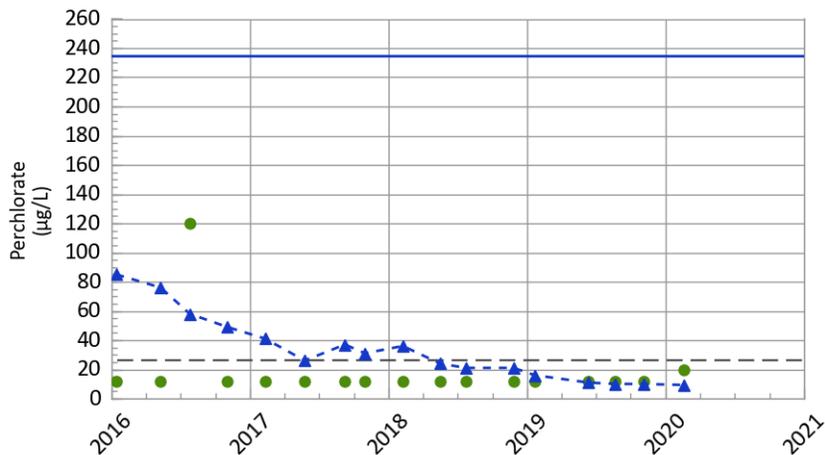
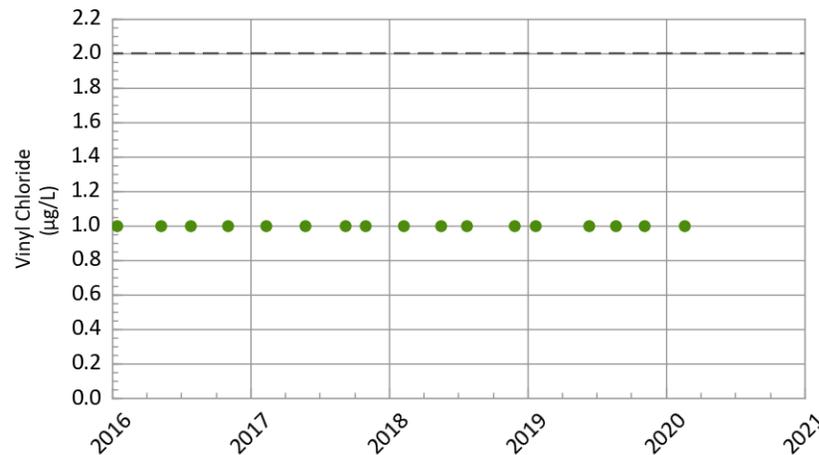
**PTX06-1150 Downgradient Performance Indicators
Zone 11 In Situ Bioremediation System
USDOE/NNSA Pantex Plant**

Most Recent Measured COC Concentrations (Feb 19, 2020)

COC	Concentration (µg/L)	GWPS (µg/L)
PERC	9.3	26.0
DCE12C	0.42	70.0
TCE	10.0	5.0
VC	Non-Detect	2.0
