PANTEX QUARTERLY PROGRESS REPORT

Remedial Action Progress

3rd Quarter 2020

In support of Hazardous Waste Permit #50284 and
Pantex Plant Interagency Agreement
December 2020

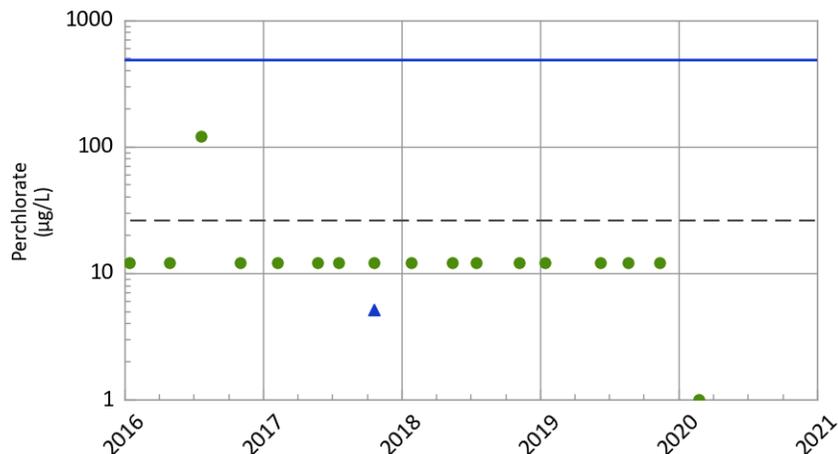
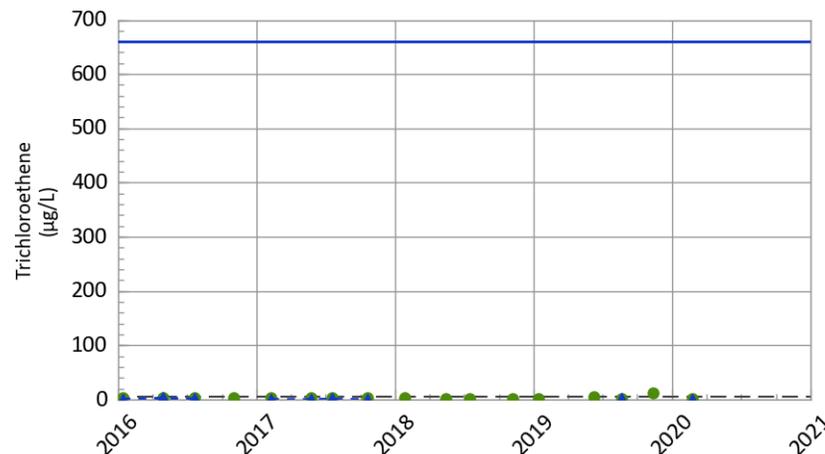
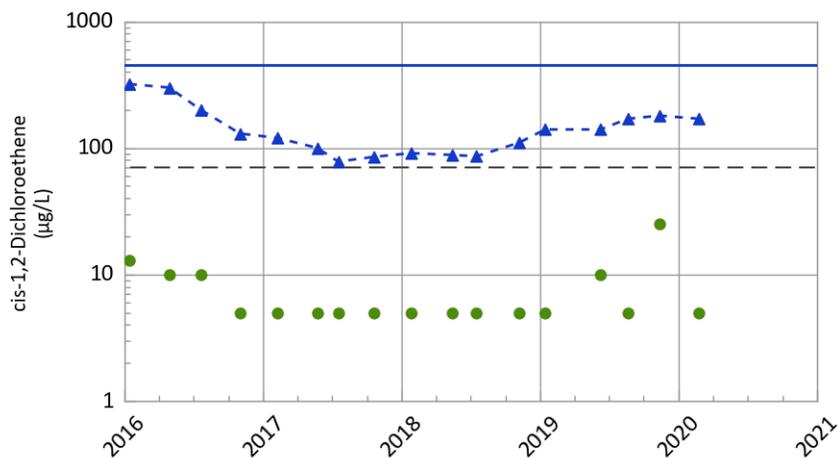
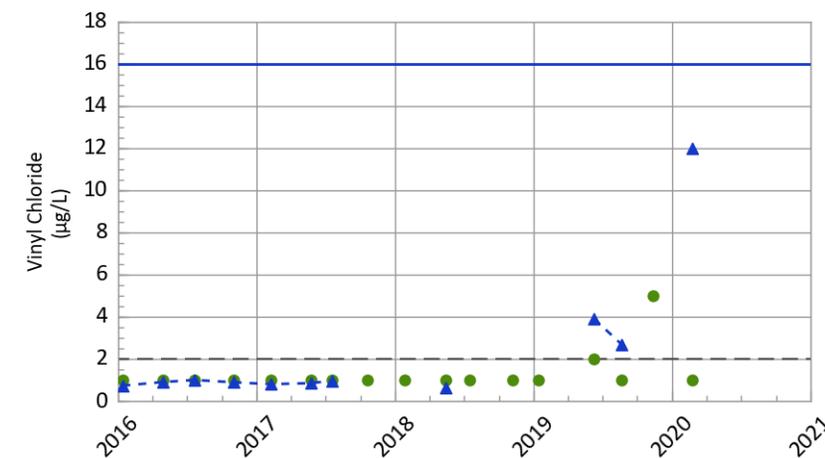
**PTX06-1155 Downgradient Performance Indicators
Zone 11 In Situ Bioremediation System
USDOE/NNSA Pantex Plant**

Most Recent Measured COC Concentrations (Feb 24, 2020)

COC	Concentration (µg/L)	GWPS (µg/L)
PERC	Non-Detect	26.0
DCE12C	170.0	70.0
TCE	0.59	5.0
VC	12.0	2.0

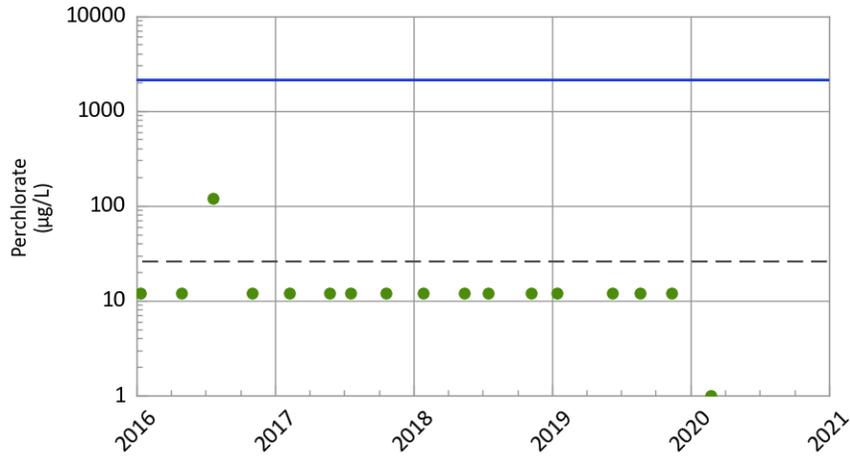
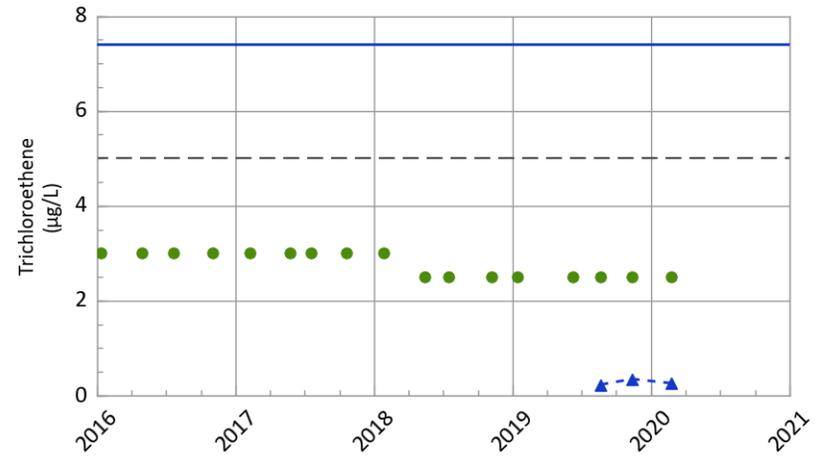
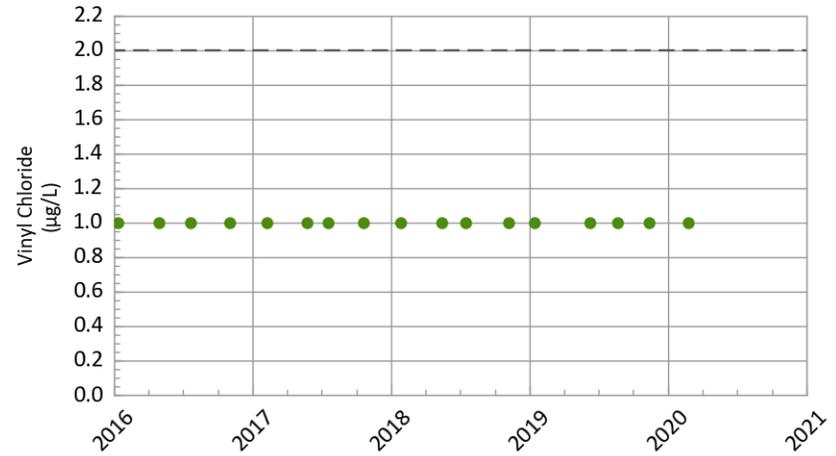
**PTX06-1156 Downgradient Performance Indicators
Zone 11 In Situ Bioremediation System
USDOE/NNSA Pantex Plant**

Most Recent Measured COC Concentrations (Feb 24, 2020)

COC	Concentration (µg/L)	GWPS (µg/L)
PERC	Non-Detect	26.0
DCE12C	1.8	70.0
TCE	0.26	5.0
VC	Non-Detect	2.0

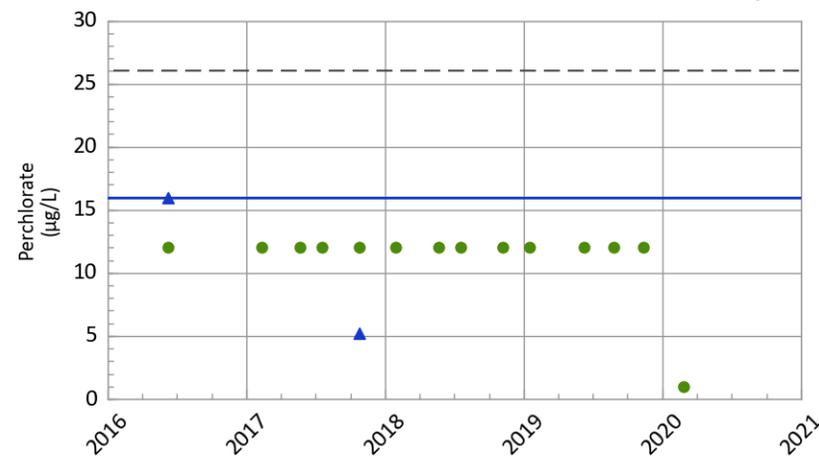
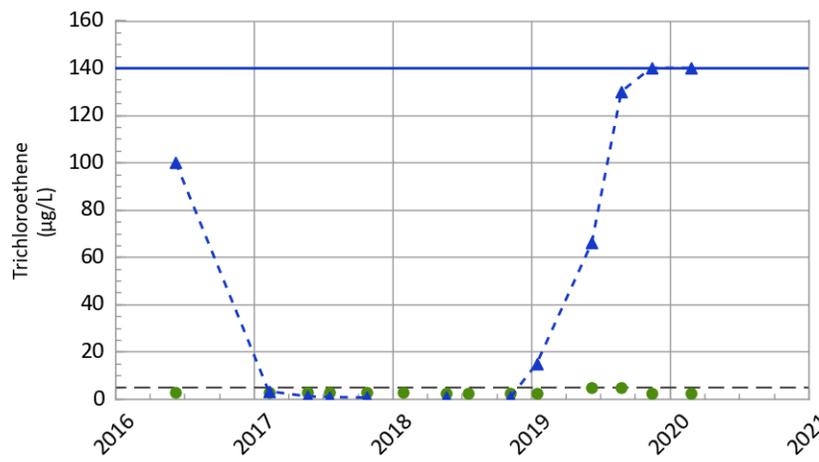
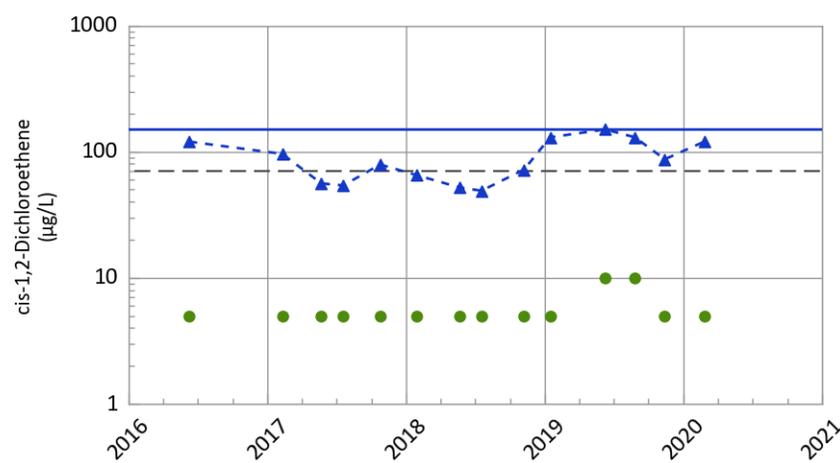
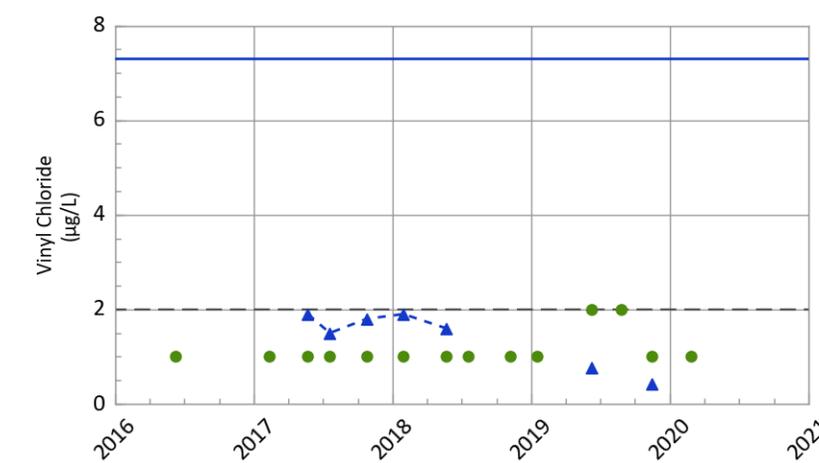
**PTX06-1173 Downgradient Performance Indicators
Zone 11 In Situ Bioremediation System
USDOE/NNSA Pantex Plant**

Most Recent Measured COC Concentrations (Nov 13, 2019)

COC	Concentration (µg/L)	GWPS (µg/L)
PERC	Non-Detect	26.0
DCE12C	120.0	70.0
TCE	140.0	5.0
VC	Non-Detect	2.0

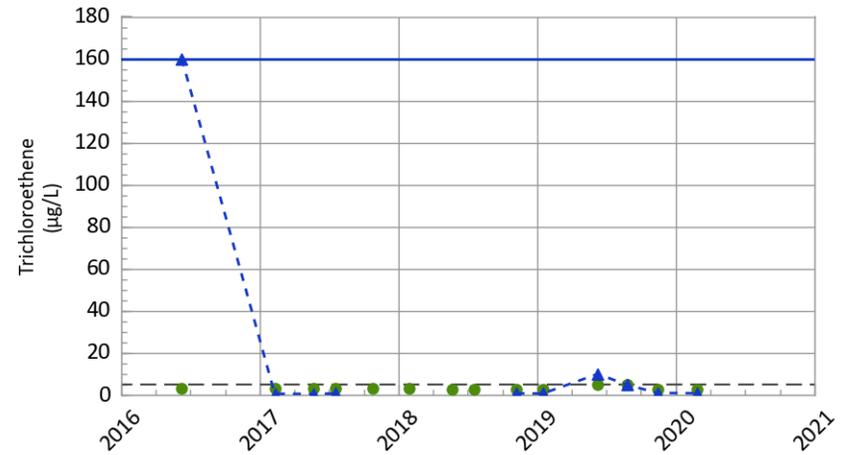
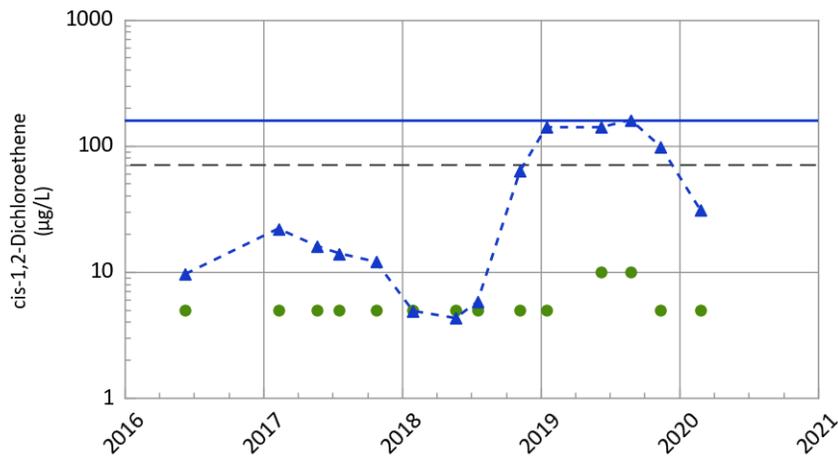
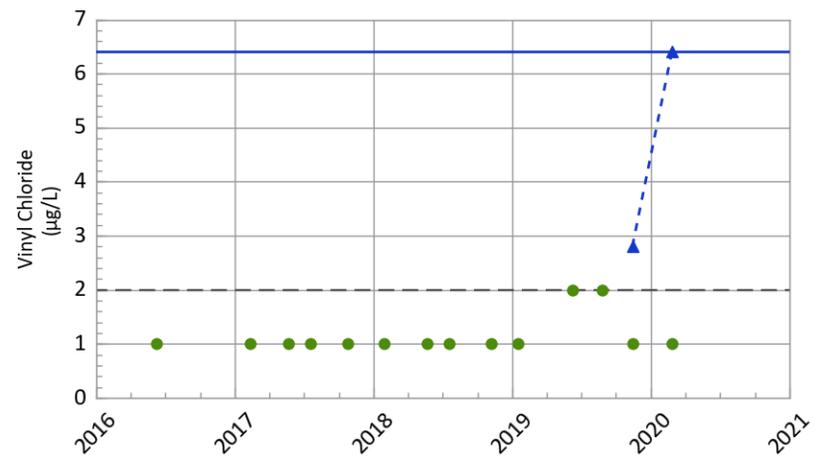
**PTX06-1174 Downgradient Performance Indicators
Zone 11 In Situ Bioremediation System
USDOE/NNSA Pantex Plant**

Most Recent Measured COC Concentrations (Feb 25, 2020)

COC	Concentration (µg/L)	GWPS (µg/L)
PERC	Non-Detect	26.0
DCE12C	31.0	70.0
TCE	0.83	5.0
VC	6.4	2.0

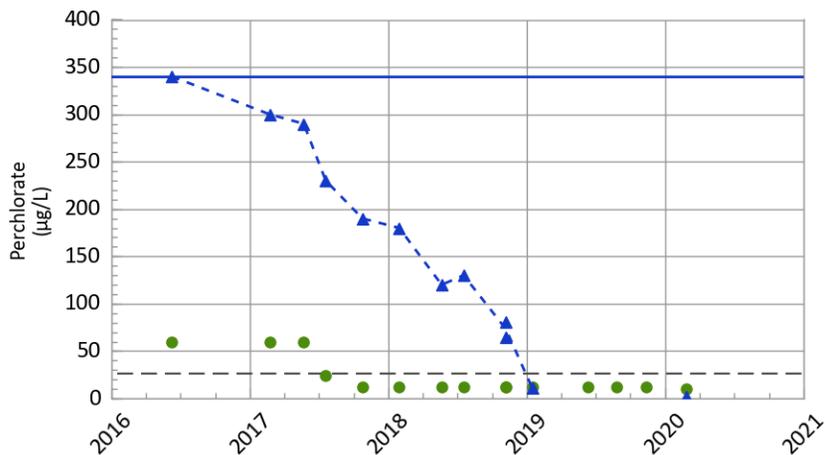
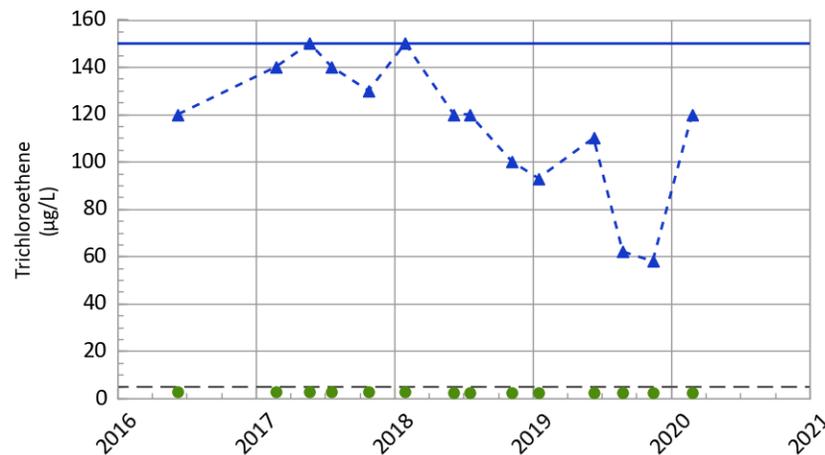
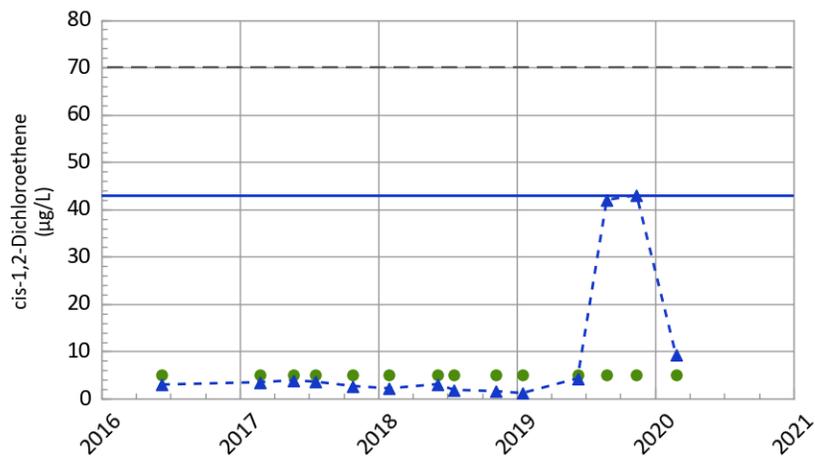
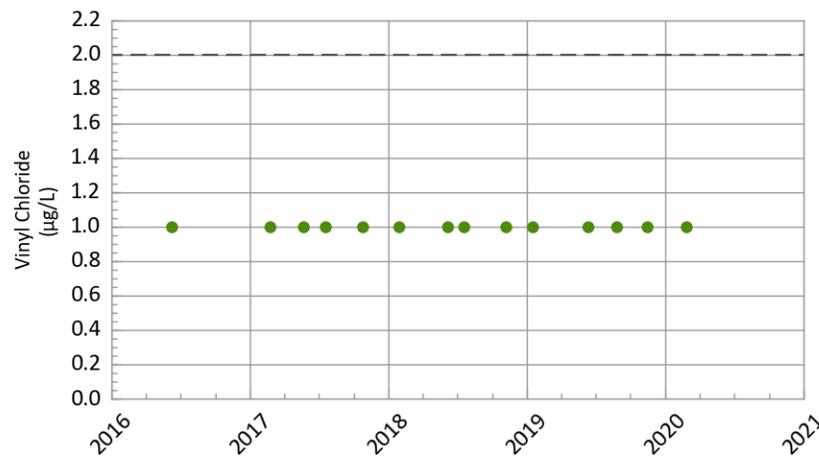
**PTX06-1175 Downgradient Performance Indicators
Zone 11 In Situ Bioremediation System
USDOE/NNSA Pantex Plant**

Most Recent Measured COC Concentrations (Feb 25, 2020)

COC	Concentration (µg/L)	GWPS (µg/L)
PERC	2.4	26.0
DCE12C	9.2	70.0
TCE	120.0	5.0
VC	Non-Detect	2.0

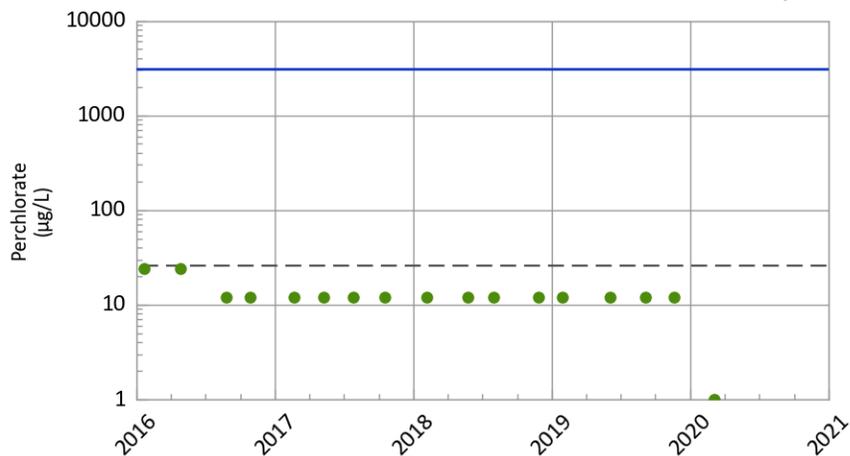
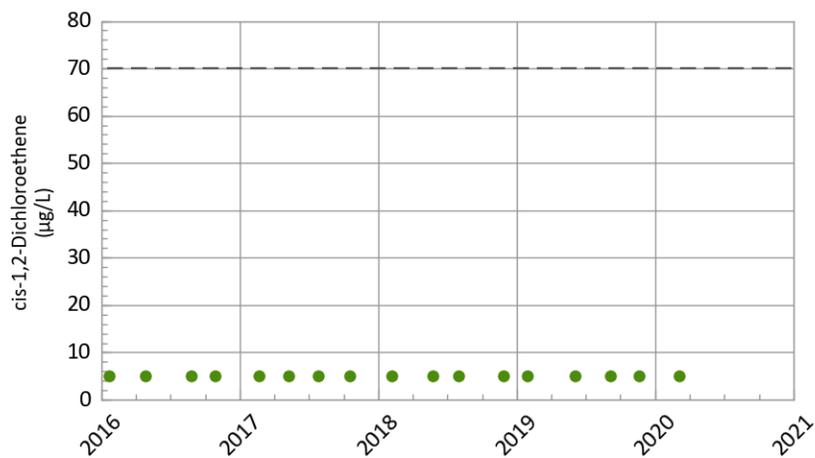
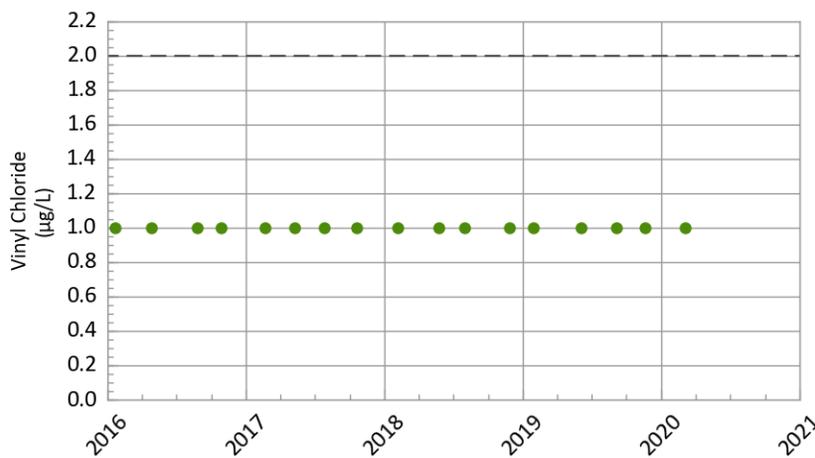
**PTX06-ISB082 Downgradient Performance Indicators
Zone 11 In Situ Bioremediation System
USDOE/NNSA Pantex Plant**

Most Recent Measured COC Concentrations (Mar 04, 2020)

COC	Concentration (µg/L)	GWPS (µg/L)
PERC	Non-Detect	26.0
DCE12C	Non-Detect	70.0
TCE	Non-Detect	5.0
VC	Non-Detect	2.0

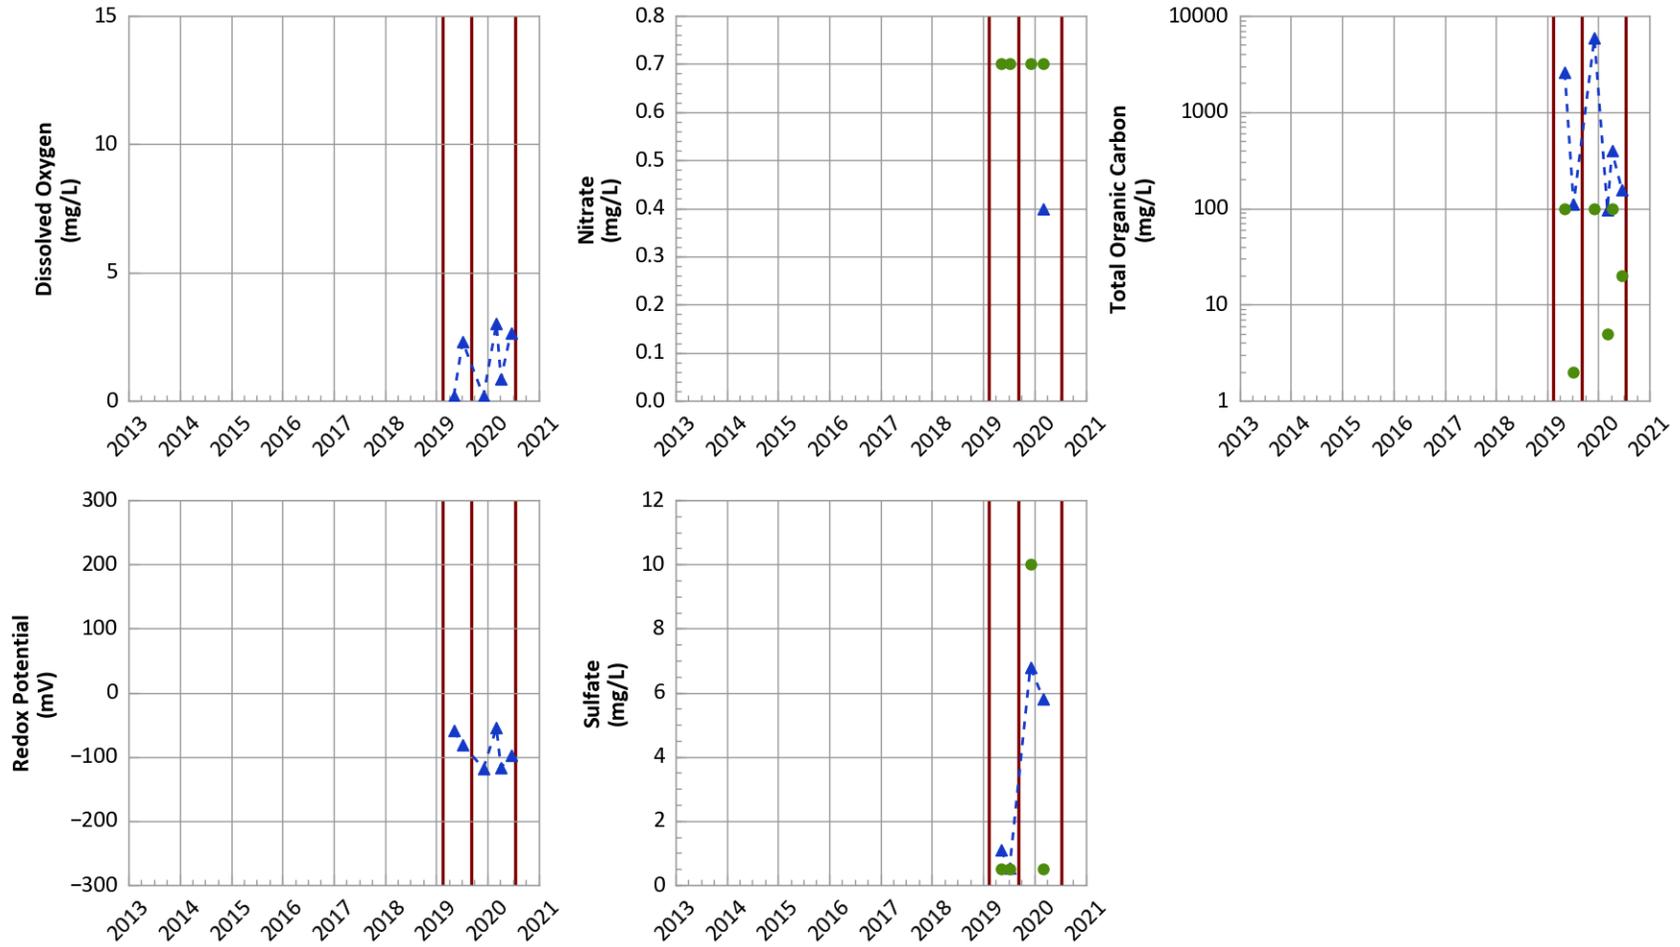
PTX06-ISB302 Treatment Zone Performance Indicators
USDOE/NNSA Pantex Plant

Typical Baseline Concentrations in Perched Groundwater
 Dissolved Oxygen: 5-10 mg/L
 Redox Potential: > 100 mV
 Nitrate: > 1 mg/L
 Sulfate: > 10 mg/L
 Total Organic Carbon: < 5 mg/L
 Total Volatile Fatty Acids: Not Detected

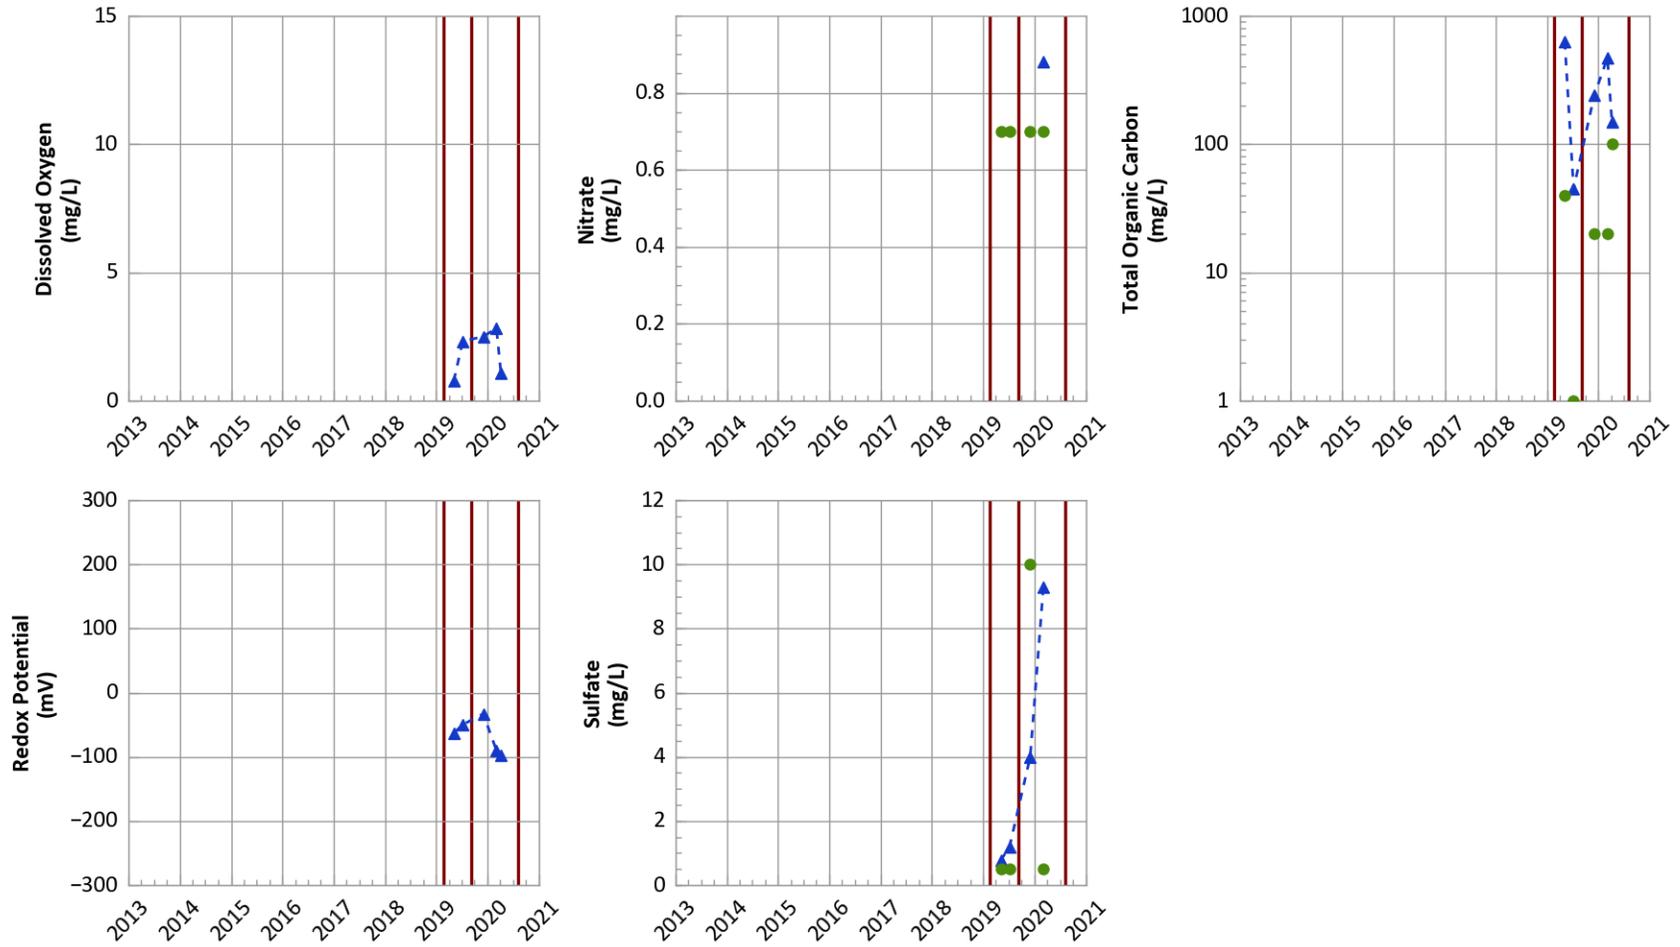
PTX06-ISB307 Treatment Zone Performance Indicators
USDOE/NNSA Pantex Plant

Typical Baseline Concentrations in Perched Groundwater

Dissolved Oxygen: 5-10 mg/L
 Redox Potential: > 100 mV
 Nitrate: > 1 mg/L
 Sulfate: > 10 mg/L
 Total Organic Carbon: < 5 mg/L
 Total Volatile Fatty Acids: Not Detected

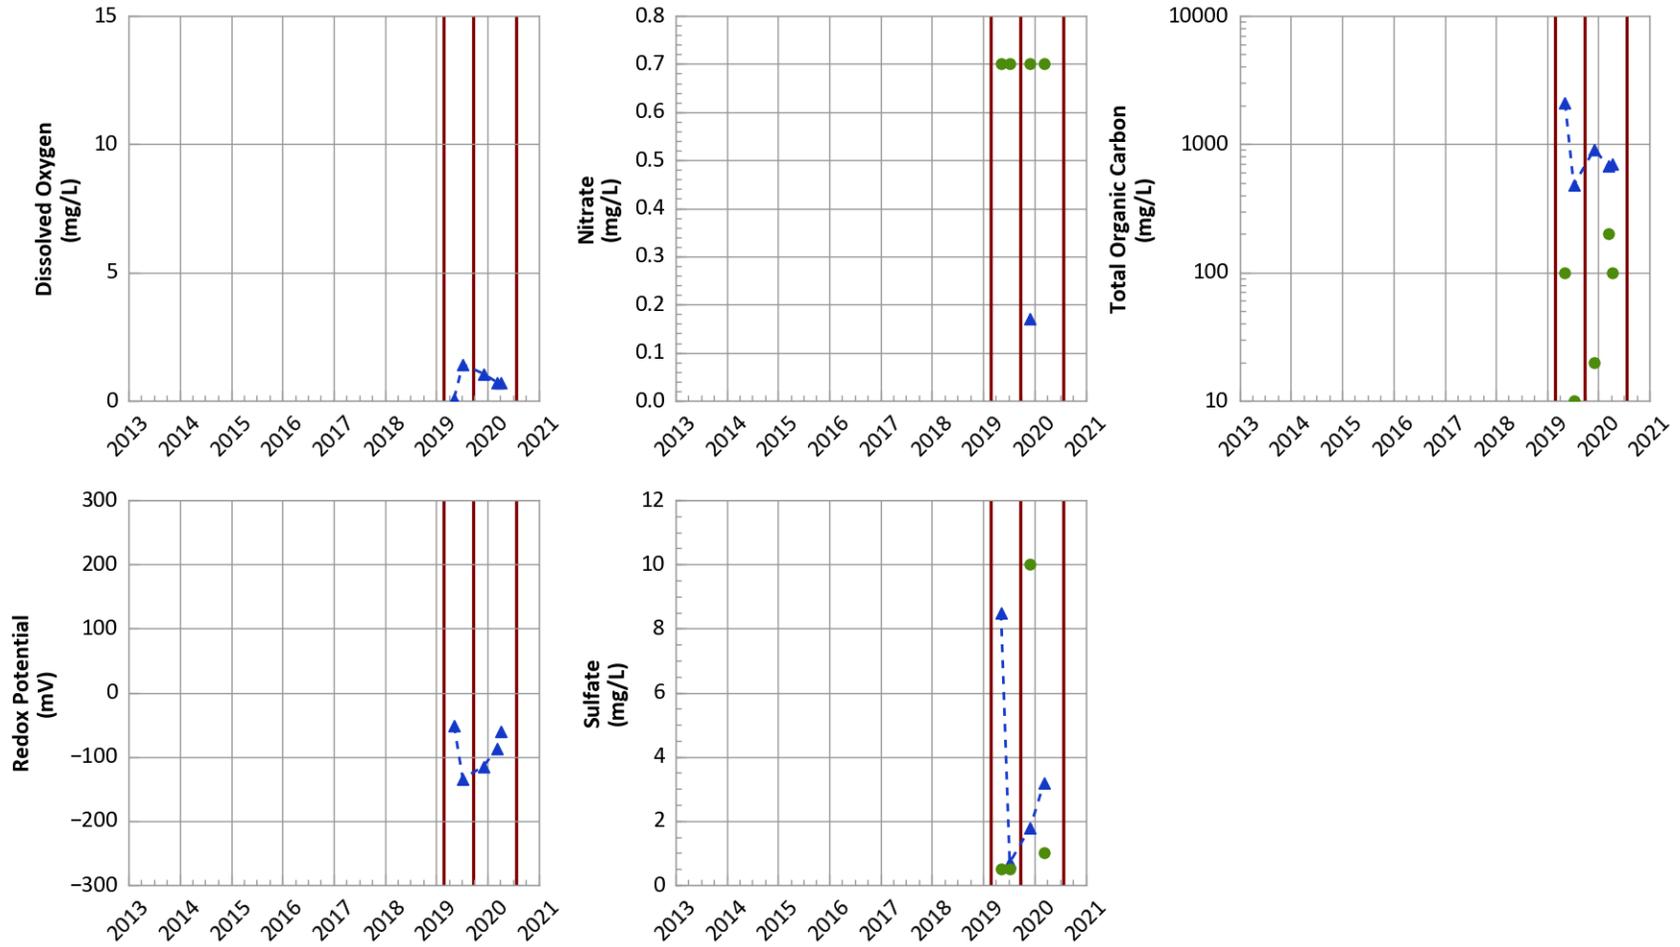
PTX06-ISB317 Treatment Zone Performance Indicators
USDOE/NNSA Pantex Plant

Typical Baseline Concentrations in Perched Groundwater

- Dissolved Oxygen: 5-10 mg/L
- Redox Potential: > 100 mV
- Nitrate: > 1 mg/L
- Sulfate: > 10 mg/L
- Total Organic Carbon: < 5 mg/L
- Total Volatile Fatty Acids: Not Detected

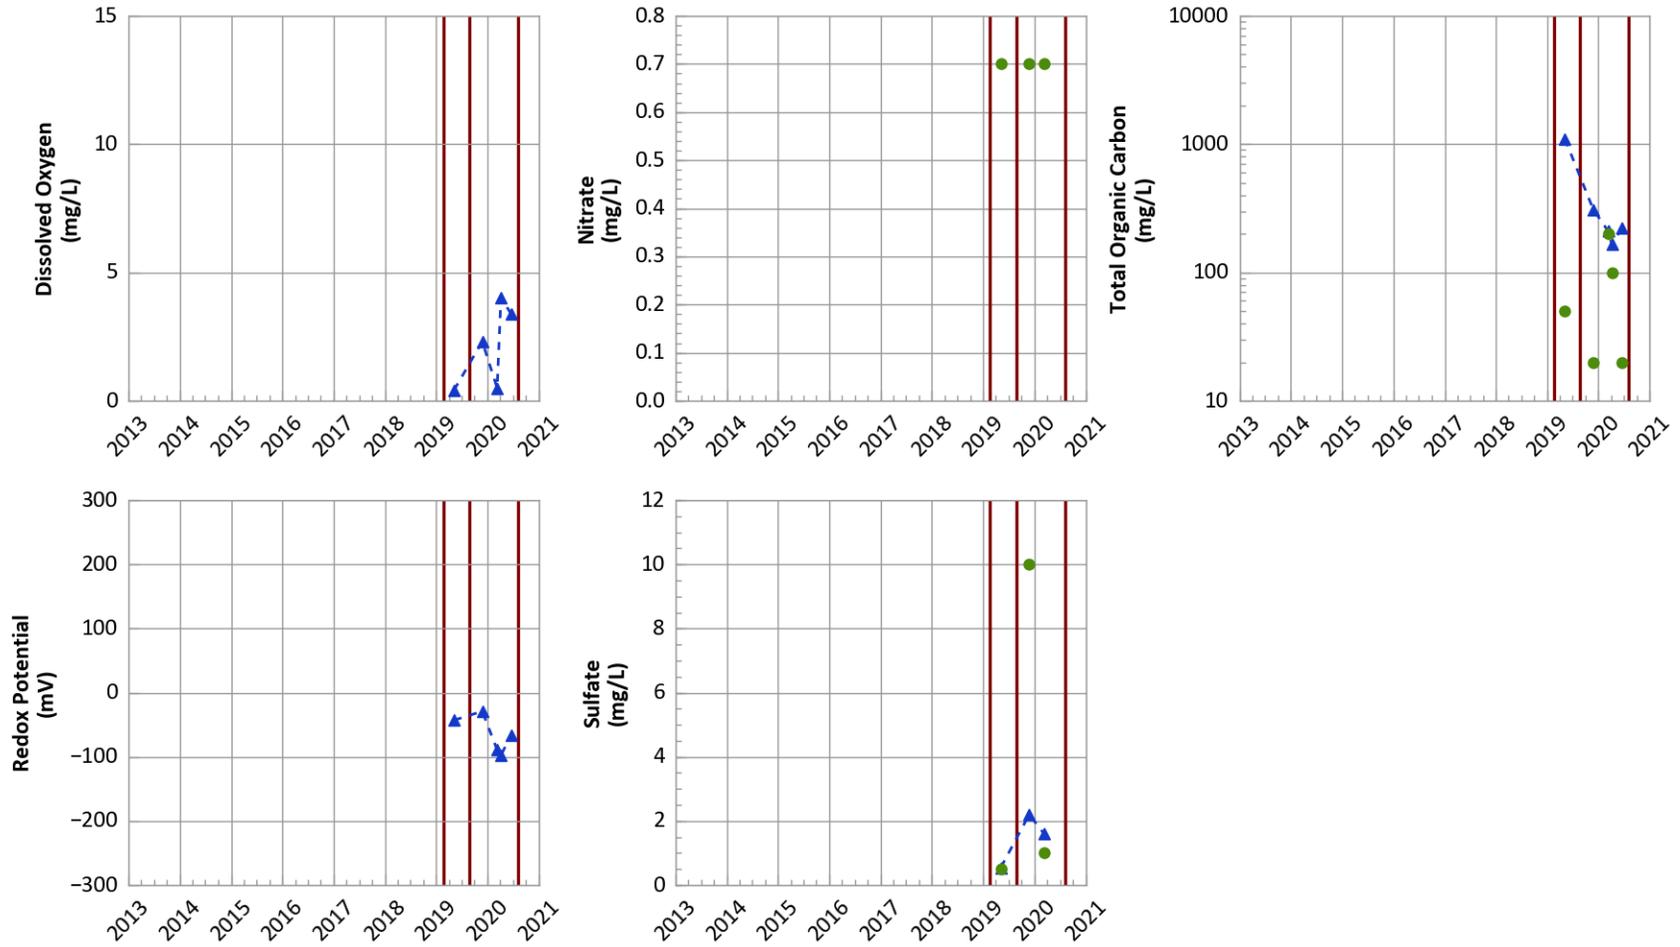
**PTX06-ISB321 Treatment Zone Performance Indicators
USDOE/NNSA Pantex Plant**

Typical Baseline Concentrations in Perched Groundwater

Dissolved Oxygen: 5-10 mg/L
 Redox Potential: > 100 mV
 Nitrate: > 1 mg/L
 Sulfate: > 10 mg/L
 Total Organic Carbon: < 5 mg/L
 Total Volatile Fatty Acids: Not Detected

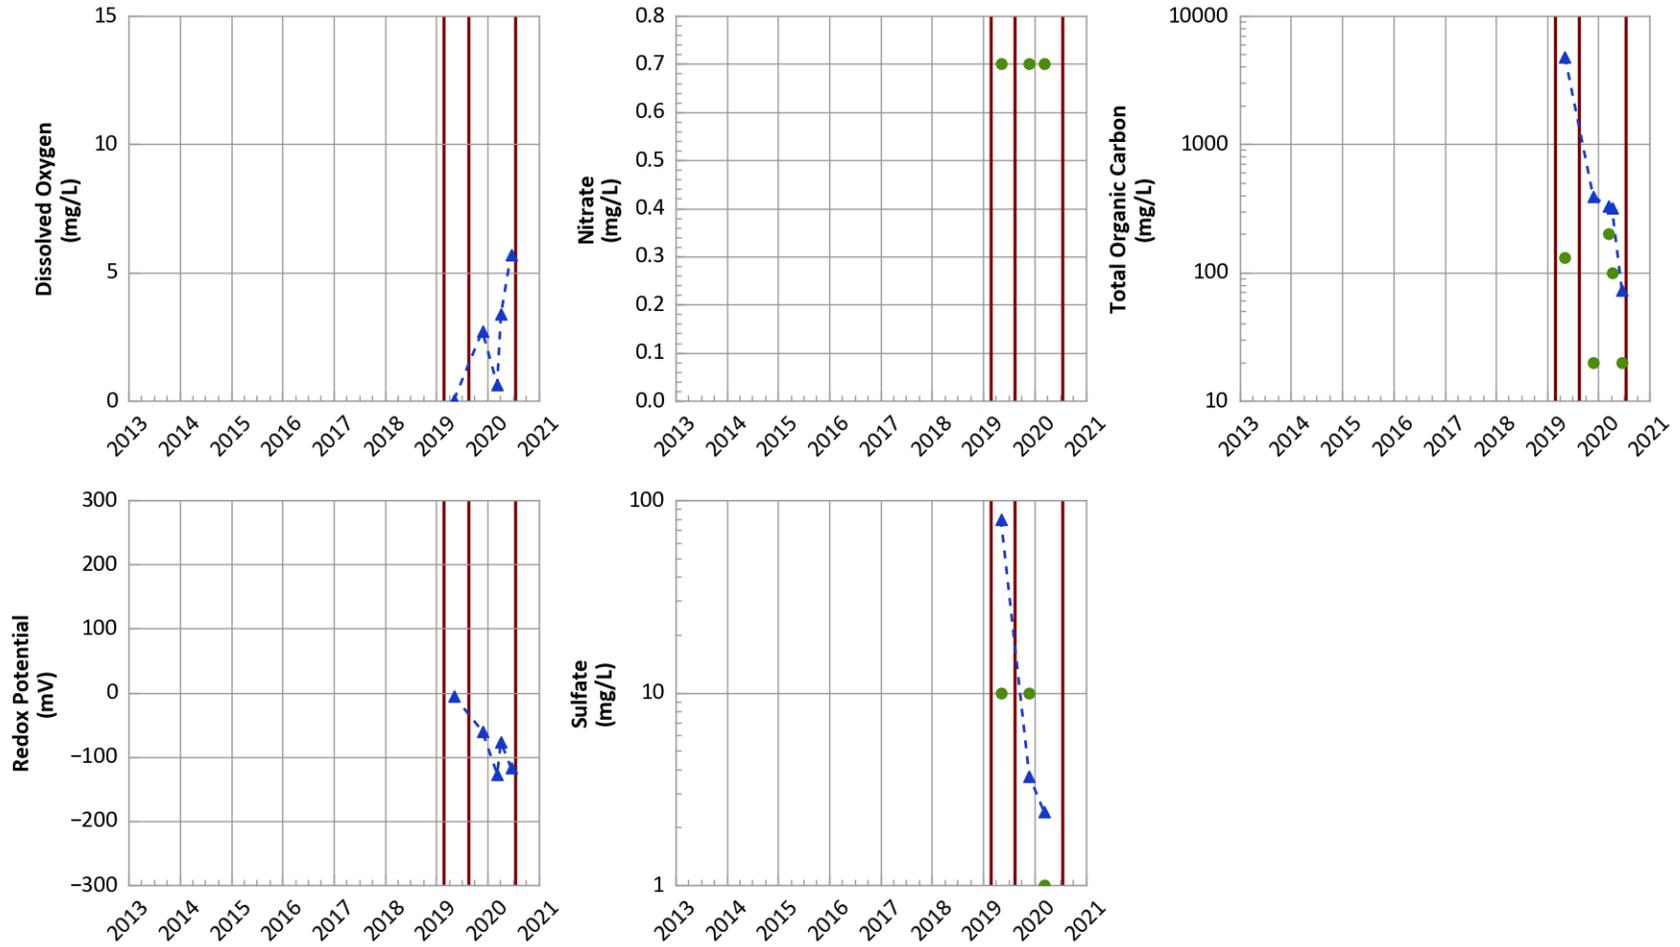
PTX06-ISB325 Treatment Zone Performance Indicators
USDOE/NNSA Pantex Plant

Typical Baseline Concentrations in Perched Groundwater

Dissolved Oxygen: 5-10 mg/L
 Redox Potential: > 100 mV
 Nitrate: > 1 mg/L
 Sulfate: > 10 mg/L
 Total Organic Carbon: < 5 mg/L
 Total Volatile Fatty Acids: Not Detected

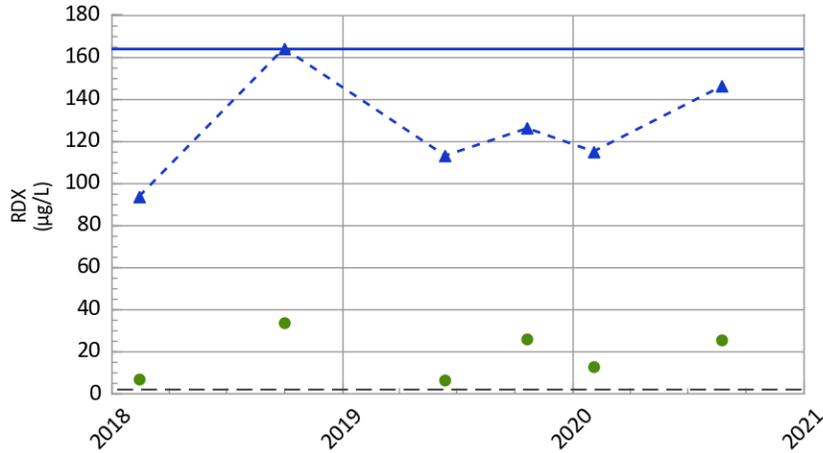
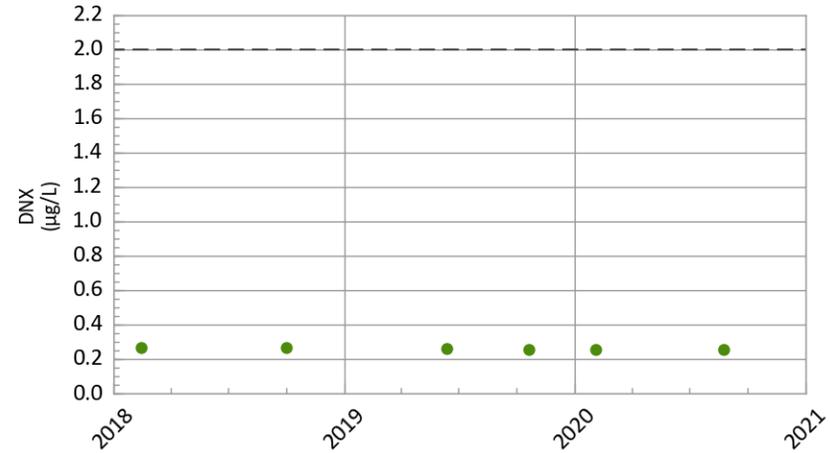
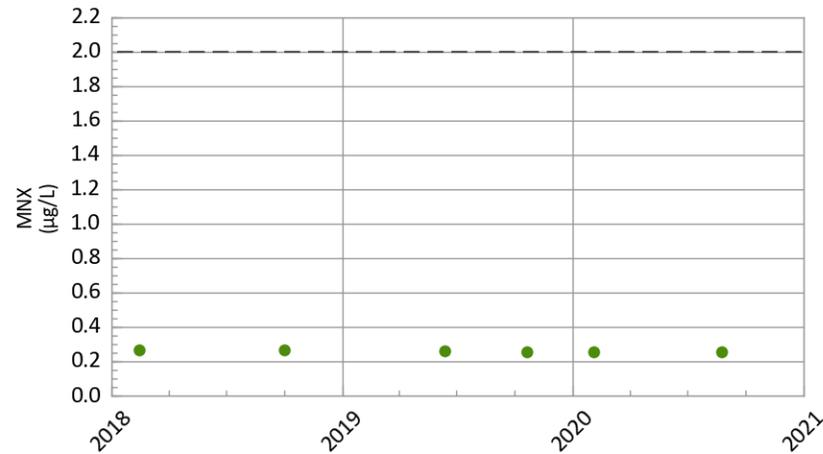
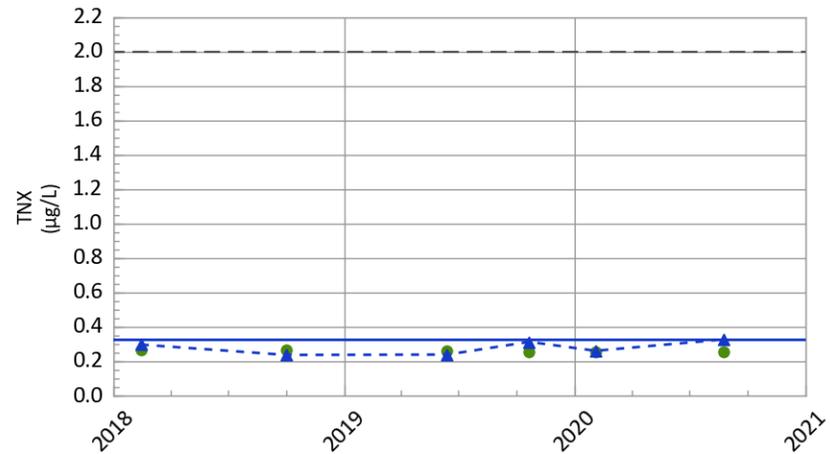
**PTX06-1191 Downgradient Performance Indicators
Southeast Ext In Situ Bioremediation System
USDOE/NNSA Pantex Plant**

Most Recent Measured COC Concentrations (Aug 24, 2020)

COC	Concentration (µg/L)	GWPS (µg/L)
RDX	146.0	2.0
MNX	Non-Detect	2.0
DNX	Non-Detect	2.0
TNX	0.327	2.0

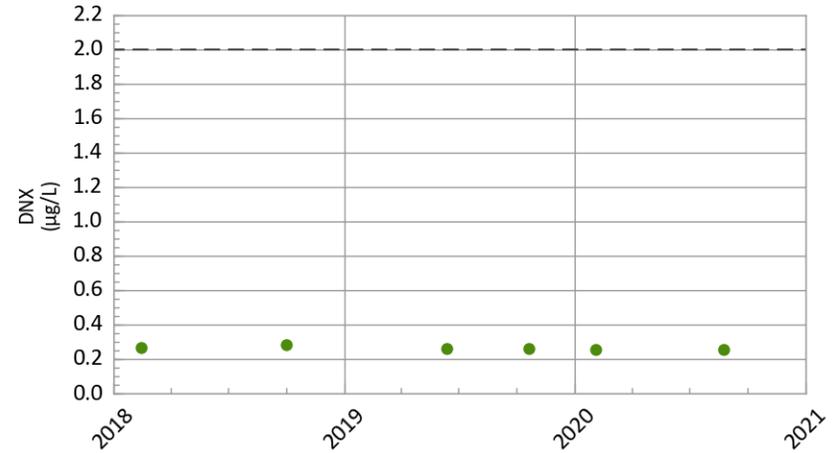
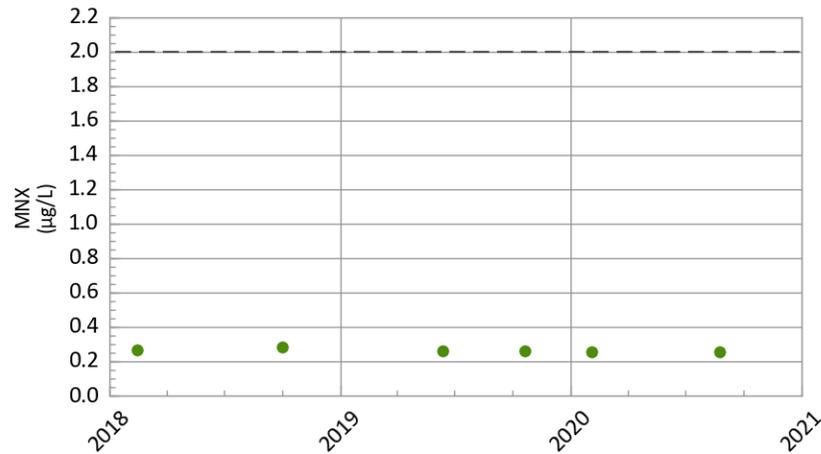
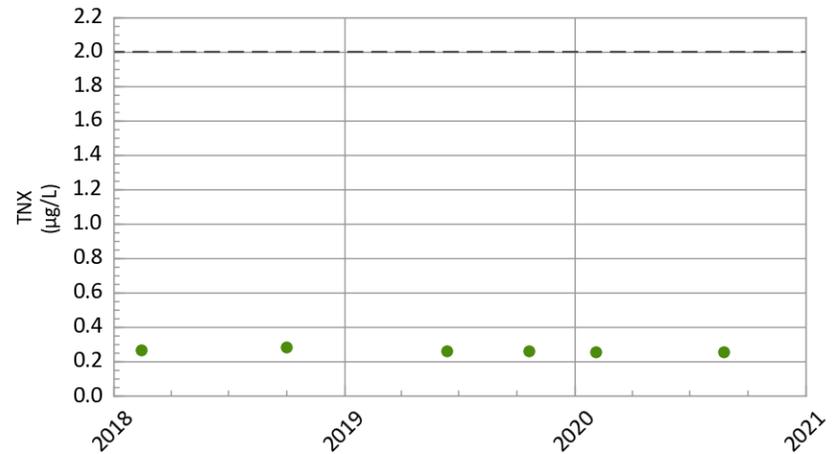
**PTX06-1194 Downgradient Performance Indicators
Southeast Ext In Situ Bioremediation System
USDOE/NNSA Pantex Plant**

Most Recent Measured COC Concentrations (Aug 24, 2020)

COC	Concentration (µg/L)	GWPS (µg/L)
RDX	Non-Detect	2.0
MNX	Non-Detect	2.0
DNX	Non-Detect	2.0
TNX	Non-Detect	2.0

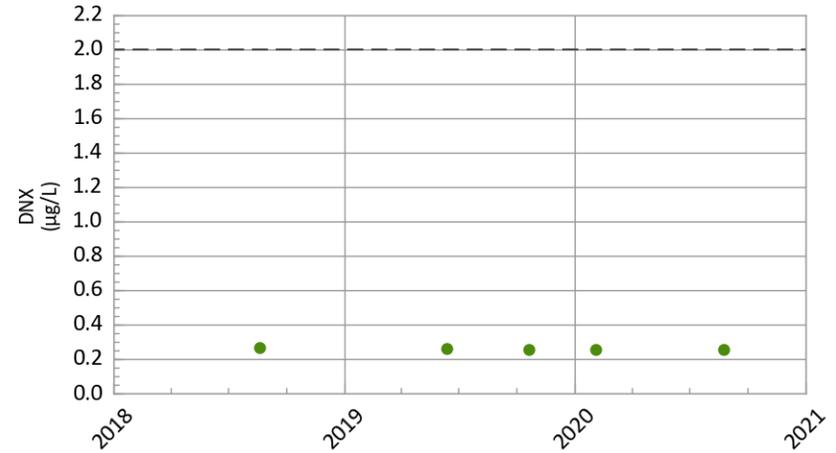
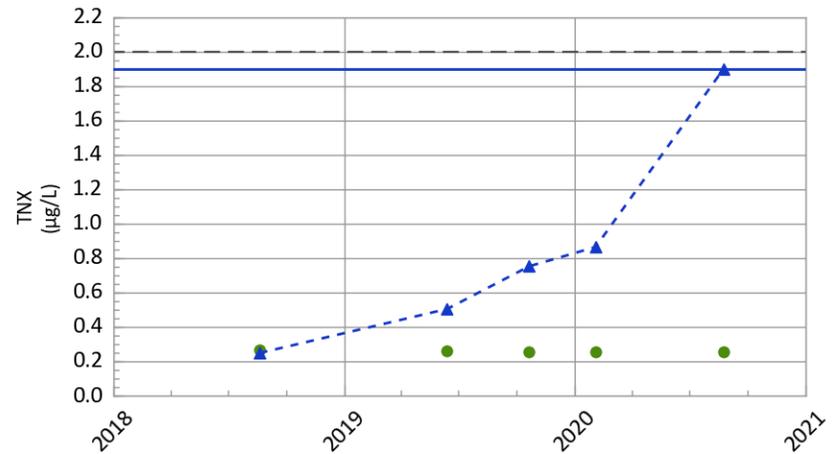
**PTX06-1196 Downgradient Performance Indicators
Southeast Ext In Situ Bioremediation System
USDOE/NNSA Pantex Plant**

Most Recent Measured COC Concentrations (Aug 24, 2020)

COC	Concentration (µg/L)	GWPS (µg/L)
RDX	29.9	2.0
MNX	Non-Detect	2.0
DNX	Non-Detect	2.0
TNX	1.9	2.0
