# Ecological Risk Assessment Summary

Pantex Plant – Amarillo, Texas

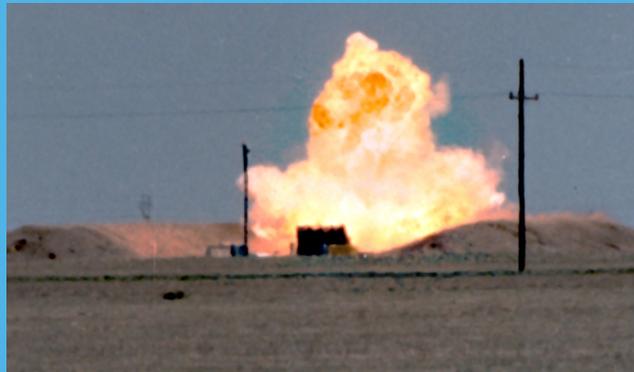
This photo shows testing of high explosives at a Pantex firing Site.

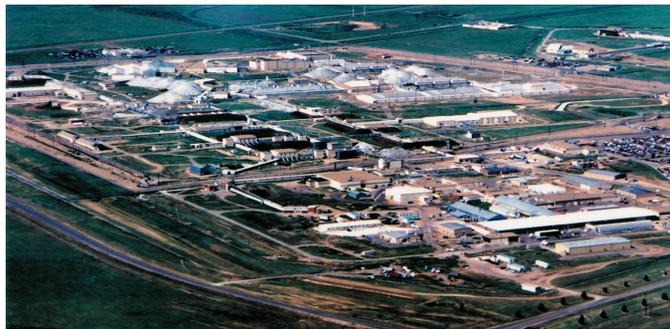
*Aerial photograph of Zone 12 at Pantex Plant.*

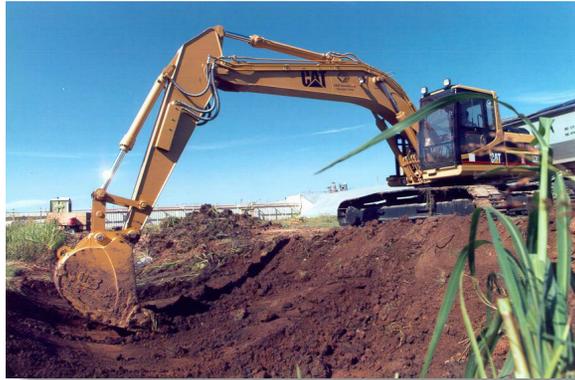
*Excavation of ditch soils in Zone 11.*

Pantex has removed chemical hotspots in affected soils and backfilled with clean soil in many of the industrial areas (Zones 11 and 12), Zone 10, Burning Ground, Firing Site 5, landfills, and ditches. These excavations have removed affected soils that can be contacted by plants and animals and will also help prevent runoff of chemicals to other areas.

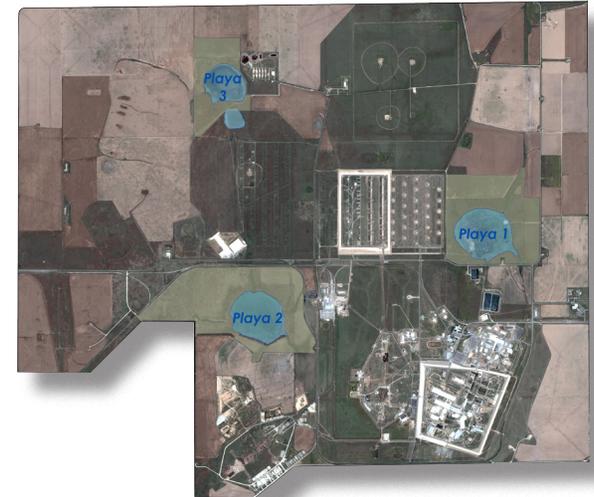
*Playa Management Units for Playas 1, 2, and 3.*

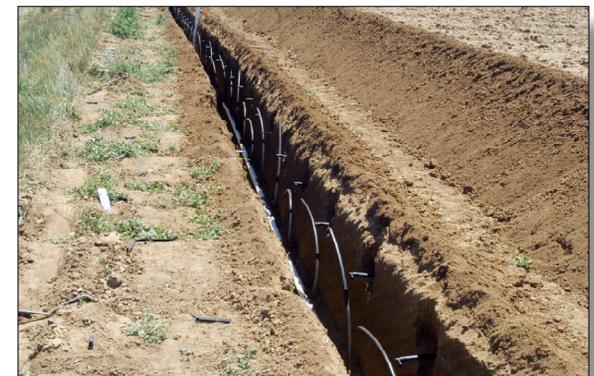
*Installation of a subsurface irrigation system near Playa 1.*

Pantex installed a subsurface irrigation system in the croplands at Pantex in 2005 to minimize discharge of the wastewaters from the Wastewater Treatment Facility to Playa 1. This measure reduced infiltration to perched groundwater and returned Playa 1 to its natural ecological condition.

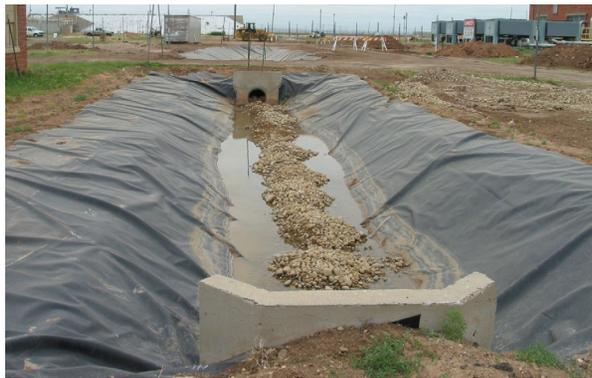
*Installation of a ditch liner in Zone 12.*

Ditches are lined to reduce infiltration from natural runoff in the industrial zones. This also reduces runoff to the downstream ditches and the playas. These measures help protect the playa wetlands and the plants and animals that use the playas.

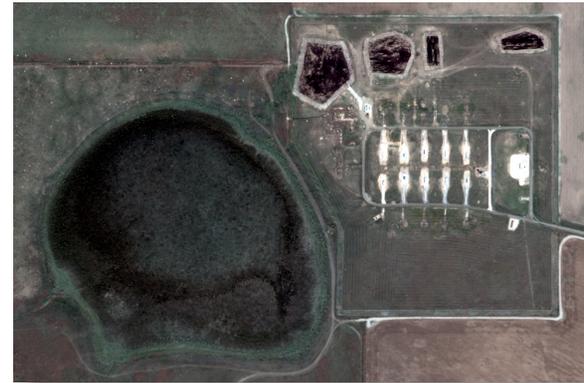
*Newly installed landfill covers appear black in this June 2005 photo of the Burning Ground and Playa 3.*

Several landfills had up to three feet of new cover material added to reduce dust emissions, promote runoff of rainwater, and to eliminate chemicals from running off to the surrounding lands and the playas. These covers significantly improve the habitat for animals that use the surface soils.

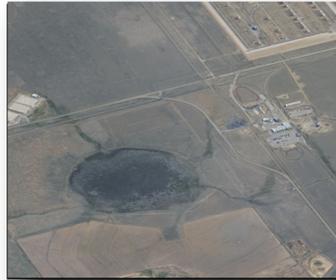
Playa 2 contains about 74 acres of wetland habitat and is wet only in response to rainfall events. Some of the areas around Playa 2 are farmed, and managed grazing is allowed in Playa 2. Playa 2 is also actively managed under the Pantex Playa Management Plan. An extensive prairie dog community surrounds Playa 2 to the west, north, and east. Results of the investigation of Playa 2 indicate sediments have been impacted by persistent chemicals, including metals and SVOCs. A single detection of a VOC was found at Playa 2.

**Playa 2 and Associated Ditches** received treated and untreated industrial discharges from a portion of Zone 11. Discharges from facilities in this portion of Zone 11 were much less than those sent to Playa 1 because most of the water from the high explosive facility in Zone 11 was routed to a treatment facility that released wastewater to ditches leading to Playa 1. Wastewater practices changed over time until all discharges to the ditches were discontinued in 1999.

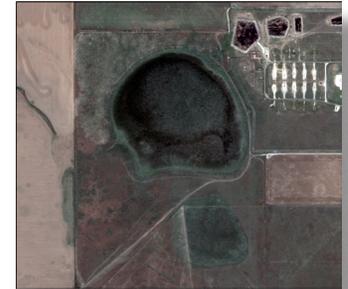
Playa 3 and its small sub-basin to the south contain about 54 acres of wetland habitat. These two playa basins are connected when enough water is present. Playa 3 is surrounded by agricultural land on three sides with the Burning Ground adjacent to the east. Playa 3 is actively managed under the Pantex Playa Management Plan, and managed grazing is allowed under this plan. A small prairie dog community surrounds Playa 3. Results of the investigation indicate Playa 3 has been impacted by low levels of metals, pesticides, SVOCs, and VOCs. A single detection of one high explosive was found at Playa 3.

**Playa 3** receives stormwater runoff from the Burning Ground and surrounding agricultural lands. Playa 3 was investigated for impacts because of potential runoff from solvent evaporation pits and burn pads that were formerly used in the adjacent Burning Ground.

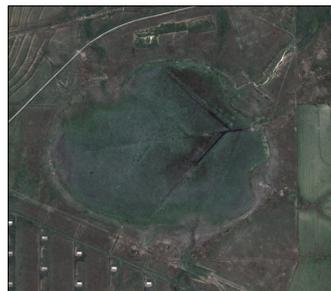
Playa 4 contains about 113 acres of wetland habitat and is only wet in response to rainfall events. Playa 4 is grazed and the surrounding agricultural area is managed by TTU. An extensive prairie dog community surrounds Playa 4. Results of the investigation indicate Playa 4 is impacted by low levels of metals, pesticides, SVOCs, and VOCs.

**Playa 4 and Associated Ditches** are located on Texas Tech University (TTU) property south of Pantex and formerly received treated and untreated industrial discharges from the southern portions of Zones 11 and 12. Discharges to Playa 4 were much less than those sent to Playa 1 because no high explosive fabrication facilities were located in those areas. Wastewater practices changed over time until all discharges to the ditches were discontinued in 1999.

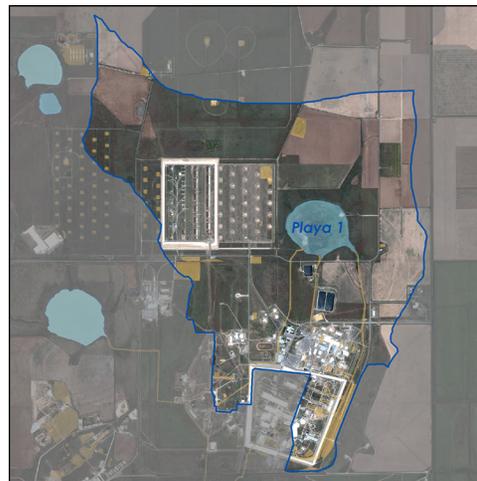
### Playa 1 Drainage Basin

Playa 1 receives stormwater runoff from its surrounding basin, including many of the industrial areas at Pantex. The drainage basin for Playa 1 covers 2,430 acres. Approximately 7% of the basin contains impacted areas (highlighted in orange) that could contribute chemicals to the playa basin.

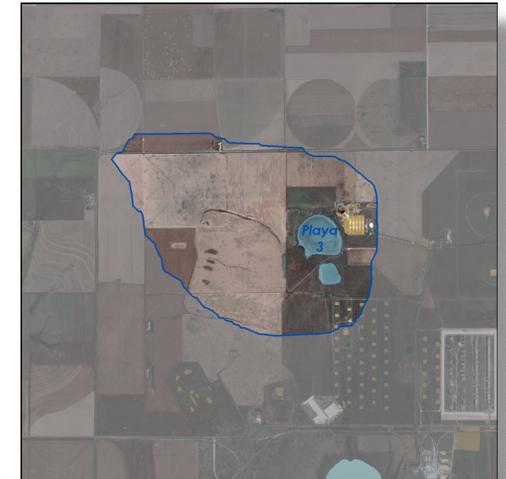
### Playa 3 Drainage Basin

Playa 3 receives stormwater runoff from the Burning Ground and surrounding agricultural lands. A second smaller sub-basin just south of Playa 3 was also investigated as part of the future risk evaluation. The two playa basins are only connected when enough water is present in the playas. For this reason, each playa basin was assessed separately. The Playa 3 sub-basin receives runoff from surrounding agricultural lands and the Firing Sites to the south. The Playa 3 drainage basin covers approximately 980 acres. Approximately 6% of the basin contains impacted areas that could contribute chemicals to the playa basin. The Playa 3 sub-basin covers approximately 210 acres. Less than 1% of the basin contains impacted areas that could contribute chemicals to the playa basin.
